MEMORANDUM

TO: Monica Styles - ETP and Nick Bryan - ETP
FROM: Richard Wardrop, P.G., GES
CC: Dave Demko, P.G., GES
DATE: August 17, 2020
SUBJECT: Restart Report – Mariner East 2 HDD S3-0290
Milford Road / Little Connestoga Road
Upper Uwchlan Township, Chester County,
Pennsylvania

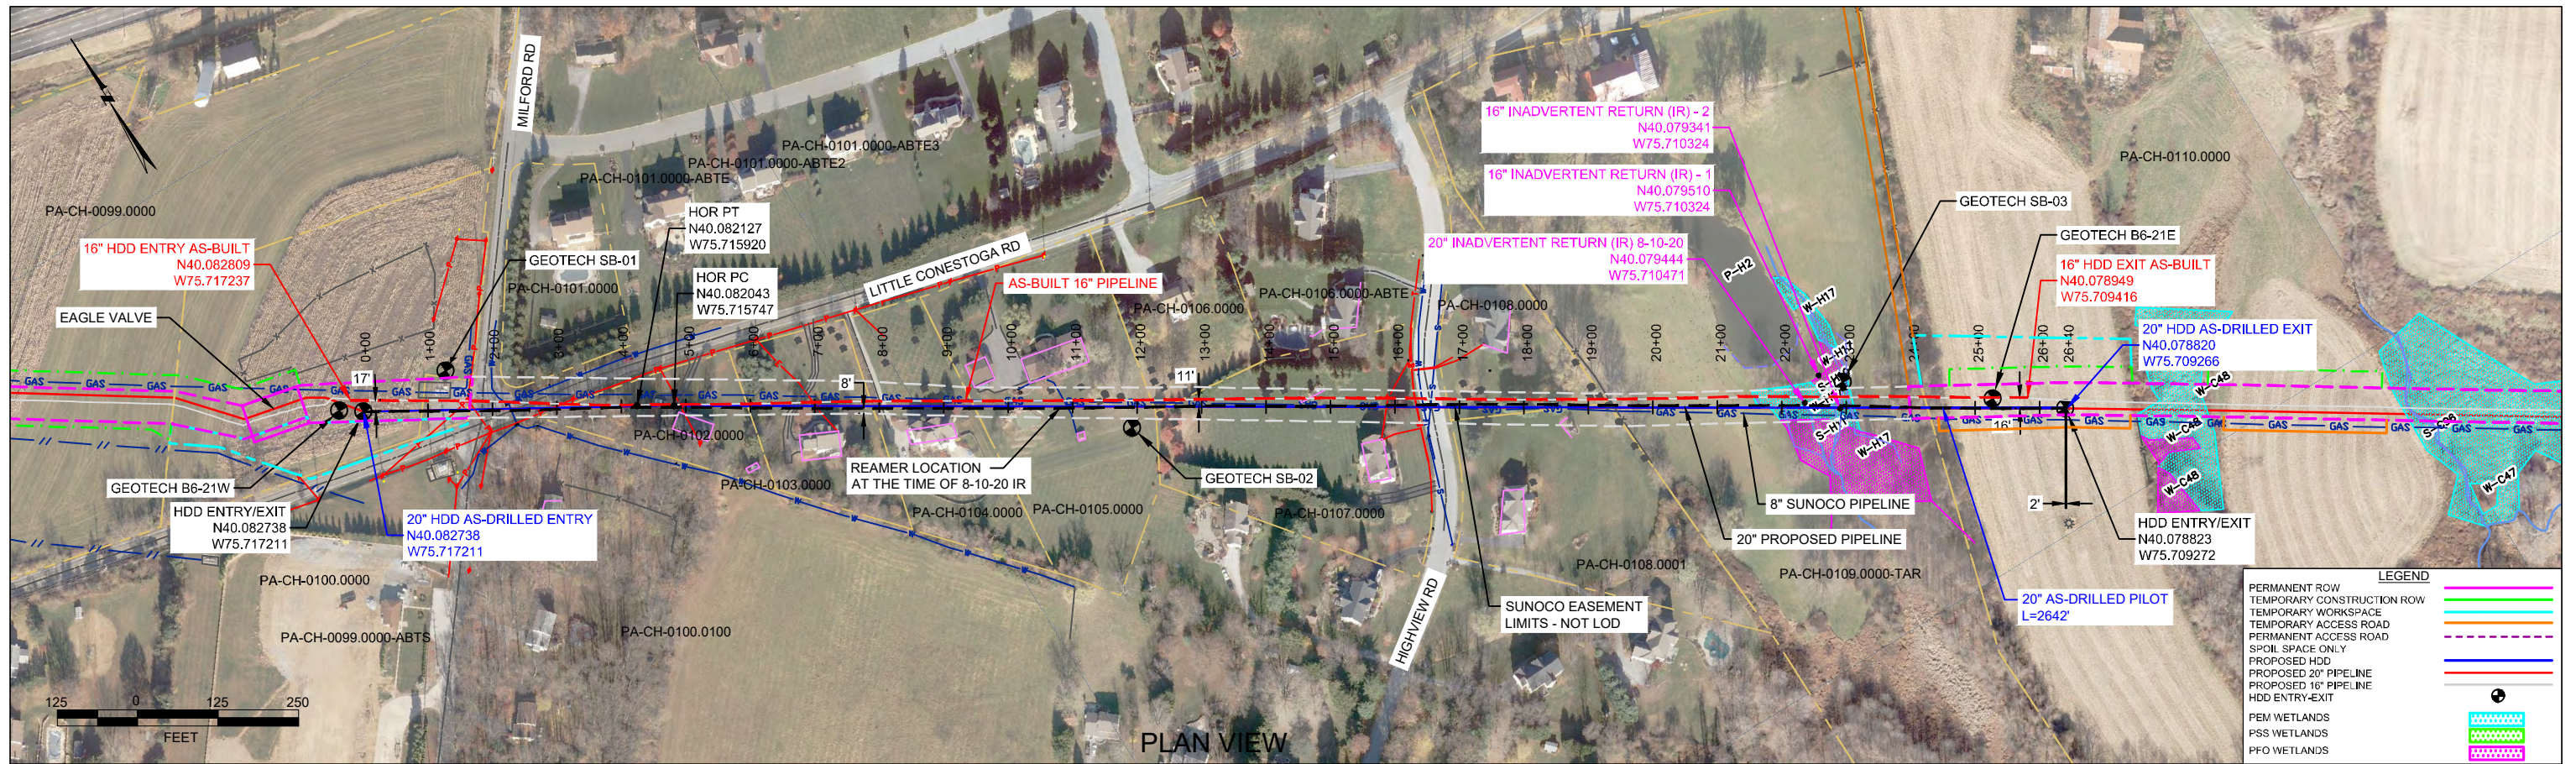
Attachment A – As-built Plan and Profile

On August 10, 2020, the 30-inch reamer was advancing northwest and was approximately 1,170 feet northwest of the IR location, as measured along the profile, when the IR occurred. At that time, the contractor was attempting to regain lost circulation at the southeast entry/exit. They advanced a wash over tool, over the drill string, and cleared bridging in the annulus between the reamer and the southeast entry/exit. During this process, the IR occurred. HDD drilling experts on the HDD team believe the IR occurred due to a build-up of fluid northwest of the bridging, within a higher section of the borehole, that was instantaneously released back to the southeast and flowed to the surface at the IR.

Attachment A shows the depth and position of the reaming bit when the IR was discovered on August 8, 2020. The 30-inch reamed hole had been advanced approximately 1,574 feet along the profile and was approximately 1,190 feet horizontal distance northwest of the location of the IR when the IR occurred. The depth of the bit was approximately 215 feet below ground surface.

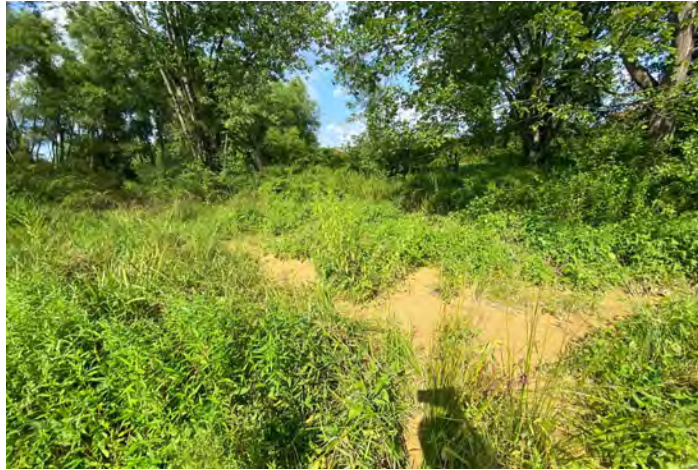
View of drilling fluid within WL-H17 at location of IR release point.

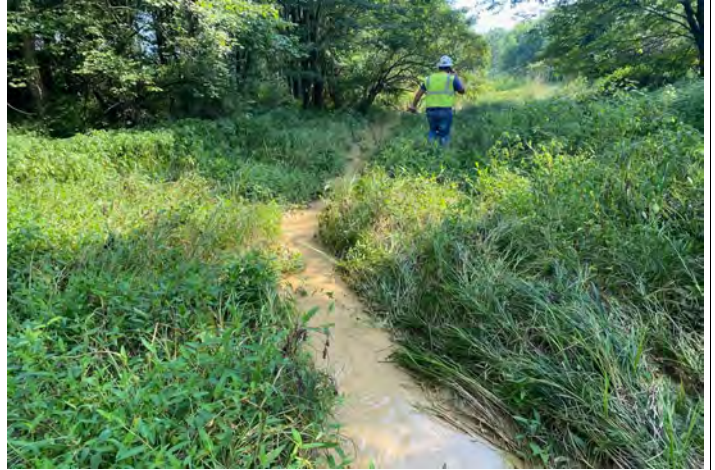
View of drilling fluid flowing downstream within stream S-H10 (UNT to Marsh Creek).

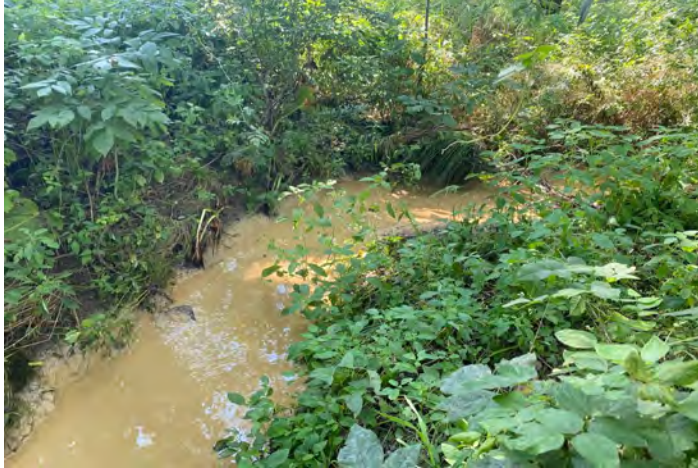
View of drilling fluid within stream S-H10 (UNT to Marsh Creek).

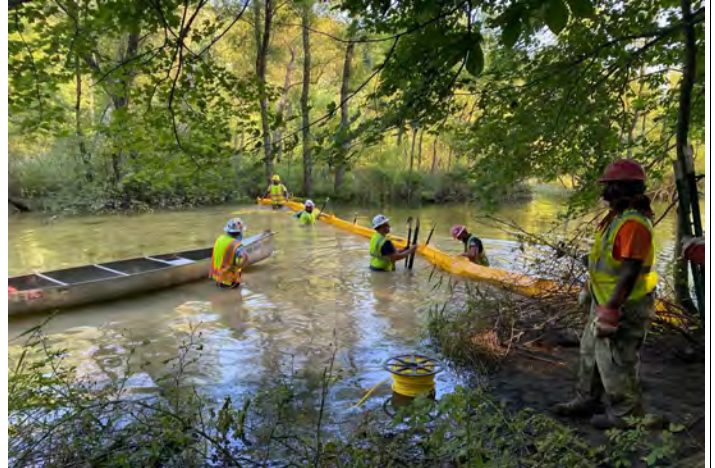
View of contractor crew members installing two turbidity curtains at the confluence of stream S-H10 (UNT to Marsh Creek) and pond H3 (Marsh Creek Reservoir).

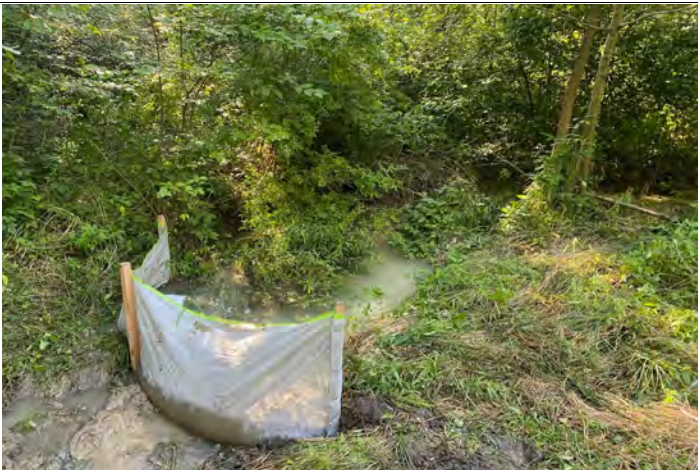
View of sand bag and silt fence dam constructed within stream S-H10 (UNT to Marsh Creek).
