Active and Abandoned Mine Operations

New Hope Crushed Stone

Monthly Update

February and March 2017

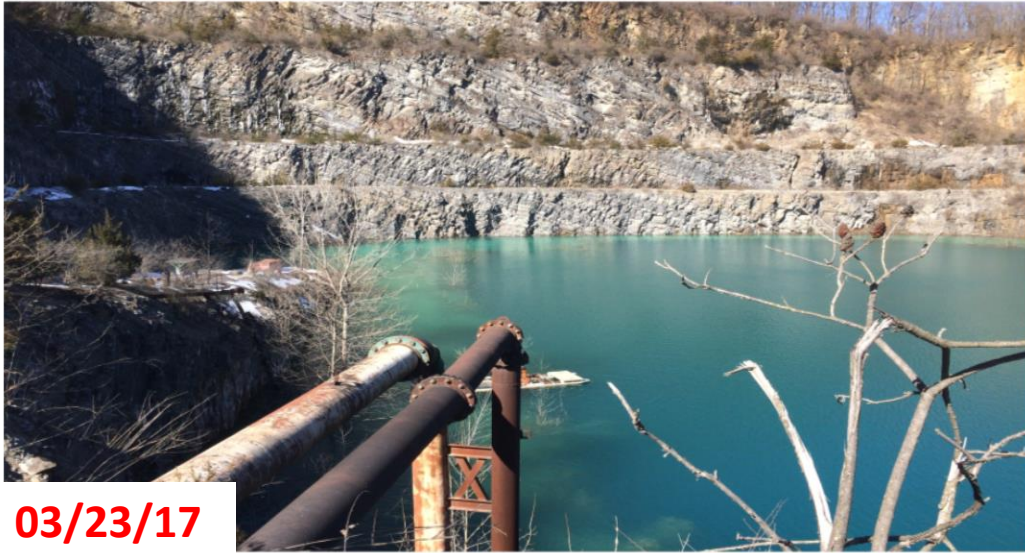
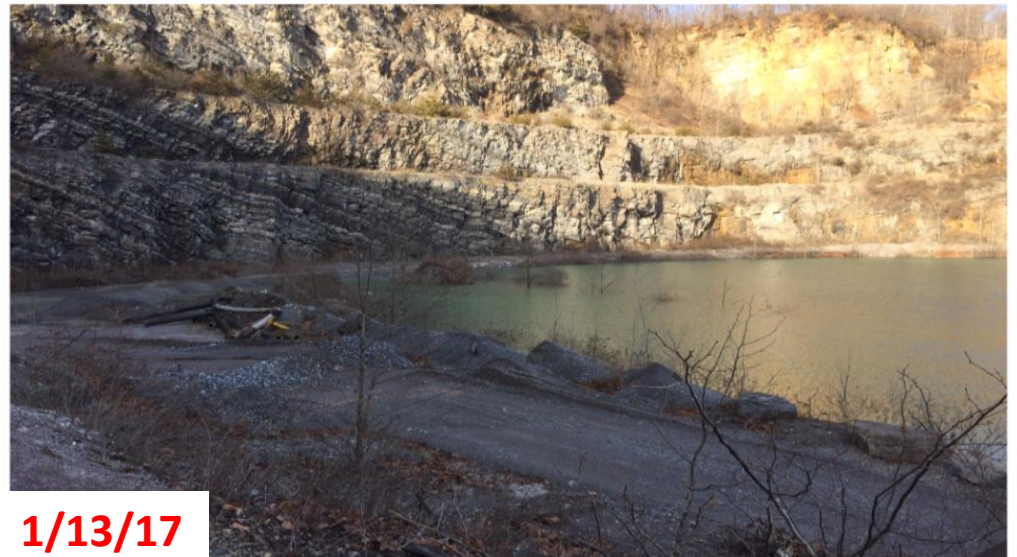
Sump - Reclamation

Sump area water level is up about 3 feet from January.

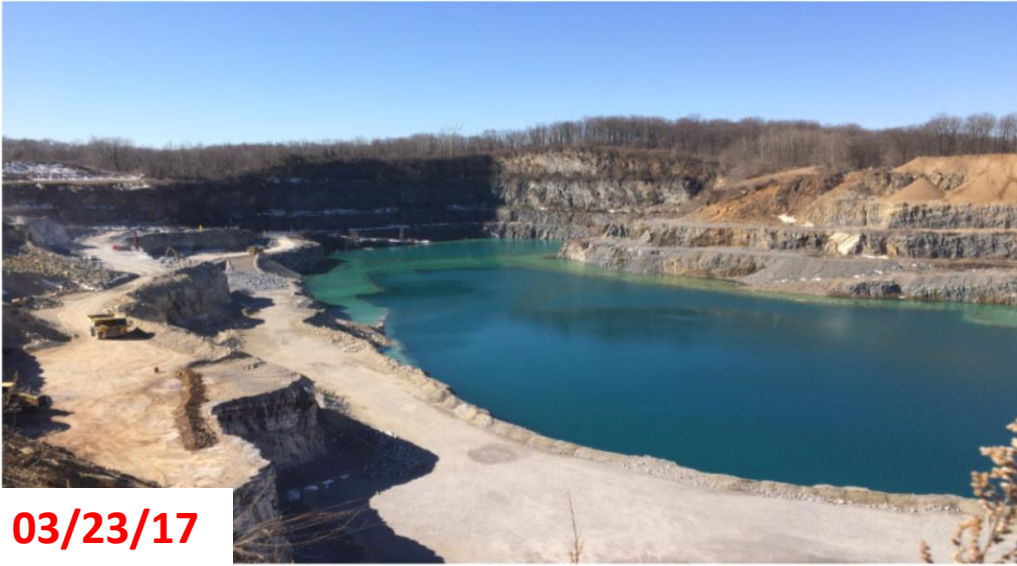
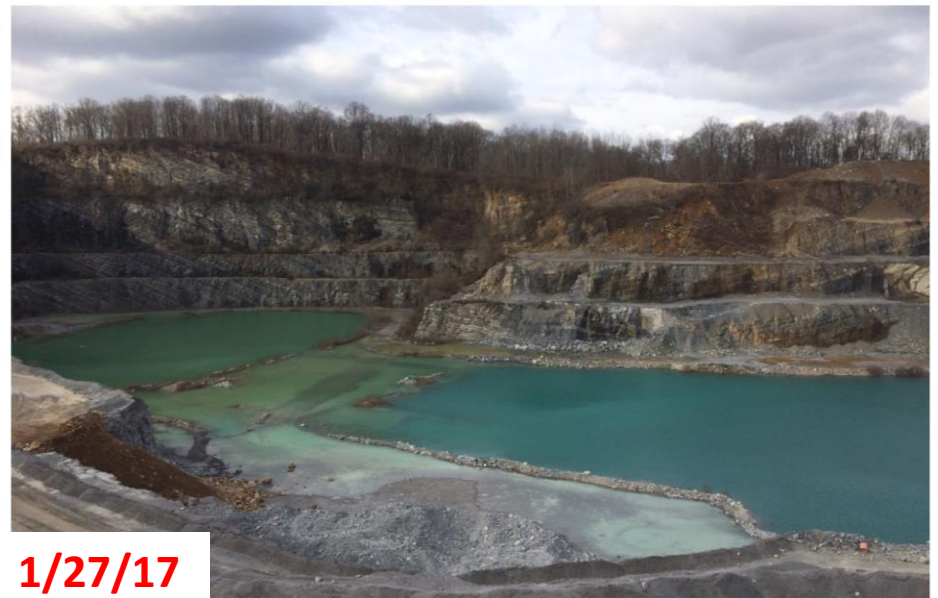
Ramp, Looking South - Reclamation

Water level continues to rise.

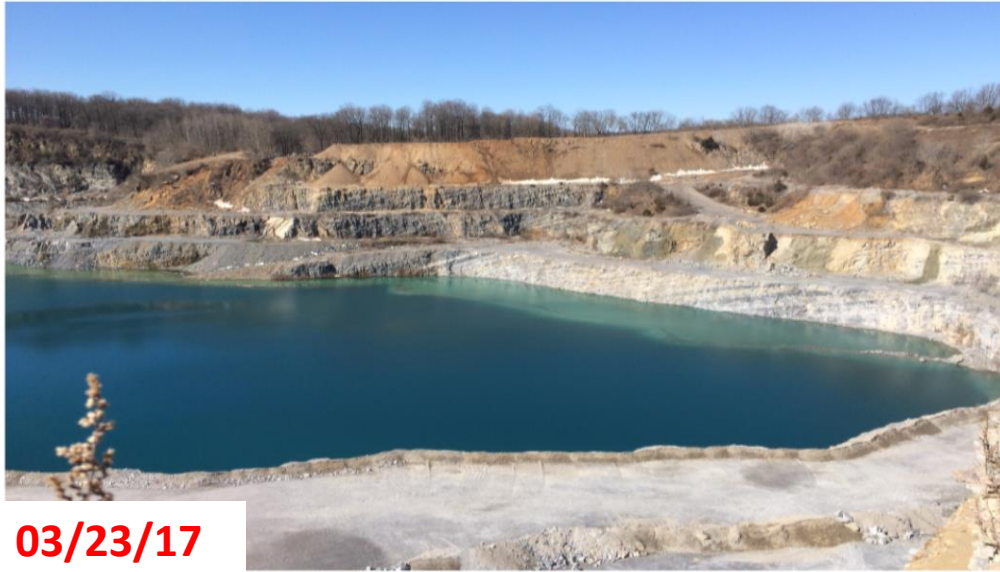
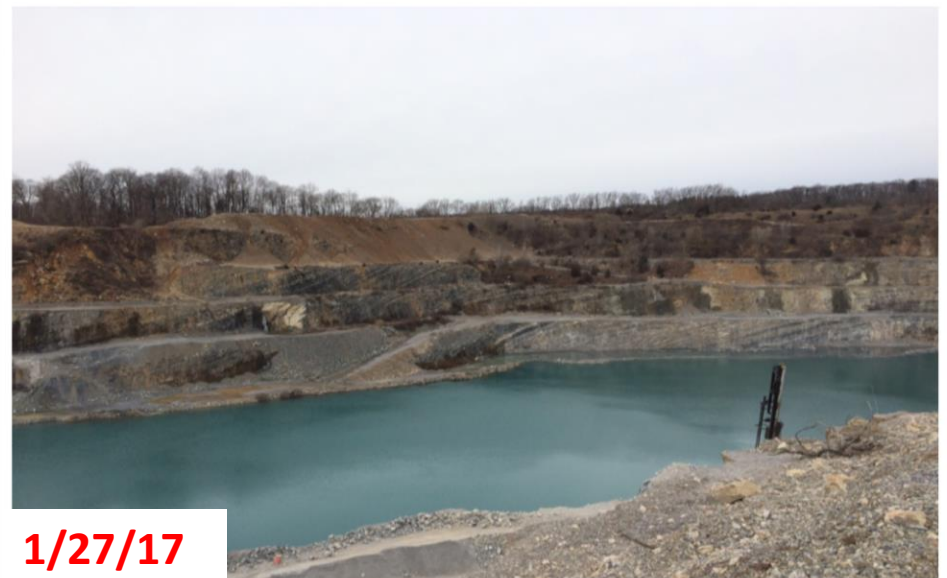
Ramp, Looking West - Reclamation

Minimal reclamation work completed.

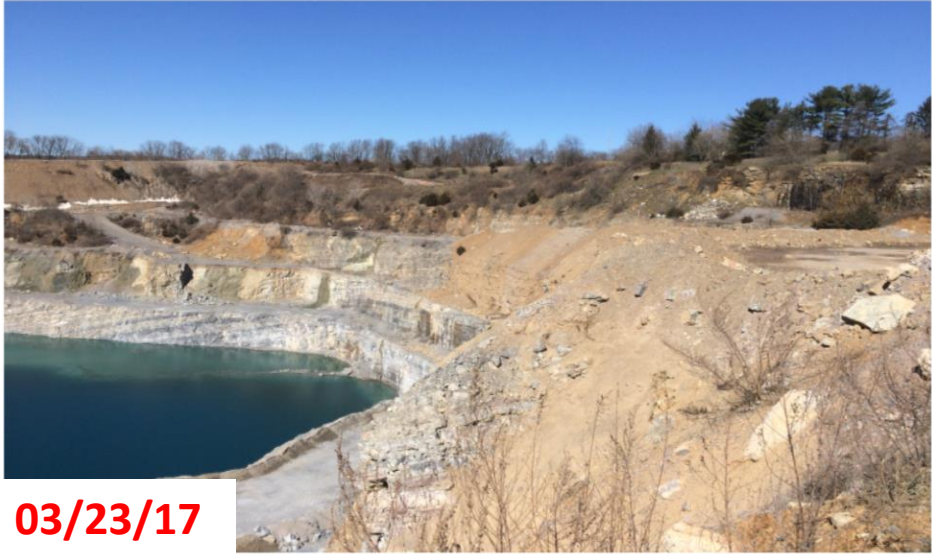
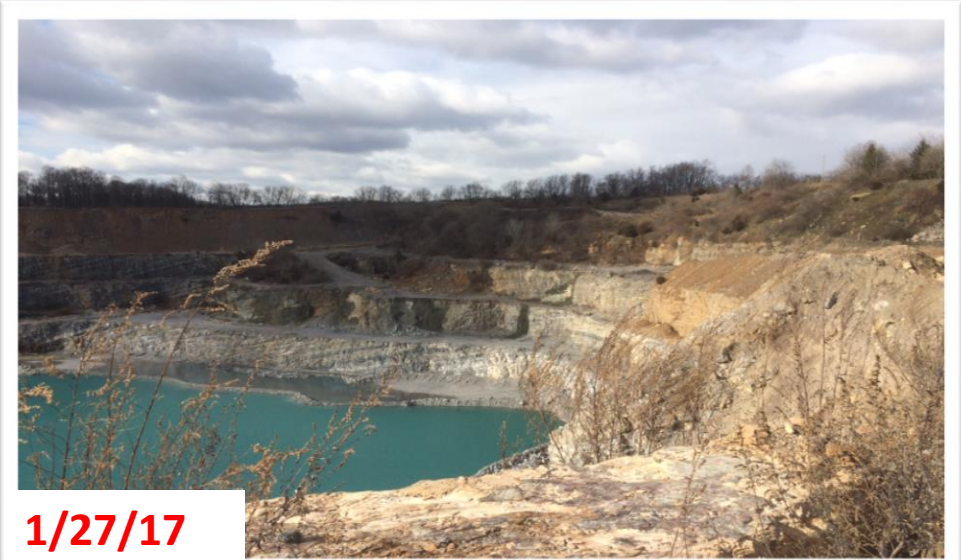
➤ Garage, Looking North - Reclamation

Some reclamation work continued in the northwest corner.

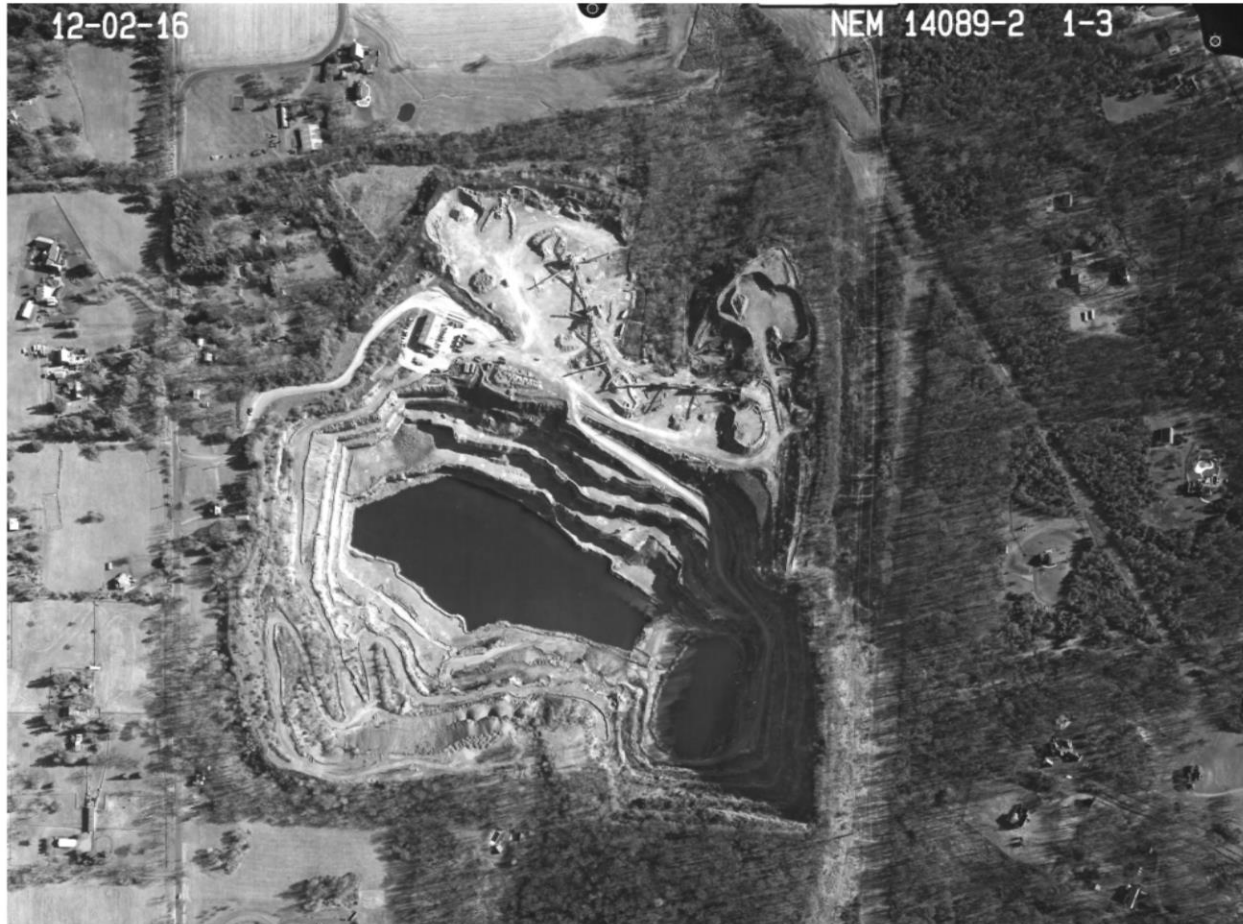
Aerial View - Reclamation

View from December 2, 2016. Staging of material can be seen to the left of the sump area at the top of the quarry. This view is before the water rose to combine the sump area and the quarry floor.

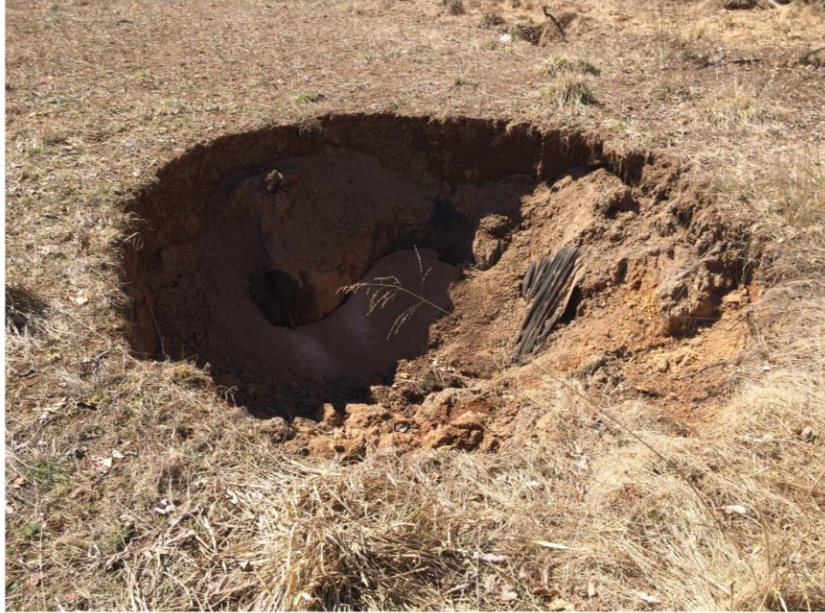
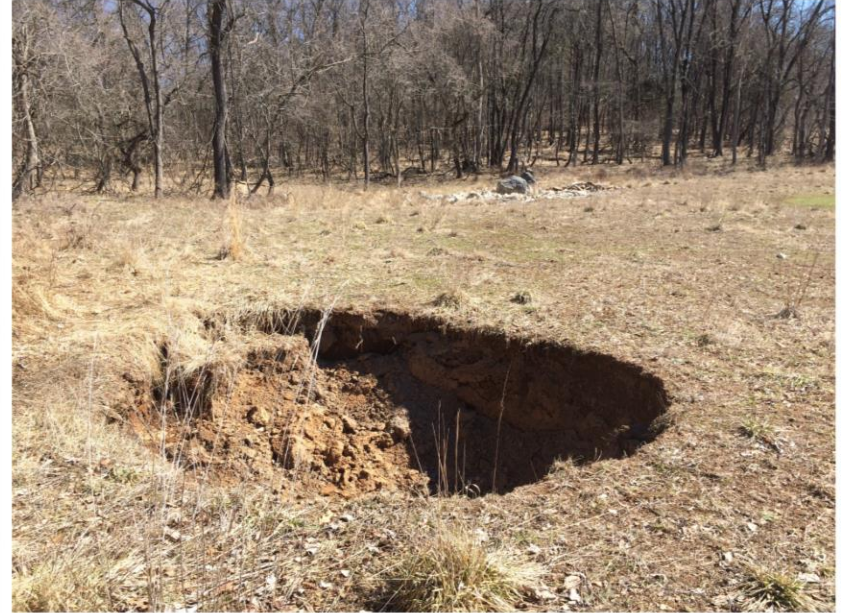
New Sinkhole

- NHCS completed actions in accord with MSHA citations and DEP comments.
 - On March 23 a sinkhole was reported on the Busik property across from the school. Repair work is expected to begin in mid April (see pictures).

This sinkhole was reported on March 23 on the Busik property across from the school. The area has been staked off. Work to make the repair is expected to begin by mid April.
