Shell Chemical Appalachia LLC  
300 Frankfort Rd  
Monaca, PA 15061

November 10, 2023

**RE: PA-04-00740C LP Multipoint Ground Flare (C204B) Ethylene Header Visible and Excess Emissions Malfunction Report**

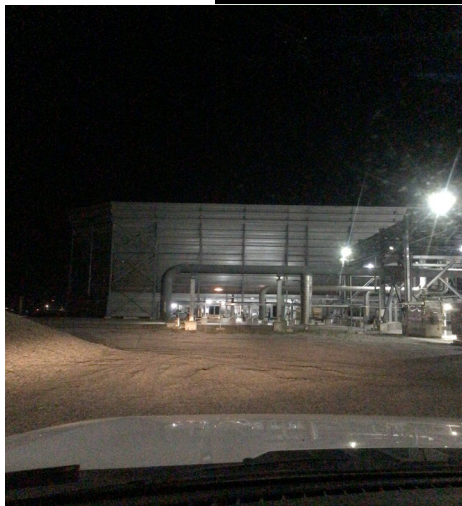
Begin	Clock Time	Observation Period (when you are actually looking at stack)	Emissions Observed (when you actually see smoke)
10/11/2023	19:30		0:00:00
	19:45		0:00:00
	20:00		0:00:00
	20:15		0:00:00
	20:30		0:00:00
	20:45	10 sec intervals	0:00:00
	21:00		0:00:00
	21:15		0:00:00
	21:20		0:00:00
End	21:30		0:00:00
Compliant? (Y/N)	Y	Y

smoking observed for approximately 8 minutes on camera before M22 was started
