Shell Chemical Appalachia LLC  
300 Frankfort Rd  
Monaca, PA 15061

**RE: PA-04-00740C LP Multipoint Ground Flare (C204B) Ethylene Header Visible Emissions Malfunction Report**

**Attachment A**  
Method 22 Form

**Shell Polymers Monaca**  
**Method 22 Visible Emissions Observation Form SPM-HSE-FO-0003**

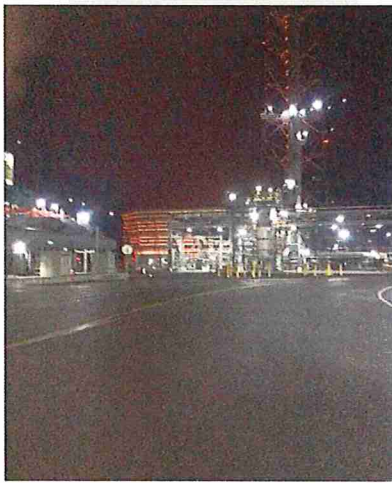
Observer Name: [REDACTED]  
 Observer Title: Field Operator  
 Date and Time (MM/DD/YY XX:XX): 2/22/24 3:10  
 Sky Conditions: Partly Cloudy  
 Precipitation: Light Rain  
 Wind Direction (direction from): SE 149.9  
 Wind Speed (m/s): 0.3  
[Site MET Data \(Wind Direction 500QT-060A and Speed 500QT-050A\)](#)  
 Visible Emissions Source: Multipoint Ground Flare (A-59004)  
 Observation Location: I (CVTO)  
 Observation Picture:

ECU sending ethylene seal gas to MPGF ethylene storage header in preparation for BOG compressor startup. Console operator observed possible smoking on the flare camera and dispatched field operator to confirm. Air Assist Fan speed was manually increased by console operator 03:12 and smoking ceased. 1 minute and 45 seconds of smoking noted.
