Shell Chemical Appalachia LLC
300 Frankfort Rd
Monaca, PA 15061

June 29, 2023

RE: PA-04-00740C Source ID 205 High Pressure (HP) Header System – Brush Fire Near the HP Flare Area Malfunction Report

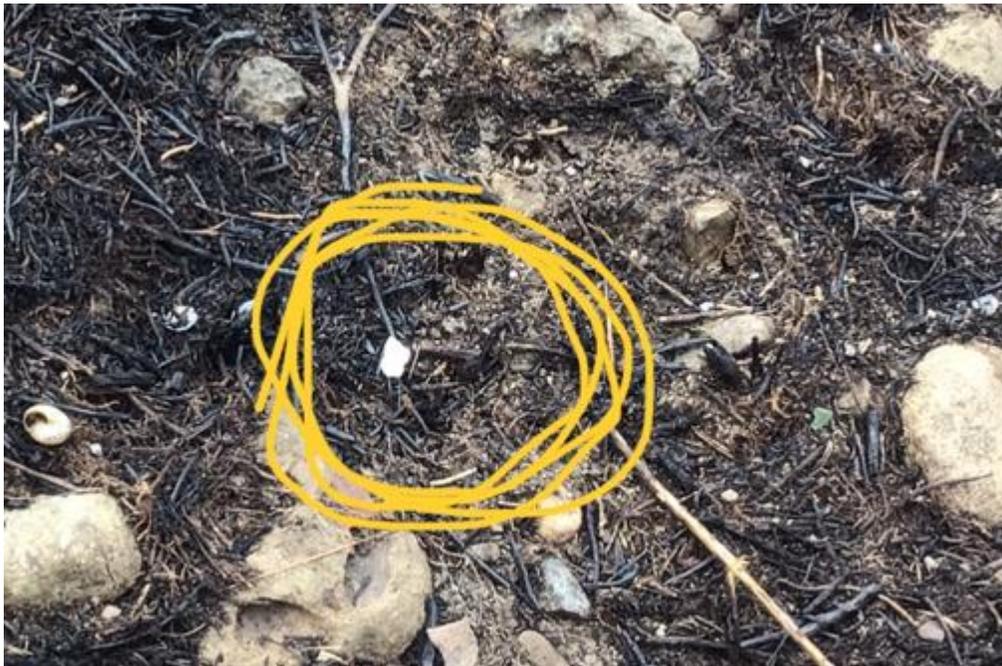
Small glowing pieces of insulation (refractory) material coming out of the top of the TEGF have been observed during the last couple of months due to the loss of refractory material - Figure 1. The glowing material from recent hot spot repairs landed near the HP flares in some vegetation that due to insufficient rain and higher than normal temperatures caused vegetation to dry and when in contact with the refractory material ignited.

At the time of the event wind was blowing in the direction towards the burned area and lined up with where the closest vegetation just happened to be located supplying oxygen causing the brush fire to grow swiftly.

Figure 1. Insulation refractory material in contact with vegetation

SPM started to perform periodic thermal imaging activities on the TEGFs since the brushfire incident to provide assurance that there has been no significant loss of refractory causing hot spots.

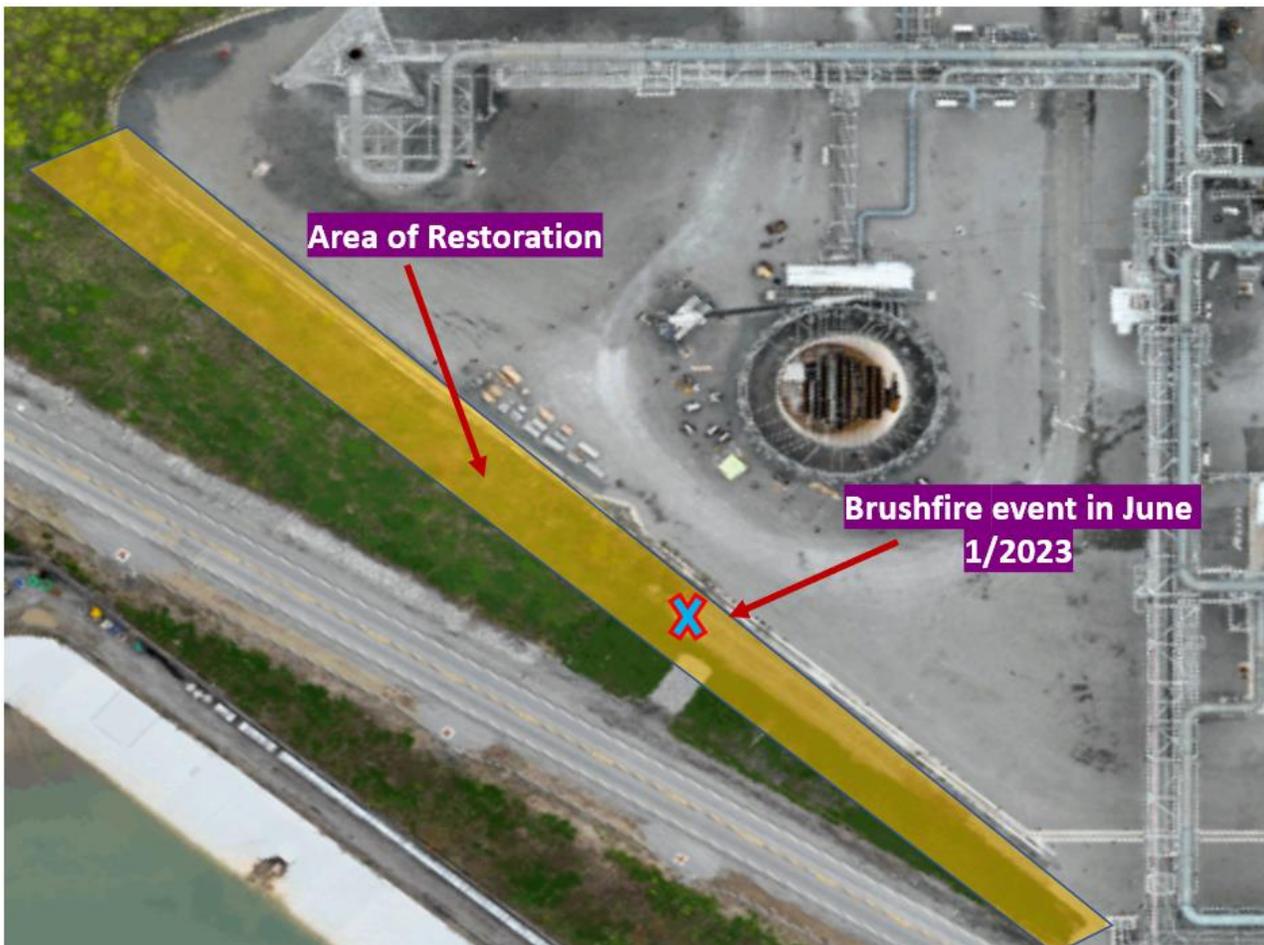
Figure 2. Vegetative mitigation area

In addition to the monitoring loss of refractory material described above and to prevent recurrence of an identical incident in the future, Shell is evaluating several mitigation plan options to be implemented in the area where the brush fire occurred (light yellow area Figure 2 below):

| Option | Description | Benefit |
|---|--|--|
| #1 | Mow hillside and plant non flammable vine such as a Myrtle Vine | Benefit to this is that it would root and hold hillside together |
| #2 | Mow hillside, install barrier ¹ , then place stone 12' from top on hill | Benefit would be permanent stone, downfall is the hill could slip in a heavy storm |
| #3 | Install a sprinkler system around perimeter | Benefit would be ability to control moisture on hillside |

A panel review team comprised of Maintenance, Operations, HSSE, Logistics, and Real Estate will discuss and evaluate the different options and implement the mitigation by the end of August, 2023.
