BLUE GOOSE SOUTH Abandoned Mine Reclamation Project Contract No. OSM 11(4092)101.1

BLUE GOOSE SOUTH ABANDONED MINE RECLAMATION PROJECT CONTRACT NO. OSM 11(4092)101.1

FACT SHEET

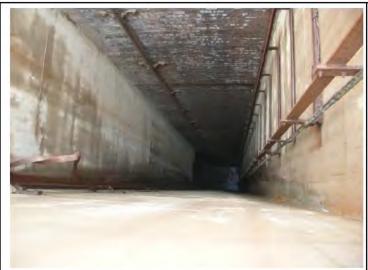
Open shafts.

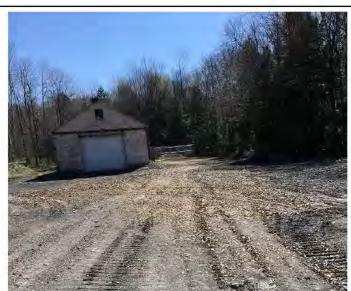
View from the entrance gate to the shaft.
