**INVESTIGATION OF DAMAGE TO STRUCTURES
IN THE McCUTCHANVILLE-DAYLIGHT
AREA OF SOUTHWESTERN INDIANA**

Volume 2 of 3

Racking Response of Large Structures from
Airblast, A Case Study.

RACKING RESPONSE OF LARGE STRUCTURES FROM AIRBLAST, A CASE STUDY

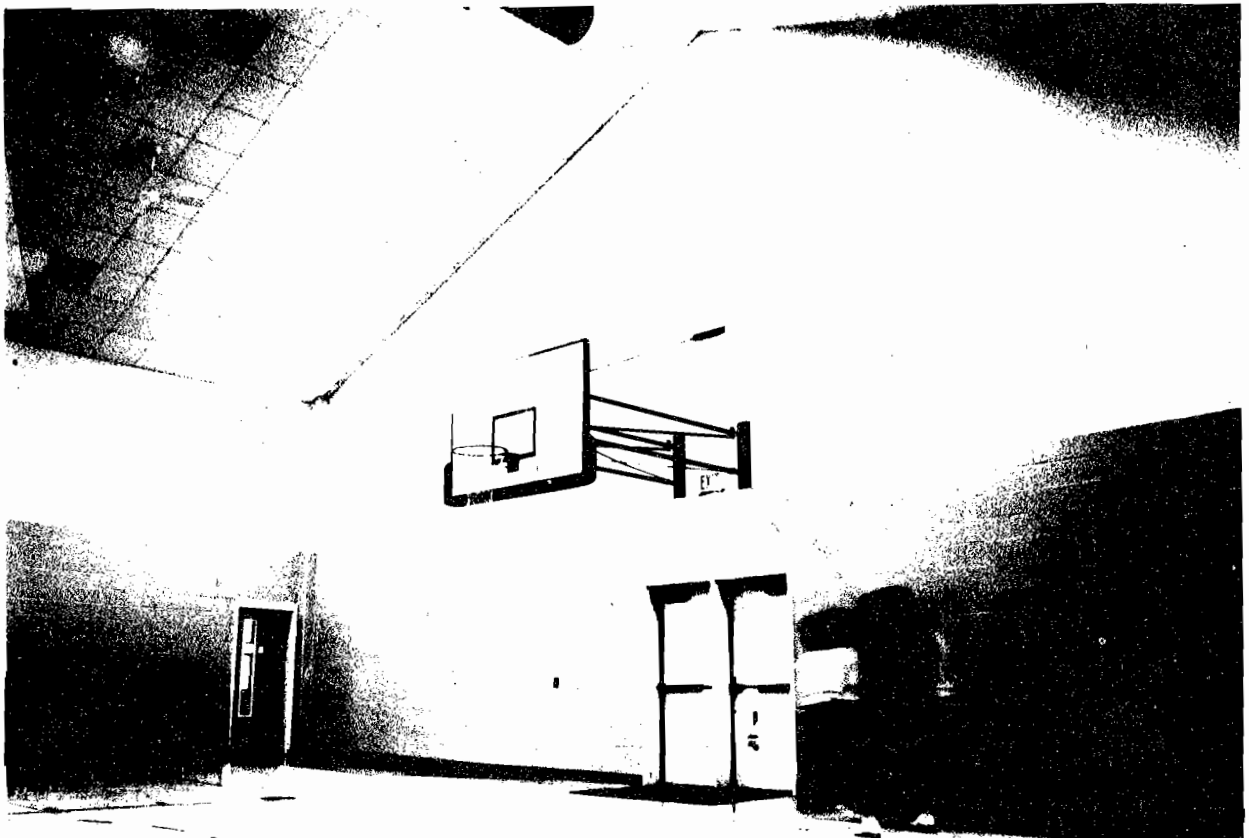
Figure 12.- Inside east wall of St. John's Church showing backstop mounted near midwall antinode

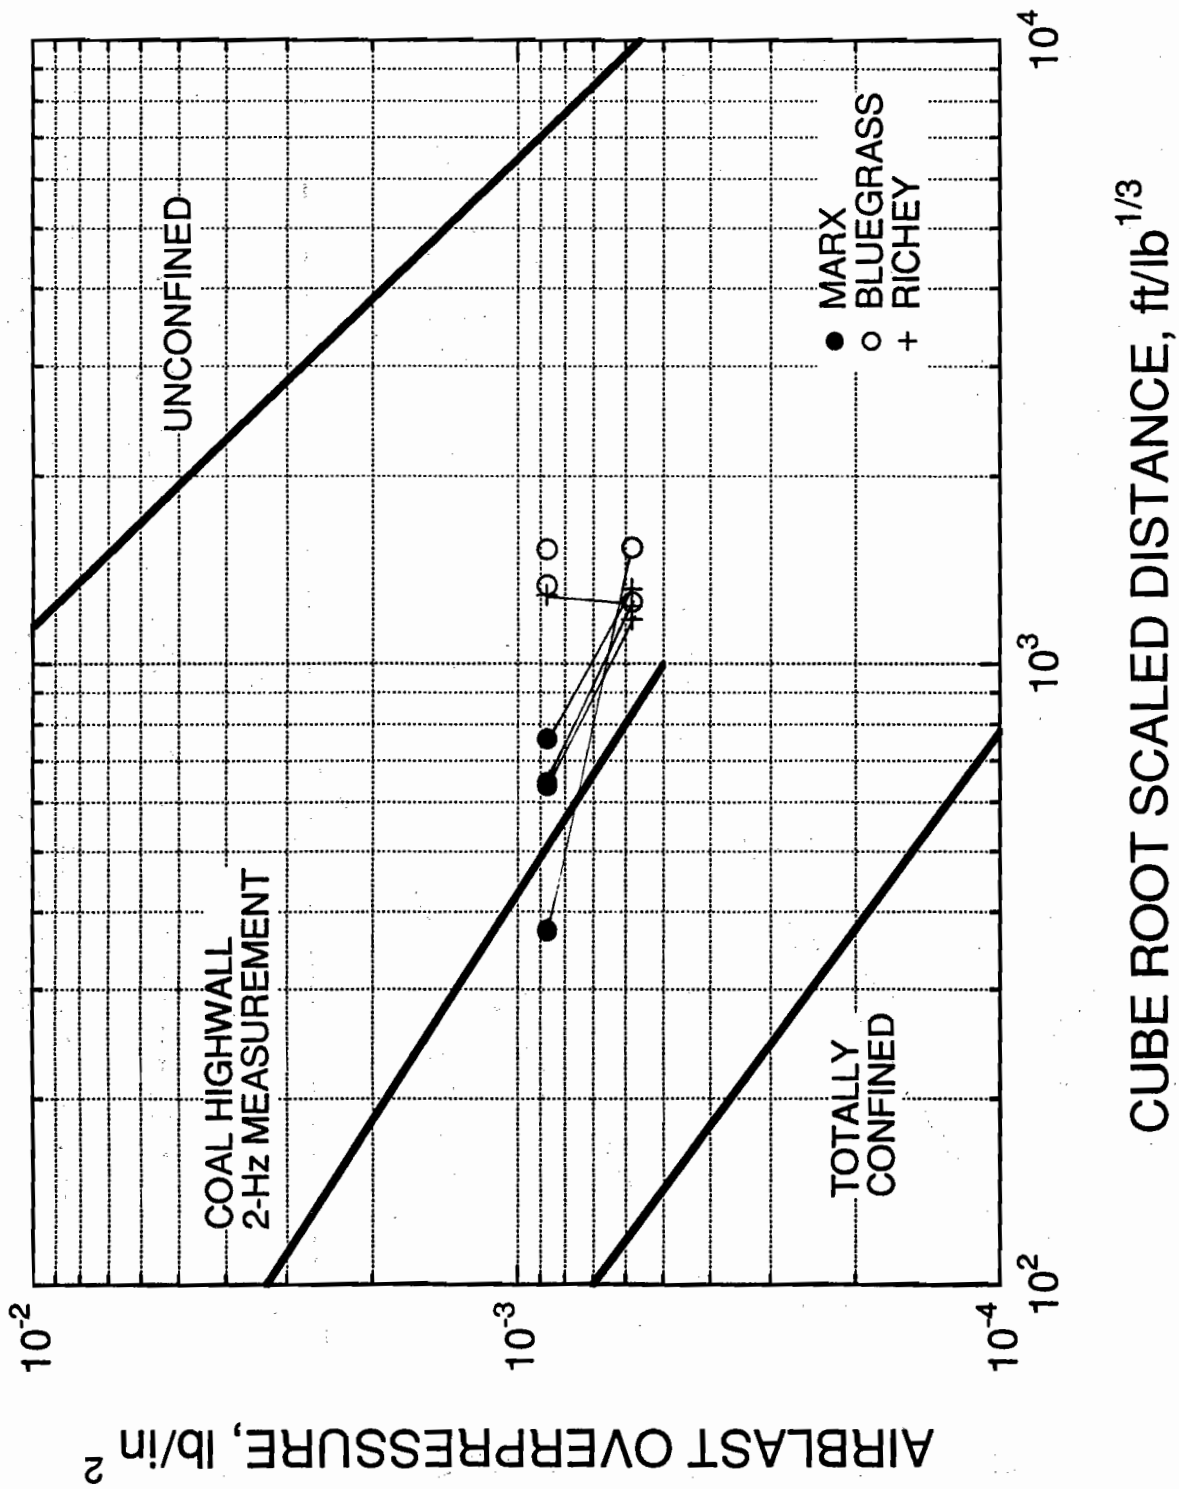
Interpreting anything meaningful from such sparse and low-level airblast data is beyond prudent extrapolative ability. Only the two closest structures, Marx and St. John's have airblast amplitudes which reliably represent the peaks. Airblasts recorded at different times cannot be pooled to establish losing distinctive weather conditions affecting the propagations. Taking the airblast values from Appendix A, the authors plotted amplitudes in figure 14 and 15. Lines connecting points are to show values measured at different sites for a given blast. They are not regression lines representing statistical averages. Figure 14 and 15 also show the historical values of 2-Hz measured airblast from RI 8485 plus extremes of total confinement and unconfined (4).

Figure 14.- Airblast amplitudes obtained in this study in the NW direction. Values collected from a given blast are connected

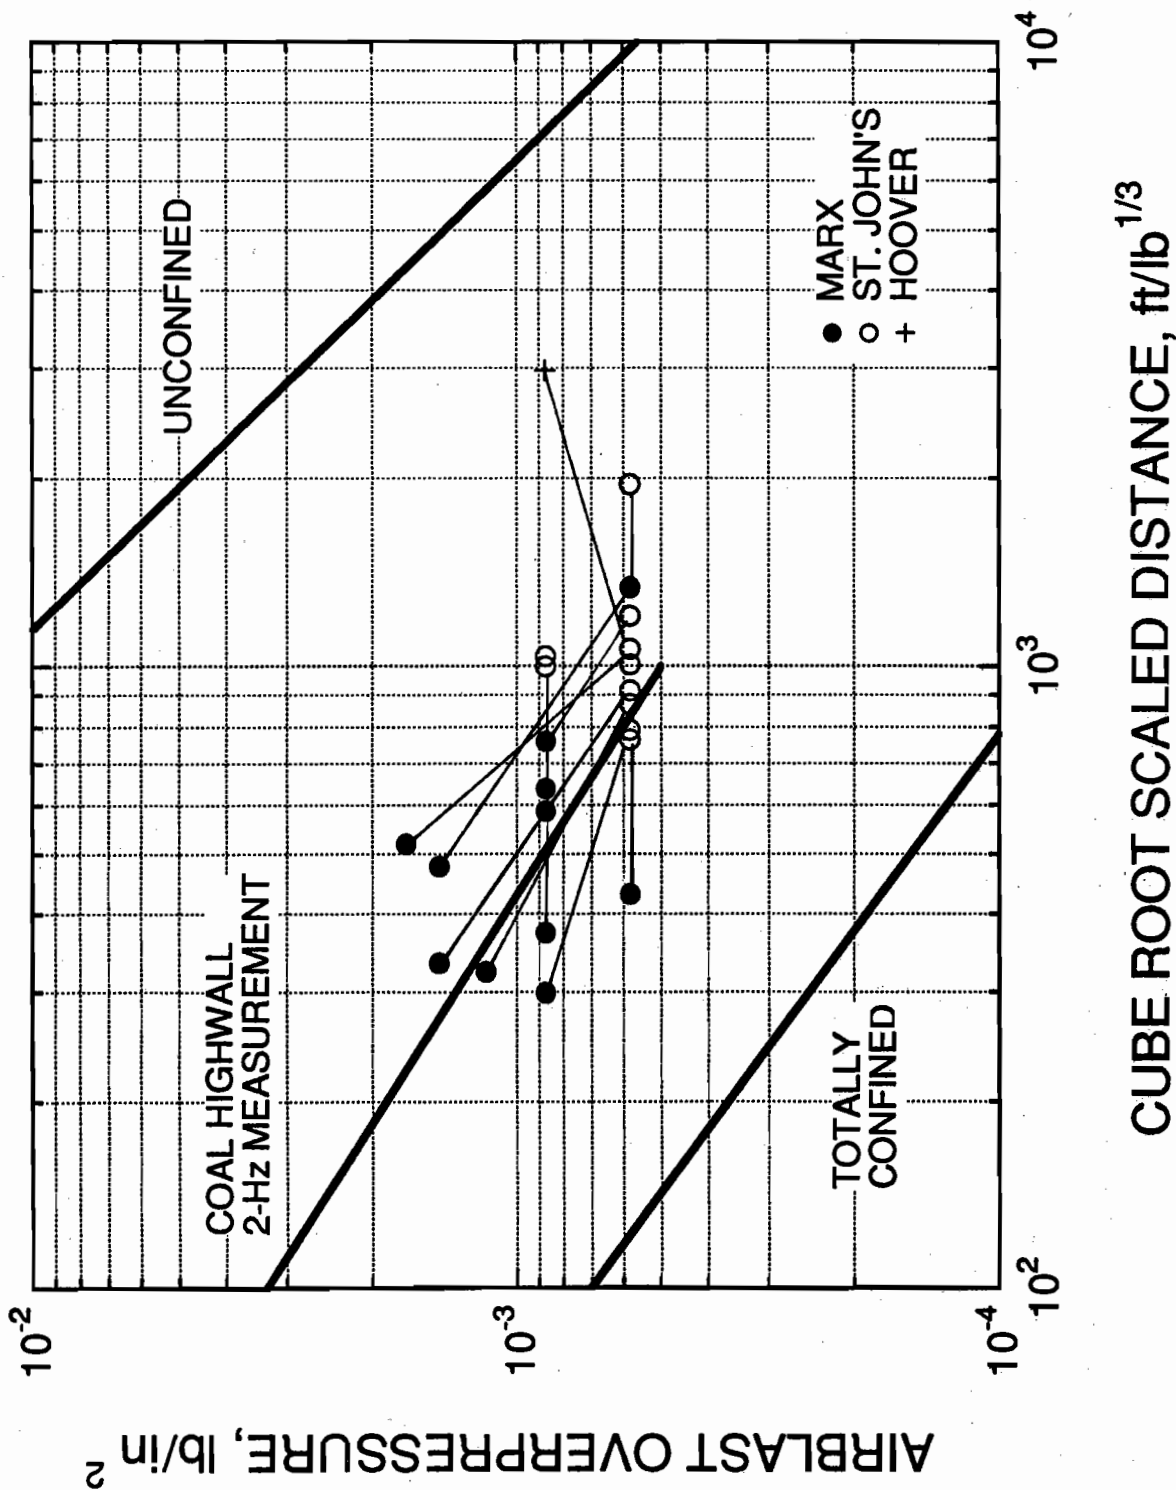
Figure 15.- Airblast amplitudes obtained in this study in the SW direction. Values collected from a given blast are connected

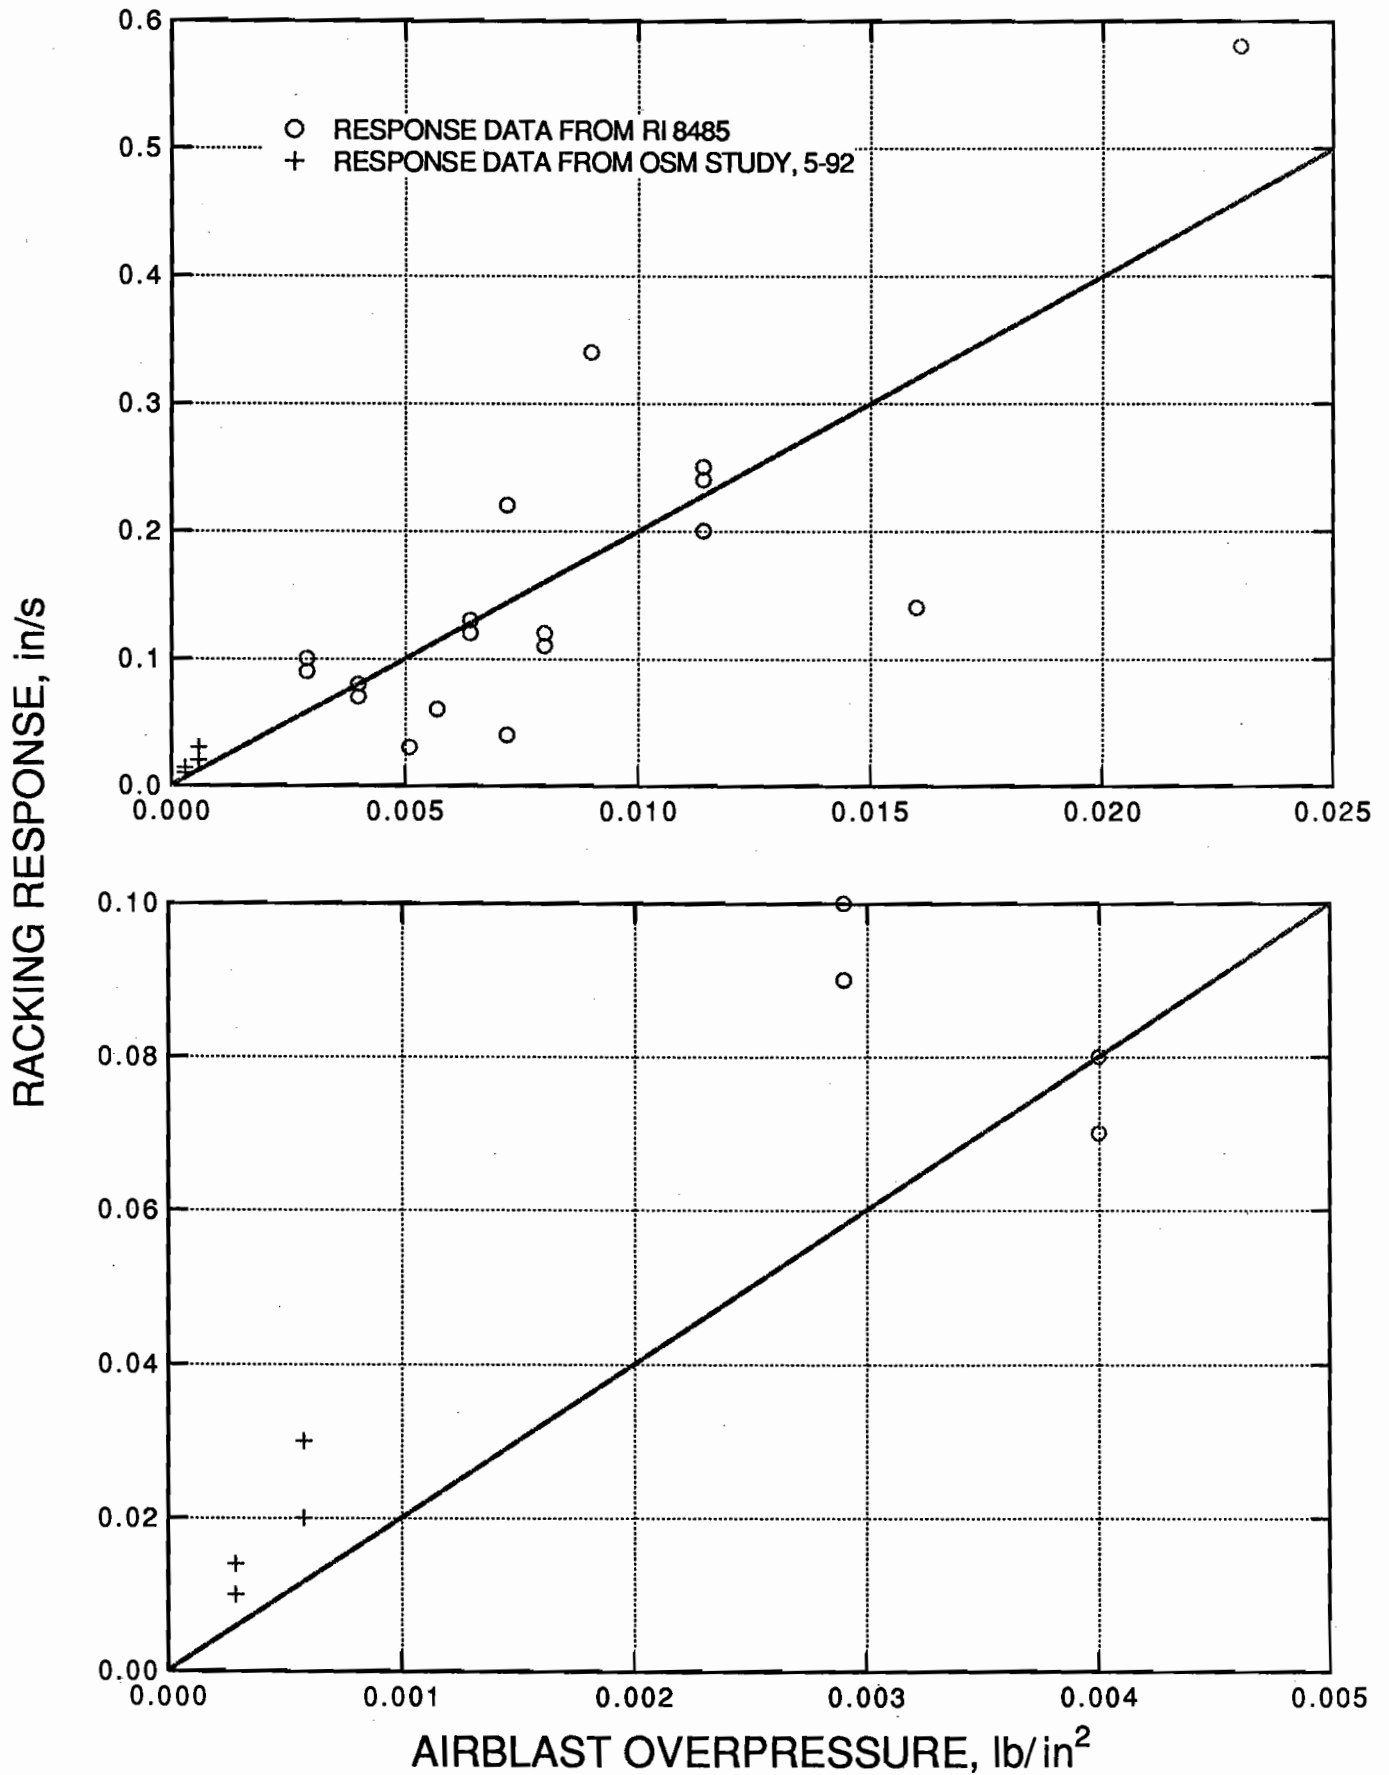
Figure 16 shows airblast-induced structure responses with the bottom graph having a greatly expanded origin zone. The least-squares line is from RI 8485 (4). This least squares mean is an origin-based prediction curve and pertains to 2-Hz systems, as also employed for this study. This means flat amplitude response down to 2 Hz. The few structural response values obtained in this study are also plotted. All are from the St. John's monitoring, and all are very approximate at such low amplitudes. Points above the mean prediction suggest relatively high responses. This is not surprising and was originally hypothesized as possible because of the height of St. John's and the large area of exposed wall. If extrapolated proportionally according to Fig. 16, airblasts above 130 dB should produce responses as large as some of the bigger basketball-induced responses. However, such extreme extrapolation is not recommended.

Figure 16.- Structure responses from airblast. Top is all data out to .025 lb/in² (139 dB) and bottom shows a greatly expanded origin zone. Solid line is least squares mean prediction for the RI 8485 (4) data

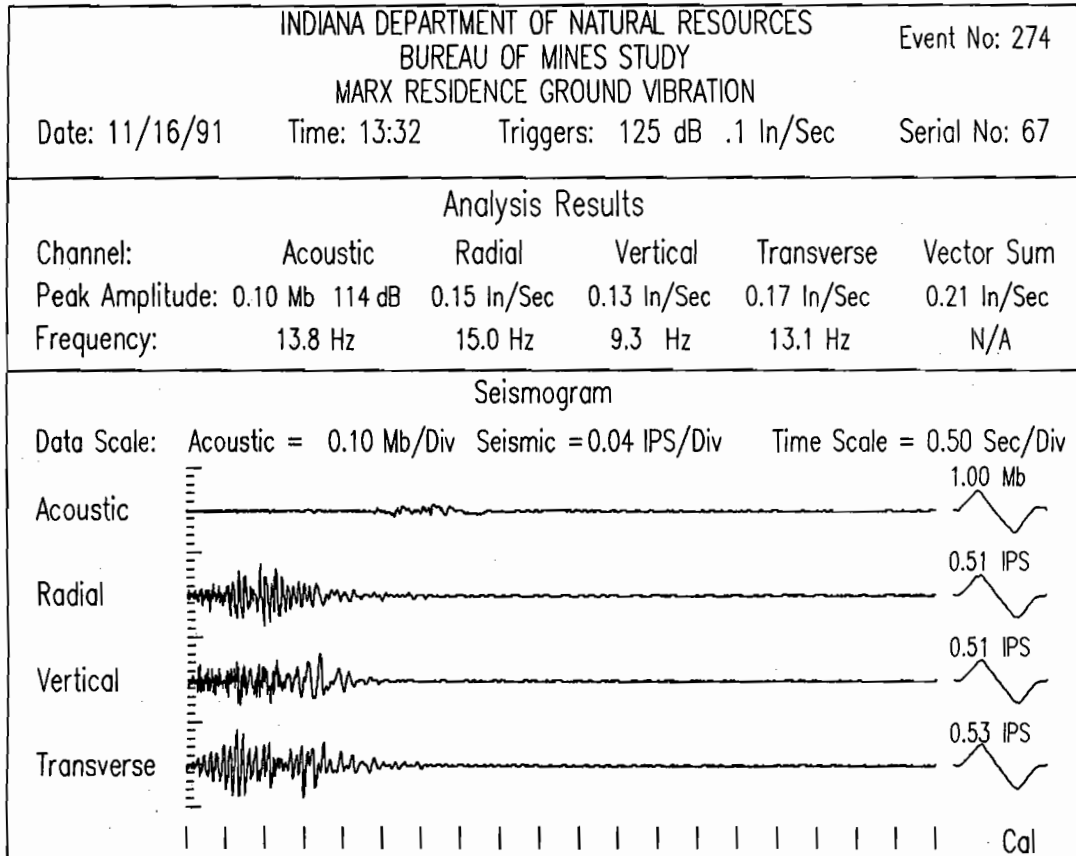
Figures B-7 and B-8 show two vibrations with very different frequencies. Although clearly beyond the scope of this airblast study, careful analysis of such recordings could lead to techniques for controlling vibration characteristics through blast design, at least for moderate distances. Such studies have been proposed and some preliminary results of a blast design

Figure B-7.-Ground vibration record from Marx house showing relatively high frequencies.

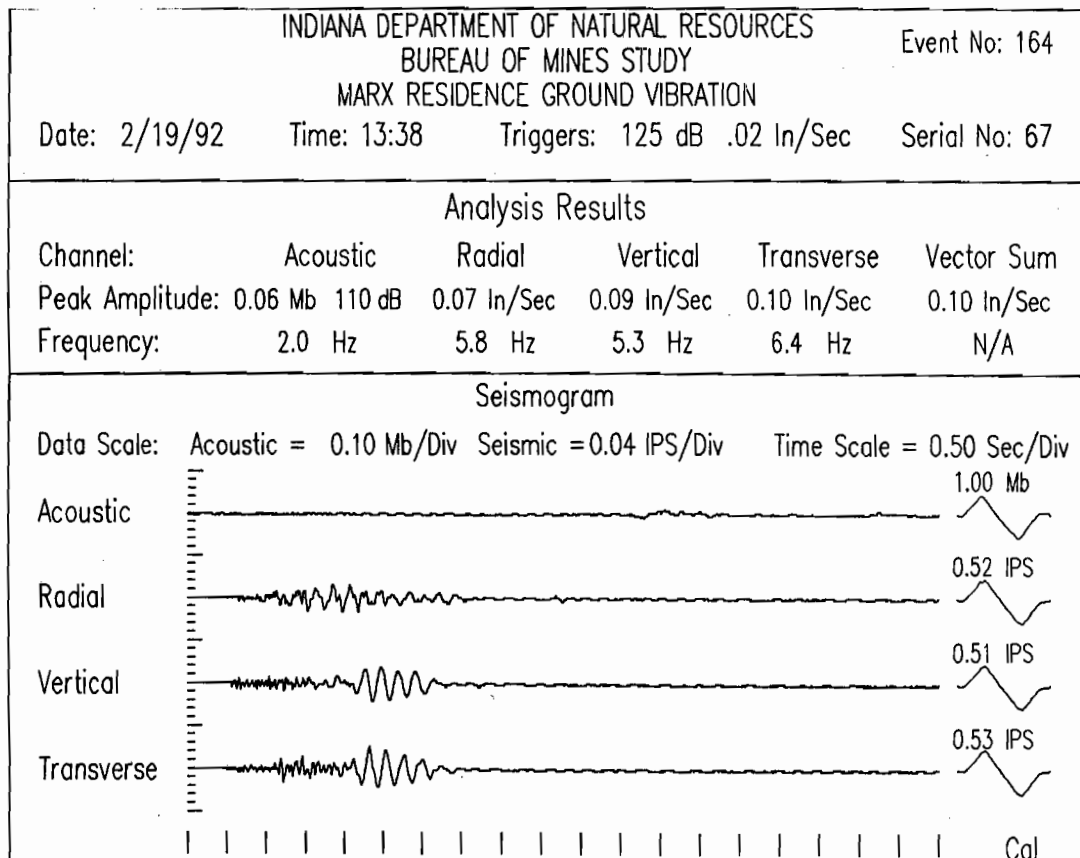
Figure B-8.-Ground vibration record from Marx house dominated by relatively low frequencies and contrasting with figure B-7

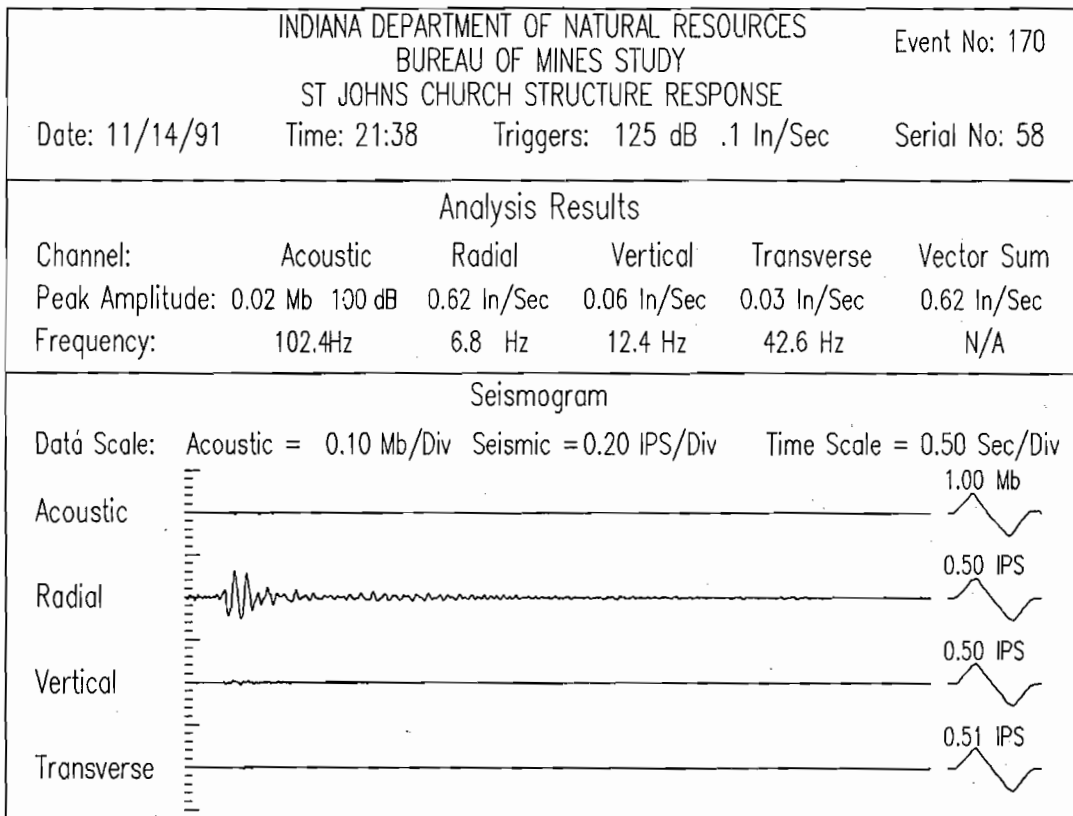
Figure C-3.-Vibration non-blast recording of structure response at St. John's, largest one during study period
