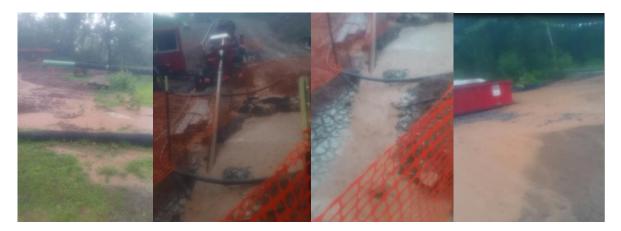
(Left to right-1) erosion protection failures at top of hill 2) HDD site full of water 3) complete wash out of HDD rig, sediment and drilling mud 3) ponding prior to entry into East Branch of Conestoga)

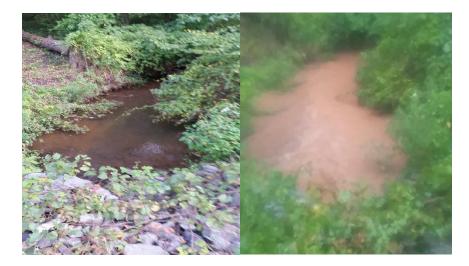
Left- Normal conditions of East Branch of the Conestoga Right- August 18th- Notice the grey tint of drill mud in addition to brown sediment.

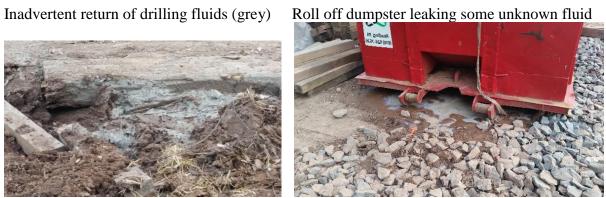
Inadvertent return of drilling fluids (grey)

Drilling Mud spills (grey)

Drilling mud spills (grey)

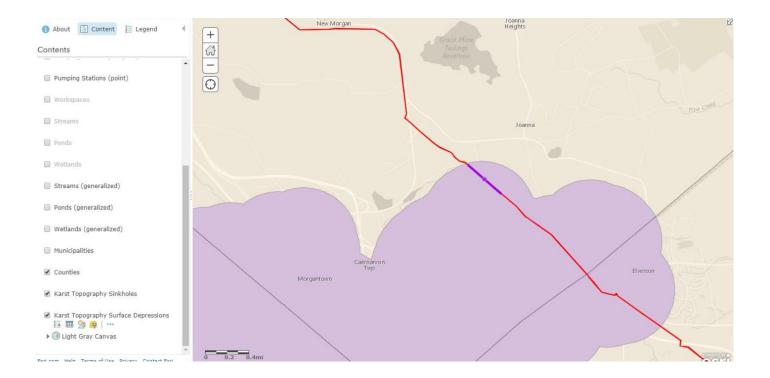
Left: Expanded view showing the extent of the HDD route through the Karst region. While not entirely a flawless photo it can be clearly seen that both the beginning and end of the HDD# S3-0250 lie within the identified Karst Region. The extremely sensitive and unstable region is particularly susceptible to geological and hydrological damages through the use of Horizontal Directional Drilling (HDD).
