## EARTH DISTURBANCE INSPECTION REPORT

Project Name PA Pipeline Project/Mariner East 2 Inspection Date 8/25/2017			n Date <u>8/25/2017</u>	7 Inspection Time 1145		
Inspe	ectio	on Findings			Reference	
	No	violations observed at this time.			☐ (N/A)	
					П и оо и	
		Failure to develop a written Erosion and Sediment (E&S)	Plan.		(102.4)

Inspection Report: No. 1

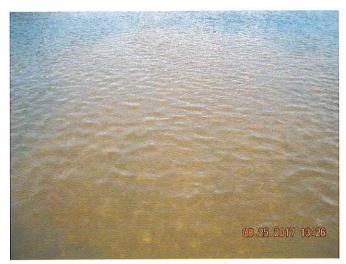
East Shore HDD Mud Pit (Highspire Borough, Dauphin County)

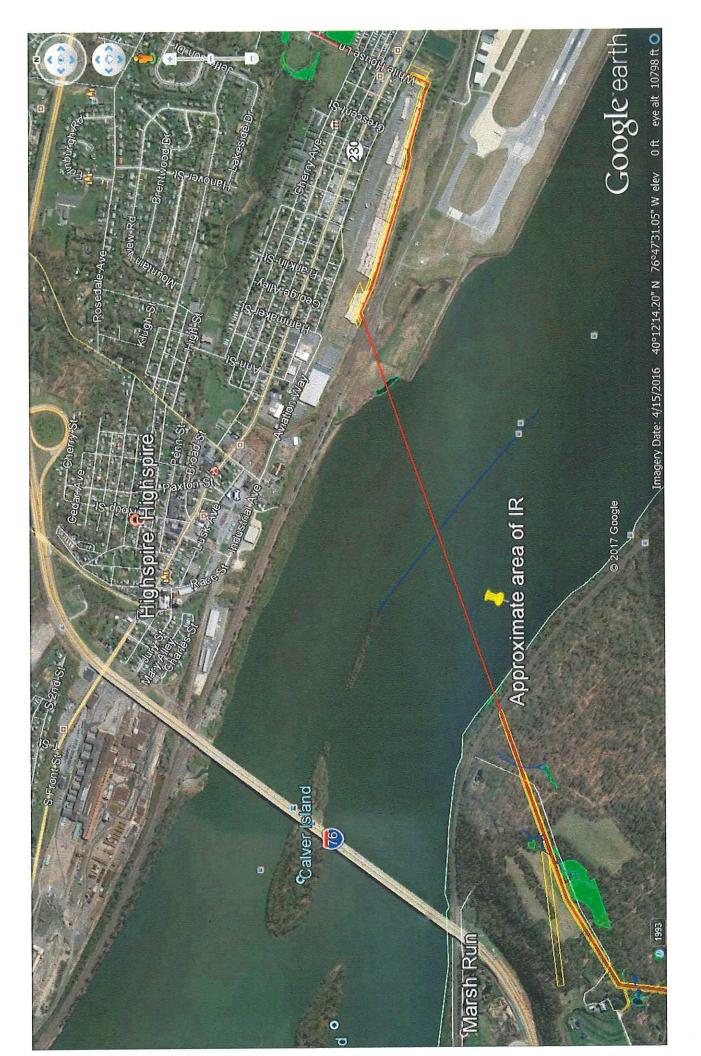
Above view of IR on riverbed (Lower Swatara Township, Dauphin County)
