Re: Violations of the Clean Streams Law
Pennsylvania Pipeline/Mariner East II Project
DEP Permit Nos. ESG03000115002 and E38-194
DEP File No NOV 38 17 102
South Annville Township, Lebanon County
Non-compliance Report

SUNOCO PIPELINE L.P.
PHILADELPHIA, PENNSYLVANIA
**PENNSYLVANIA PIPELINE PROJECT
CONSTRUCTION SPREAD 5**

1-20" & 1-16" PROPOSED WELDED STEEL NATURAL GAS LIQUIDS PIPELINES
LEBANON COUNTY CONSERVATION DISTRICT
BAUCHMAN RUN S-A15 DETAIL

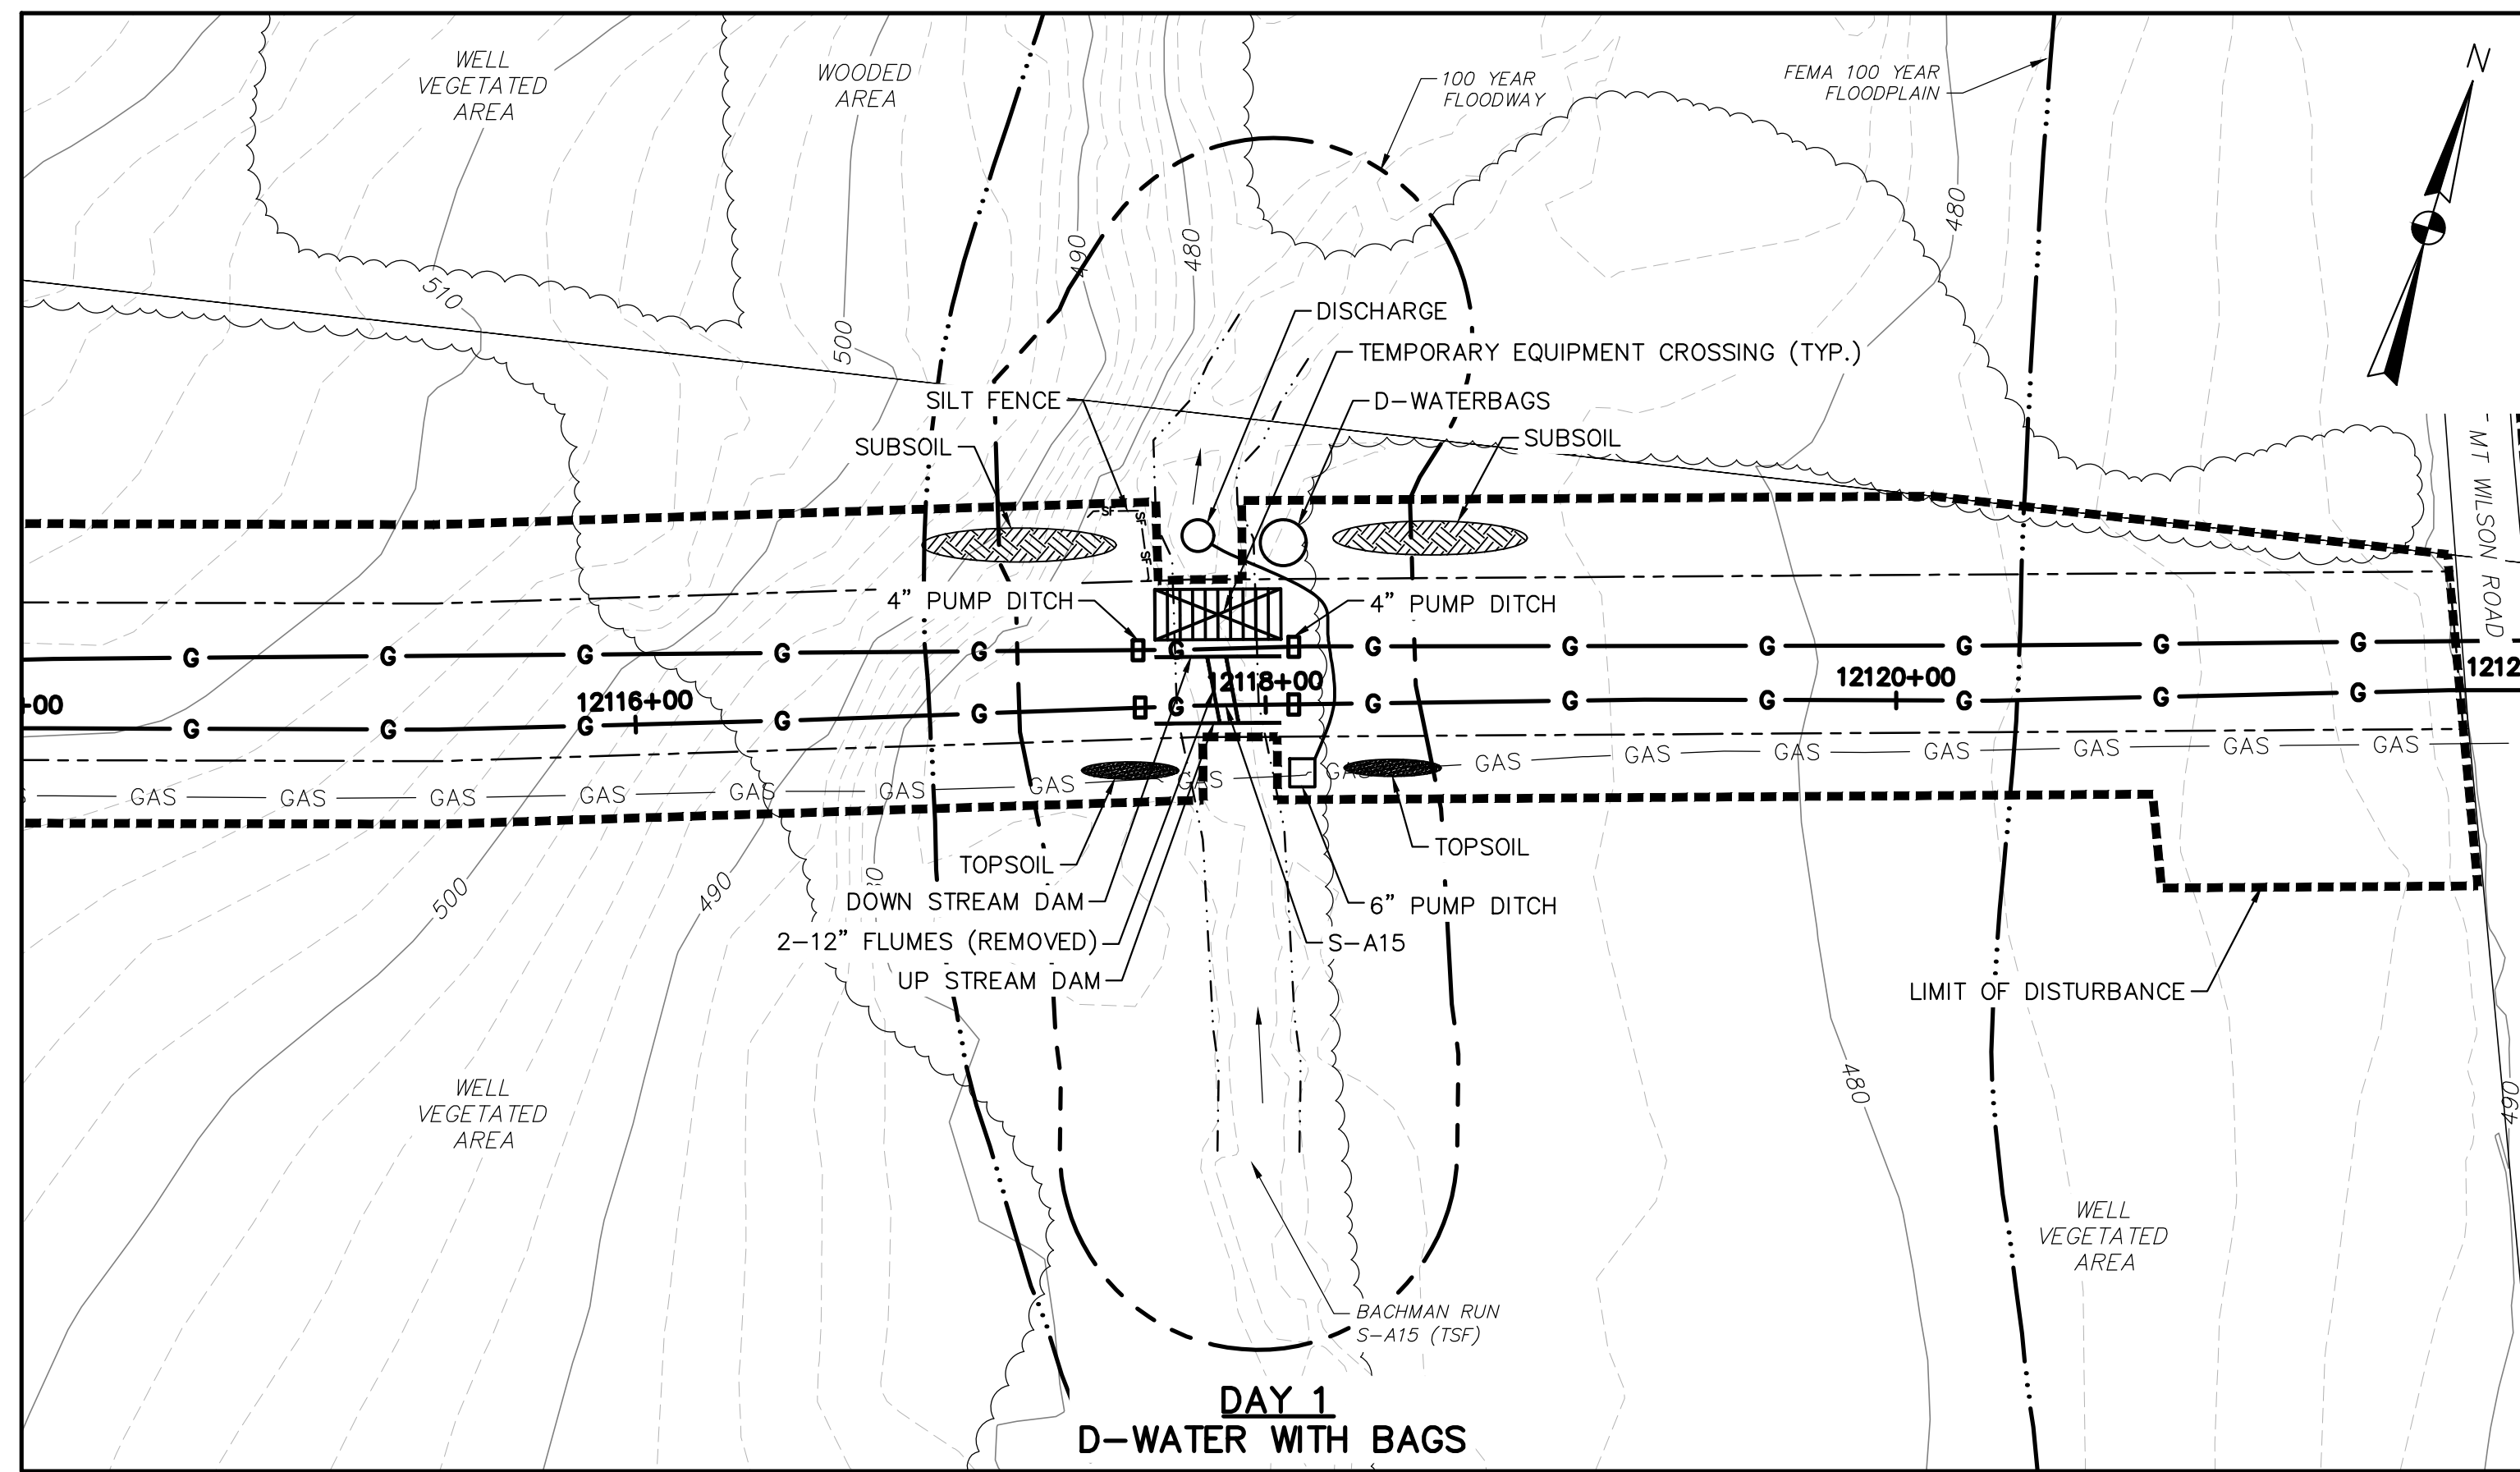
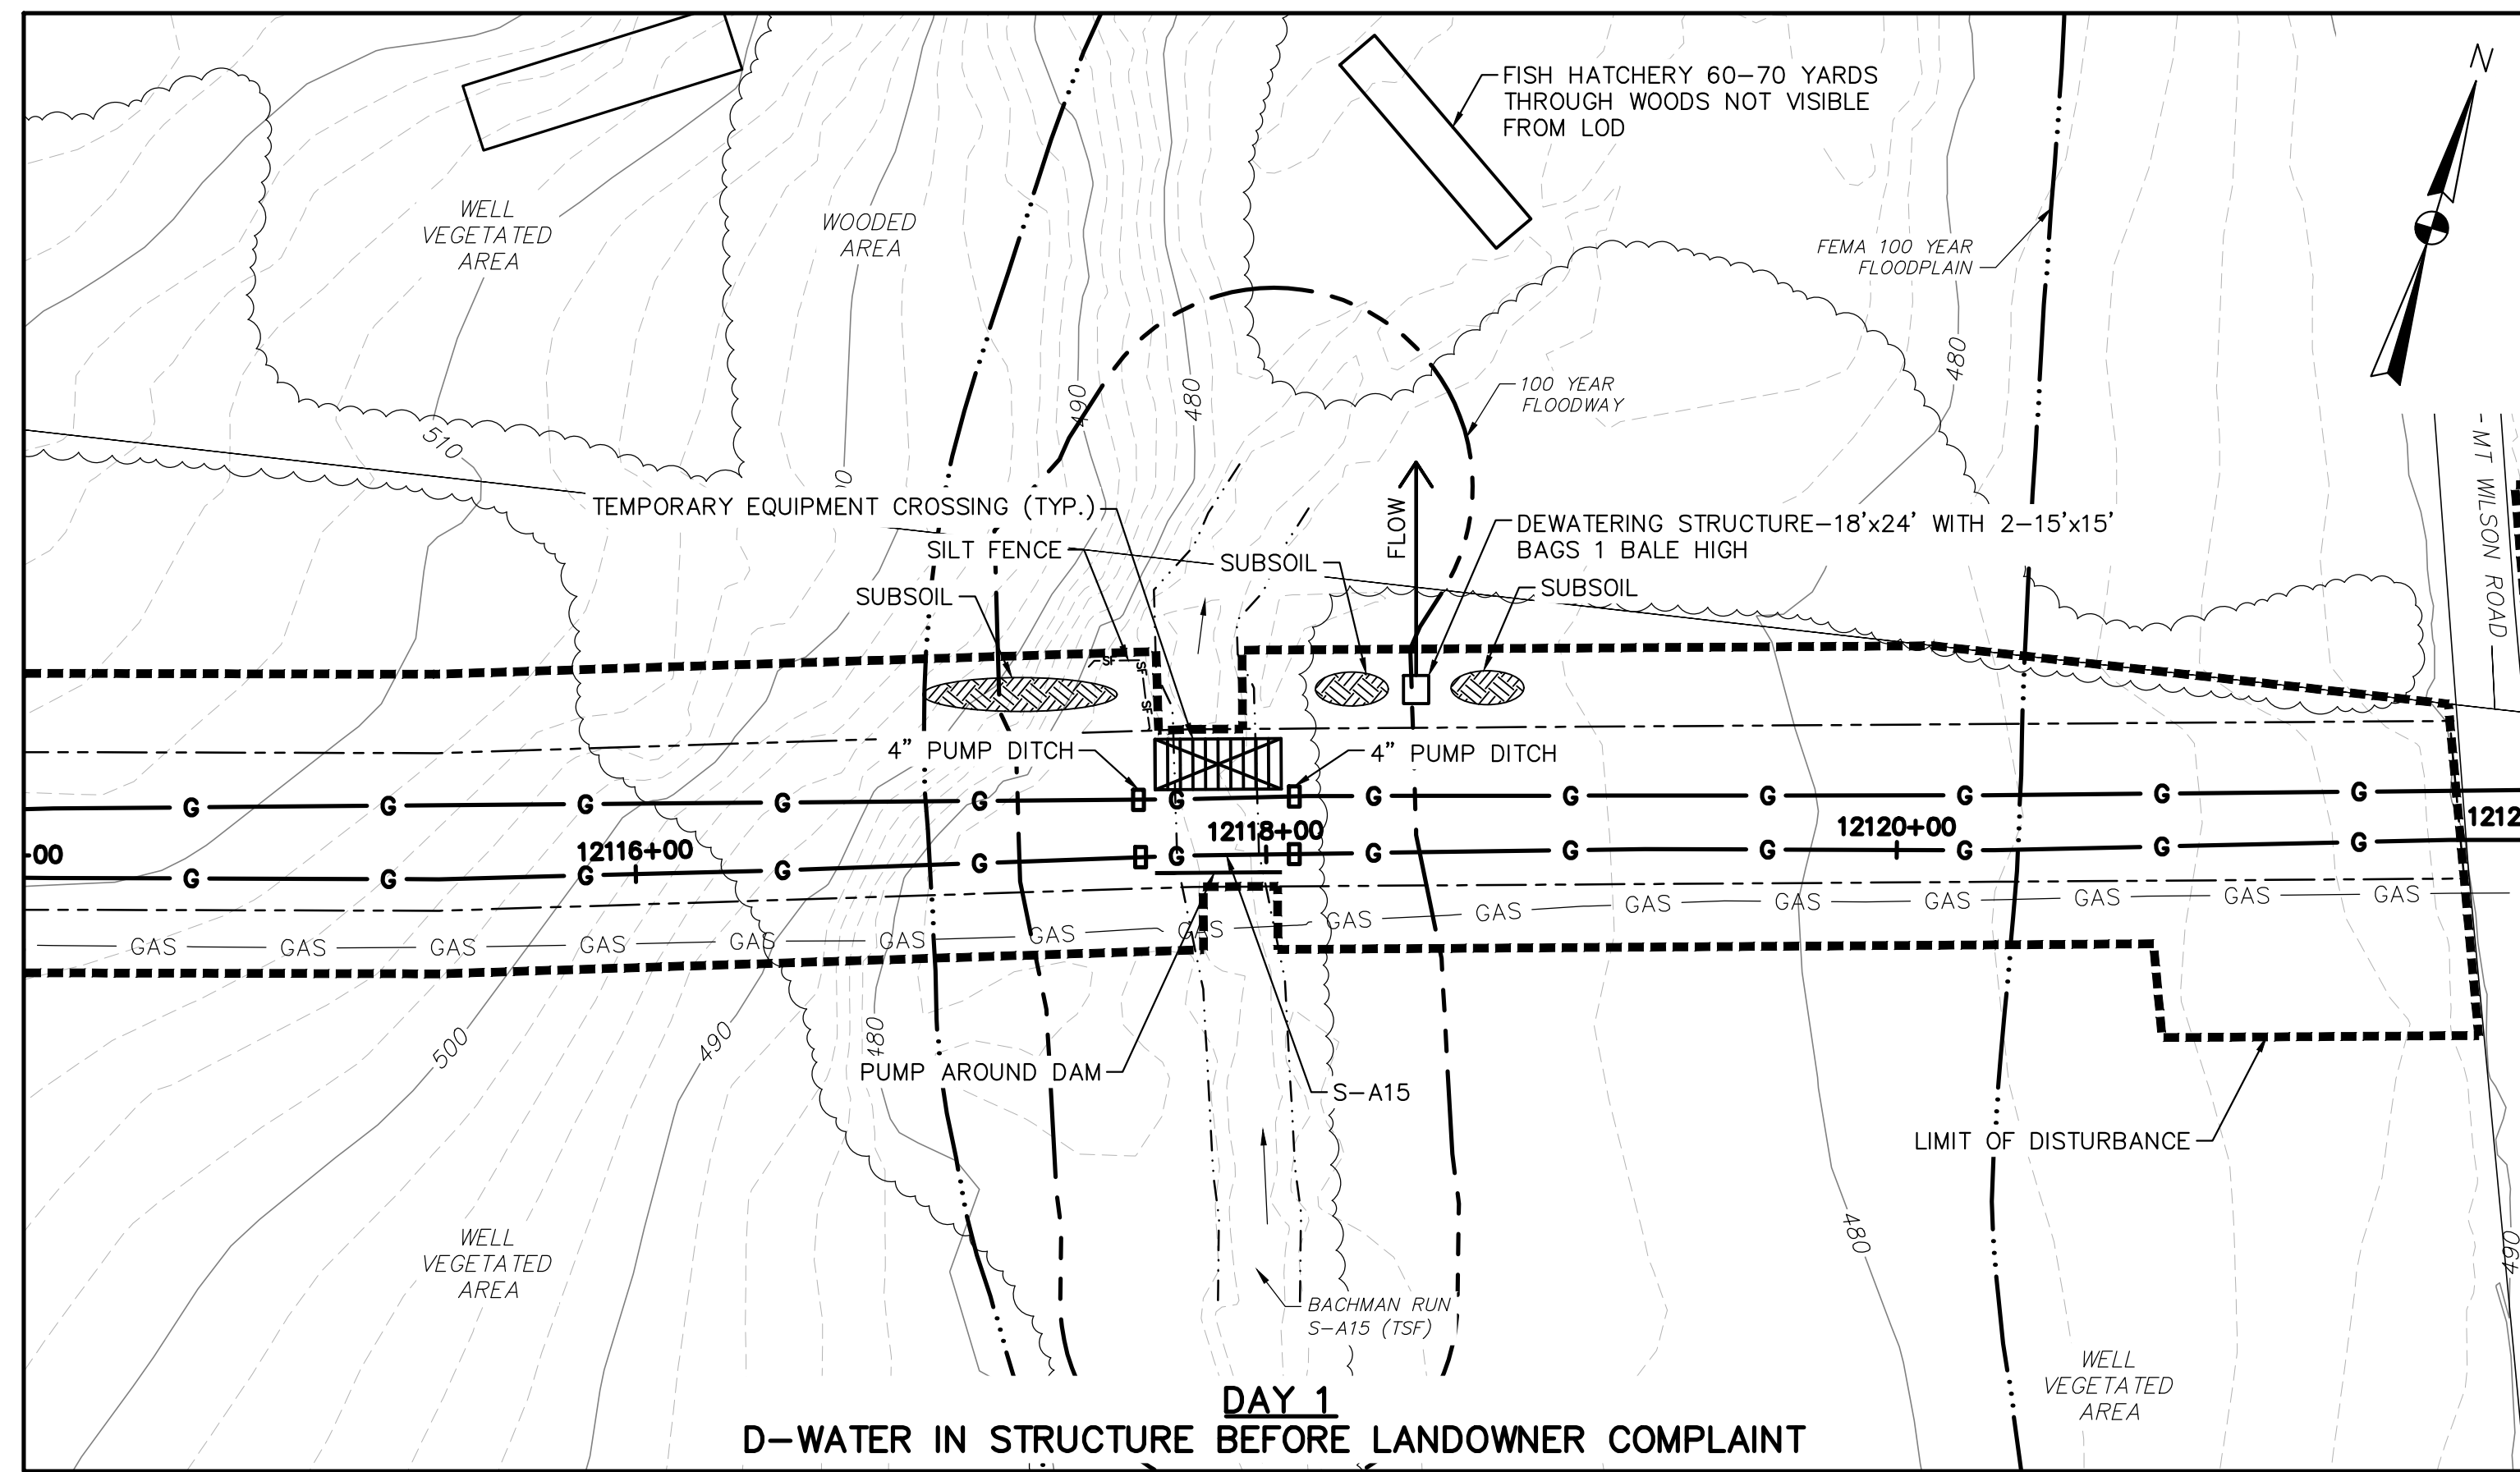
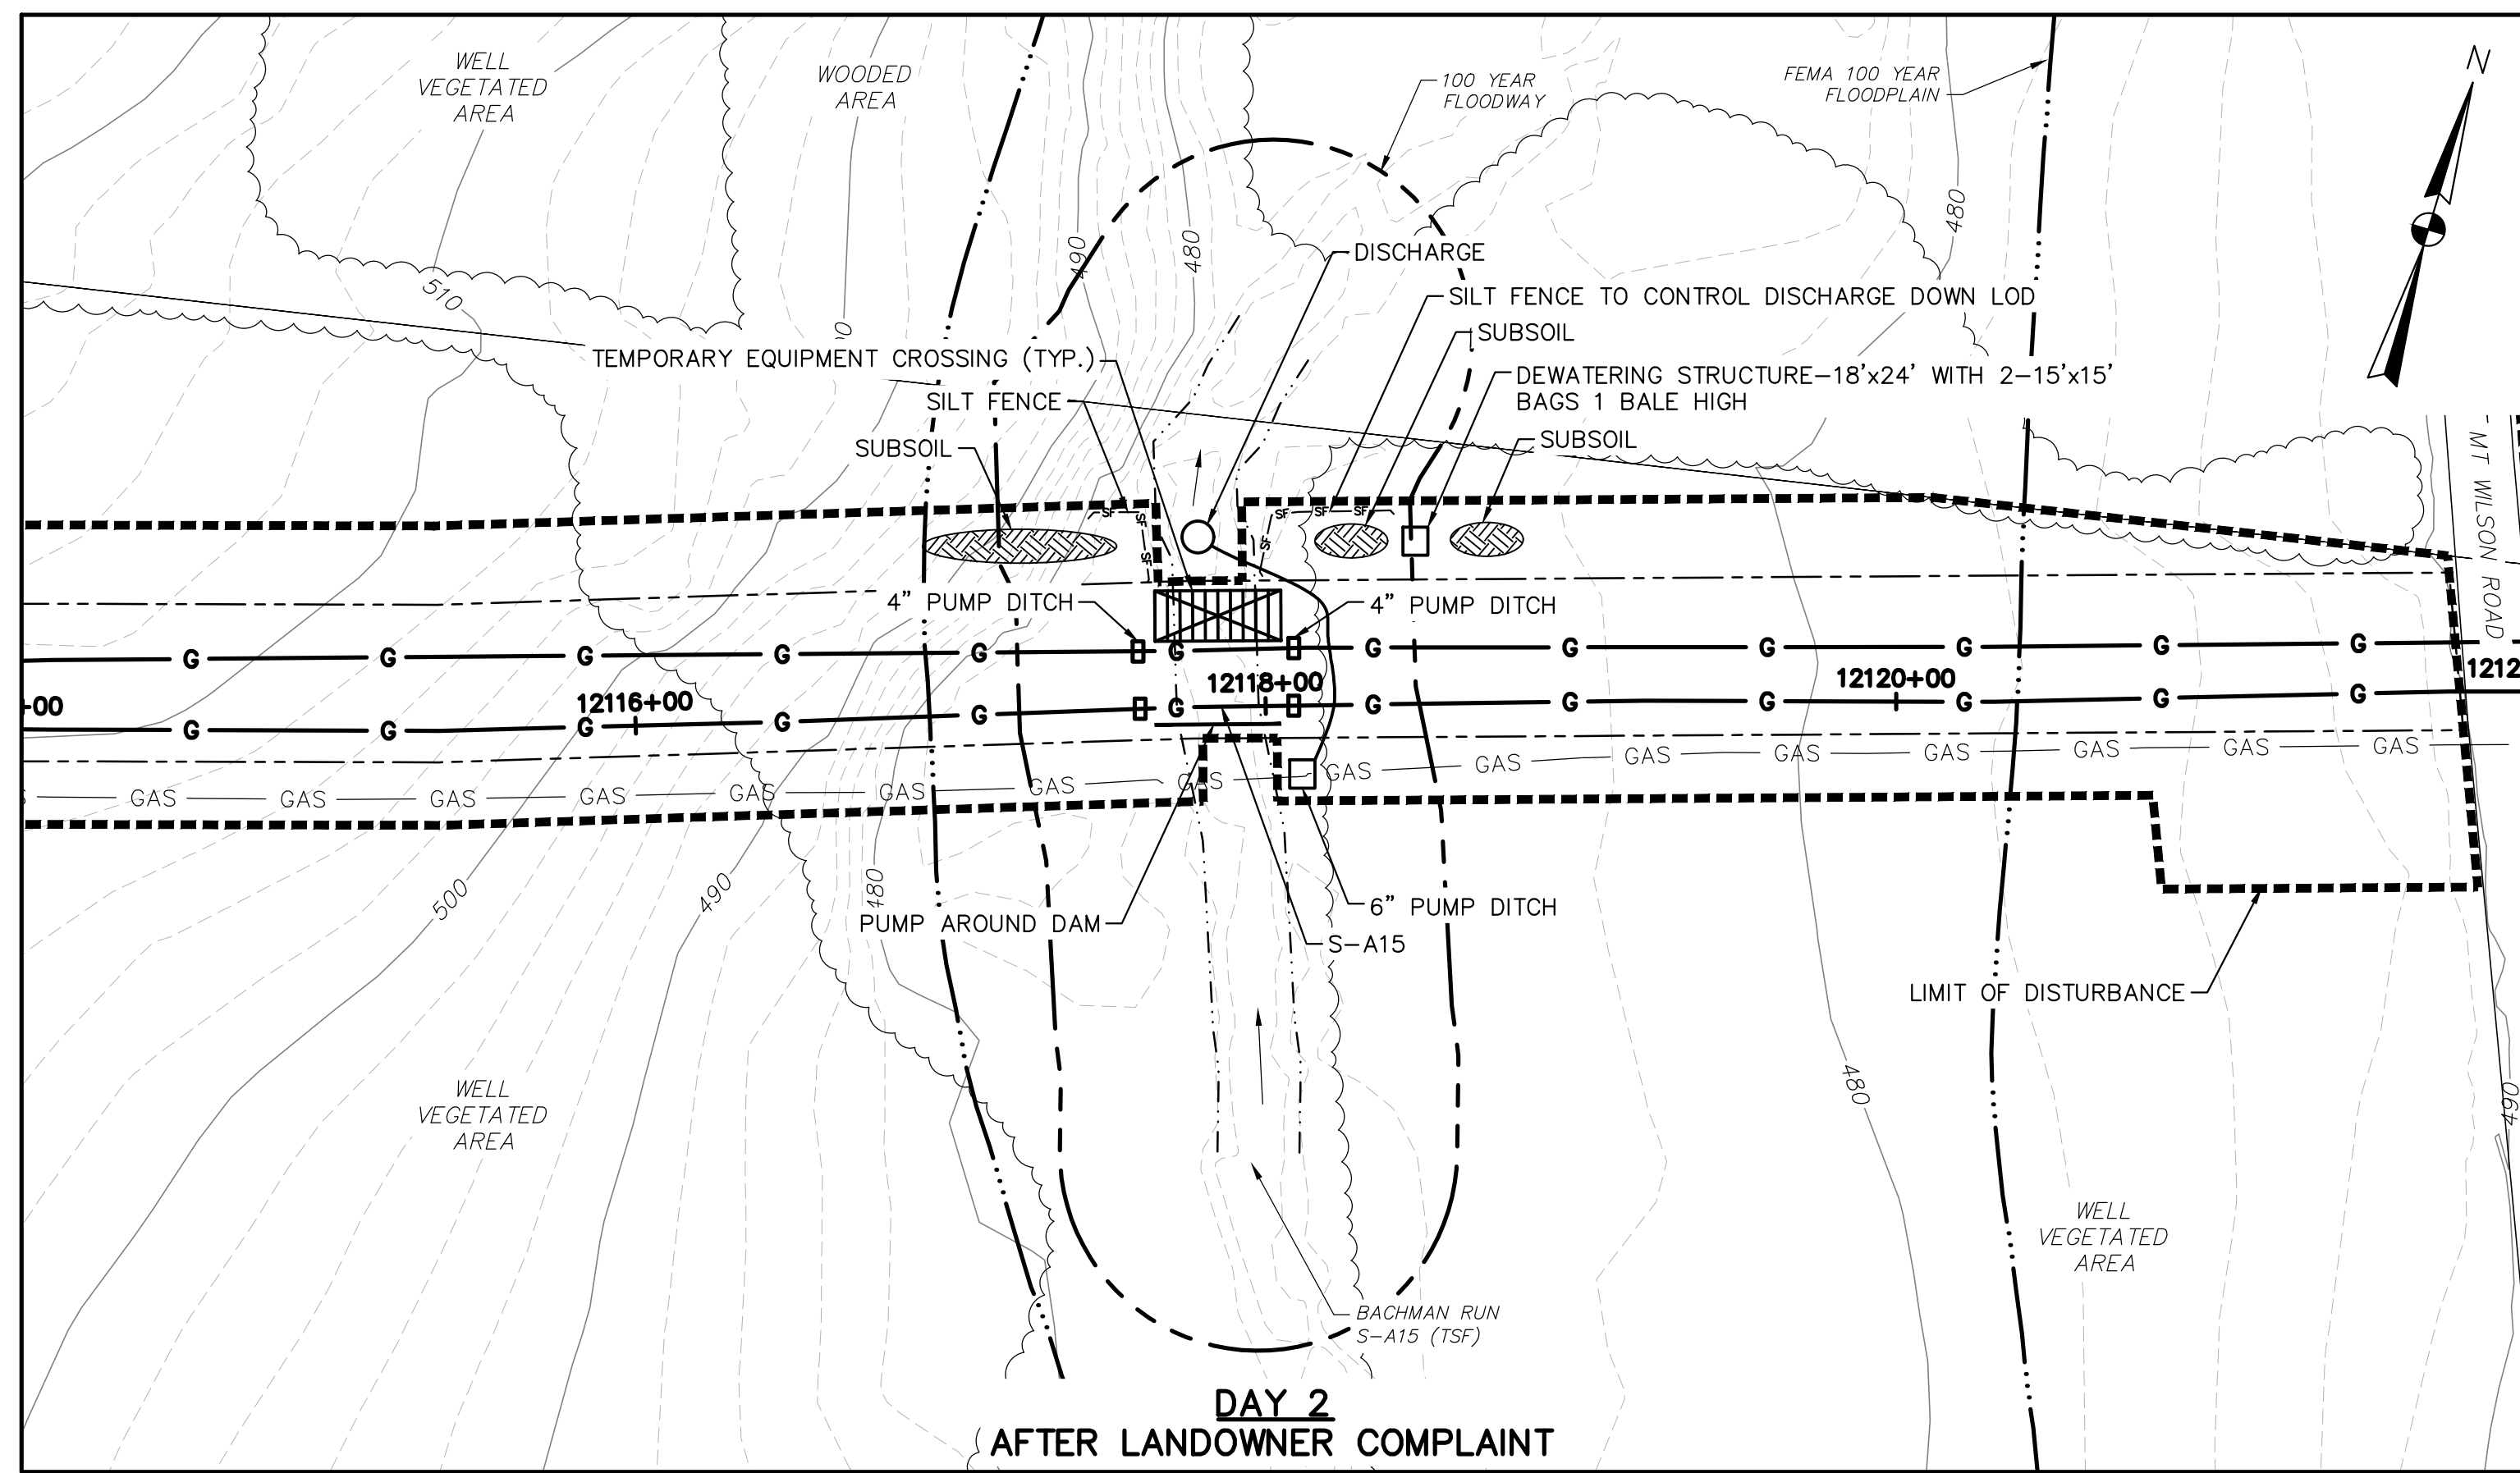
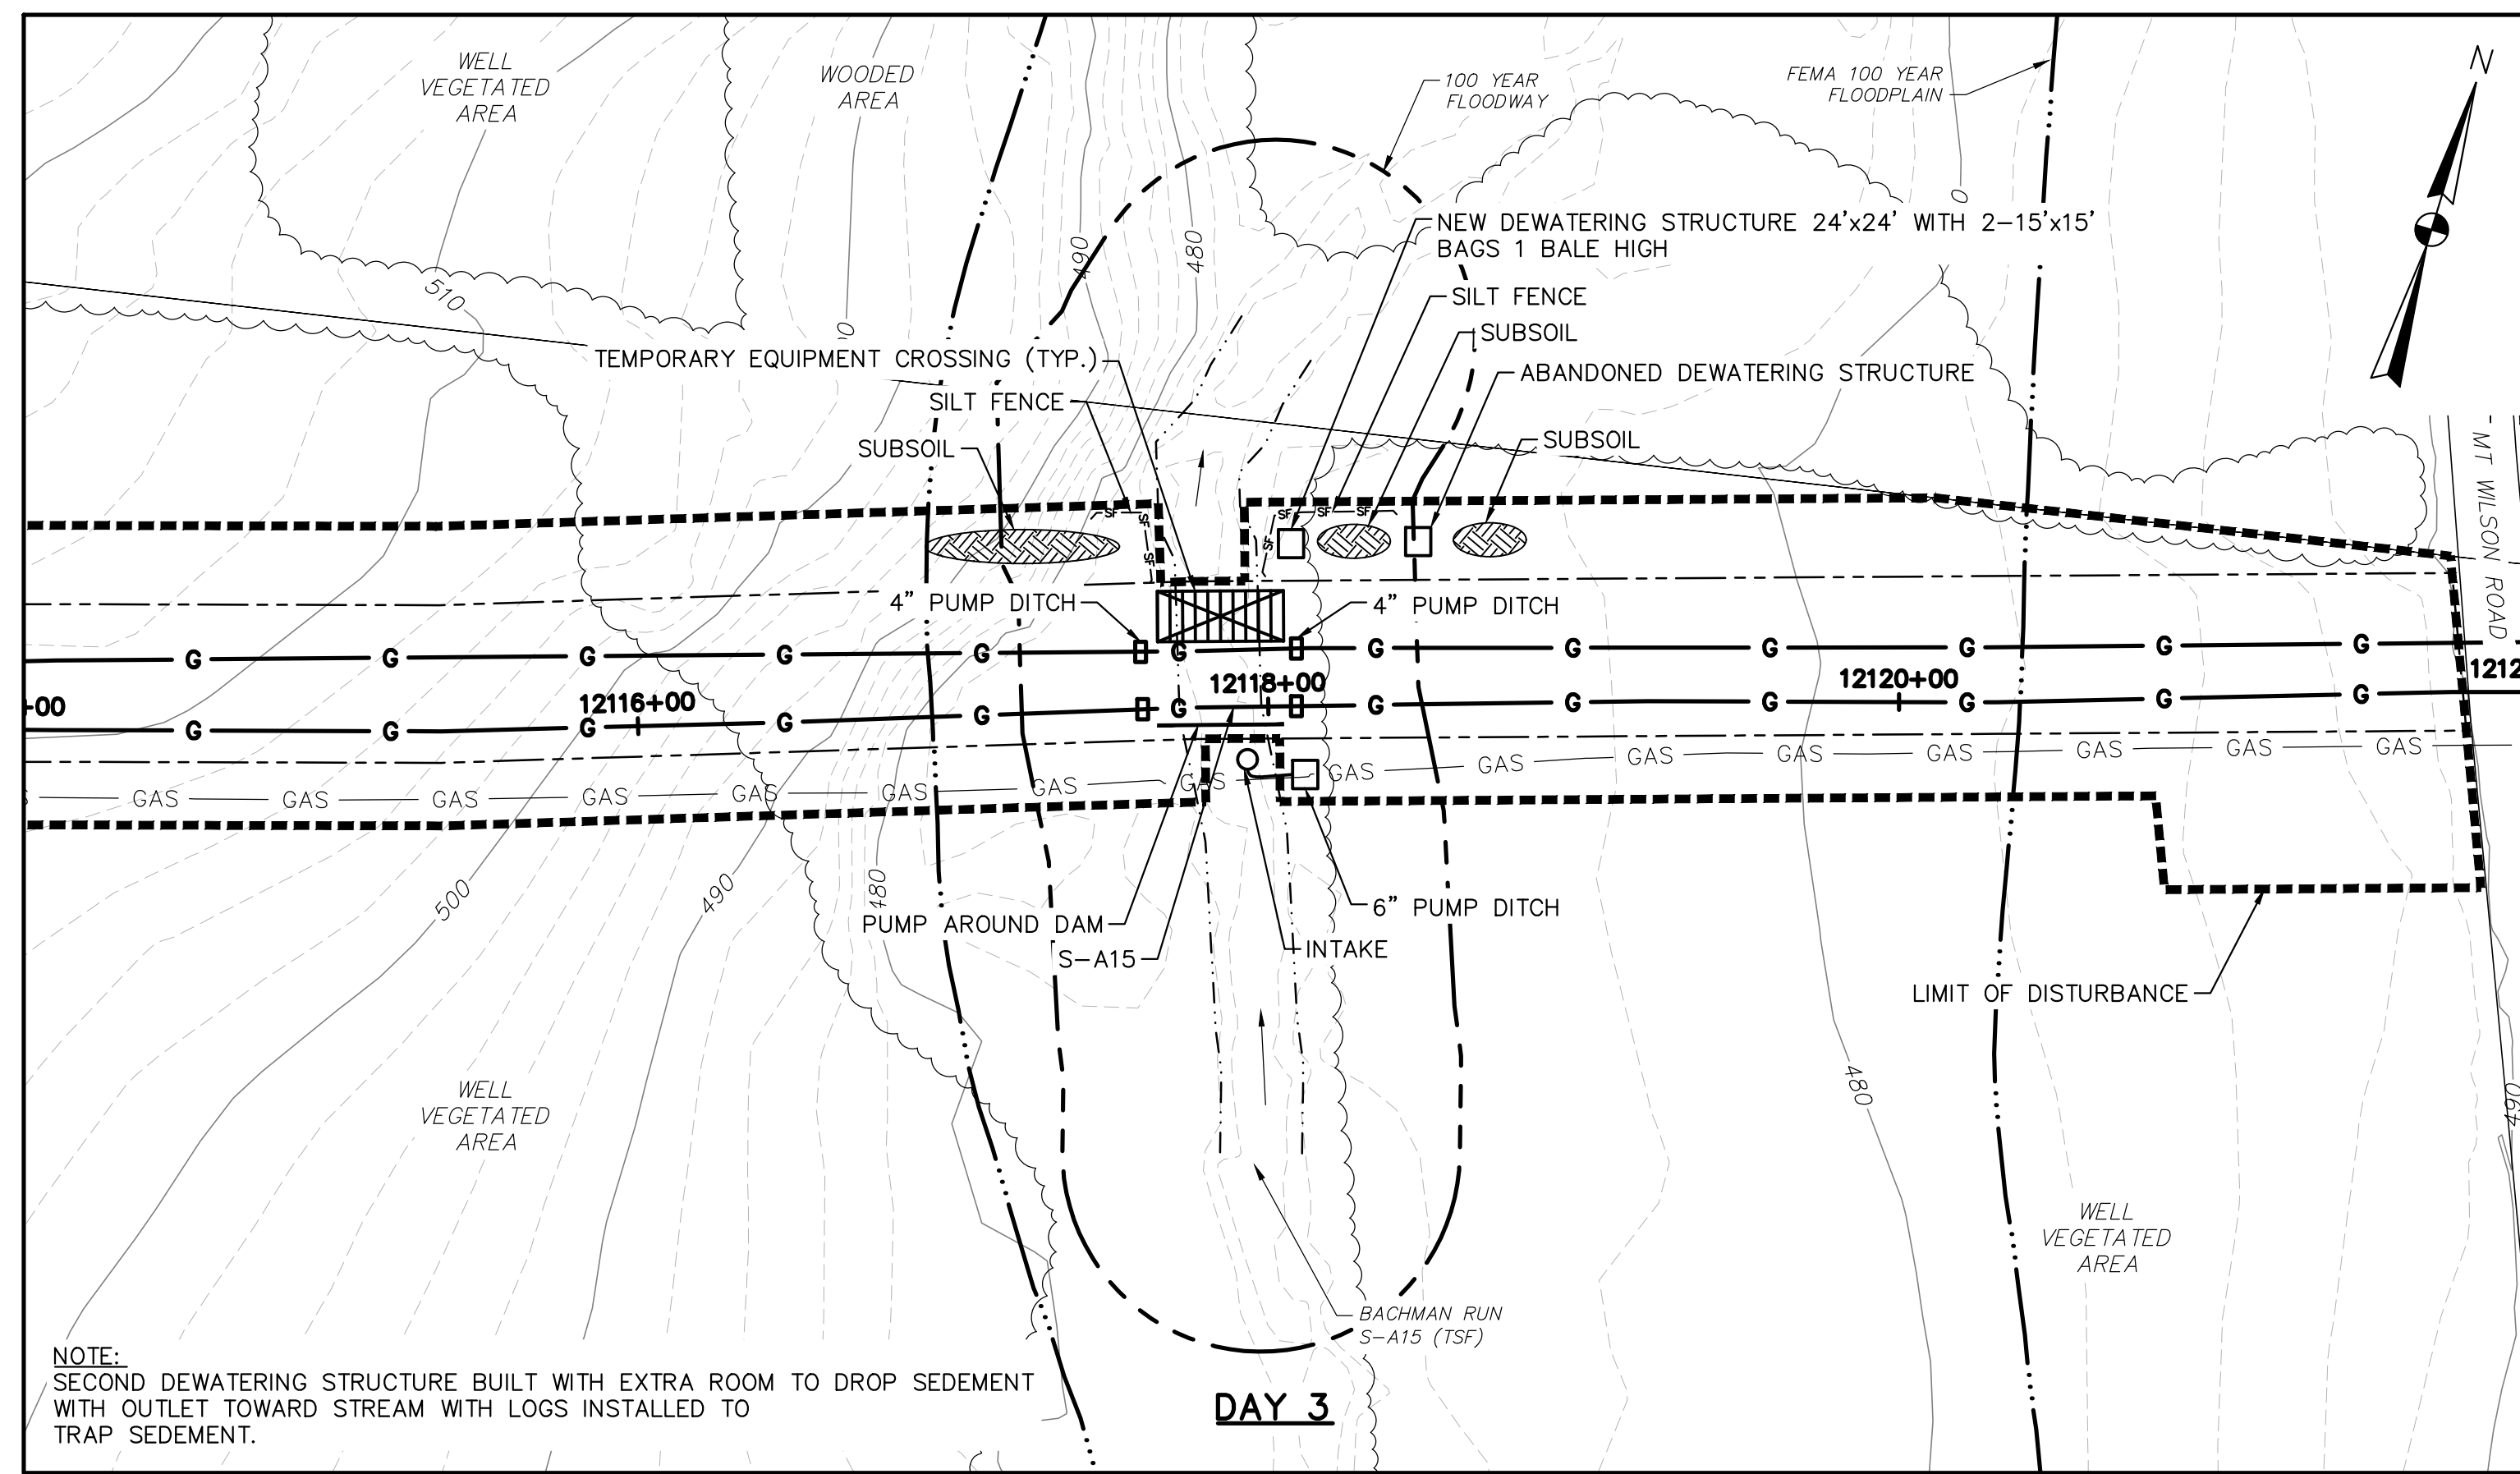
DATE:	8/18/17
PROJECT NO.:	112C05958
DESIGNED BY:	CC
DRAWN BY:	NN
CHECKED BY:	CC
COPYRIGHT TETRA TECH INC.	
FIGURE 1	
SHEET 1 OF 1

A diagram of the Site depicting the approximate location of the two dewatering locations and the discharge point to Bachman run is included with this Non-compliance Report at Attachment A.
