FEDERAL ENERGY REGULATORY COMMISSION FIELD INSPECTION REPORT

Date June 8, 2016

Project Texas Eastern Transmission, L.P.
Appalachia to Market 2014 (TEAM 2014) Project
Berks, Dauphin, Fayette, Huntingdon, Indiana, Lebanon, Perry, and
Westmoreland Counties, Pennsylvania; and various counties in West
Virginia, Ohio, Kentucky, Tennessee, Alabama, and Mississippi
Docket No.: CP13-84-000
Authority: Section 7(b) and 7(c)

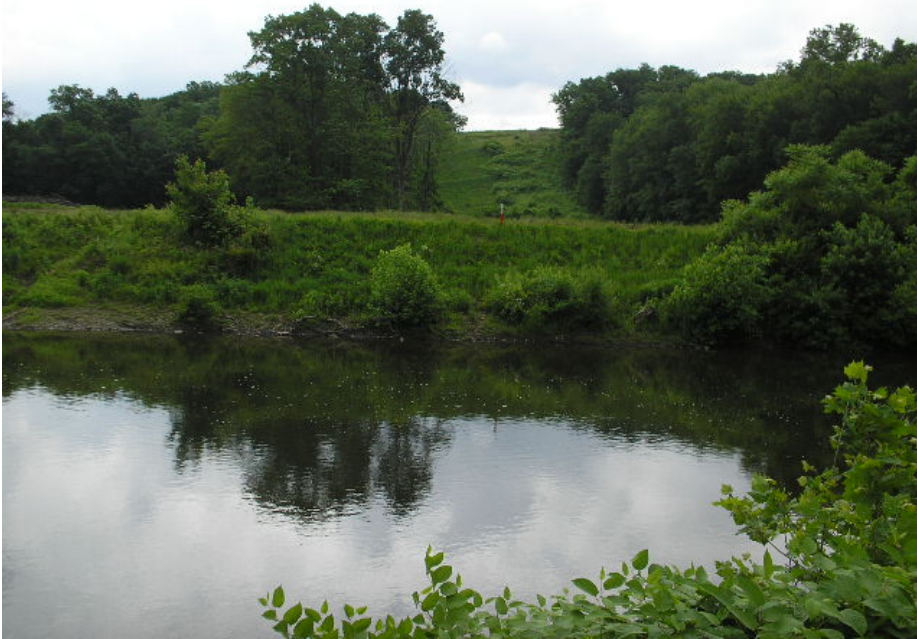
Photo No.: 1

Assessment: Acceptable

Comments: Open ROW, Grantville West Loop, Waterbody GW_S06 (Swatara Creek). The eastern crossing of Swatara Creek was acceptably restored, and the banks were well vegetated and stable. No construction debris or other environmental concerns were identified. The steep hill beyond was stable and well vegetated.

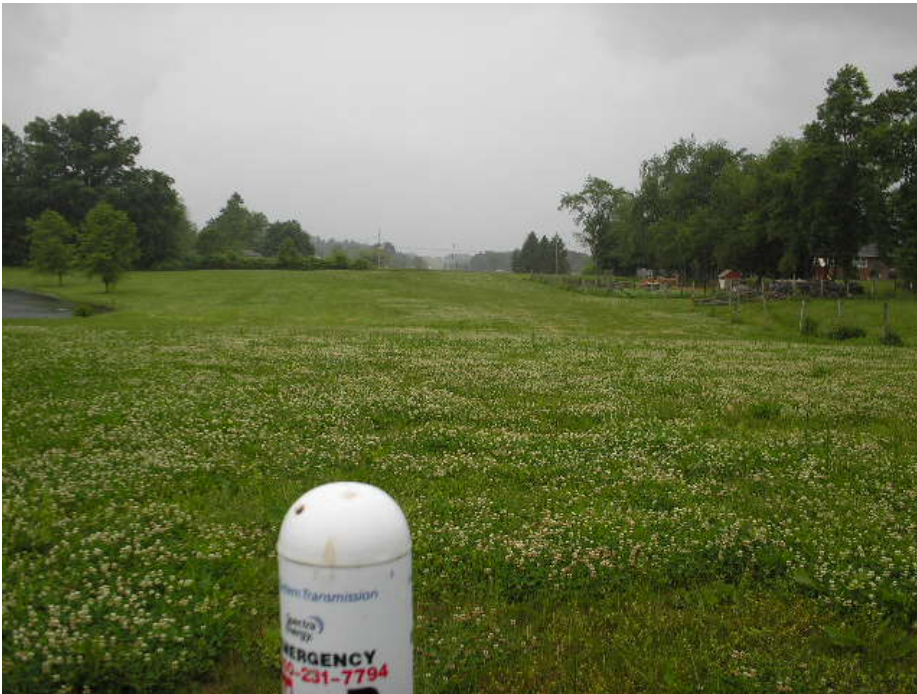
Photo No.: 2

Assessment: Acceptable

Comments: Open ROW, Grantville West Loop. The ROW, which passes through the backyards of several residences, was acceptably restored and well vegetated. No construction debris or other environmental issues were observed.

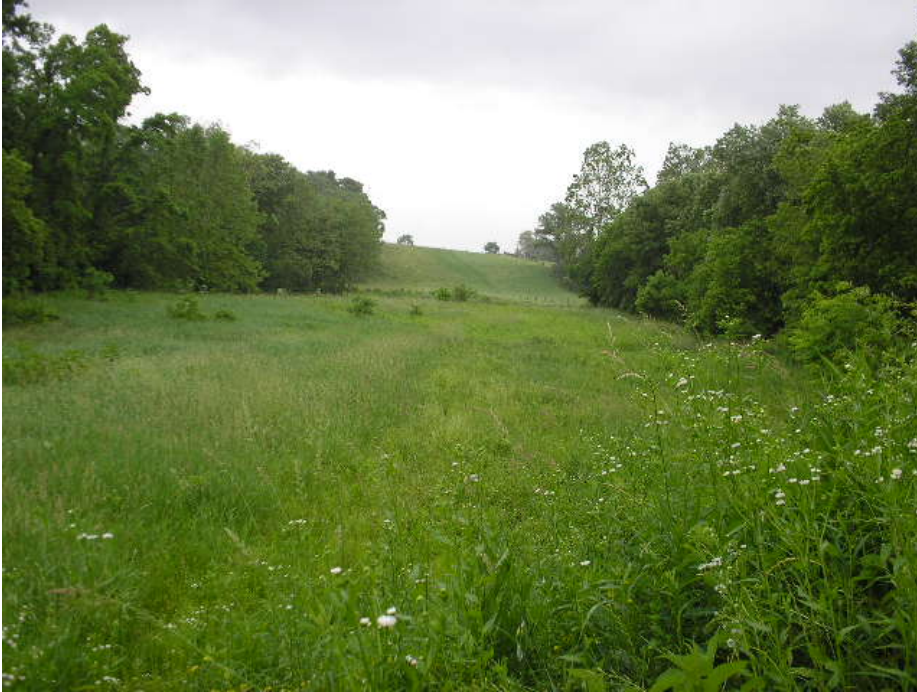
Photo No.: 3

Assessment: Acceptable

Comments: Forested ROW, Grantville West Loop, Wetland GW_W03, Waterbody GW_S04. The ROW and wetland were generally well vegetated, as was a small waterbody within the wetland (Waterbody GW_S04). The nearby Sensitive Resource Area was acceptably restored and well vegetated.

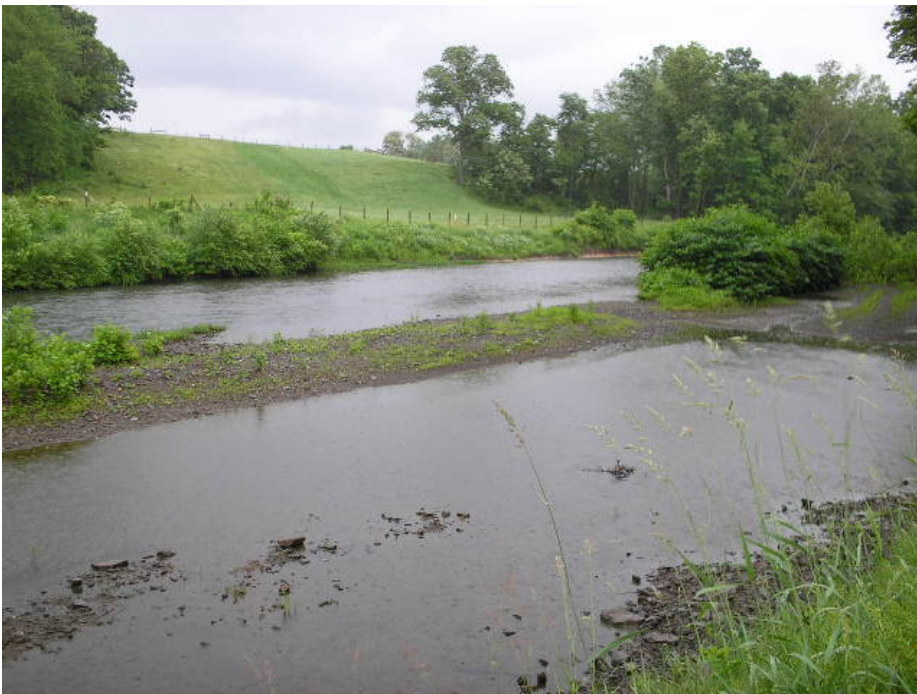
Photo No.: 4

Assessment: Acceptable

Comments: Open ROW, Grantville West Loop, Waterbody GW_S03 (Swatara Creek). The western crossing of Swatara Creek was acceptably restored. Contours were restored, and the stream banks were well vegetated and stable. Fences on the far (eastern) side were restored.

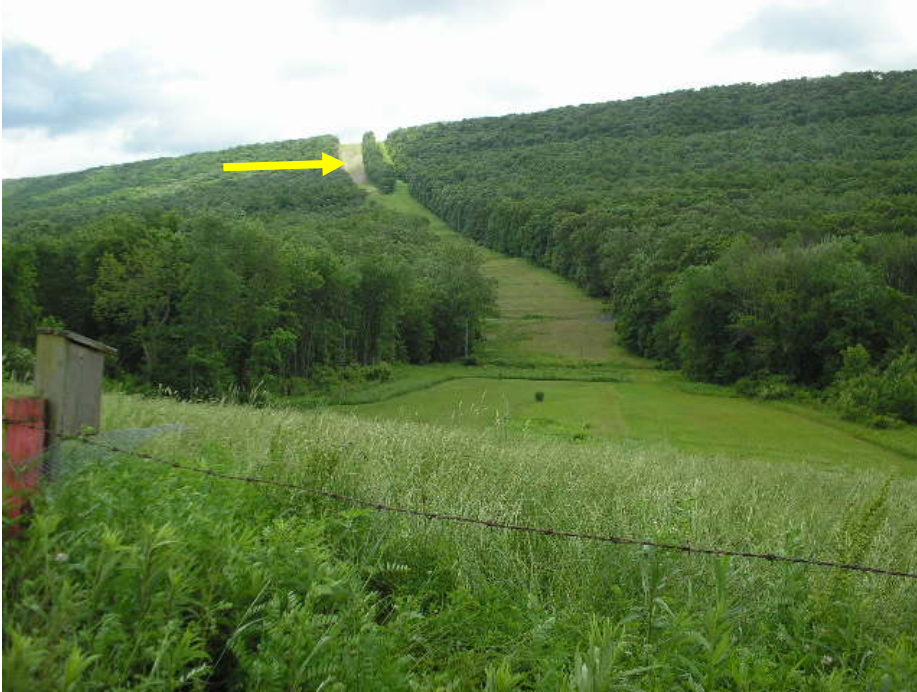
Photo No.: 5

Assessment: Acceptable

Comments: Open ROW, Shermans Dale Loop, Waterbody SD_S12 (Stony Creek), Wetland SD_W10. The ROW was adequately restored, and the wetland on the left (north) side in the foreground appeared well vegetated. The middle slope appeared well vegetated with no erosion visible. Texas Eastern reported that slope breakers along the middle slope will be reworked, per the request of the landowner (the Pennsylvania Game Commission), to better line up with slope breakers on the adjacent ROW. Viewed through binoculars, gully erosion may be present along the center of the steep, rocky, upper slope (arrow). The base of the steep section was inaccessible and could not be clearly viewed, so it was unclear whether there was any sediment or off-ROW impacts. Texas Eastern stated that they will assess the rocky slope when work on the middle slope begins in several weeks.

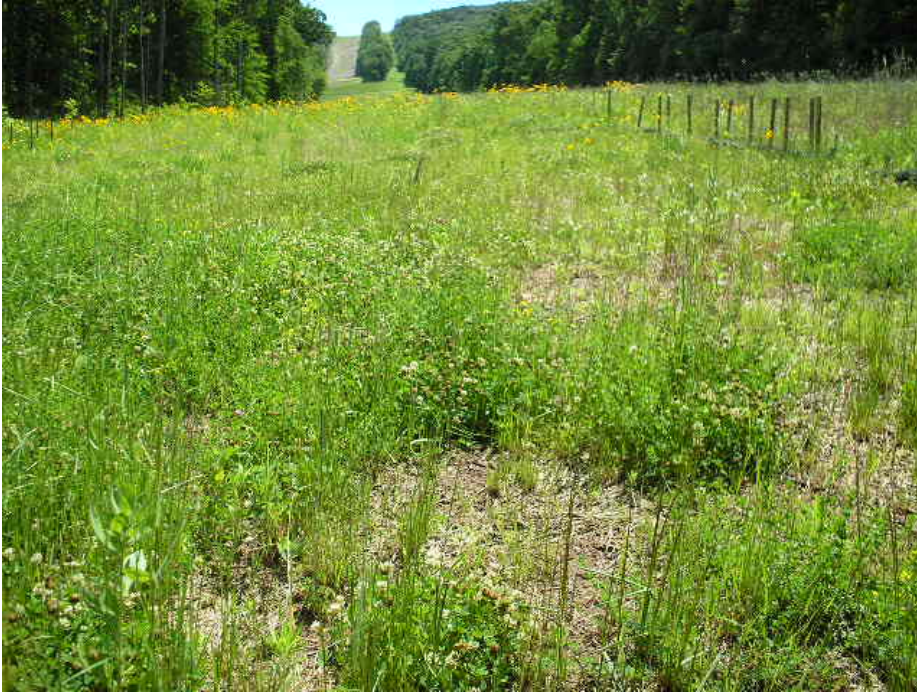
Photo No.: 6

Assessment: Acceptable

Comments: Forested ROW, Shermans Dale Loop. The ROW was generally well vegetated with a few small patches of poor-to-moderate revegetation. Inspection participants discussed the removal of ECDs, now that vegetation was more established, but the temporary ECDs at the road crossing may have helped during spring runoff. Texas Eastern stated that the ECDs were slated for removal, but some may be left or reinforced for planned construction in this area (unrelated to the Project) this summer. All of the nearby mitigation tree plantings appeared healthy.

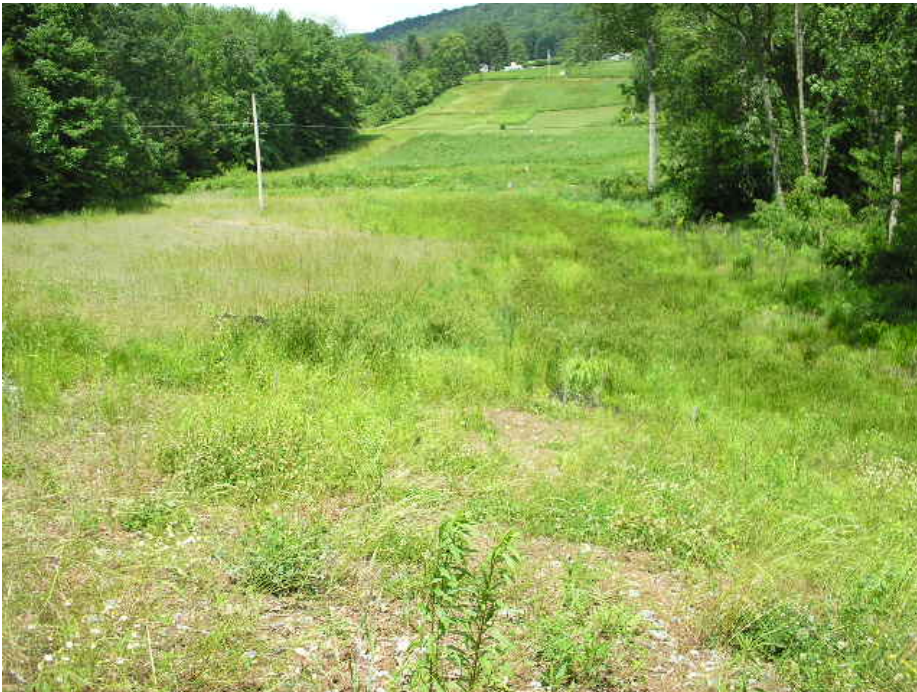
Photo No.: 7

Assessment: Acceptable

Comments: Forested ROW, Shermans Dale Loop, Wetland SD_W11. Revegetation along the short, steep slope was fair, with some rill and gully erosion. Super silt fence along the right (north) side of the ROW was partially knocked over from a previous storm, but still effectively controlled sediment. Texas Eastern planned to repair the erosion and repair or remove the ECD this summer. The wetland was well vegetated with a variety of wetland species.

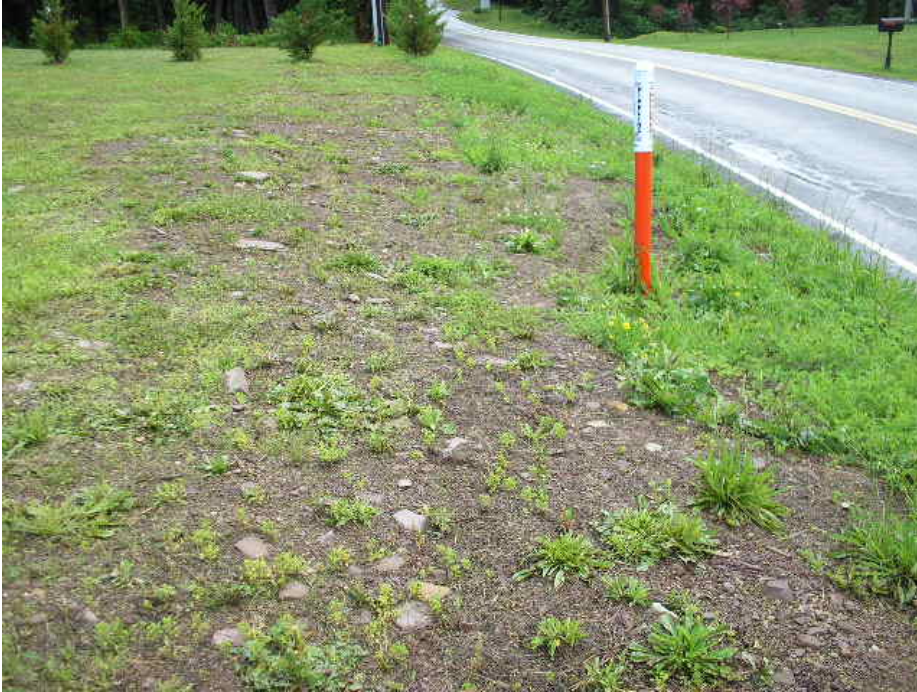
Photo No.: 8

Assessment: Acceptable

Comments: Open and Forested ROW, Shermans Dale Loop. Overall, revegetation along this residential backyard was successful, except for this area along the top of a short, steep bank where the soil was thin and rocky. No erosion or accumulated sediment was observed.

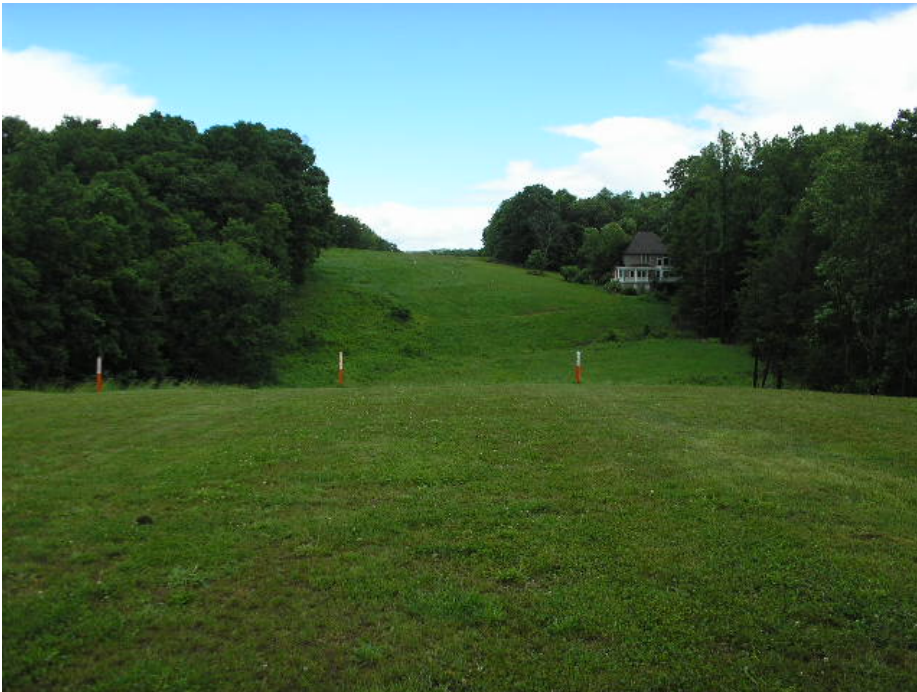
Photo No.: 9

Assessment: Acceptable

Comments: Open and Forested ROW, Shermans Dale Loop. The ROW along residential backyards, including the far slope, was well vegetated with no erosion or other environmental concerns. Similarly, the residential backyards west of the Fishing Creek Valley Road crossing were acceptably revegetated.

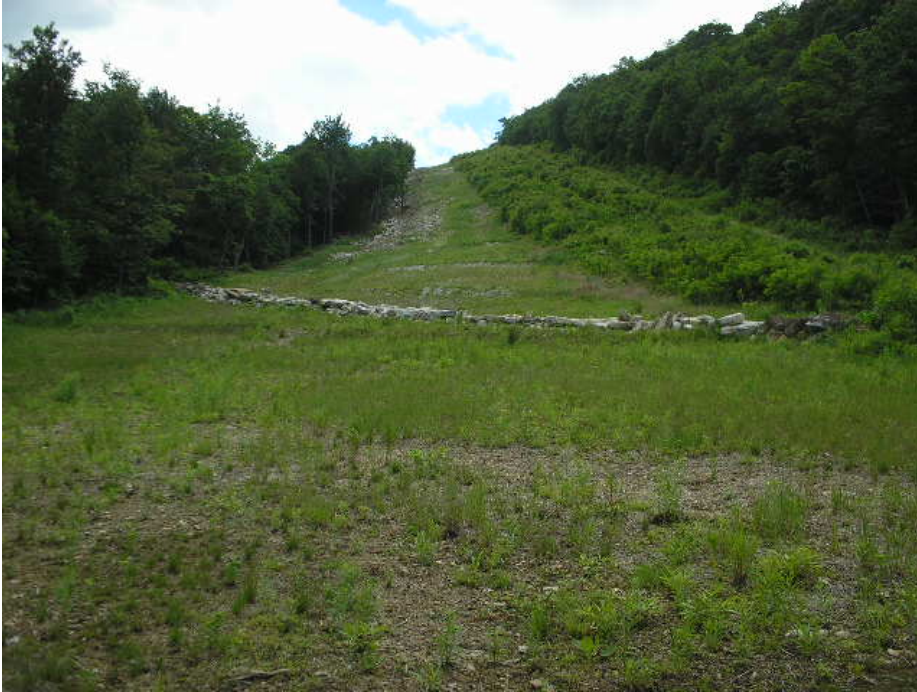
Photo No.: 10

Assessment: Acceptable

Comments: Forested ROW, Perulack West Loop. The steep and very rocky upper slope was revegetating acceptably, despite some small patches of poor-to-moderate revegetation. No significant erosion or accumulated sediment was observed.

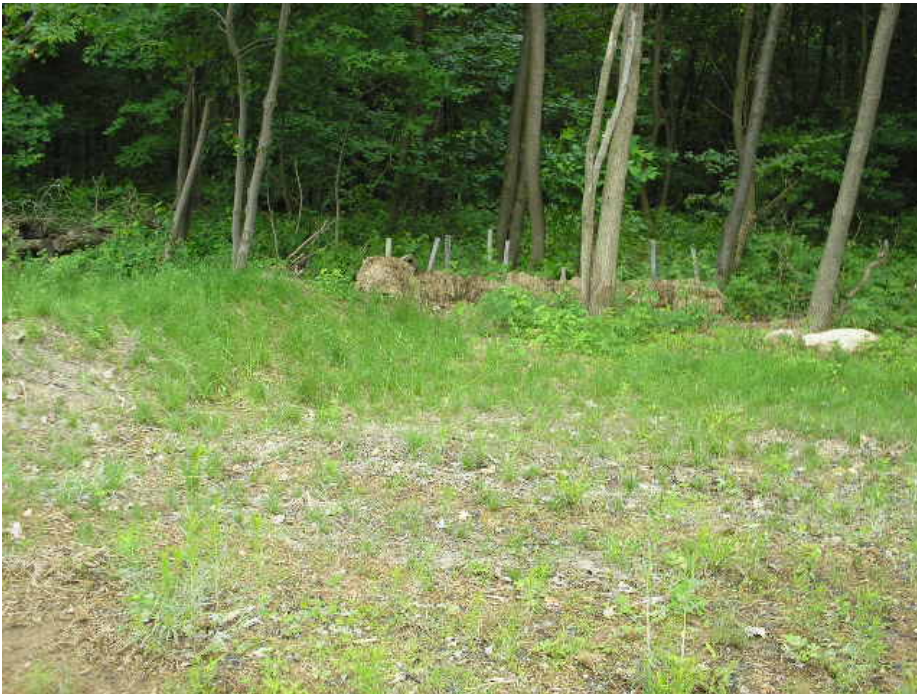
Photo No.: 11

Assessment: Acceptable

Comments: Forested ROW, Perulack West Loop. Slope breakers were installed along the ROW, many with temporary hay bale J-hooks at the ends. Inspection participants again discussed the removal of these temporary ECDs, but also noted that these may have helped control stormwater runoff during the winter and spring. No off-ROW sediment was noted.

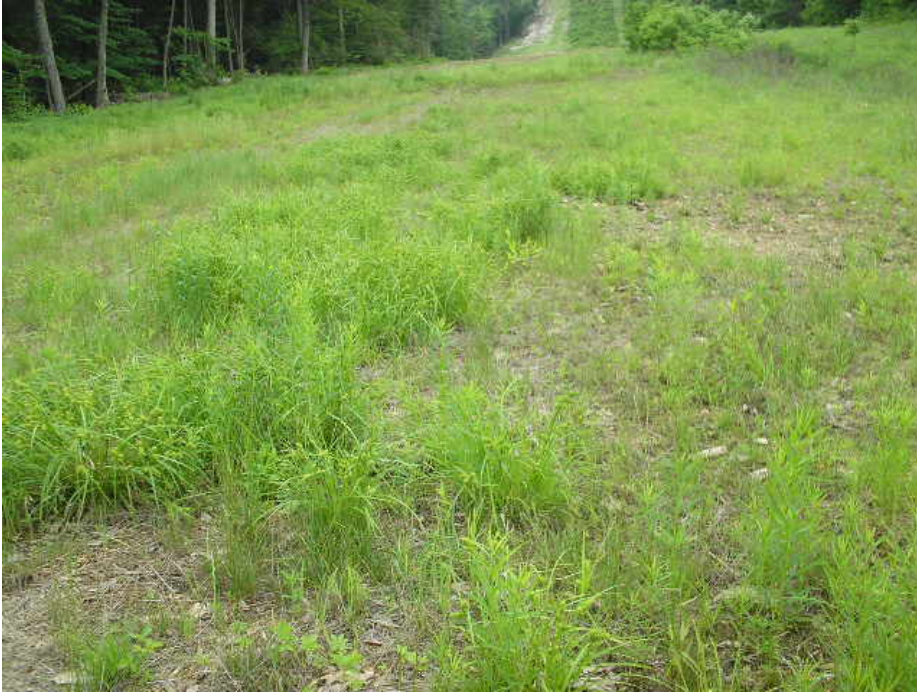
Photo No.: 12

Assessment: Acceptable

Comments: Forested ROW, Perulack West Loop. Volunteer wetland vegetation species were mixed with upland species within this apparent upland. Although revegetation was more moderate along this area compared to other areas, no erosion or accumulated sediment was noted, and the ROW appeared stable.

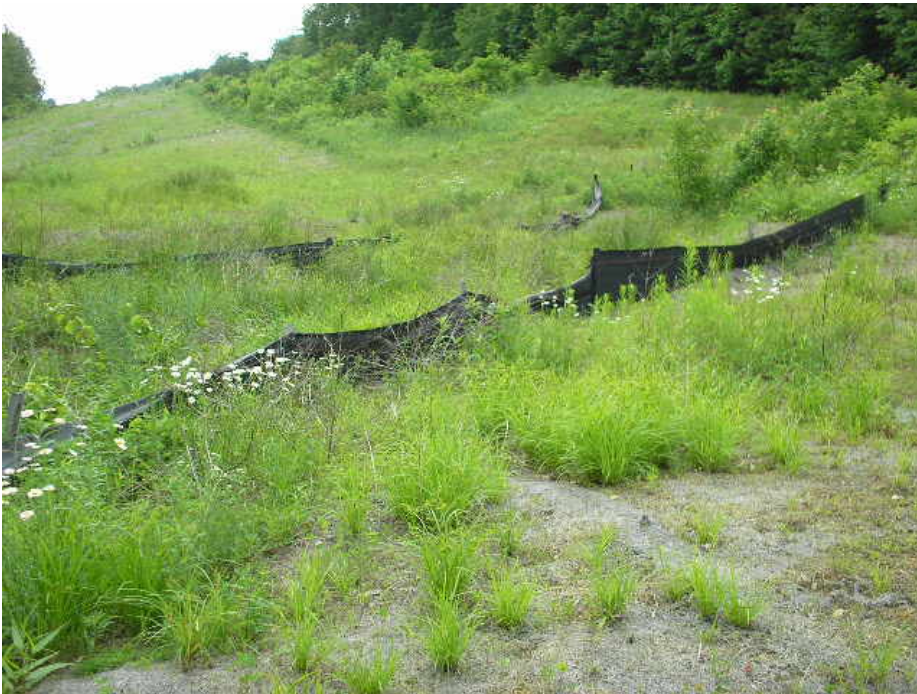
Photo No.: 13

Assessment: Acceptable

Comments: Forested ROW, Perulack West Loop, Waterbody PW_S07, Wetland PW_W09. The resource crossing was restored, and the banks were well vegetated. Temporary ECDs remained, but inspection participants discussed their removal. Texas Eastern already planned to remove the ECDs during the summer of 2016. No environmental concerns were identified.

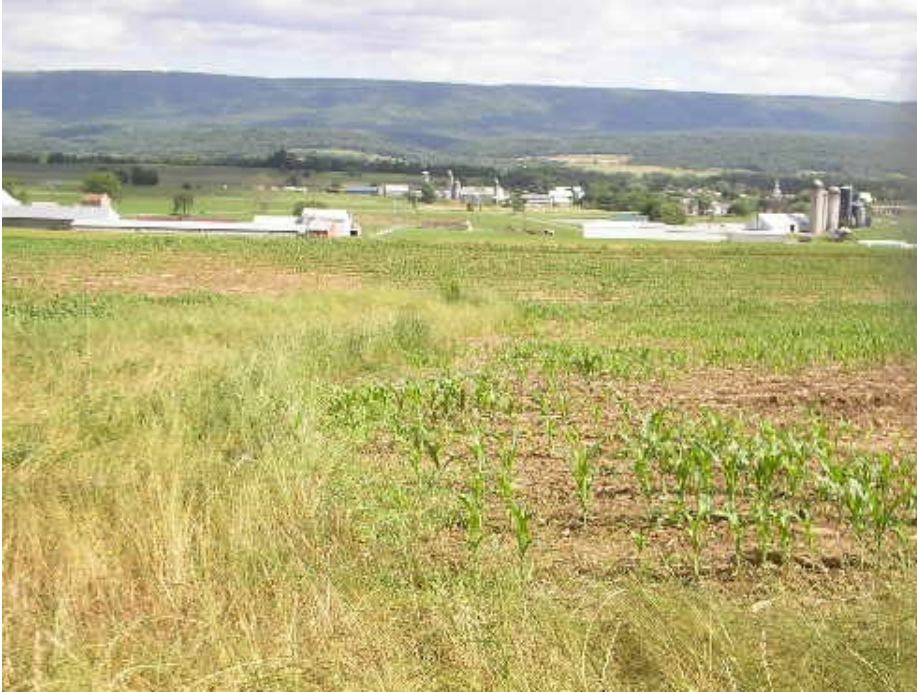
Photo No.: 14

Assessment: Acceptable

Comments: Agricultural ROW, Perulack West Loop. A narrow area, directly along the trench line, was heavily vegetated with grass, possibly following a neighboring gas pipeline repair after construction was complete. The surrounding cultivated field was planted in corn. No erosion or other concerns were noted. The corn crop was patchy within the surrounding ROW, suggesting potential crop productivity issues, such as soil compaction, etc. compared to the adjacent field. Texas Eastern reported that there were no landowner complaints.
