CHAPTER 102 INSPECTION REPORT

Permit No.:	PAD510225

Report No.: 18

GENERAL INFORMA	TION			
Project/Site Name:	Alliance 51st Street, Philadelphia	Permit Issuance	e Date:	9/5/2023	
Site Address:	1656 S. 51 st St.	Permit Expiration	on Date:	9/4/2028	
Site City, State, ZIP:	Philadelphia, PA 19143	Permit Type:		NPDES IP	
RP/Permittee Name:	Eric Carlson	Site Municipality	y(ies):	Philadelphia	
RP/Permittee Address:	40 Morris Ave., Suite 230	Site County(ies):	Philadelphia	
RP/Permittee City, State, 2	ZIP: Bryn Mawr, PA 19010	Earth Disturban	ice:	11.54	acres
RP/Permittee Email:	ecarlson@alliancehp.com	Site Latitude:		39.935278	
Surface Water(s):	Schuylkill River	Site Longitude:	-	75.209236	
Special Protection?	☐ Yes ⊠ No	Complaint Inspe	ection?		No
Construction Stage:	Inactive	Activity:		Construction	ı <u>></u> 1 ac.
Operator Name	Operator Company	Оре	erator Er	mail	Approved
n/a					
	INSPECTION INFORM	ATION			
Inspection Date:	3/12/25	Inspection Tir	me:	10:50	АМ ПРМ
Lead Inspector Name:	Robert Page	Inspector Em	ail:	ropage@pa.go	ov

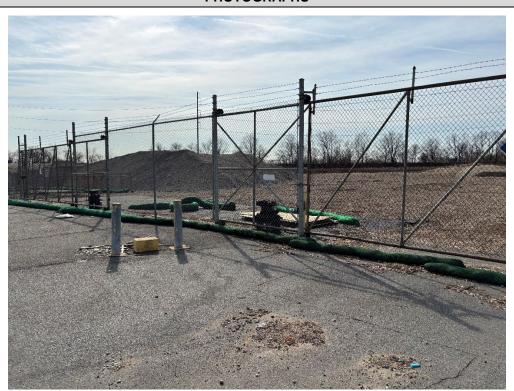
Most upslope gate and filter sock.

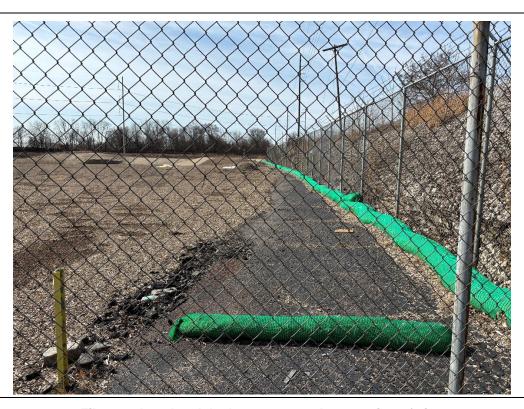
Filter sock and mulch along most upslope portion of site.

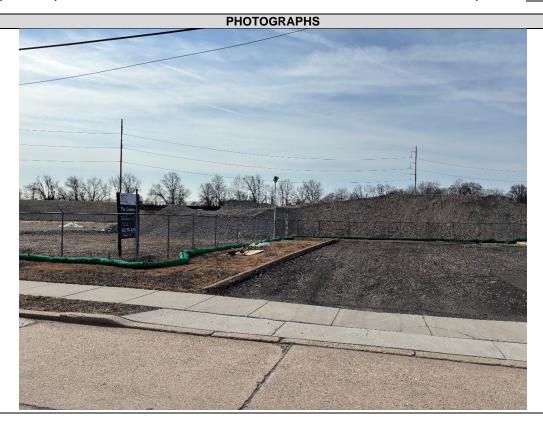
Mid-site parking lot, stone stockpile, and "For Lease" sign.

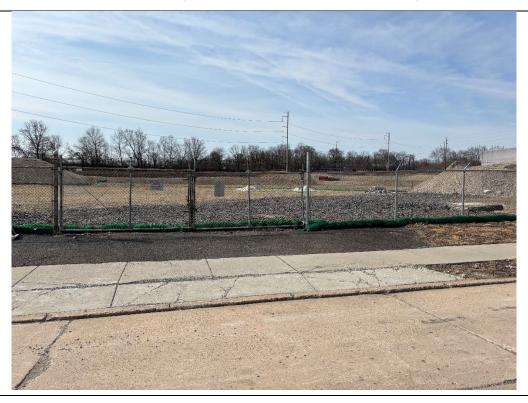
The more downslope of the 2 site gates along 51st St.

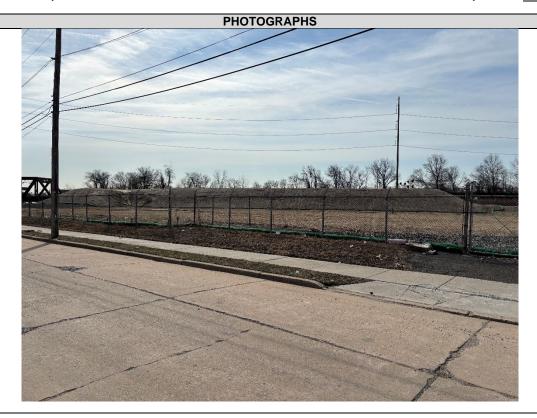
Midslope portion of site, with large fill dirt stockpile in distance.

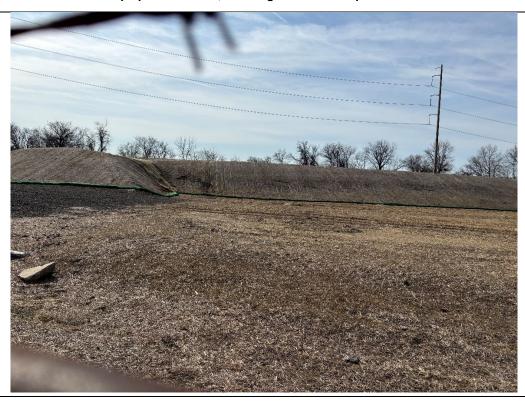
Mulch level of downslope portion of site and of large fill dirt stockpile.

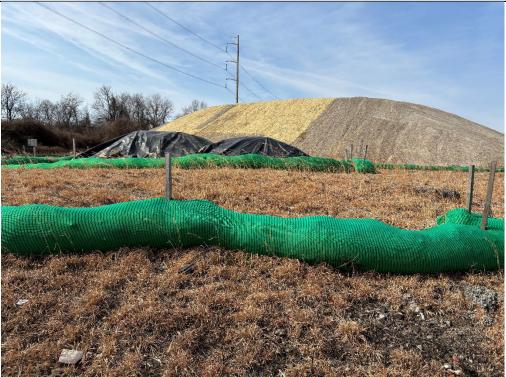
3800-FM-BCW0271g Rev. 11/2022 Permit No.: PAD510225 **Chapter 102 Inspection Report** Report No.: 18 ADDITIONAL COMMENTS (continued from Page 1) The black tarp covering the small pile of contaminated soil downslope of the large fill dirt stockpile, which was observed to be mostly displaced during the 2/26/25 inspection, was observed to be properly re-positioned during this inspection. Perimeter control (filter sock) around this pile, and the downslope site perimeter, remained intact. One inlet protection filter sock was in place along the wall of the Bartram's Garden trail. I observed that the damaged section of chain-link security fence along 51st St. that was noted during the 2/26/25 inspection, was repaired by the time of this inspection. I did not observe any change to the sediment staining on the Bartram's Garden trail downslope of the site. No violations noted during this inspection. DEP will be continuing to follow up on this site, and Robert Page can be reached at 484.250.5104 or ropage@pa.gov. **NOTICE AND SIGNATURES** This report is official notification that a representative of the Department of Environmental Protection (DEP) has conducted an inspection of your earth disturbance activity to determine compliance with 25 Pa. Code Chapter 102 and the Pennsylvania Clean Streams Law. This representative may be an employee of a County Conservation District (CCD), which by delegation agreement with DEP is authorized to investigate complaints, inspect earth disturbance activities and conduct compliance actions. Any violations observed by DEP/CCD have been noted in this report and constitute unlawful conduct as defined in Section 611 of the Clean Streams Law. Failure to take corrective actions to resolve the violations may result in administrative, civil and/or criminal penalties being assessed by DEP as as specified at Section 602 of the Clean Streams Law. The Clean Streams Law provides for up to \$10,000 per day in civil penalties, up to \$10,000 in summary criminal penalties, and up to \$25,000 in misdemeanor criminal penalties for each

Downslope (east) end of large fill dirt stockpile with erosion blanket present; contaminated dirt stockpile covered with black tarp; filter sock at downslope perimeter of site.

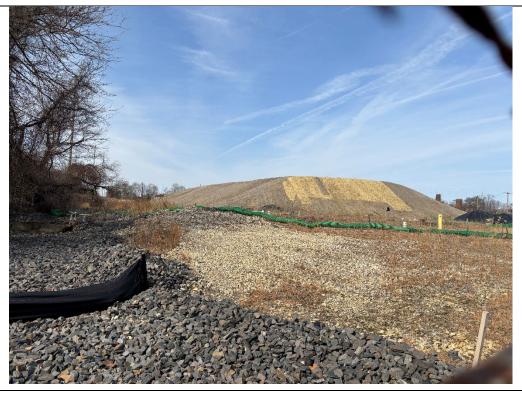
Rear side of large fill dirt stockpile; silt fence along stone-covered swale.

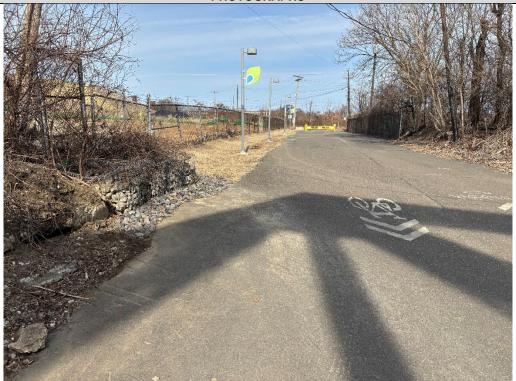
Sediment staining along Bartram's Garden trail.

3800-FM-BCW0271g Rev. 11/2022 Permit No.: PAD510225 **Chapter 102 Inspection Report** Report No.: 18 Failure to comply with the terms and conditions of a permit or order (CSL § 402(b)). Z. Failure to remove building materials and/or wastes from the site for recycling or disposal in accordance aa. with DEP regulations as required by the permit (CSL § 402(b)). Failure to comply with DEP regulations or the Clean Streams Law (CSL § 611). bb. Failure to take necessary measures to prevent pollutants from reaching waters of the Commonwealth (§ CC. 91.34(a)). Failure to notify DEP of new or expanded earth disturbance not identified in an NPDES permit application dd. (§ 92a.24(b)). Failure to notify and/or obtain authorization from DEP/CCD for changes to NPDES permitted activities (§ ee. 92a.41(a)(12)). ff. Other: During the inspection violations of Chapter 105 were observed and are identified in a separate Chapter 105 inspection report. П E&S BMPs were evaluated and appear to be functioning as designed. PCSM BMPs were evaluated and appear to be functioning as designed. Form 3800-FM-BCW0531a was used to document the PCSM BMP evaluation. There is a need for modifications to the E&S Plan, PCSM Plan, or permit coverage. Describe: **COMPLIANCE ASSISTANCE RECOMMENDATIONS** 1. In accordance with DEP's Erosion and Sediment Pollution Control Program Manual, Technical Guidance No. 363-2134-008 (March 2012), Page 65, inspect filter socks weekly and after each runoff event. In addition, DEP requests that damaged socks be repaired according to manufacturer's specifications or replaced within 24 hours of inspection. 2. It is recommended to investigate the addition of a storage BMP (i.e., a sediment basin) in the downslope portion of the site.

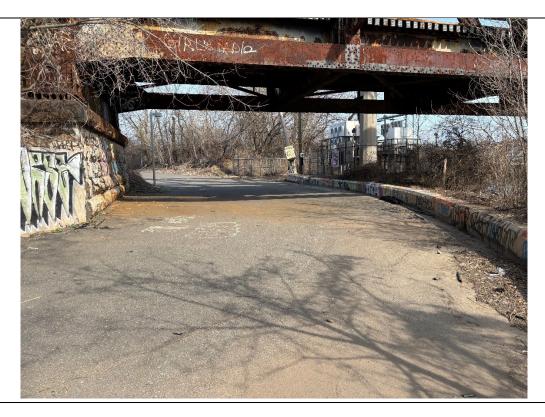
Looking north along Bartram's Garden trail from south side of railroad bridge.

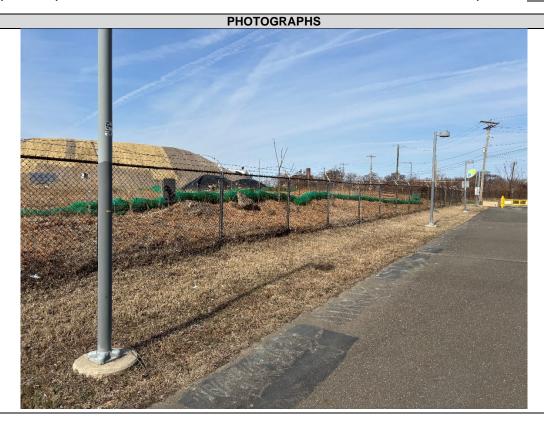
View of filter sock along downslope (east) perimeter along Bartram's Garden trail.
