# CHAPTER 102 INSPECTION REPORT

PA Department of Environmental Protection

Permit No.: PAD510225

Project/Site Name:	<u>Alliance 51<sup>st</sup> Street, Philadelphia</u>	Permit Issuance Date:	<u>9/5/2023</u>
Site Address:	<u>1656 S. 51<sup>st</sup> St.</u>	Permit Expiration Date:	<u>9/4/2028</u>
Site City, State, ZIP:	<u>Philadelphia, PA 19143</u>	Permit Type:	<u>NPDES IP</u>
RP/Permittee Name:	<u>Eric Carlson</u>	Site Municipality(ies):	<u>Philadelphia</u>
RP/Permittee Address:	<u>40 Morris Ave., Suite 230</u>	Site County(ies):	<u>Philadelphia</u>
RP/Permittee City, State, ZIP:	<u>Bryn Mawr, PA 19010</u>	Earth Disturbance:	<u>11.54</u> acres
RP/Permittee Email:	<u>ecarlson@alliancehp.com</u>	Site Latitude:	<u>39.935278</u>
Surface Water(s):	<u>Schuylkill River</u>	Site Longitude:	- <u>75.209236</u>
Special Protection?	<input type="checkbox"/> Yes <input checked="" type="checkbox"/> No	Complaint Inspection?	<input checked="" type="checkbox"/> Yes <input type="checkbox"/> No
Construction Stage:	<u>Inactive</u>	Activity:	<u>Construction ≥ 1 ac.</u>

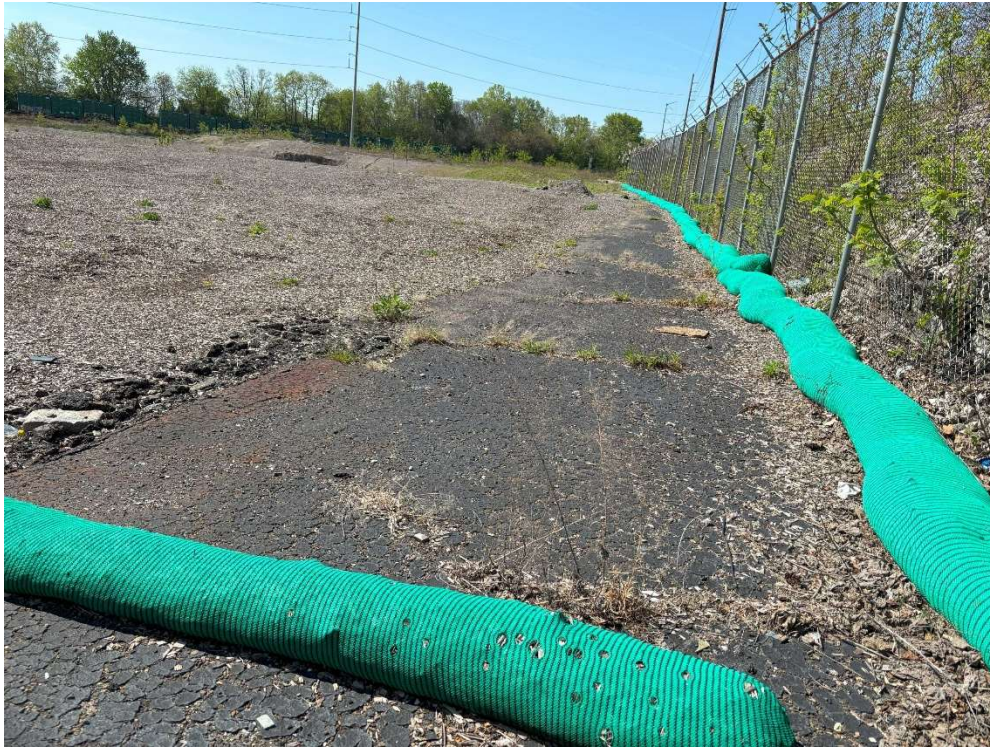
The observed upslope portion of the site maintained adequate mulching levels, and upslope filter sock was noted to be in good condition.

**Filtersock and upslope mulching of site.**

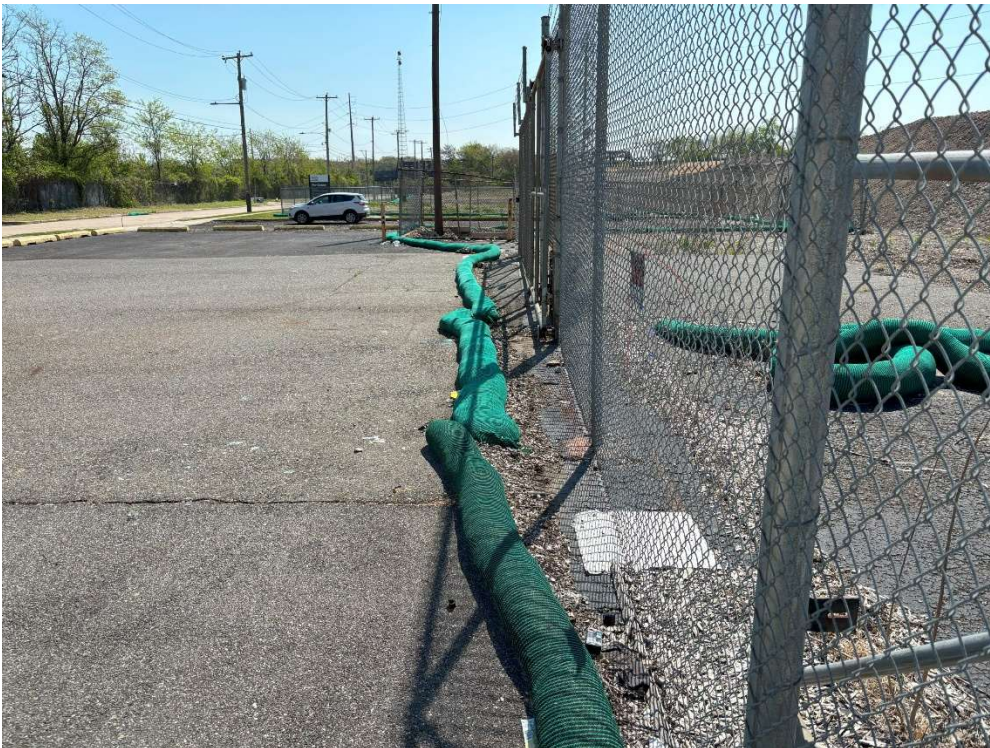
**Upslope filter sock parallel to and facing 51<sup>st</sup> St.**

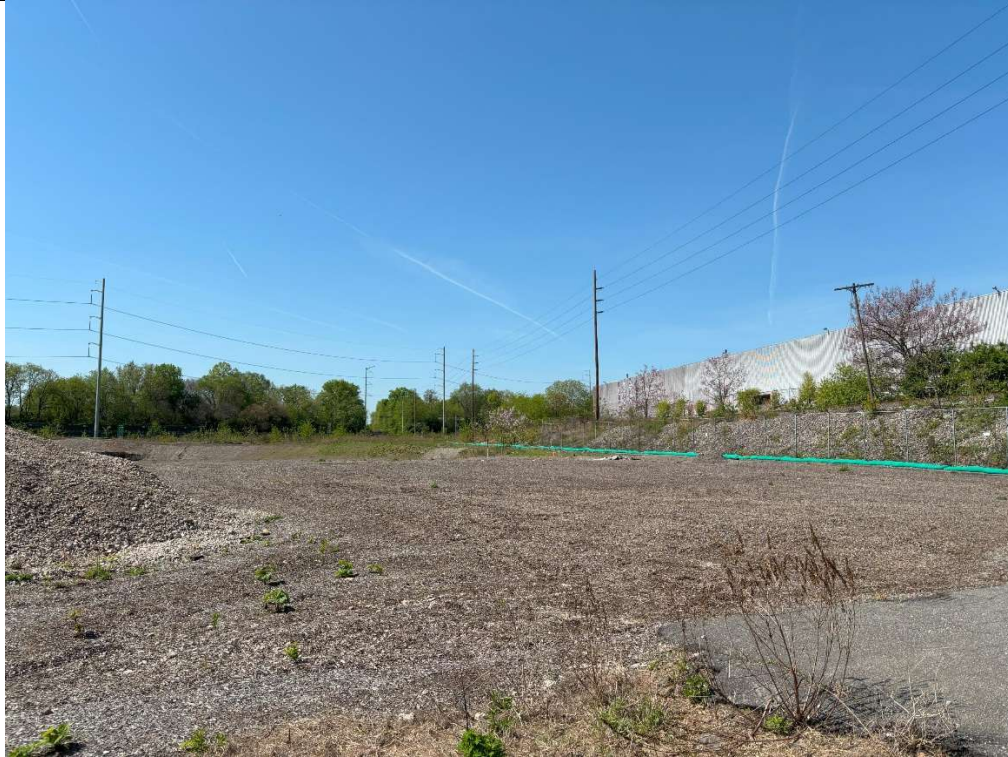
Mulching of upslope portion of site.

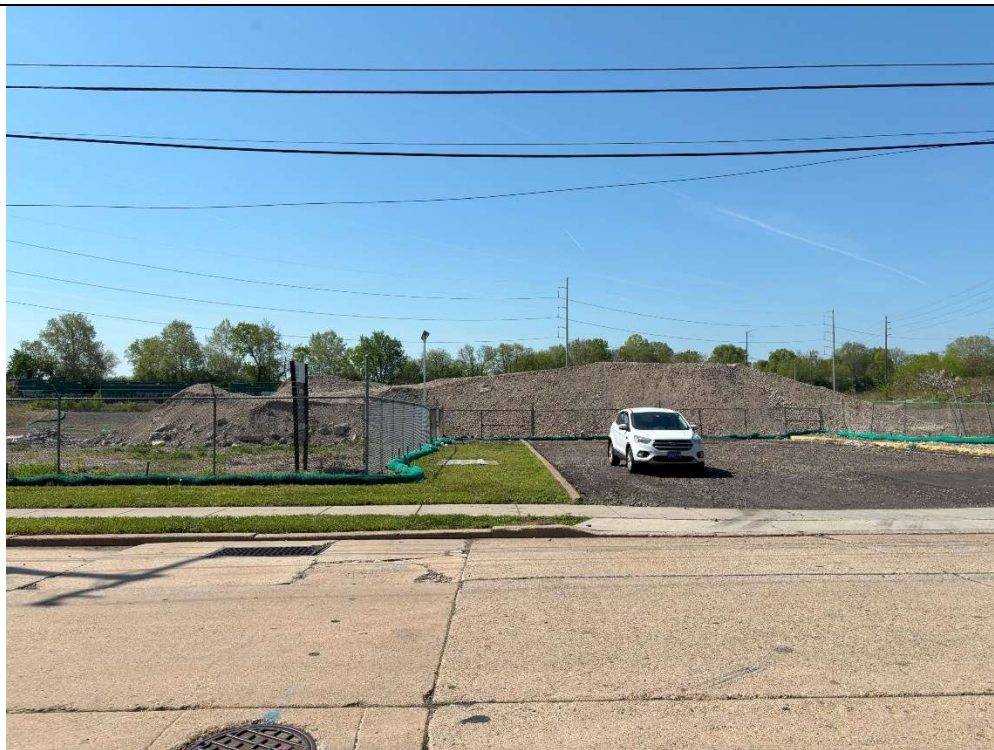
The "For Lease" signage remains in place, and the stone stockpile appeared to be unchanged.

Stone stockpile in midslope portion of site facing 51<sup>st</sup> St.

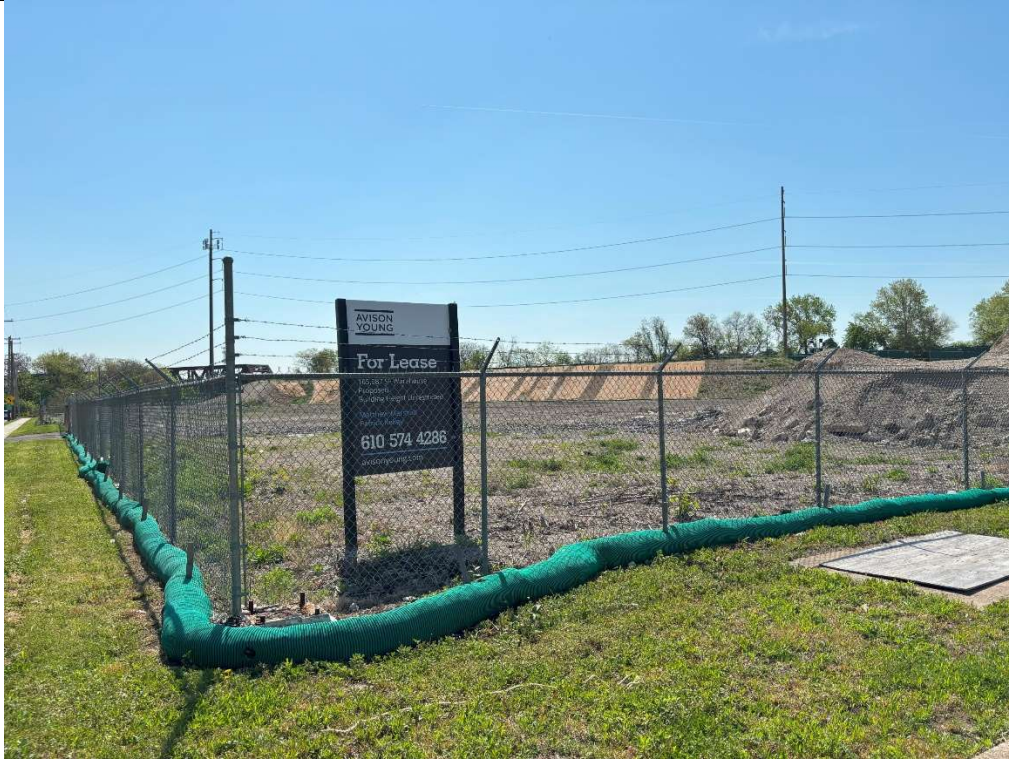
**"For Lease" signage and midslope filter sock facing 51<sup>st</sup> St.**

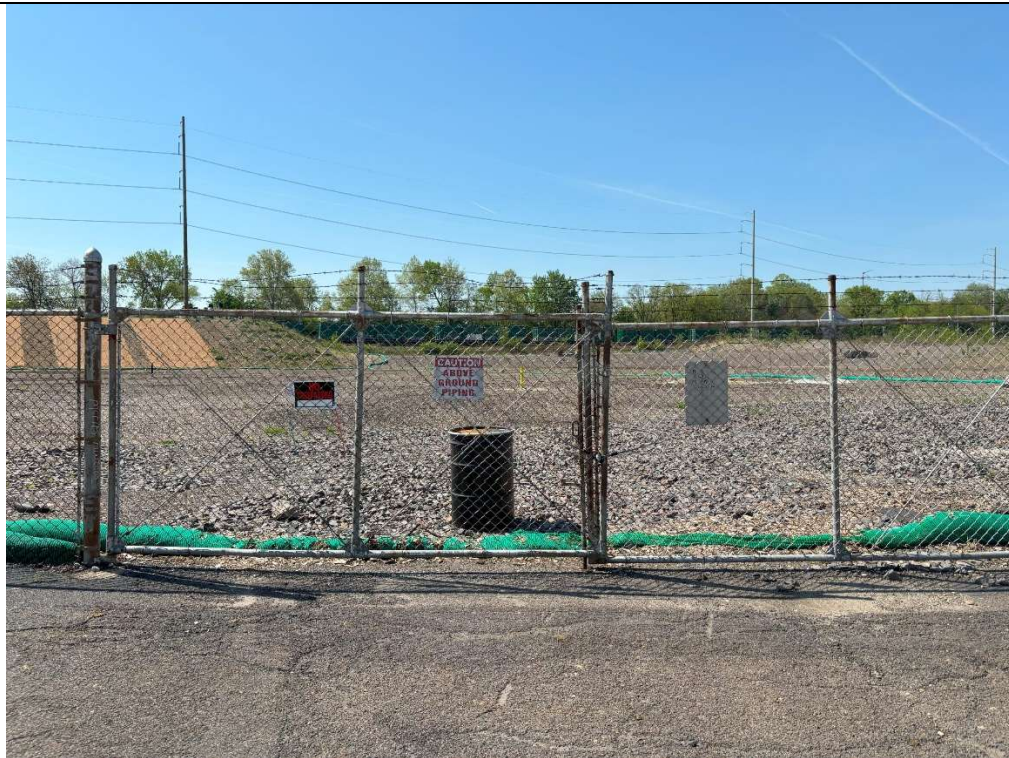
I observed most midslope sections of filtersock to be in good condition, except at the midslope gate and rock construction entrance, where I saw it to be run over. The rock construction entrance was noted to be in functional condition. (summary continued on Page 4)

**Midslope gate and damaged / run over filter sock.**

1. In accordance with DEP's Erosion and Sediment Pollution Control Program Manual, Technical Guidance No. 363-2134-008 (March 2012), Page 65, inspect filter socks weekly and after each runoff event. In addition, DEP requests that damaged socks be repaired according to manufacturer's specifications or replaced within 24 hours of inspection.

4. Repairing the section of the damaged security fence near the intersection of 51<sup>st</sup> and Botanic Sts. is recommended.
5. Replacing the damaged section of midslope filtersock at the access gate along 51<sup>st</sup> St., and advising contractors and other persons with access to the site to move and replace the filtersock before and after site access, is recommended.

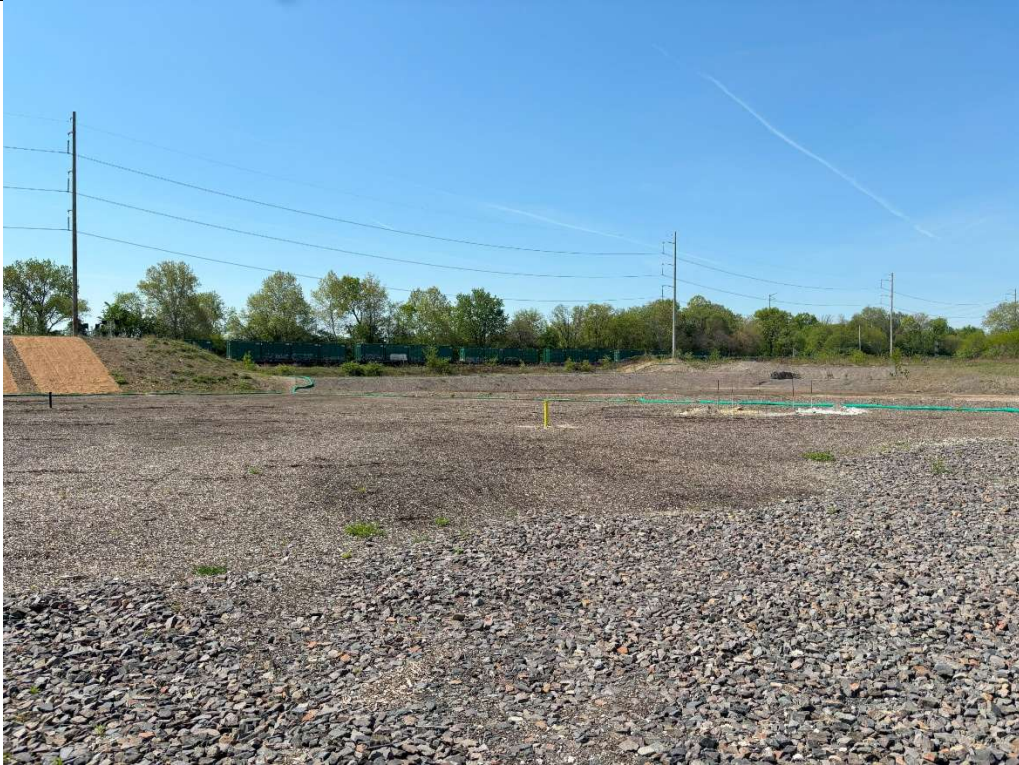
**Midslope rock / rock construction entrance and mulching level of midslope portion of site.**

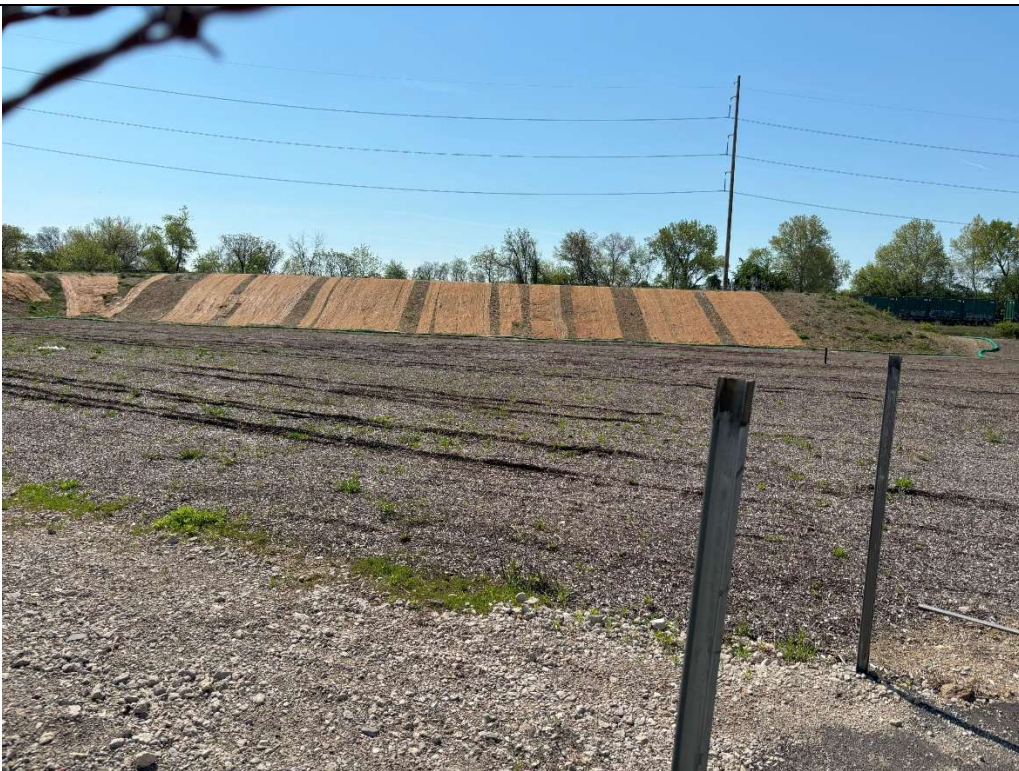
I observed that new erosion control matting was installed on the large fill dirt stockpile. The addition of this new matting abates and closes the violation of 25 Pa. Code, Section 102.4(b)(1) noted in the recent earth disturbance inspection reports.

**Midslope mulching level and new erosion matting on large fill dirt stockpile.**

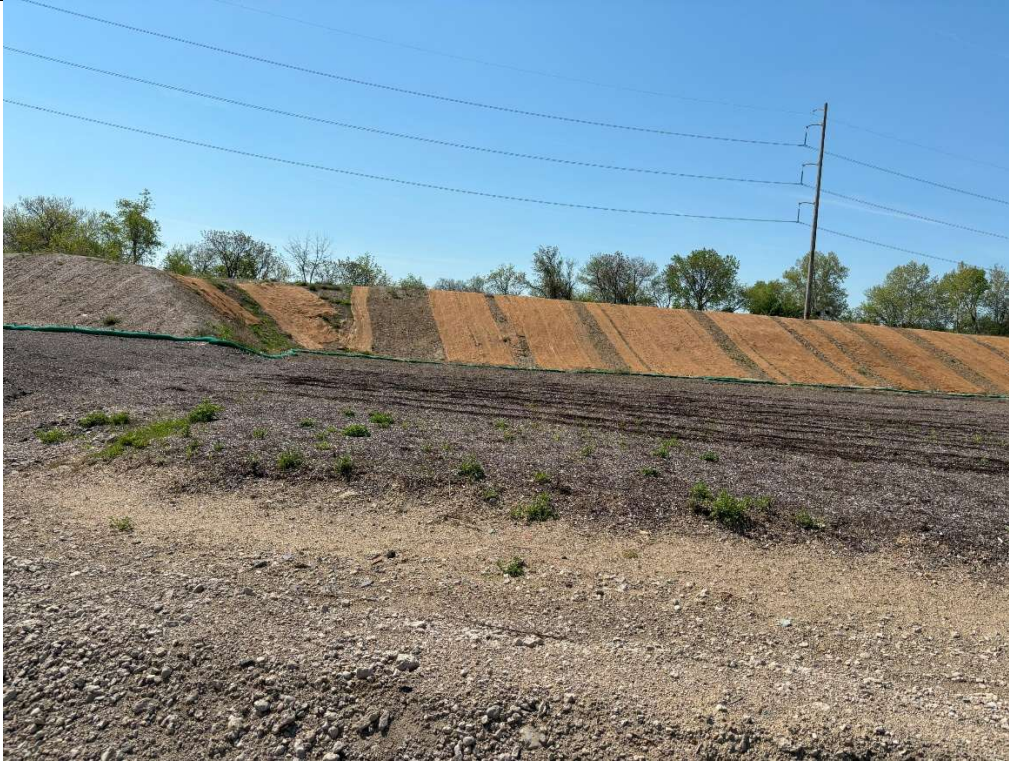
Downslope mulching levels and new erosion matting on large fill dirt stockpile.

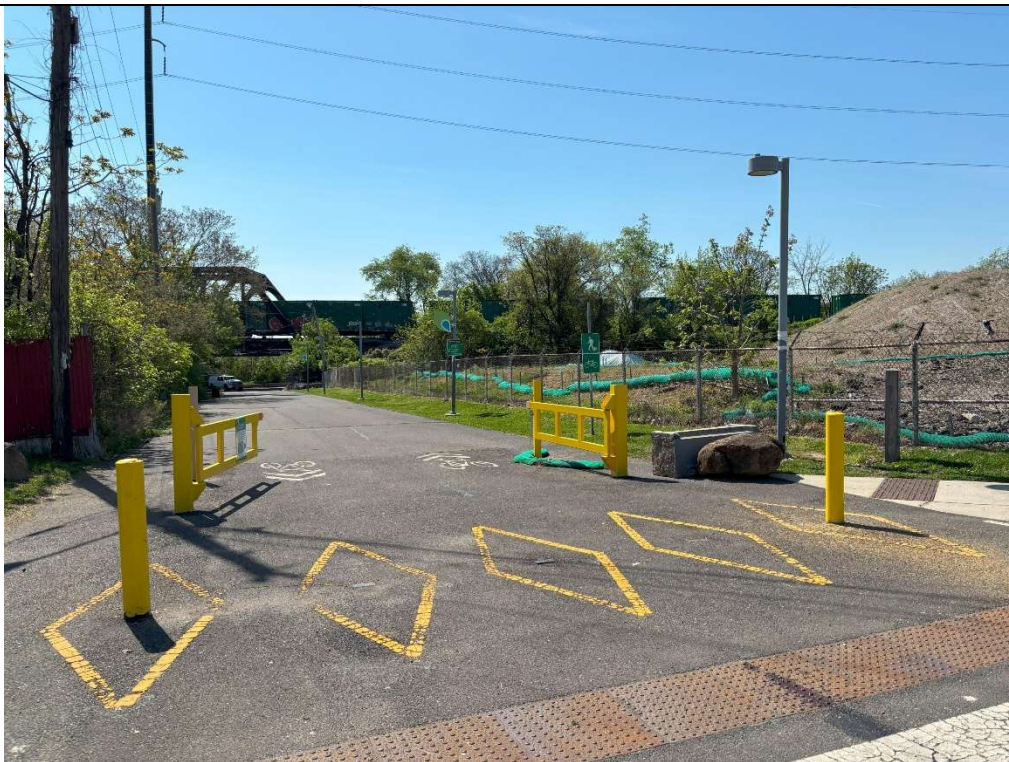
Open Bartram's Garden trail gate at 51<sup>st</sup> St.

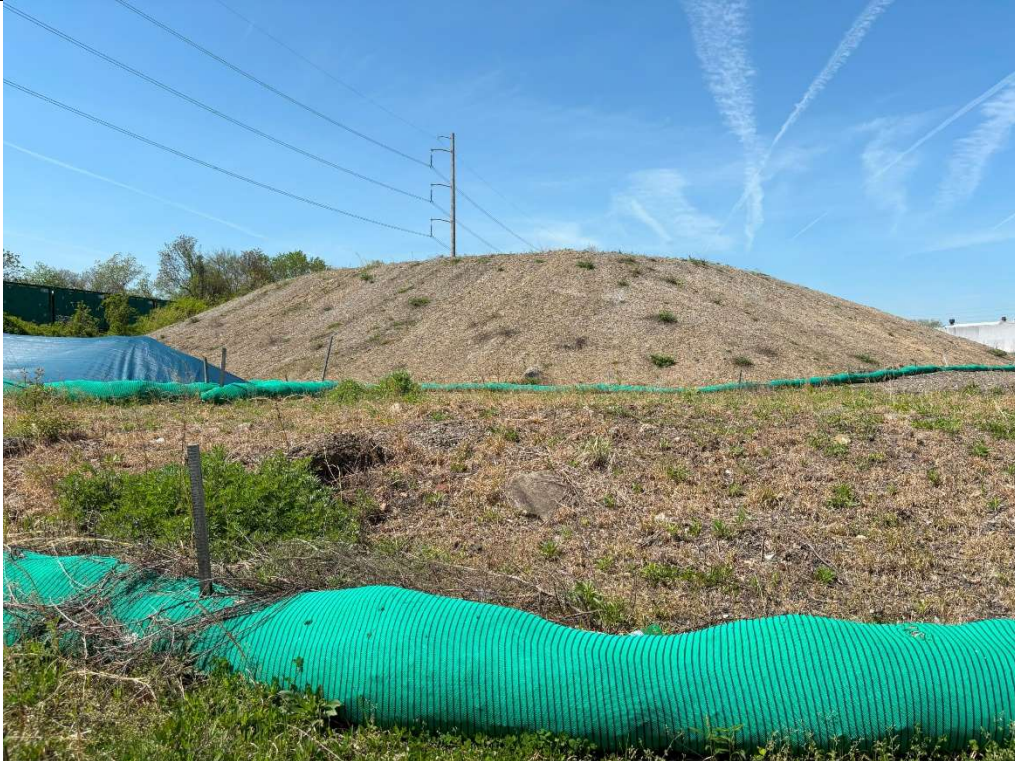
I observed the filter sock along the downslope (Eastern) portion of the site to be in good operating condition.

**Downslope filter sock and downslope end of large fill dirt stockpile.**

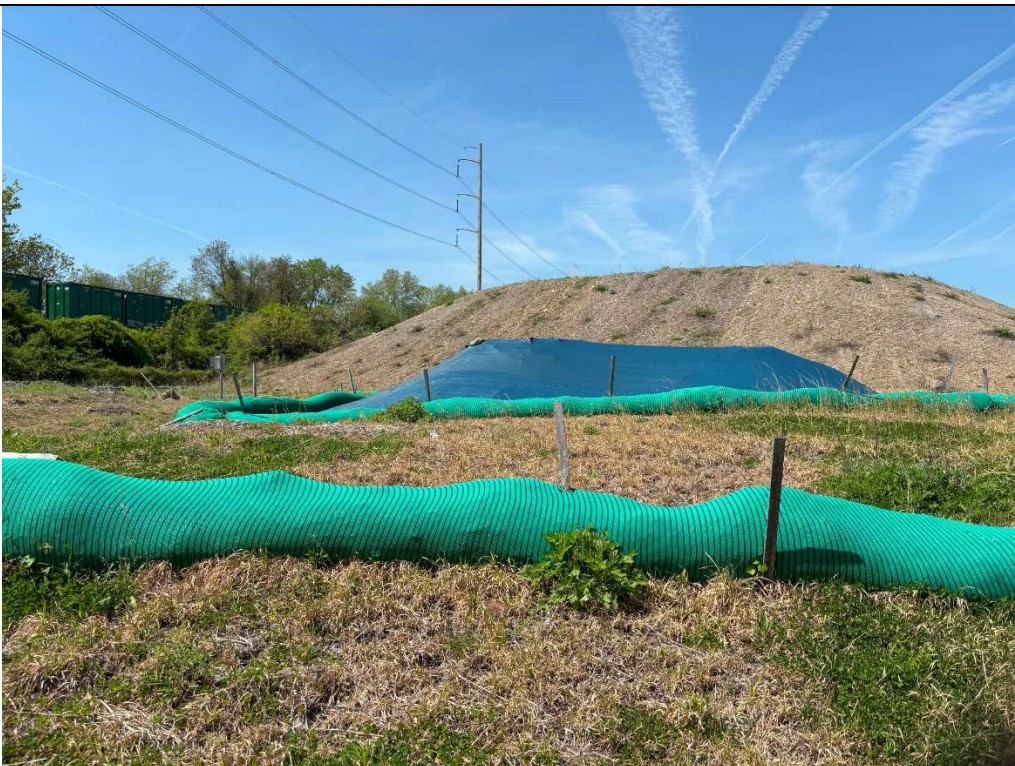
I observed that the tarp covering the contaminated fill dirt stockpile had a few small holes on the downstream side, but remained protective of the large majority of that stockpile.

**Downslope filter sock and covered contaminated fill dirt stockpile.**

2. It is recommended to investigate the addition of a storage BMP (i.e., a sediment basin) in the downslope portion of the site.
3. Replacing the tarp covering the contaminated fill dirt stockpile is recommended.

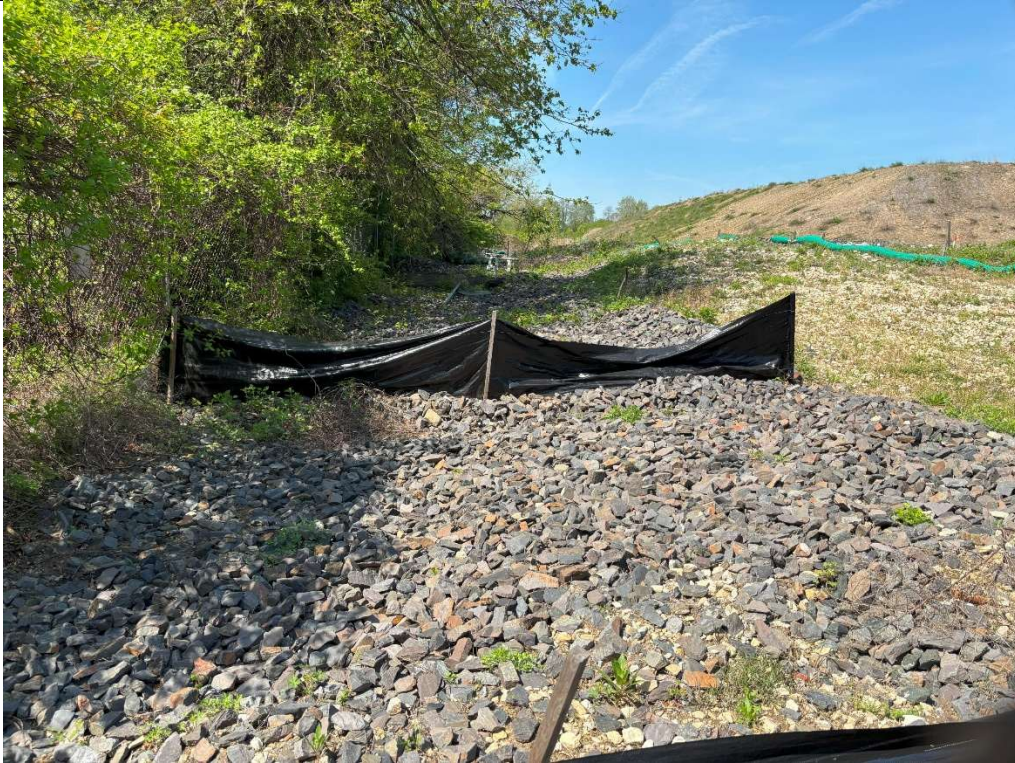
The far side of the large fill dirt stockpile (facing the railroad tracks) had some stabilization observed. No changes were noted regarding the rock-lined swale and silt fences.

Rock-covered swale and silt fence.

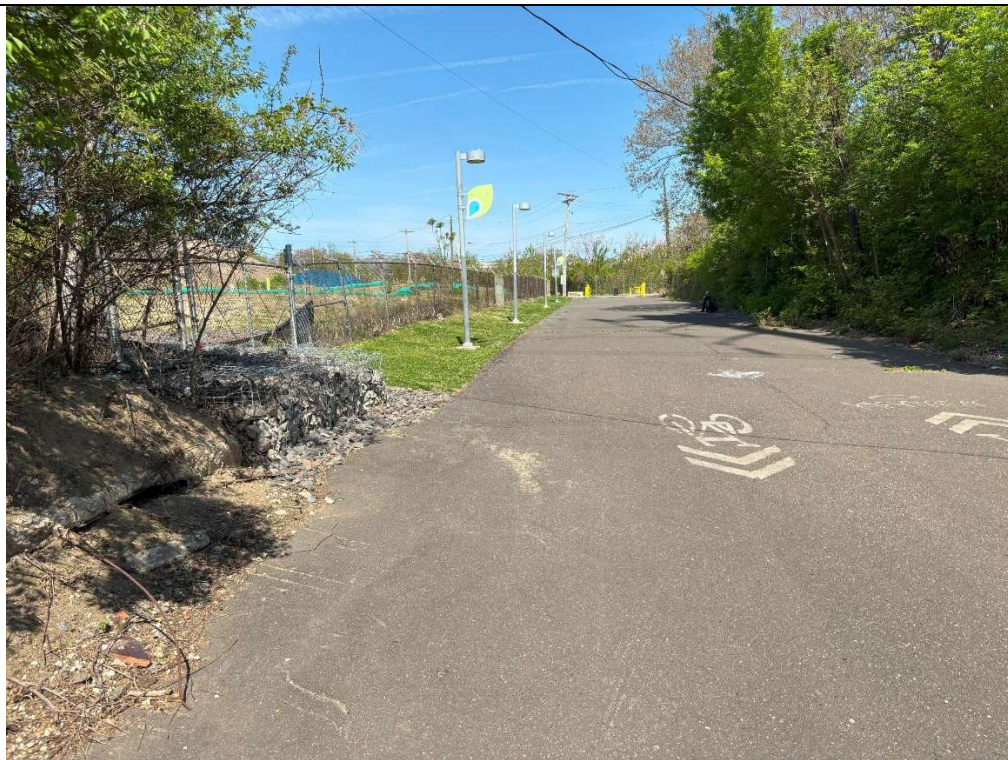
There was no new sediment discharge observed coming from the site. Sediment deposit on the far side of the Bartram's Garden trail from the site appeared to be unrelated to the site and related to the River, as it did not trail from the site and differed in character from soils at the site.

Bartram's Garden trail at downslope discharge area of site.

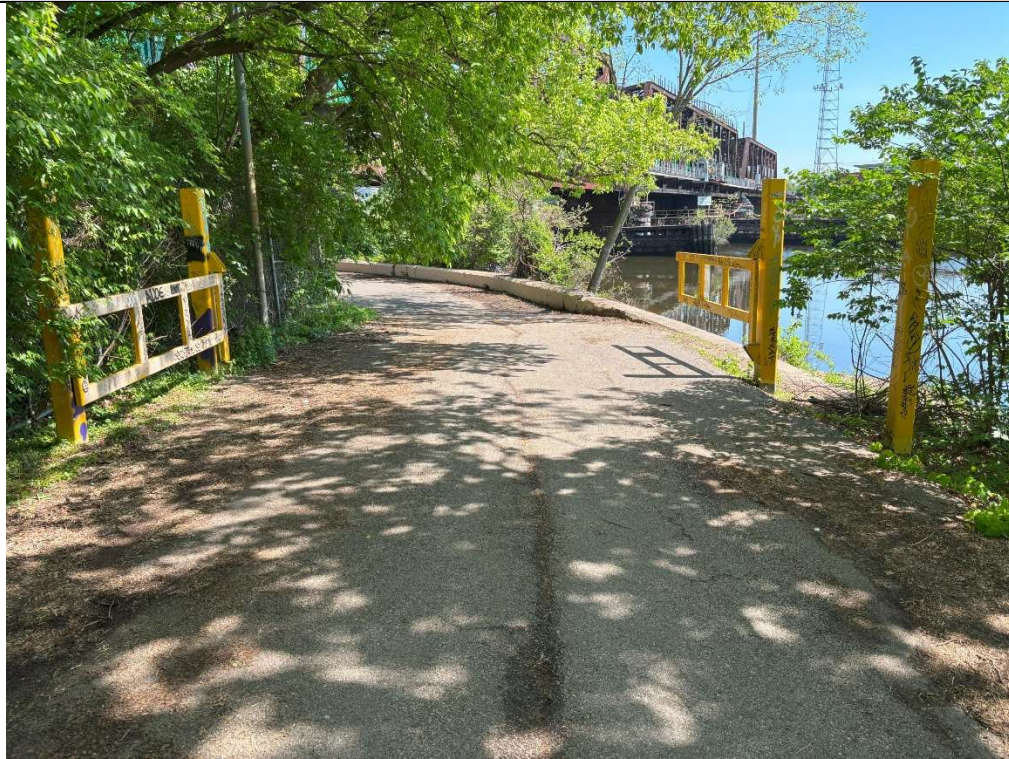
The downstream set of Bartram's Garden trail gates were open. No filter socks remain at trail inlets to river.

**Bartram's Garden trail downstream of site with gates open.**

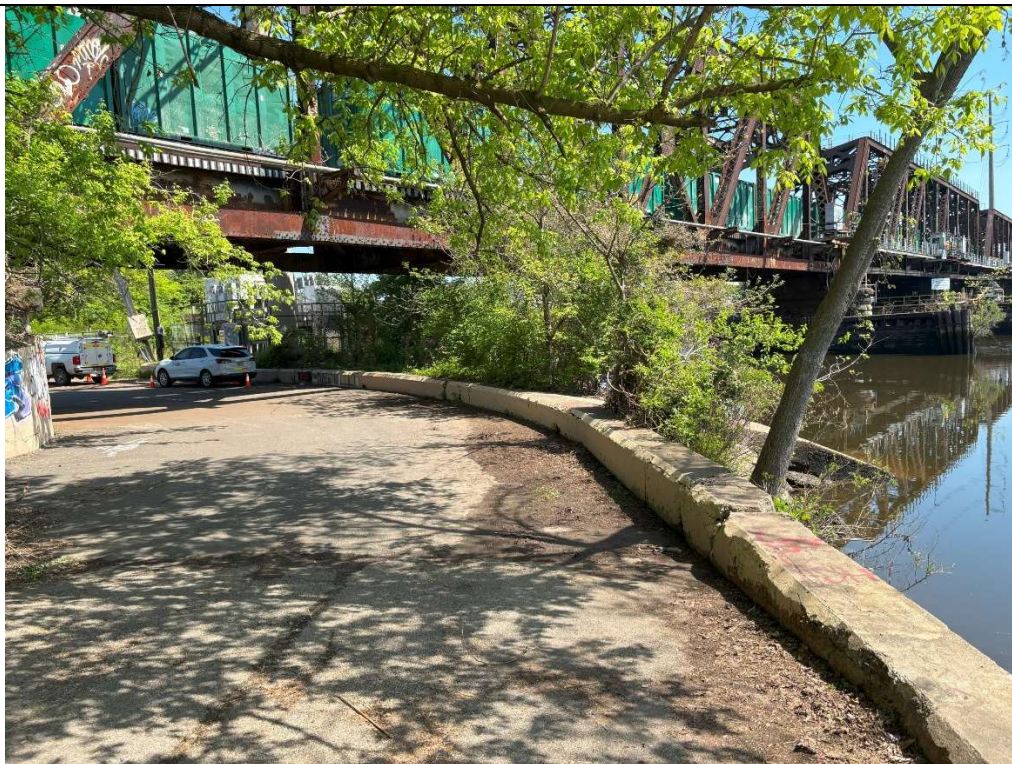
**Bartram's Garden trail downstream of site along Schuylkill River.**

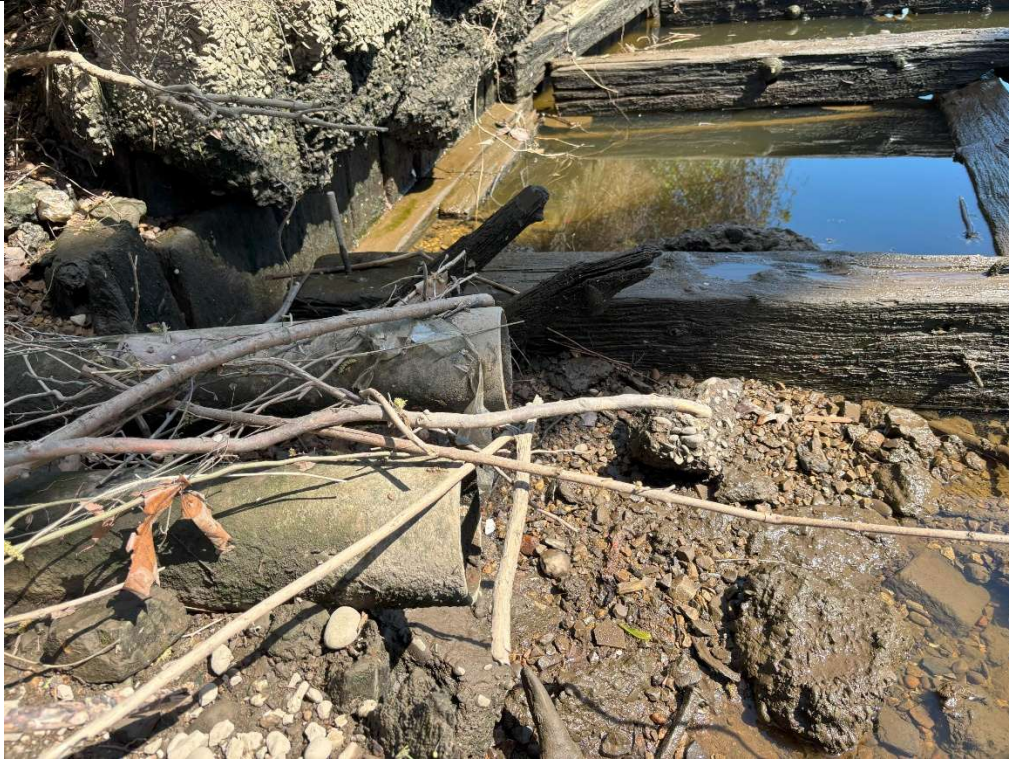
The two pipe outfalls (the pipes currently of undetermined origin) along the Schuylkill River were observed during this inspection. One pipe, the upstream pipe, demonstrated a drip of one drop approximately every 3-4 seconds. The downstream pipe, while not indicating any drip, had moisture along the pipe interior. Woody debris on the river, and river sediment disposition on the pipes, indicated that the river level was recently up over the pipe outlets.

River outlet of pipes of undetermined origin at Schuylkill River across Bartram's Garden trail from site.

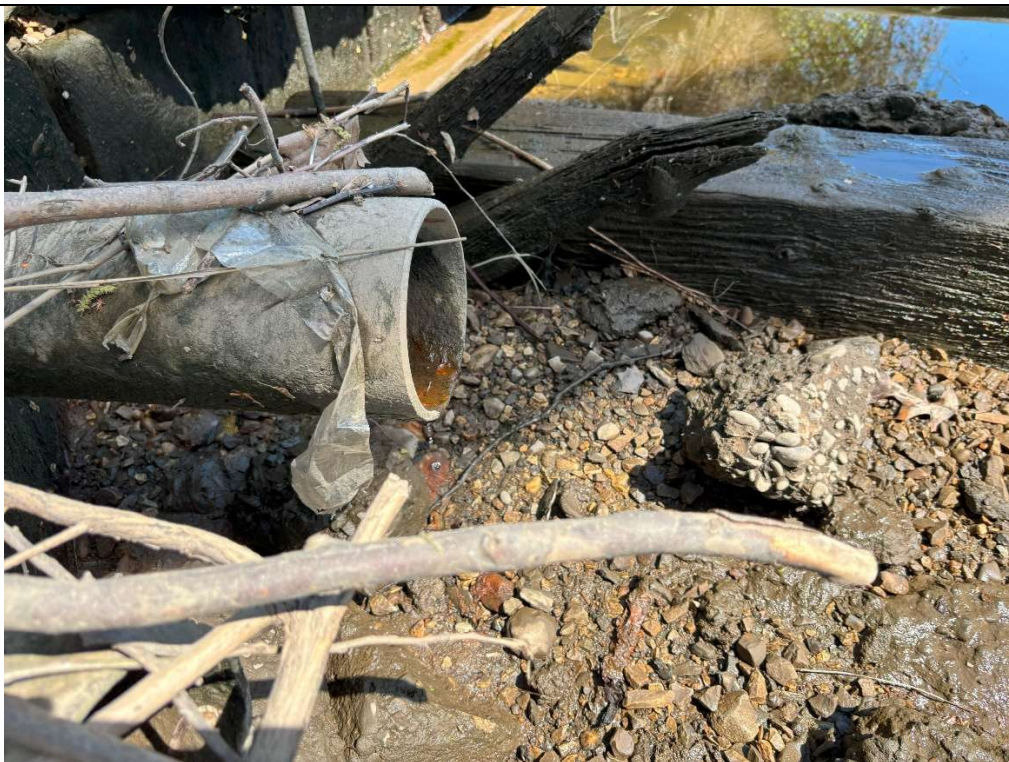
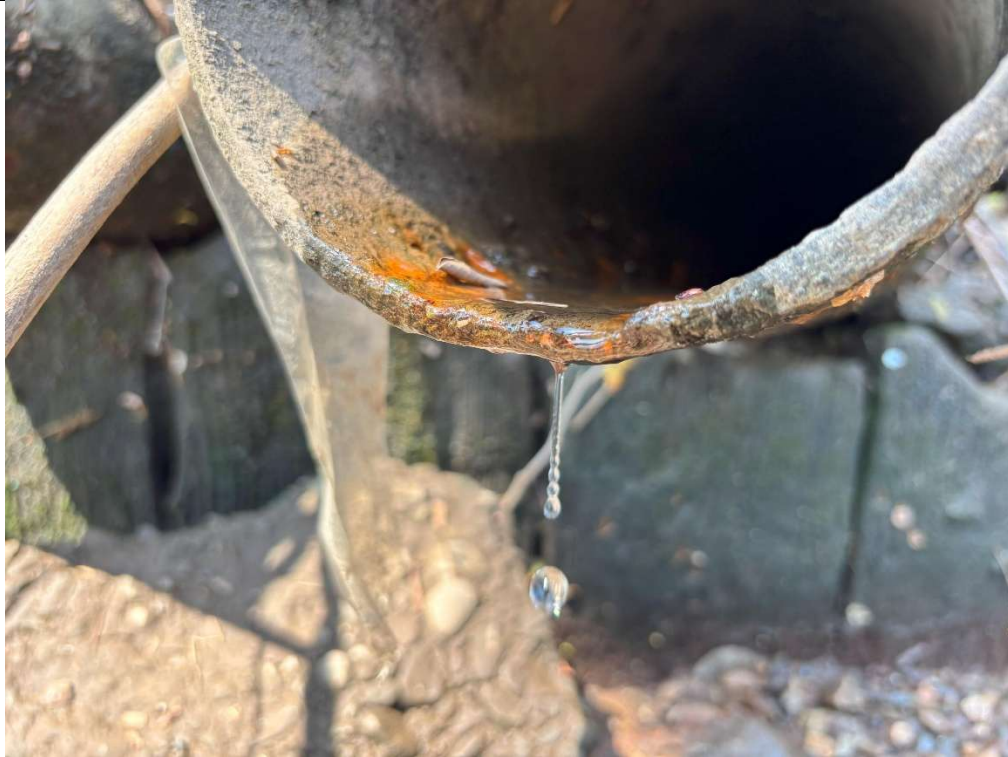
Upstream pipe outlet with drip present.

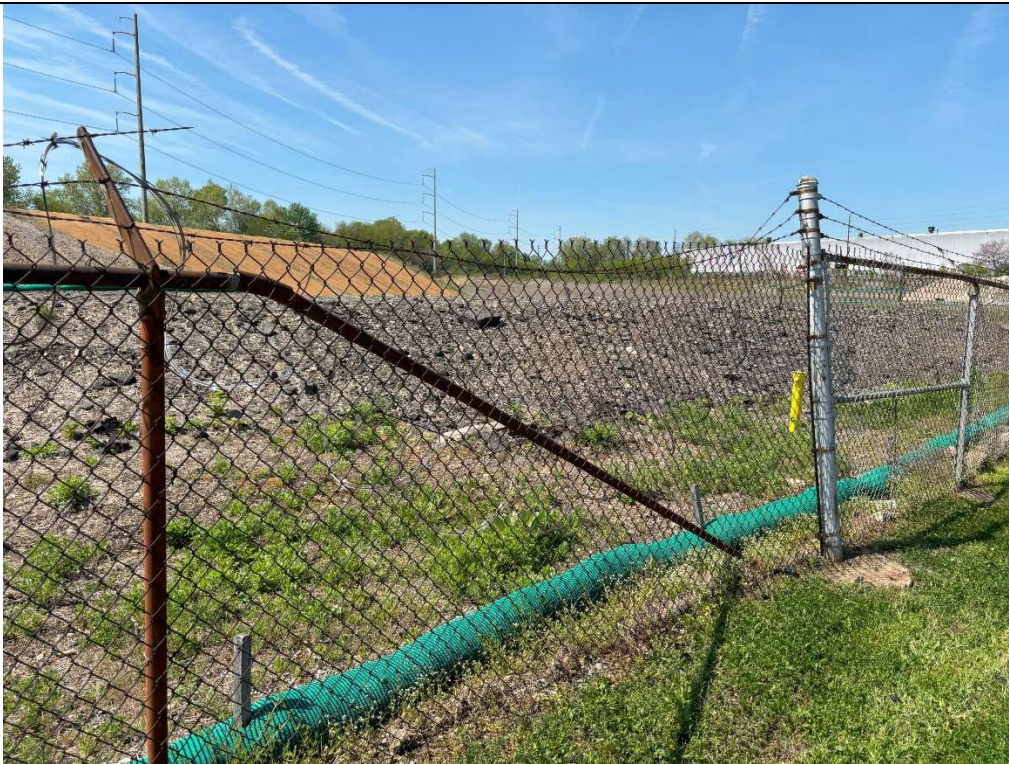
The midslope portion of the site maintained mulching except for a narrow strip of land along the 51<sup>st</sup> St. security fence. A short stretch of security fence along 51<sup>st</sup> Street was damaged.

Damaged section of security fence along 51<sup>st</sup> St.  
End of photo log.
