GENERAL INSPECTION REPORT (Non-NPDES)

Type of Inspection Incident	Site ID Number 452917	County Philadelphia	Municipality Philadelphia
Name and Location of Facility or Pollution Incident Alliance 51st St LLC 51 st and Botanic Ave. Philadelphia, PA 19143			Entry Time/Date 0900, 04/12/24
Name, Address of Responsible Party Mr. Eric B. Carlson Alliance HP 40 Morris Ave. Suite 230 Bryn Mawr, PA 19010 ecarlson@alliancehp.com			Title Telephone 757.560.0853
			Contacted Yes <input checked="" type="checkbox"/> No <input type="checkbox"/>
SUMMARY OF VIOLATIONS/RECOMMENDATION/COMMENTS:			
<p>Report of a green colored runoff from the property.</p> <p>No violations were observed</p> <p>Former PBF ID# PA0011428 Site ID# 452917</p> <p>Ref: 2024_0405_CLW_Philadelphia_NRC#1395691 - CHEMICAL SPILL</p>			
Compliance Assistance Provided <input type="checkbox"/>			
Pollution Prevention Activity <input type="checkbox"/>			
Sample No.	Location	Field Measurements and Observations

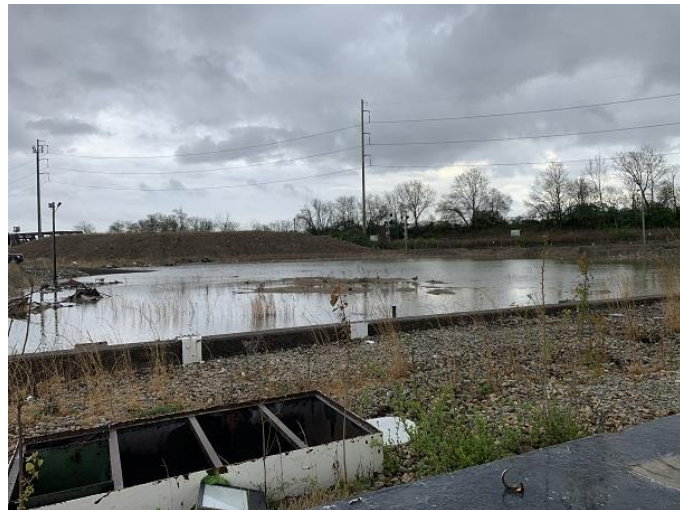
Empty tank containment looking east

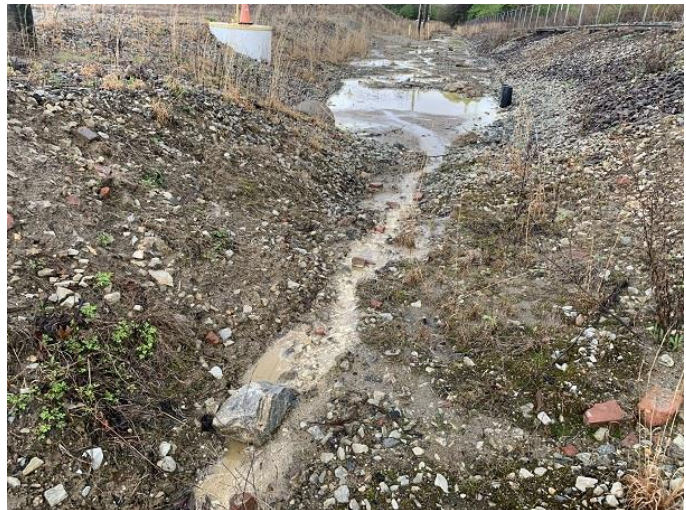
Ditch, concrete pipe discharge and valve box

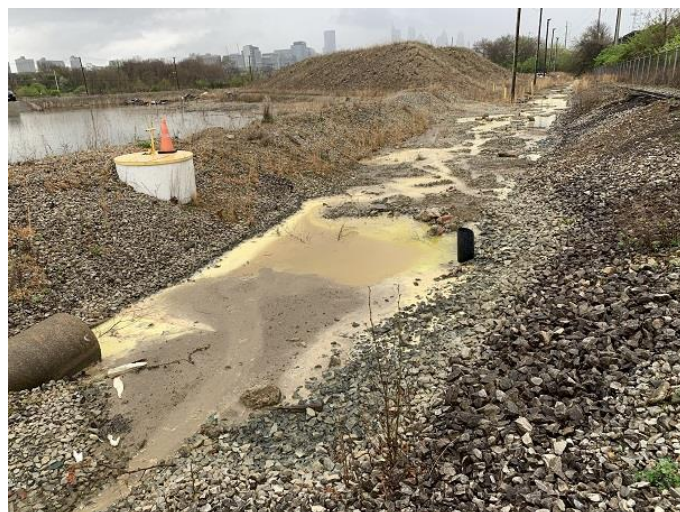
Discoloration at the concrete pipe discharge point

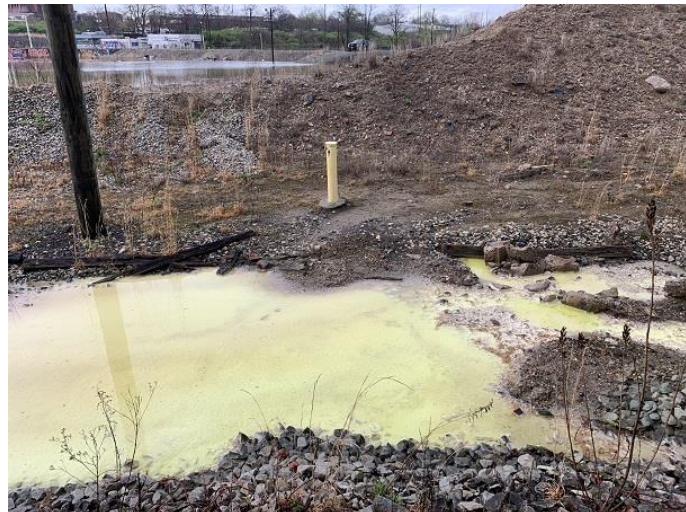
Pooled material in the ditch near MW-3

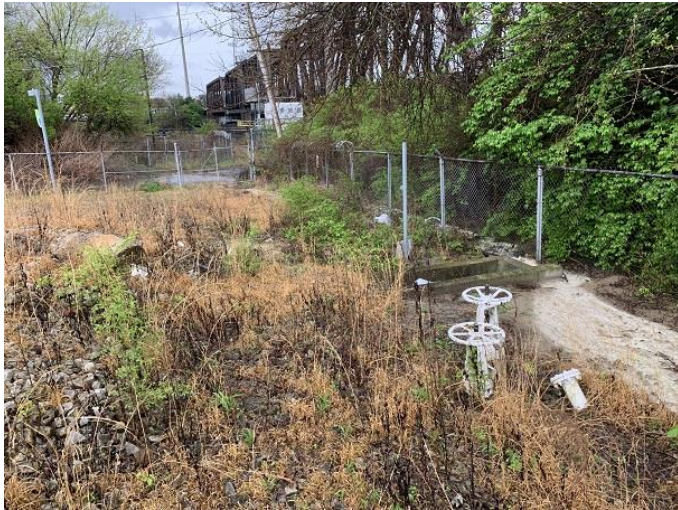
Eastern corner separator and ditch

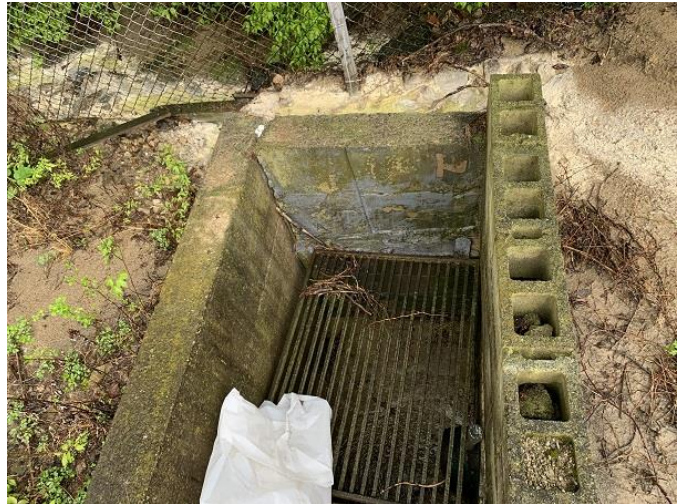
Separator and re-infiltration into the soil.

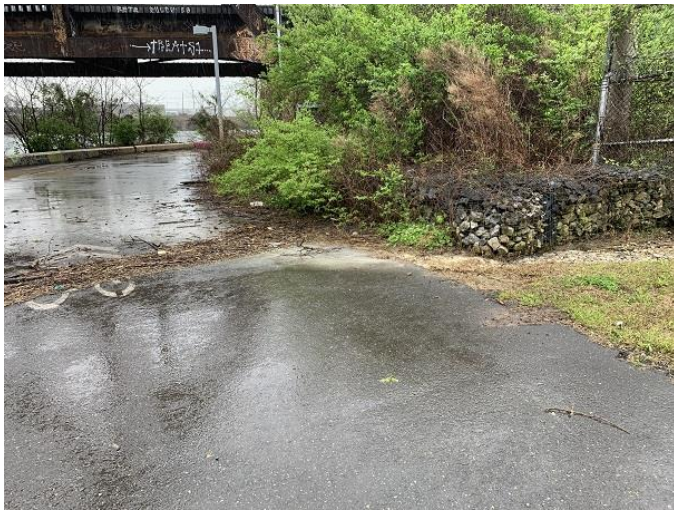
Discoloration outside of the fence line at the River Trail

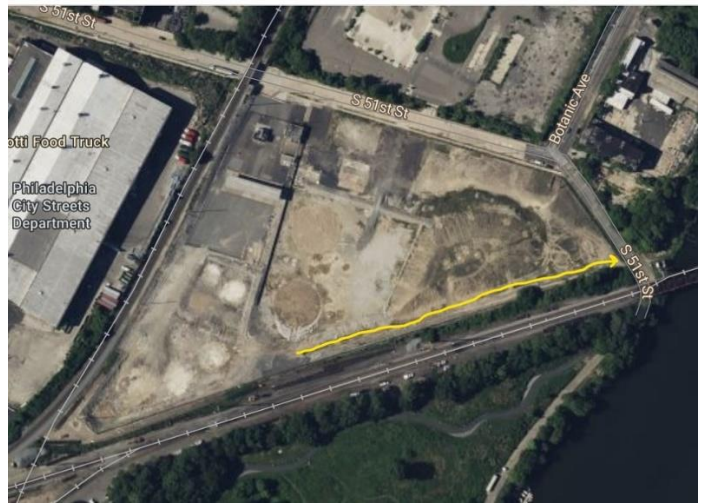
Site overview showing path of flow in the ditch

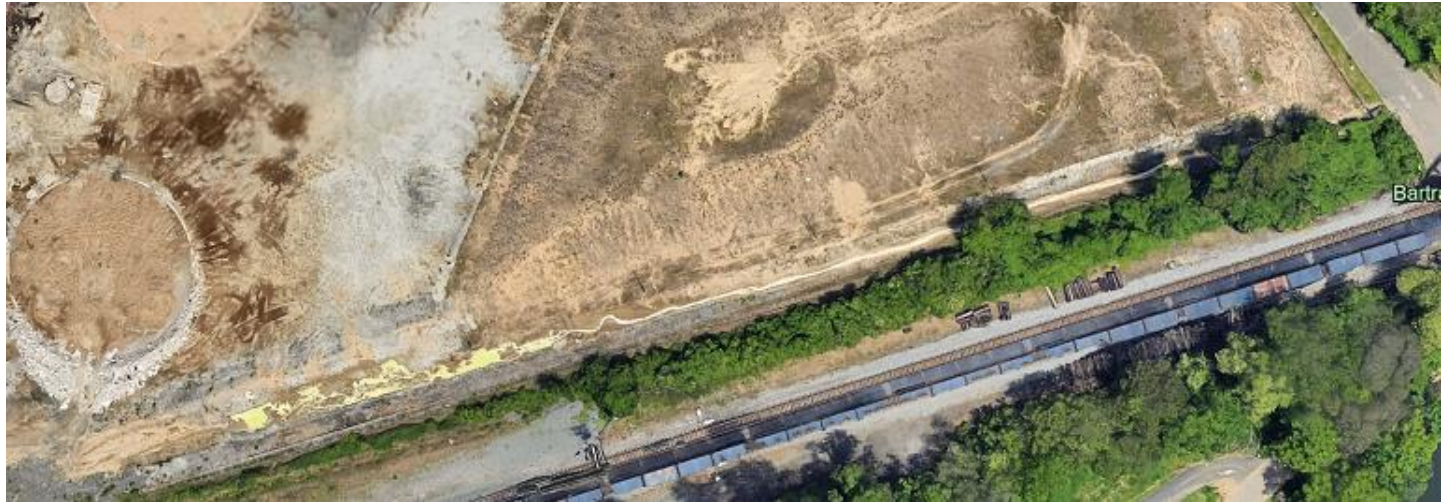
5/10/23 Google Earth view of the ditch showing discoloration

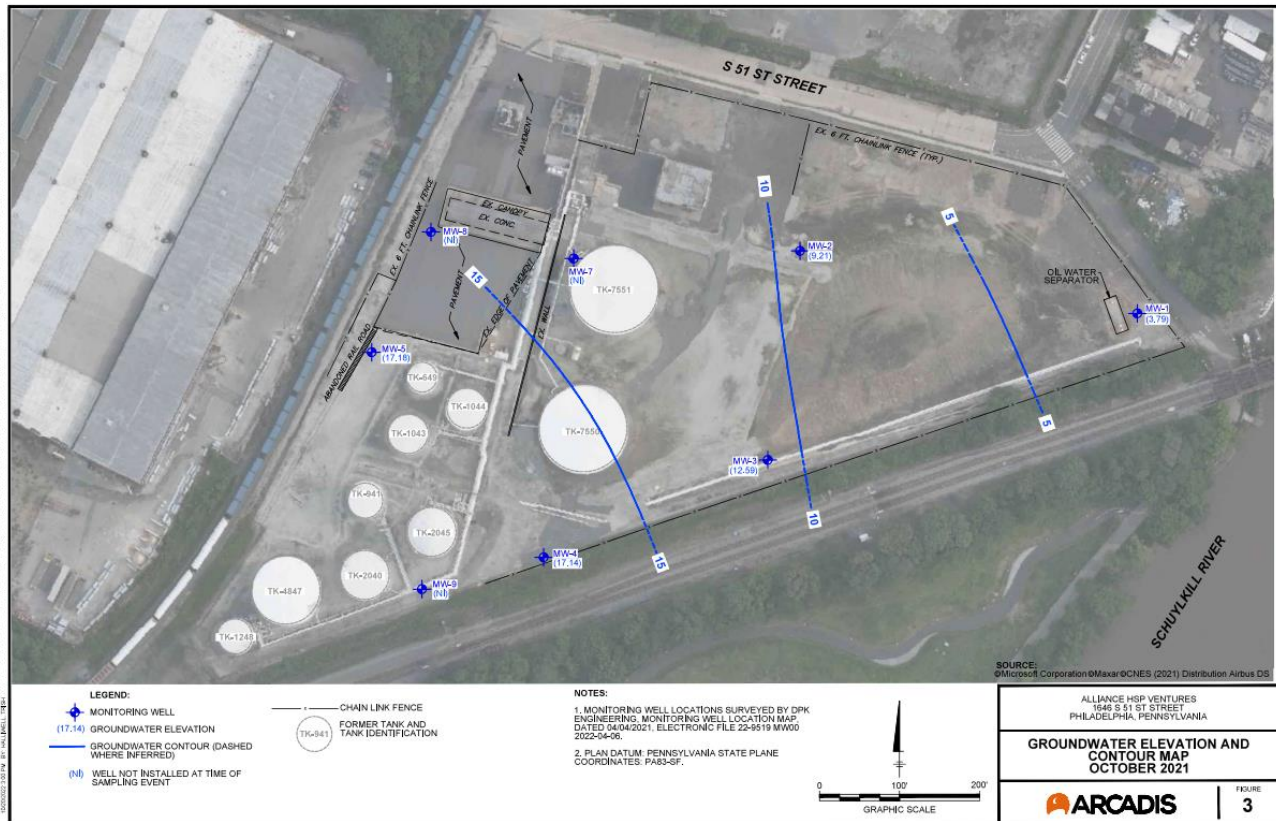
Site former tank locations and monitoring wells
