CHAPTER 102 INSPECTION REPORT

Permit No.:	PAD510225

Report No.: 24

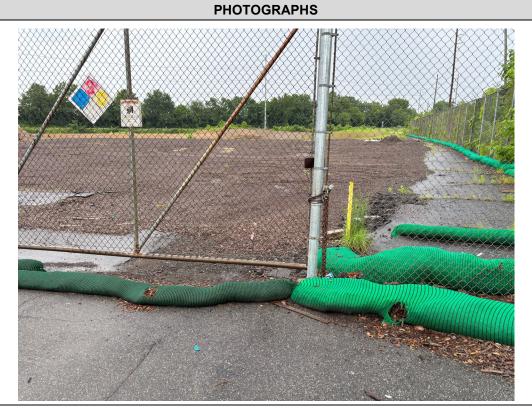
Upslope gate filter sock and upslope section of site.

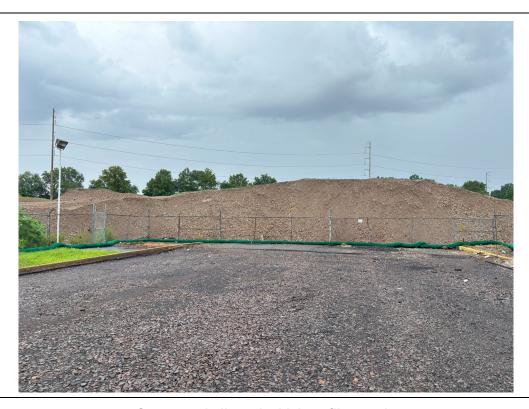
Stone stockpile and midslope filter sock.

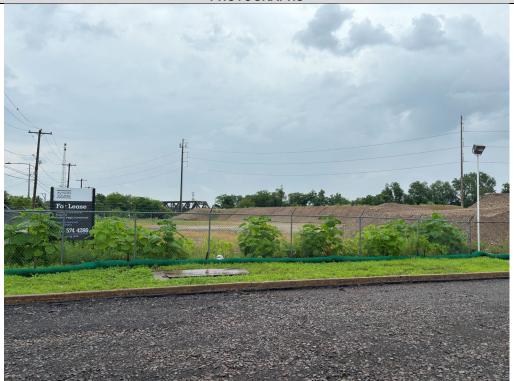
"For Lease" signage and large fill dirt stockpile in distance.

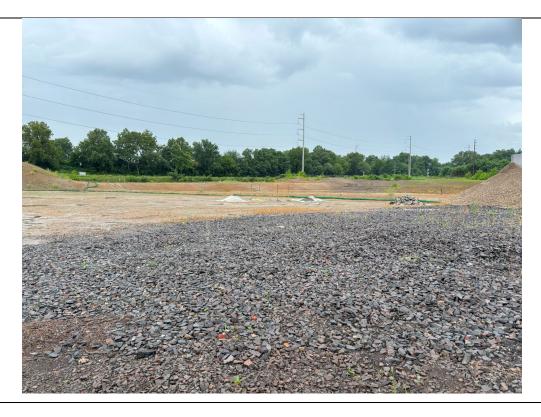
Midslope portion of site, including possible testing site area at center.

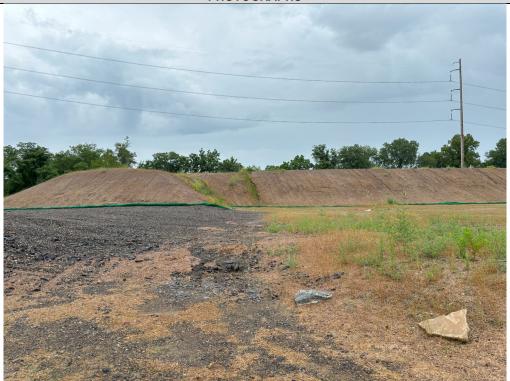
I observed that even by the time of this inspection in early July (in the midst of the growing season), very little germination has occurred at all on the large majority of the large fill dirt stockpile. The erosion control matting that was visible on the stockpile appeared to be in proper operational condition.

Large fill dirt stockpile in distance, with some partially stabilized earth at right.

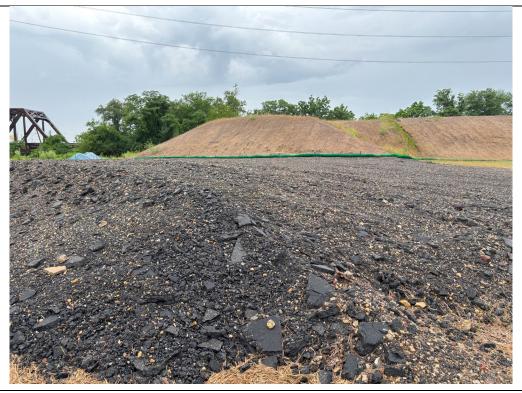
Asphalt millings in downslope portion of site.

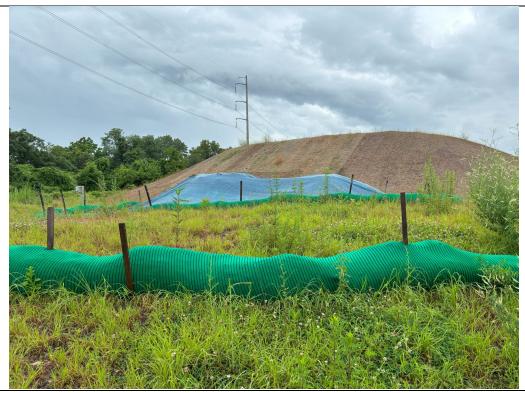
Three small holes in the tarp covering the small pile of contaminated soil downslope of the large fill dirt stockpile were noted.

Downslope end of large fill dirt stockpile with small contaminated dirt stockpile in front (covered by blue tarp).

3800-FM-BCW0271g Rev. 11/2022 Permit No.: PAD510225 **Chapter 102 Inspection Report** Report No.: 24 Failure to comply with the terms and conditions of a permit or order (CSL § 402(b)). Z. Failure to remove building materials and/or wastes from the site for recycling or disposal in accordance aa. with DEP regulations as required by the permit (CSL § 402(b)). bb. Failure to comply with DEP regulations or the Clean Streams Law (CSL § 611). Failure to take necessary measures to prevent pollutants from reaching waters of the Commonwealth (§ CC. 91.34(a)). Failure to notify DEP of new or expanded earth disturbance not identified in an NPDES permit application dd. (§ 92a.24(b)). Failure to notify and/or obtain authorization from DEP/CCD for changes to NPDES permitted activities (§ ee. 92a.41(a)(12)). ff. Other: During the inspection violations of Chapter 105 were observed and are identified in a separate Chapter 105 inspection report. П E&S BMPs were evaluated and appear to be functioning as designed. PCSM BMPs were evaluated and appear to be functioning as designed. Form 3800-FM-BCW0531a was used to document the PCSM BMP evaluation. There is a need for modifications to the E&S Plan, PCSM Plan, or permit coverage. Describe: **COMPLIANCE ASSISTANCE RECOMMENDATIONS** 1. In accordance with DEP's Erosion and Sediment Pollution Control Program Manual, Technical Guidance No. 363-2134-008 (March 2012), Page 65, inspect filter socks weekly and after each runoff event. In addition, DEP requests that damaged socks be repaired according to manufacturer's specifications or replaced within 24 hours of inspection. 2. Maintaining filtersock areas, to prevent any overtopping condition, is recommended. 3. It is recommended to investigate the addition of a storage BMP (i.e., a sediment basin) in the downslope portion of the site. 4. Since the growing season is under way as of the time of this inspection, DEP recommends considering strategies for further site stabilization at this time. 5. Replacement of the filter socks in front of the inlets draining to the Schuylkill River (along the wall of the Bartram's Garden trail), is recommended. 6. Three small holes in the tarp covering the small contaminated fill dirt stockpile were observed. Replacement of the tarp is recommended.

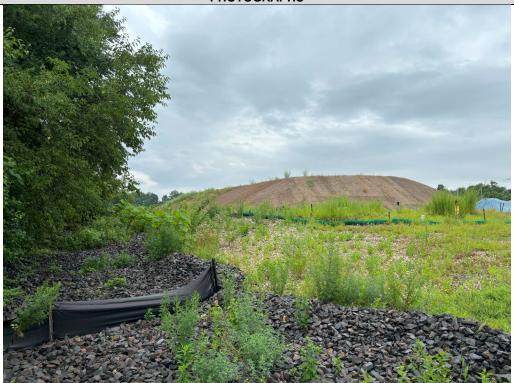
Downslope and back side of large fill dirt stockpile (adjacent to train tracks); rock-covered swale and silt sock at left.

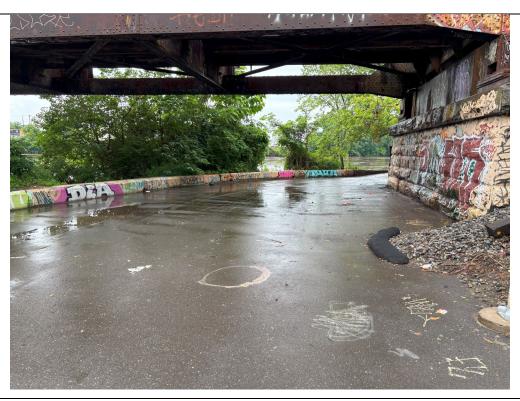
Bartram's Garden trail under railroad bridge.

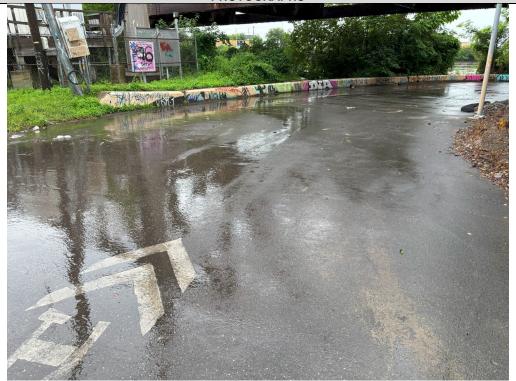
With regard to the condition of the Bartram's Garden trail, which was observed in this inspection at the end of a significant storm event, I did not note the presence of any new or fresh sediment staining, sediment trails, or deposits. Stormwater flowing downslope along the trail was observed to be clear, as seen in the accompanying photographs.

Bartram's Garden trail with stormwater, and previous sediment staining at bottom right.

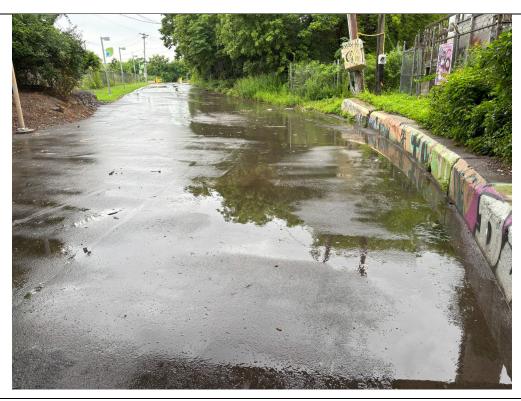
Bartram's Garden trail with stormeater, looking upslope from under railroad bridge towards Site.

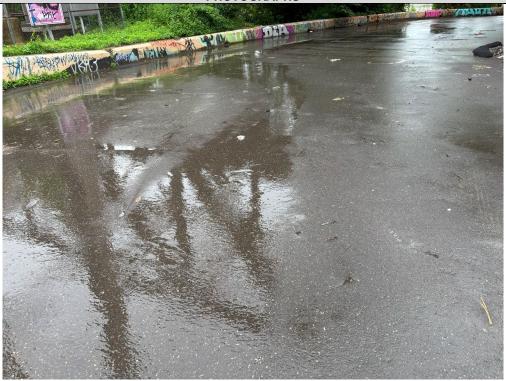
Bartram's Garden trail with stormwater.

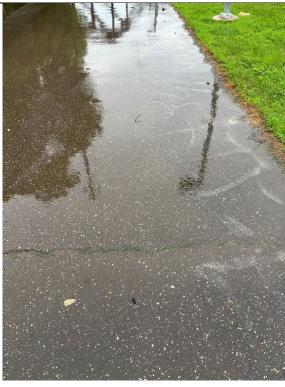
Bartram's Garden trail with stormwater. End of photo log.
