**BOYERTOWN SANITARY LANDFILL  
SUMMARY OF FINDINGS AND RECOMMENDATIONS**

**Boyertown Sanitary Landfill Site  
300 Merkel Road  
Gilbertsville, Pennsylvania**

**Boyertown Sanitary Landfill Site Coalition**

September 2017

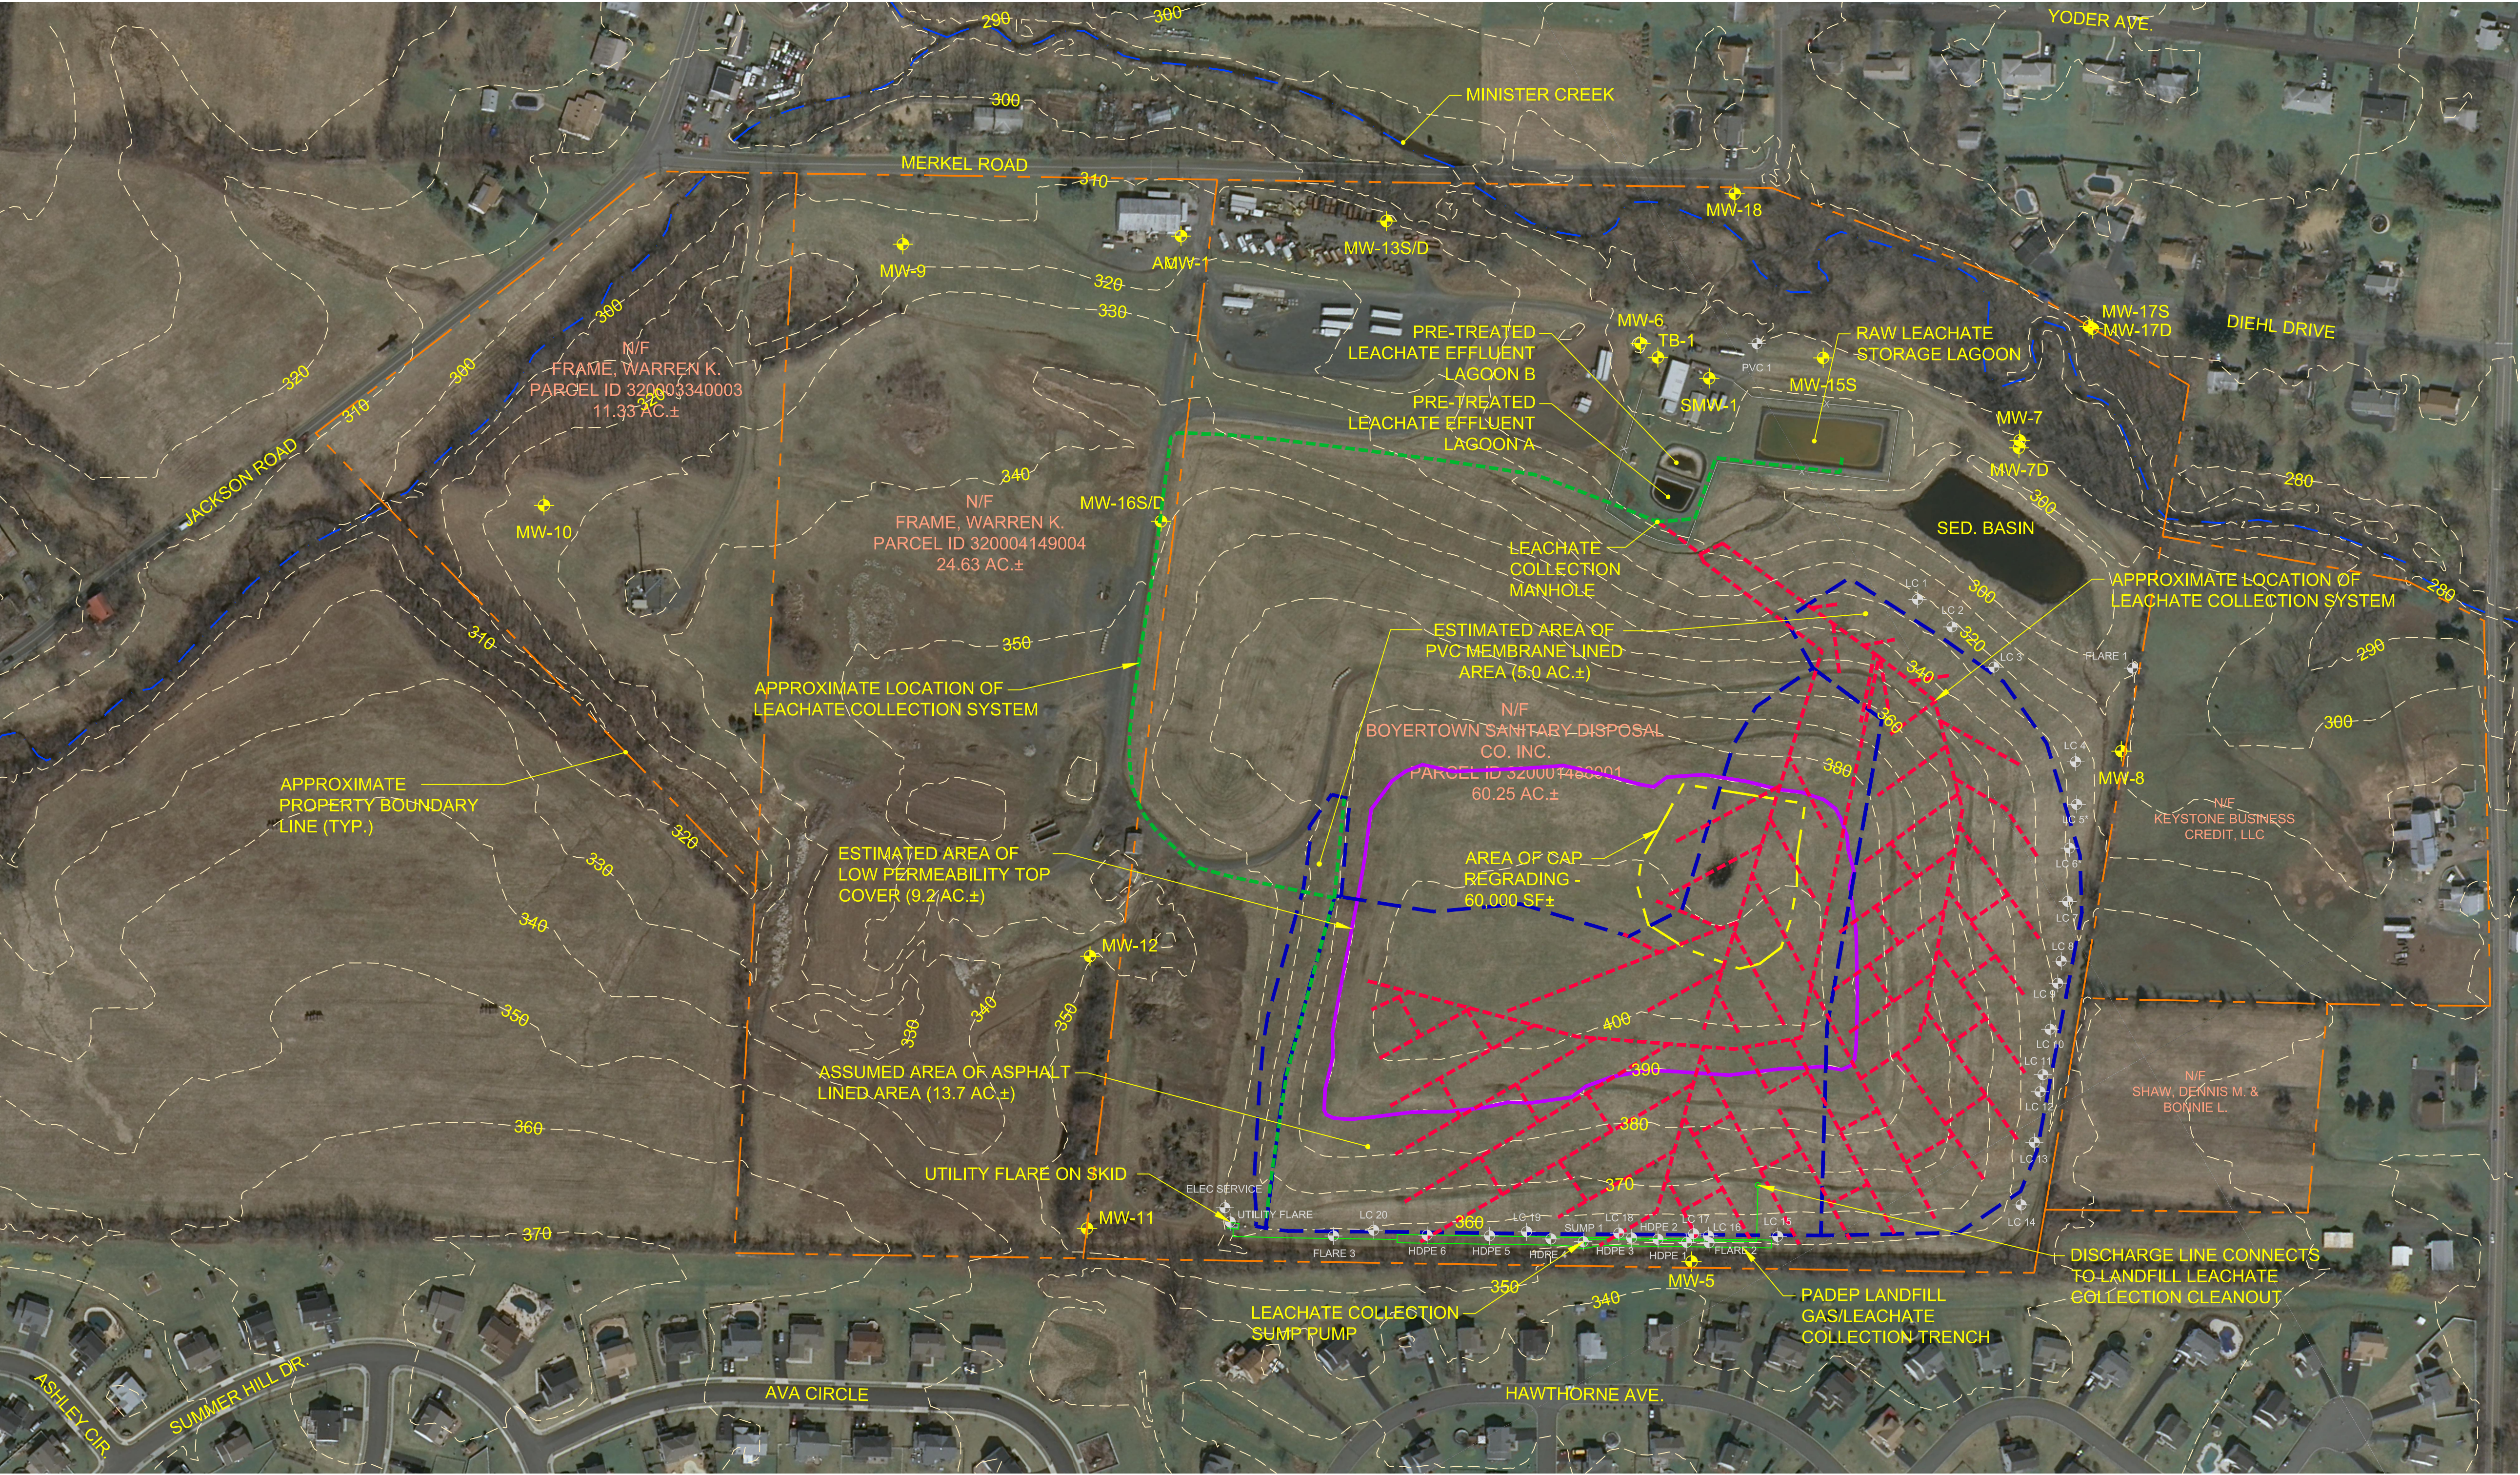
Observations from the camera work indicated that the piping appeared to be in sound condition for the entire length inspected, with no breaks, cracking, or open joints observed. The approximate collection piping layout shown on [Figure 2](#) reflects the findings from the camera work.

OBG identified 20 leachate collection system gas vents along the landfill's southeastern and southwestern boundary (LC-1 through LC-20 as shown on [Figure 2](#)) as part of landfill inspection activities, and in May 2016 camera inspections were performed to evaluate the vent conditions.
