GENERAL INSPECTION REPORT (Non-NPDES)

| Name and Location of Facility or Pollution Incident MIPC, LLC. - Chelsea Terminal | | Entry Time/Date 12/19/2005 | |

| Name and Location of Facility or Pollution Incident MIPC, LLC – Chelsea Terminal | County Delaware | Municipality Aston Township |

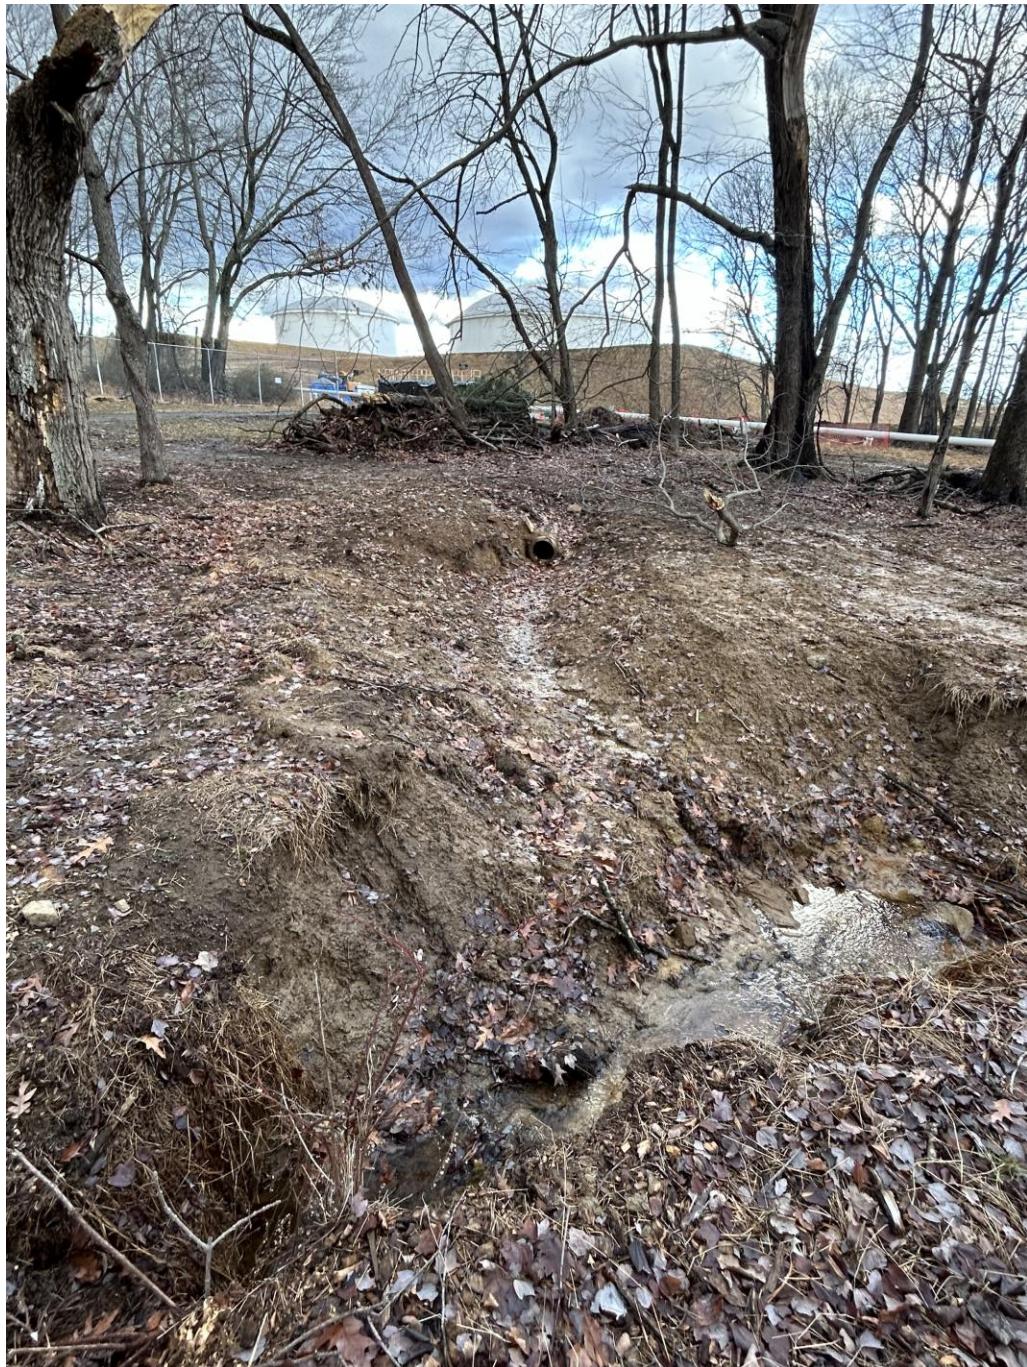
I did not determine the exact date, but MIPC personnel had detected gasoline odors originating from the outfall of the well house pipe. According to Ms. Clapp, the pipe was not discharging any water or any petroleum product, at the time, but the odors triggered an investigation. The outfall discharges to a swale that travels in a southerly direction along the western portion of the property and is believed to discharge out of outfall 003. According to Ms. Clapp, the swale is typically dry most of the year. There was a rain event earlier this morning and the swale was currently flowing and turbid in appearance. Absorbent booms remain in the swale. There were no signs of product or sheening.

Outfall from well house to swale

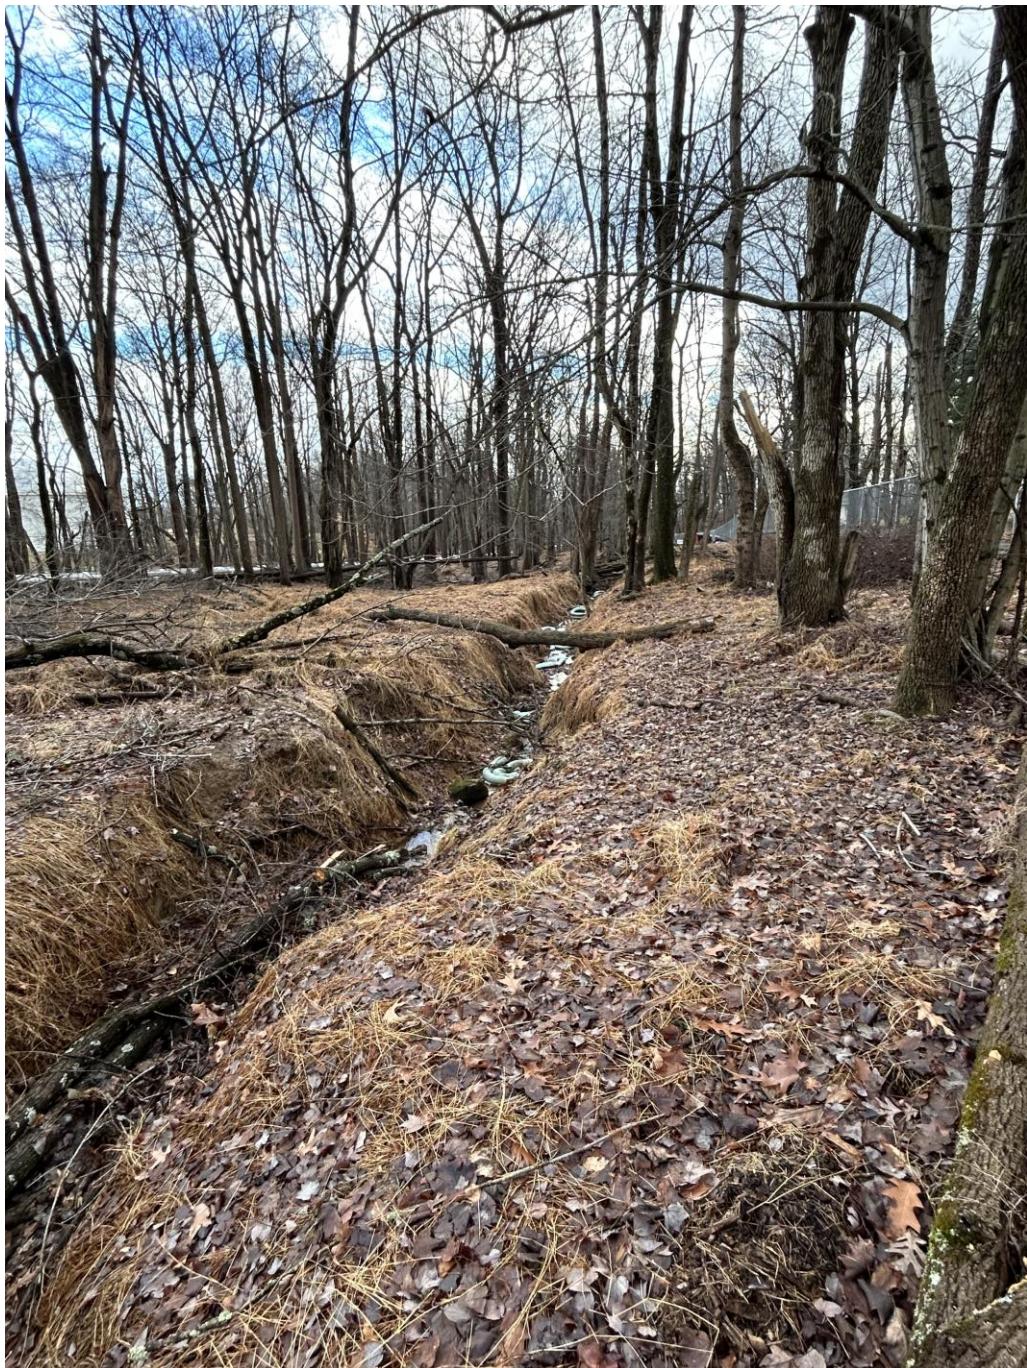
Absorbent boom in swale

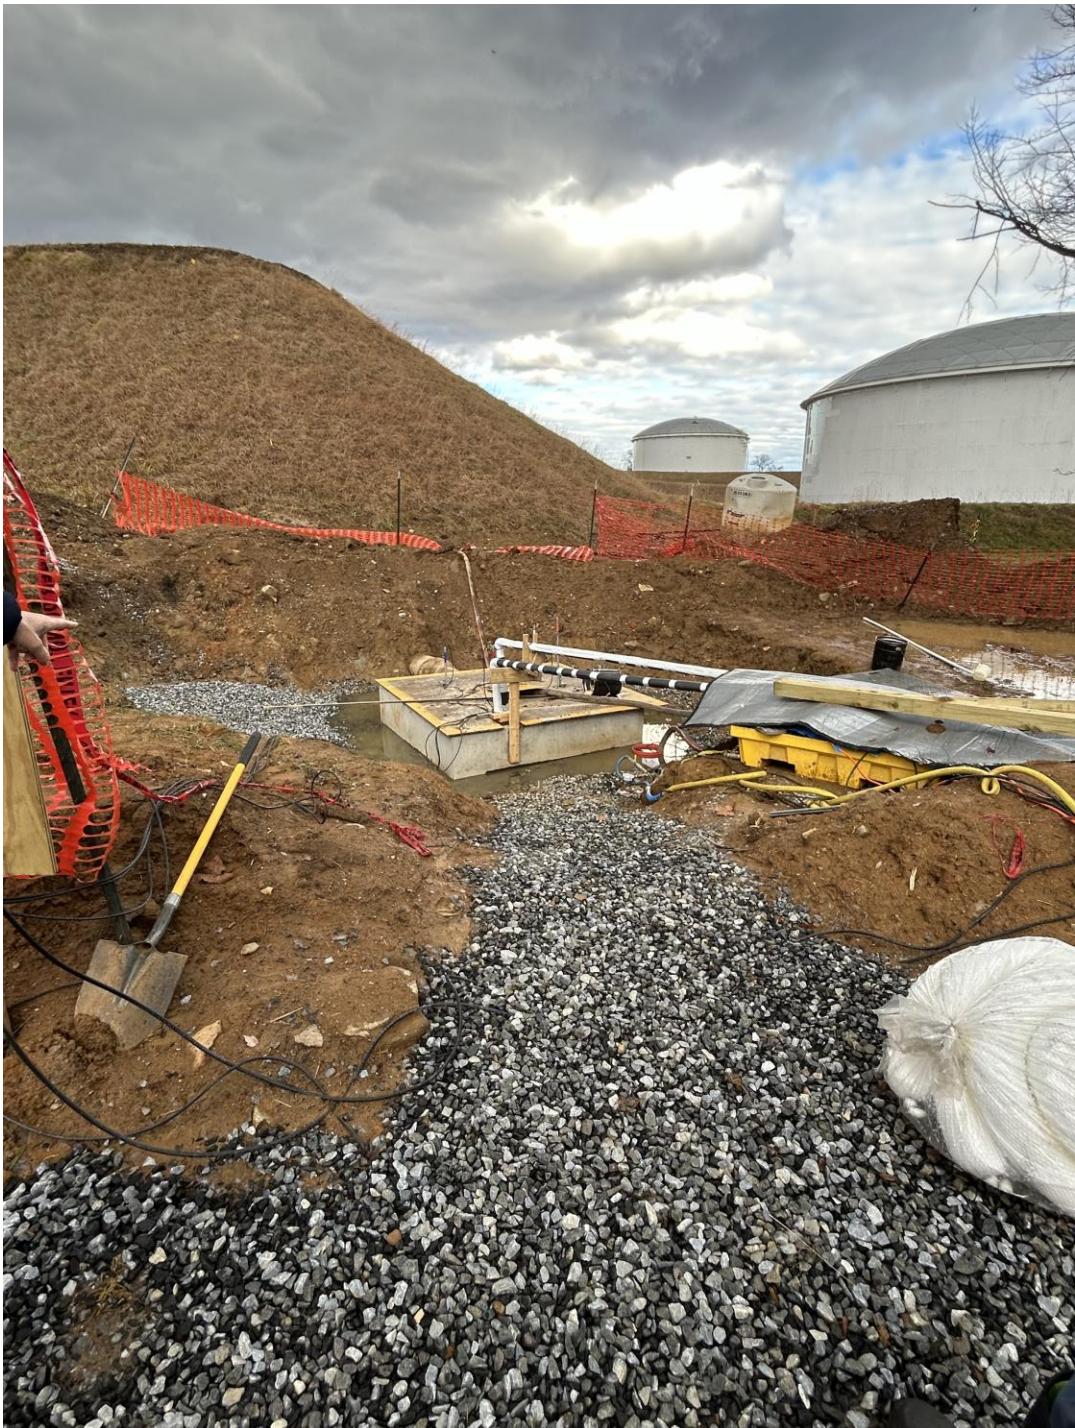
Well house

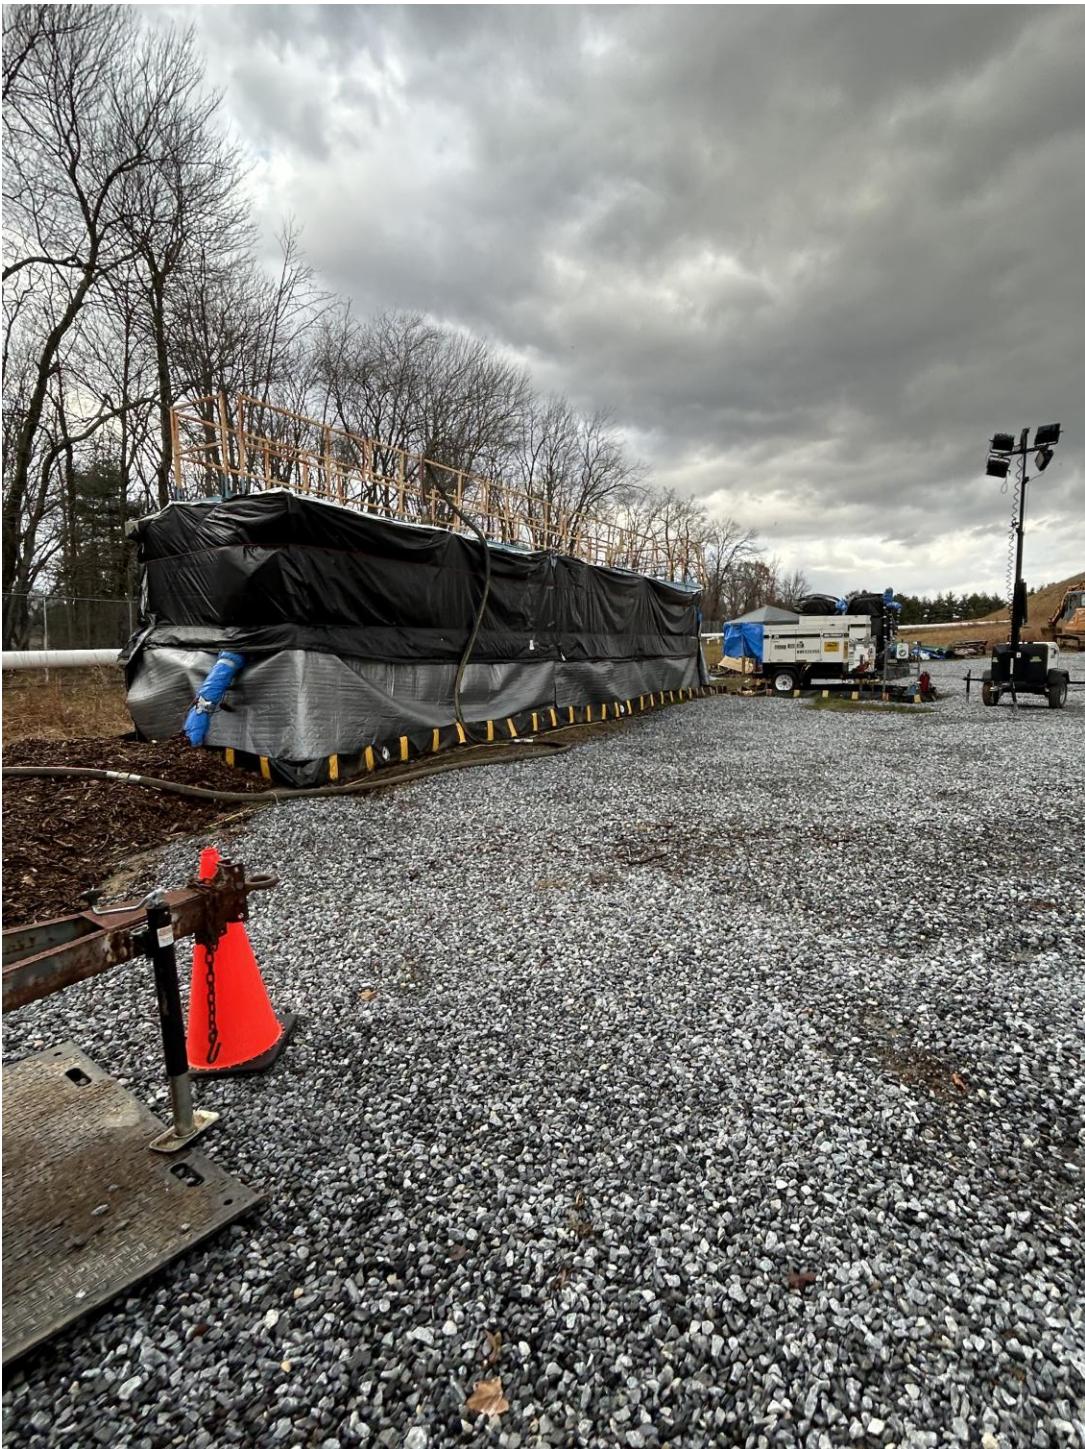
The “well house” discharge pipe has since been disconnected and is now run through a treatment system consisting of a baffled frac tank and two activated carbon vessels. Water from these tanks is piped to an existing dike drain system located at tank #710 prior to entering an oil water separator and discharging to a small retention basin. The basin discharges under a baffle and into a swale which is believed to exit through outfall 003. The basin water was turbid in appearance from the rain event. There were no signs of any product or sheening in either the basin or basin effluent. No odors were detected.

Frac tank

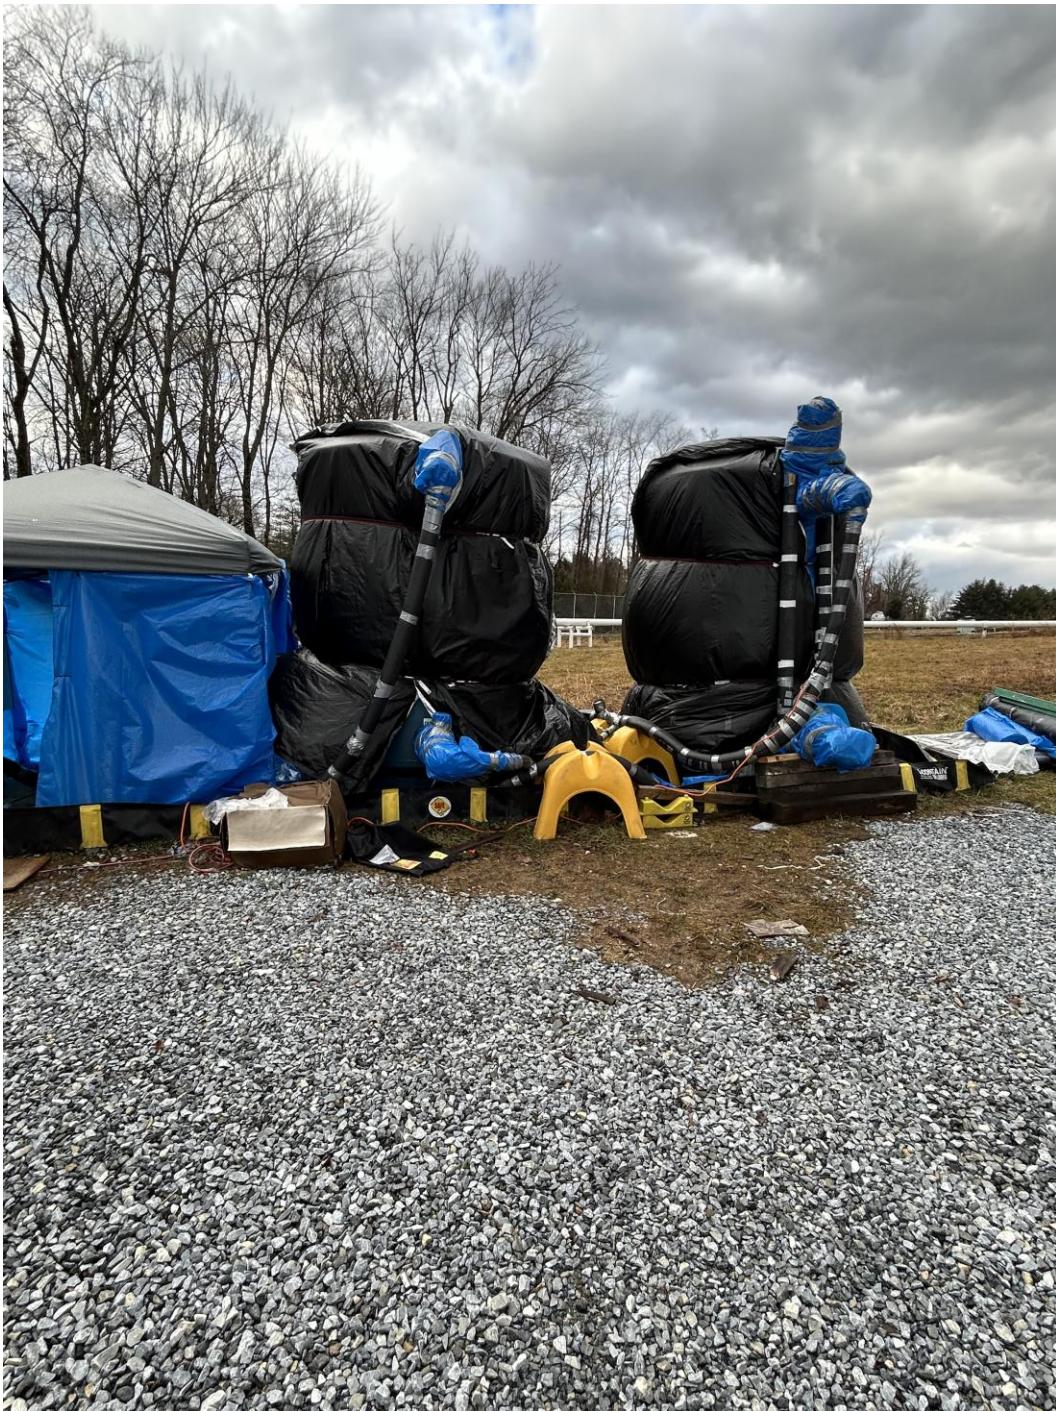
Activated carbon vessels

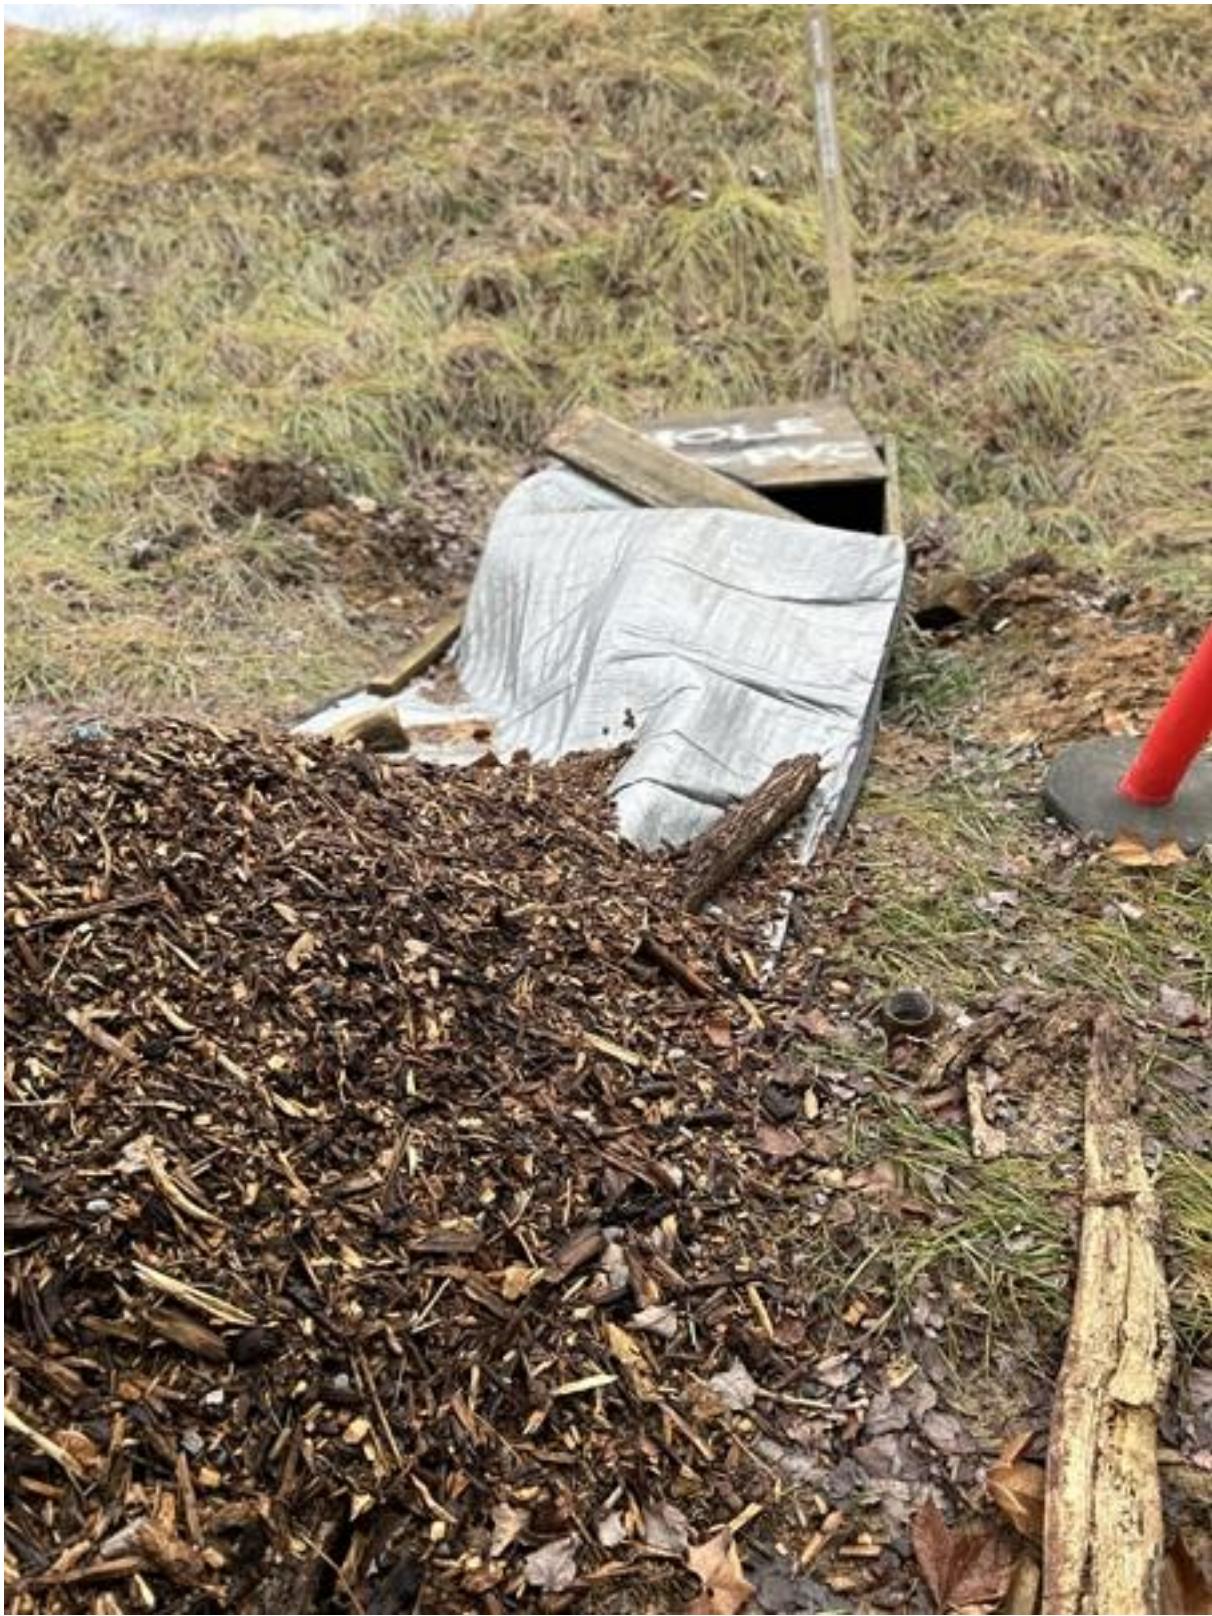
Treatment system discharge to dike drain

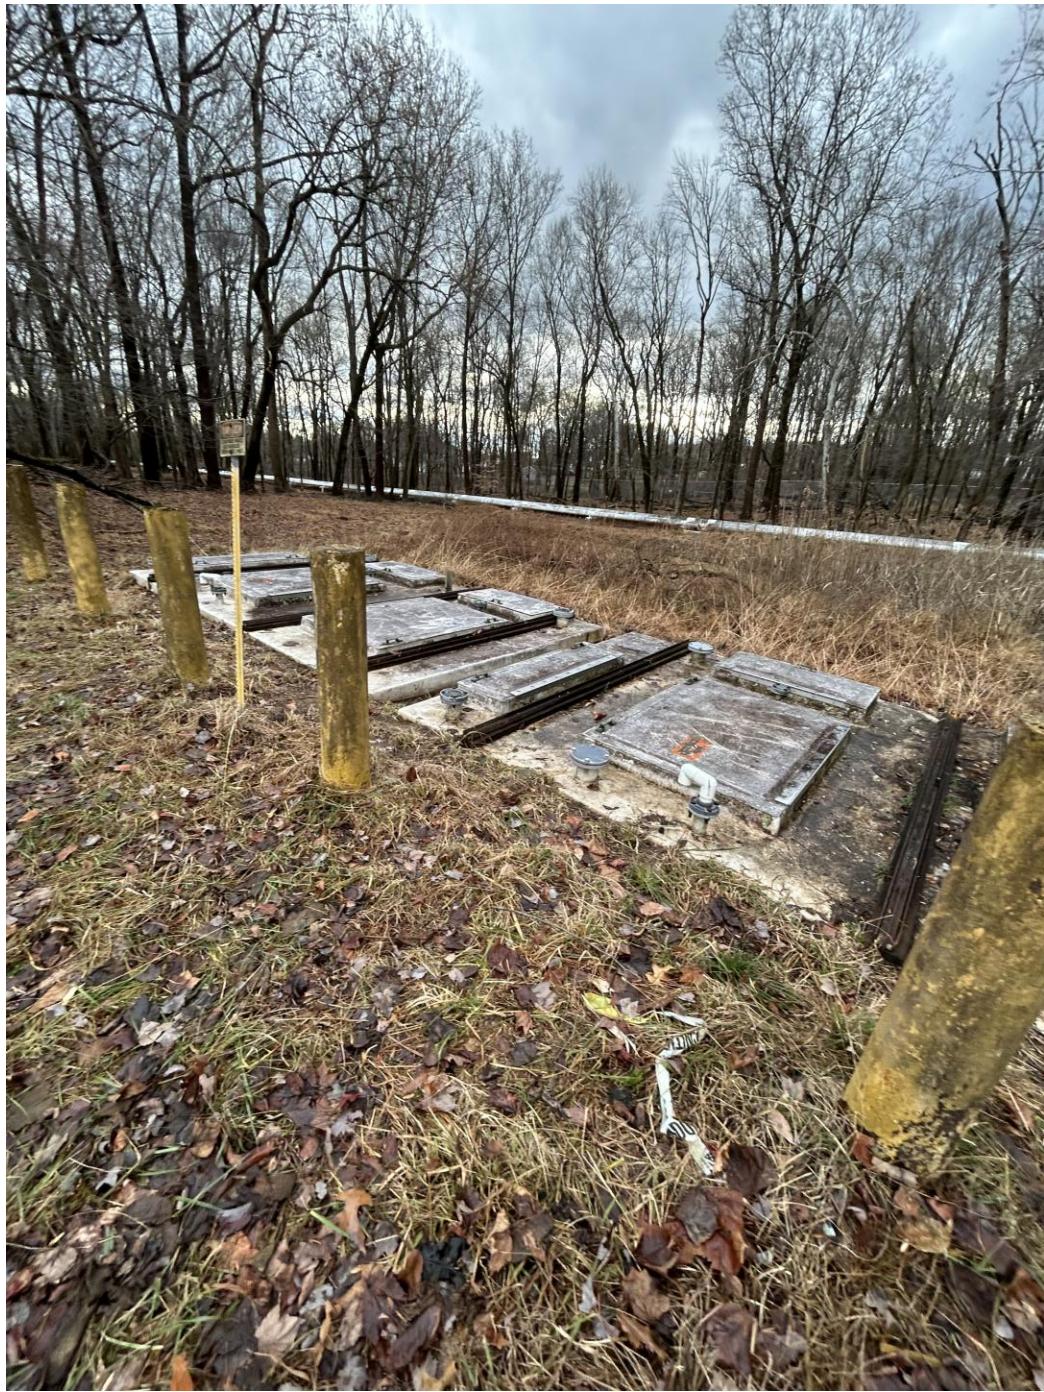
Oil water separator prior to retention basin

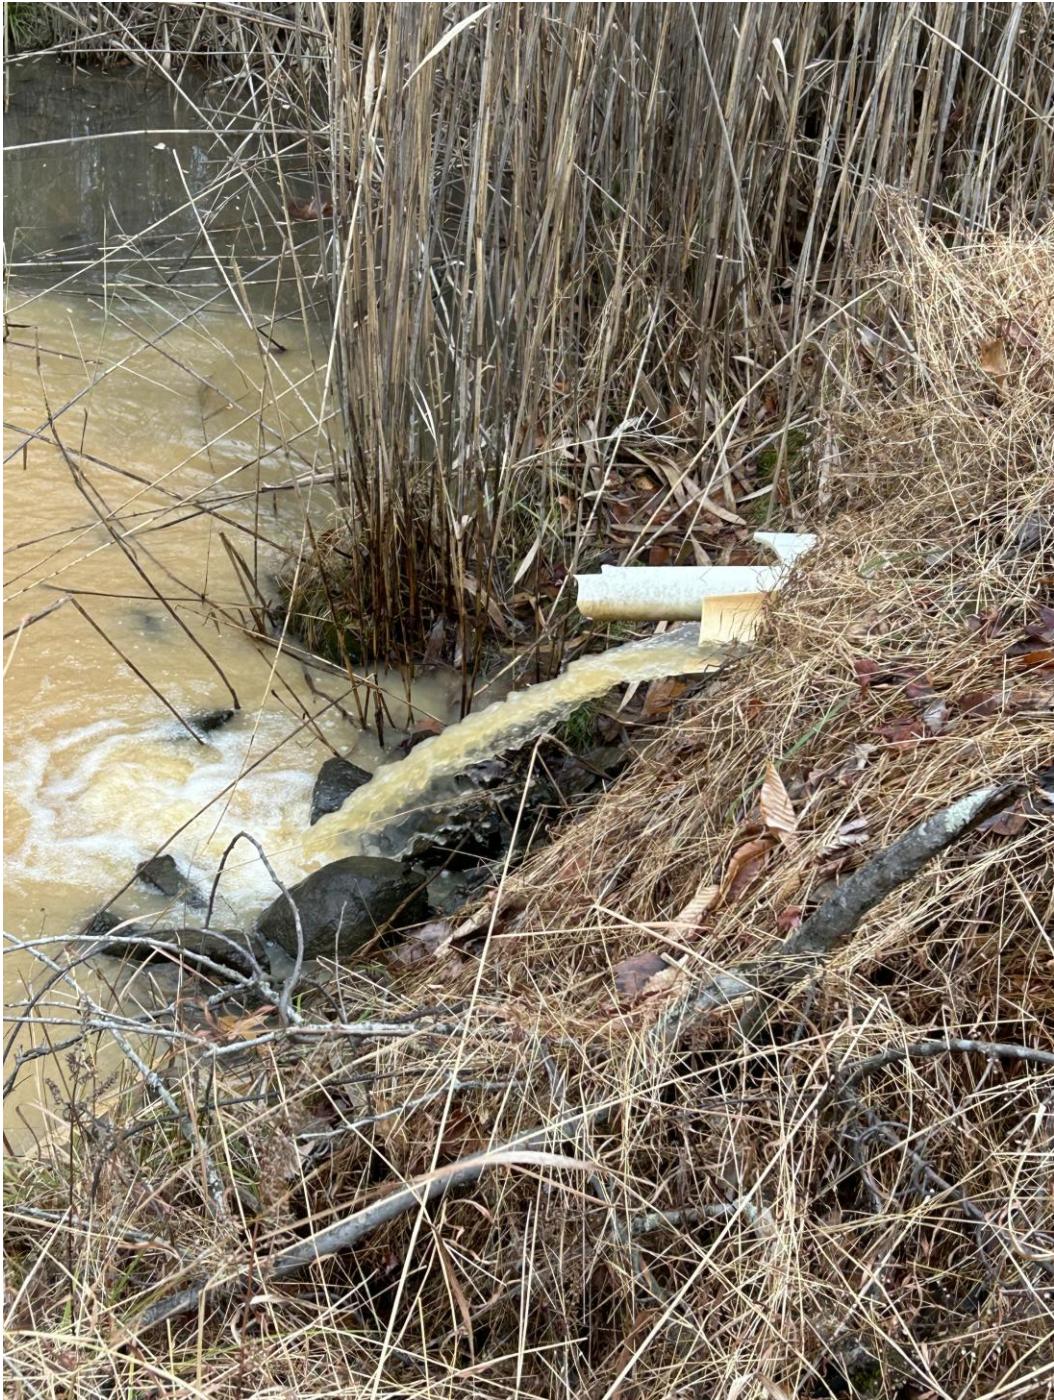
Discharge to retention basin

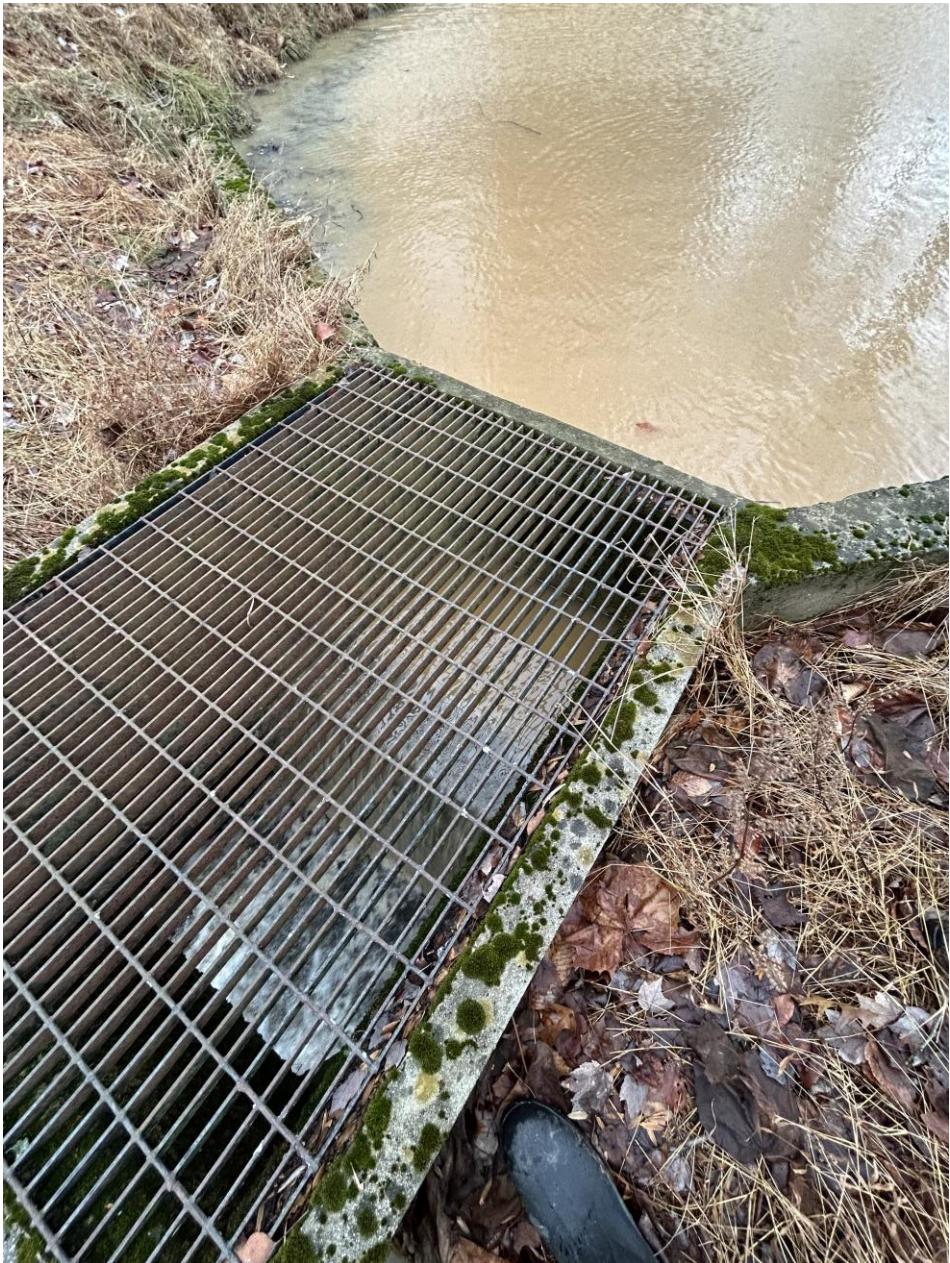
Retention basin outfall

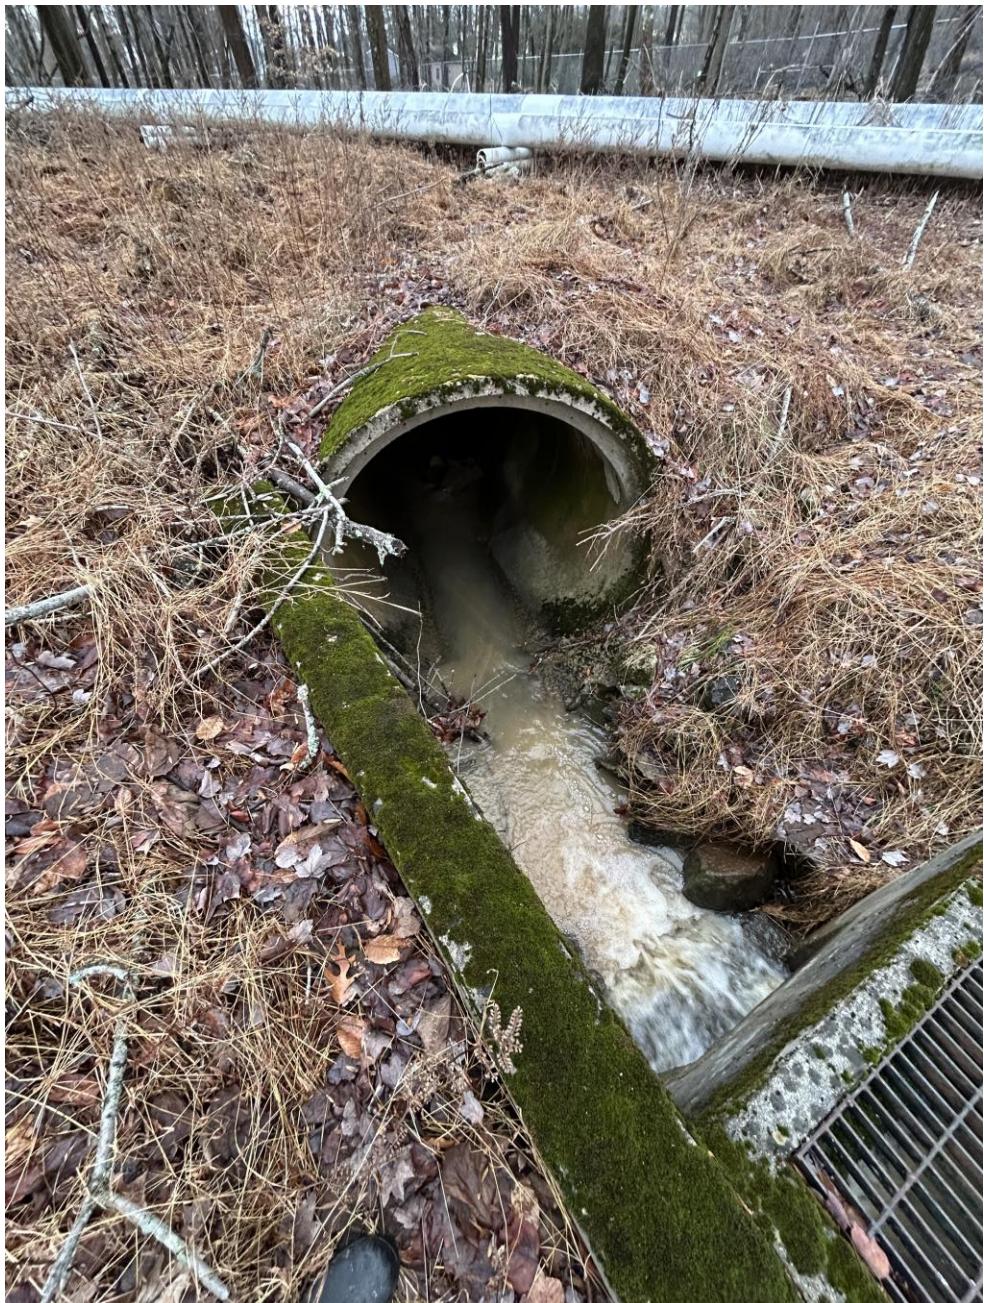
Basin effluent to swale
