COMMONWEALTH OF PENNSYLVANIA
 DEPARTMENT OF ENVIRONMENTAL PROTECTION
 BUREAU OF WATER SUPPLY AND WASTEWATER MANAGEMENT

FIELD NARRATIVE FORM

NAME Tributary to Marsh Creek Lake	DATE 02/16/2024	COUNTY Chester County	PROGRAM WQ
SITE ADDRESS/LOCATION Tributary behind homes along Waterview Road, Downingtown, PA 19335		MUNICIPALITY (TWP. BORO) Upper Uwchlan Township	
ACTIVITY <input type="checkbox"/> PLANNING <input type="checkbox"/> CONSULTATION <input type="checkbox"/> ENFORCEMENT <input type="checkbox"/> INVESTIGATION <input type="checkbox"/> INSPECTION <input checked="" type="checkbox"/> COMPLAINT <input type="checkbox"/> PROGRAM EVALUATION <input type="checkbox"/> OTHER, _____		FOLLOW UP ACTIVITY <input type="checkbox"/> NONE <input type="checkbox"/> REINSPECTION <input type="checkbox"/> LETTER <input type="checkbox"/> RETURN <input checked="" type="checkbox"/> OTHER, Contact ETP _____	
NARRATIVE: (Include as appropriate: direction to site; indicate all individuals present; list points discussed; describe conditions observed; diagram site; note sampling activities.) On 02/15/2024 @ 1535 hours, The Department of Environmental Protection received a complaint from a Downingtown reside

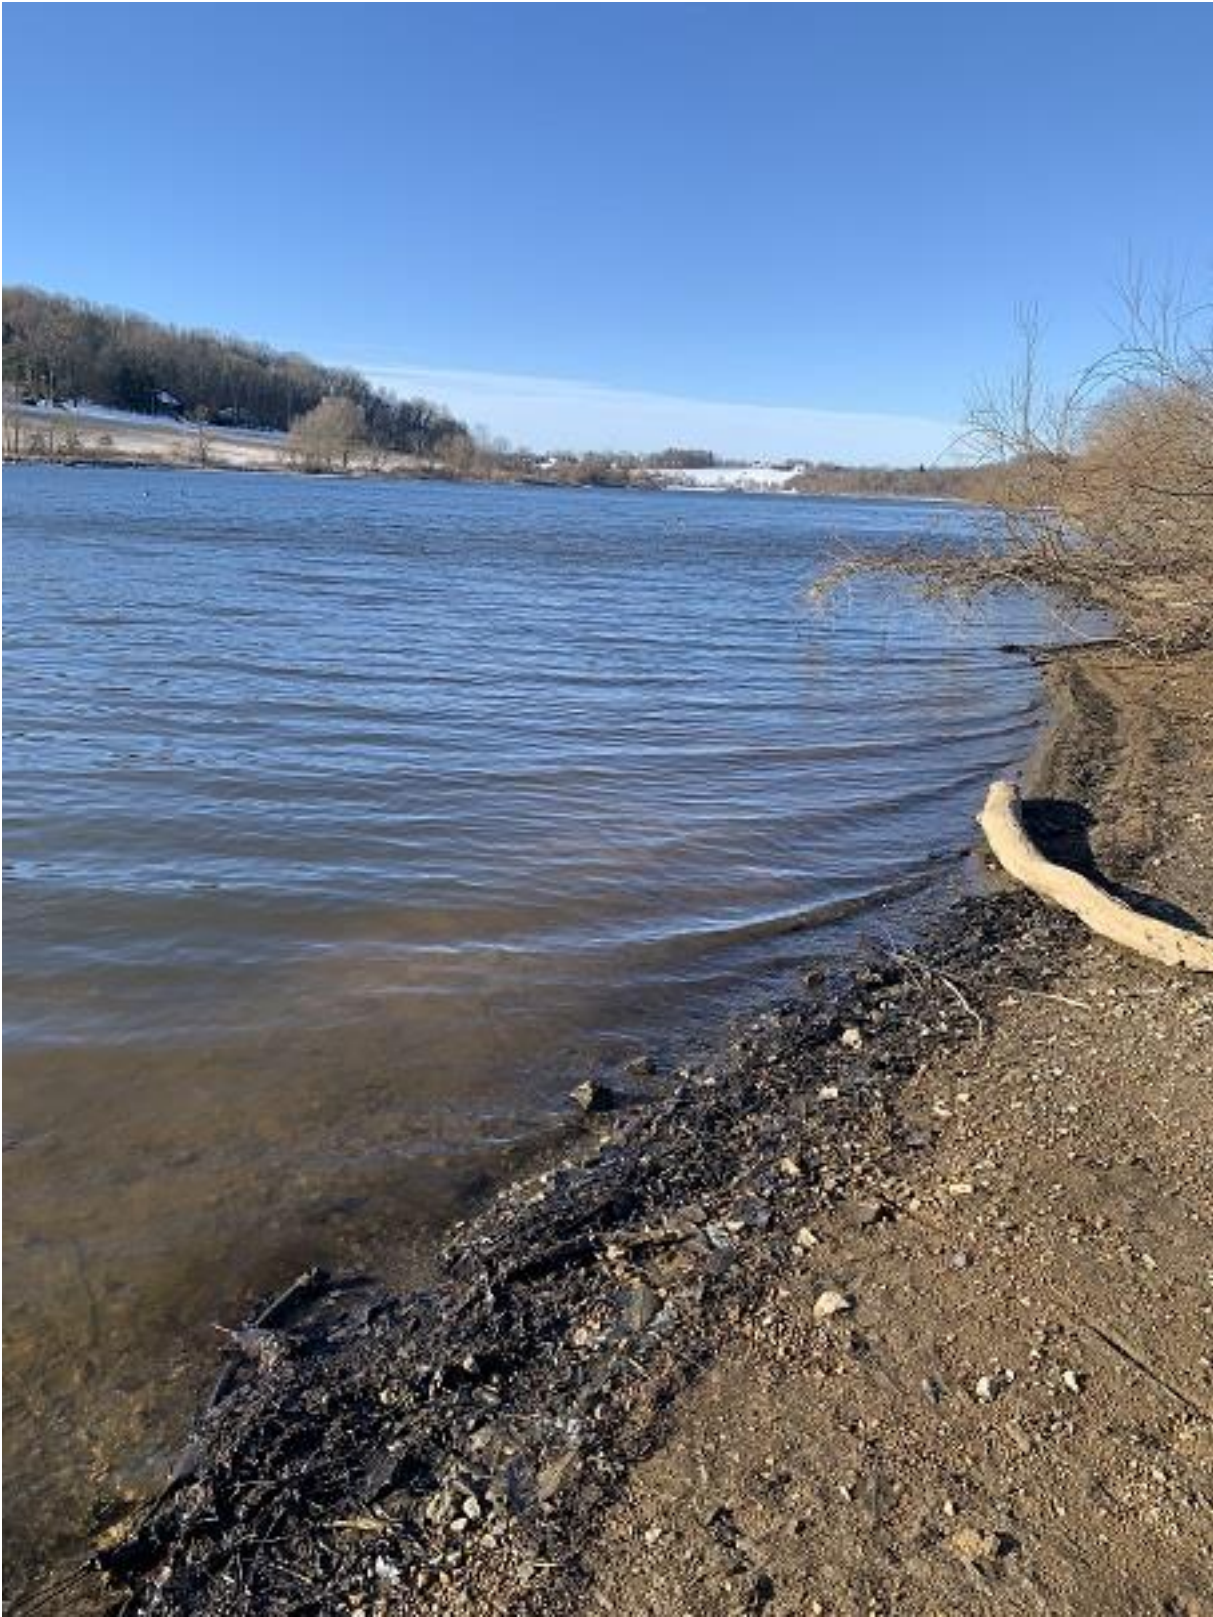
Shoreline of “Ranger Cove”

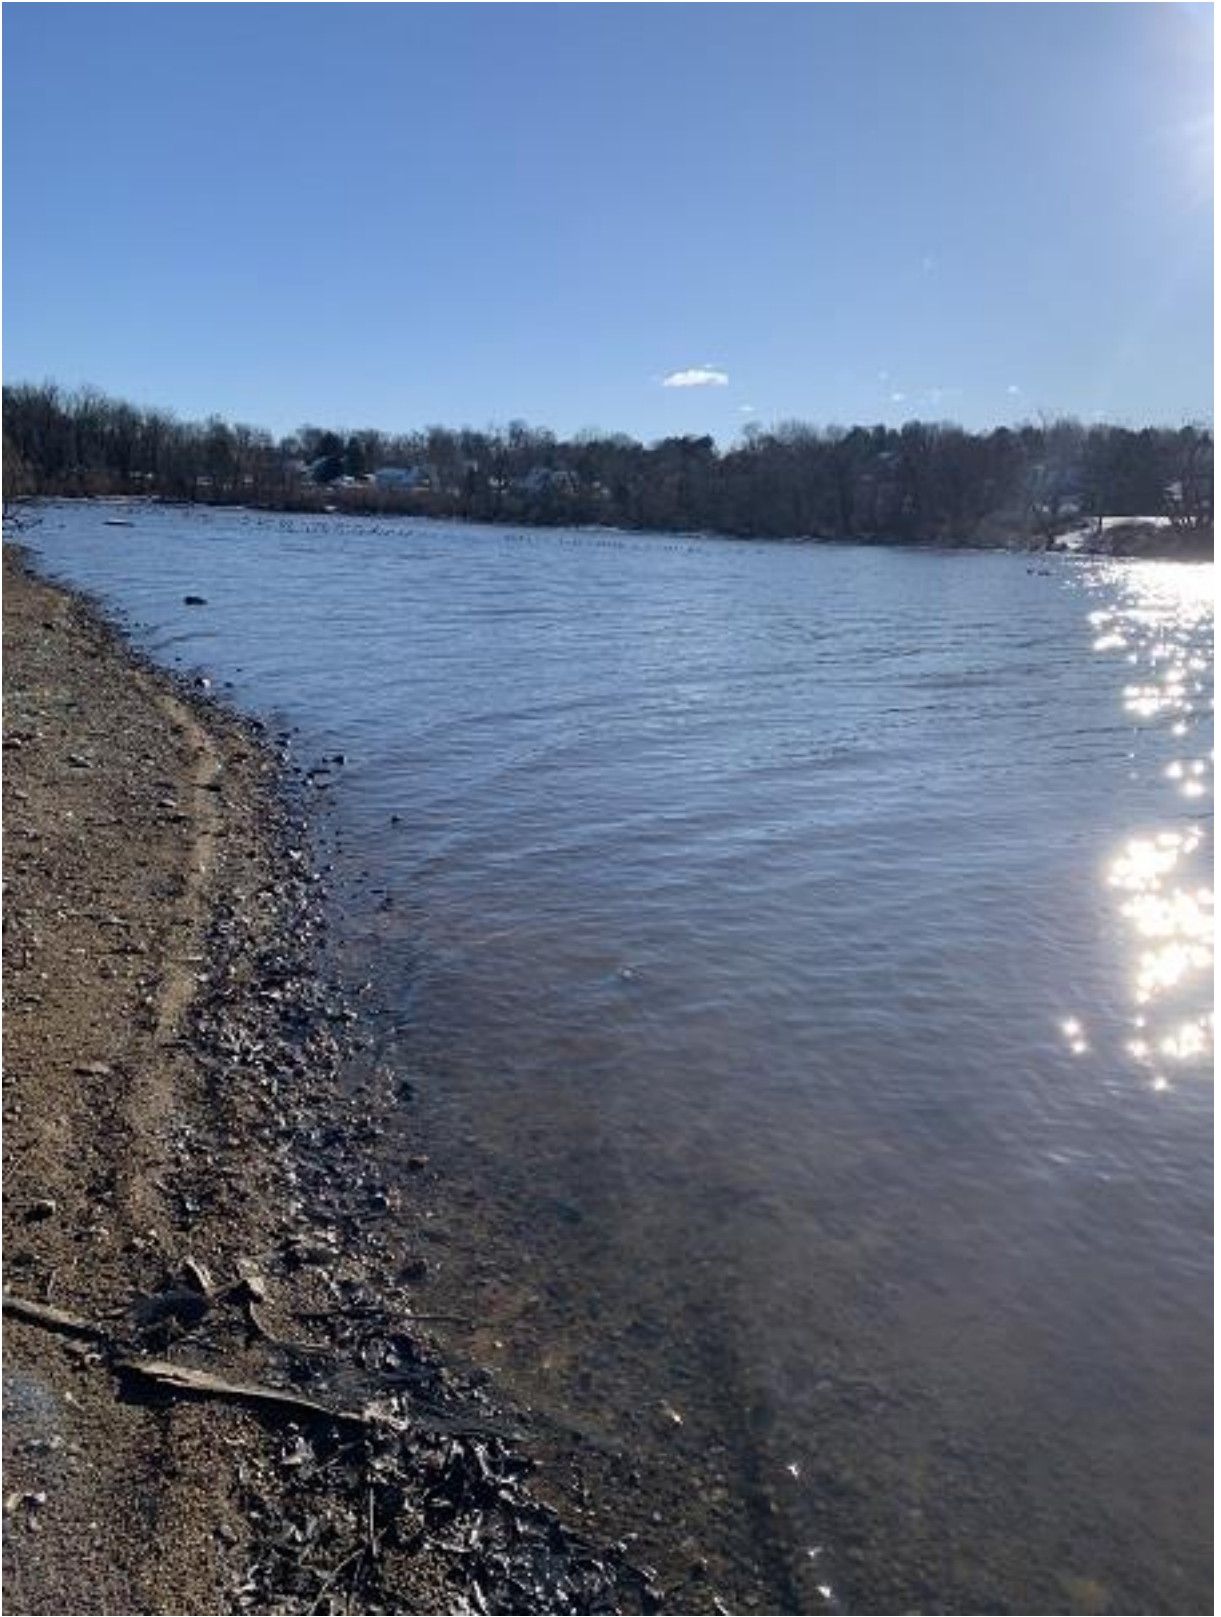
Shoreline of “Ranger Cove”

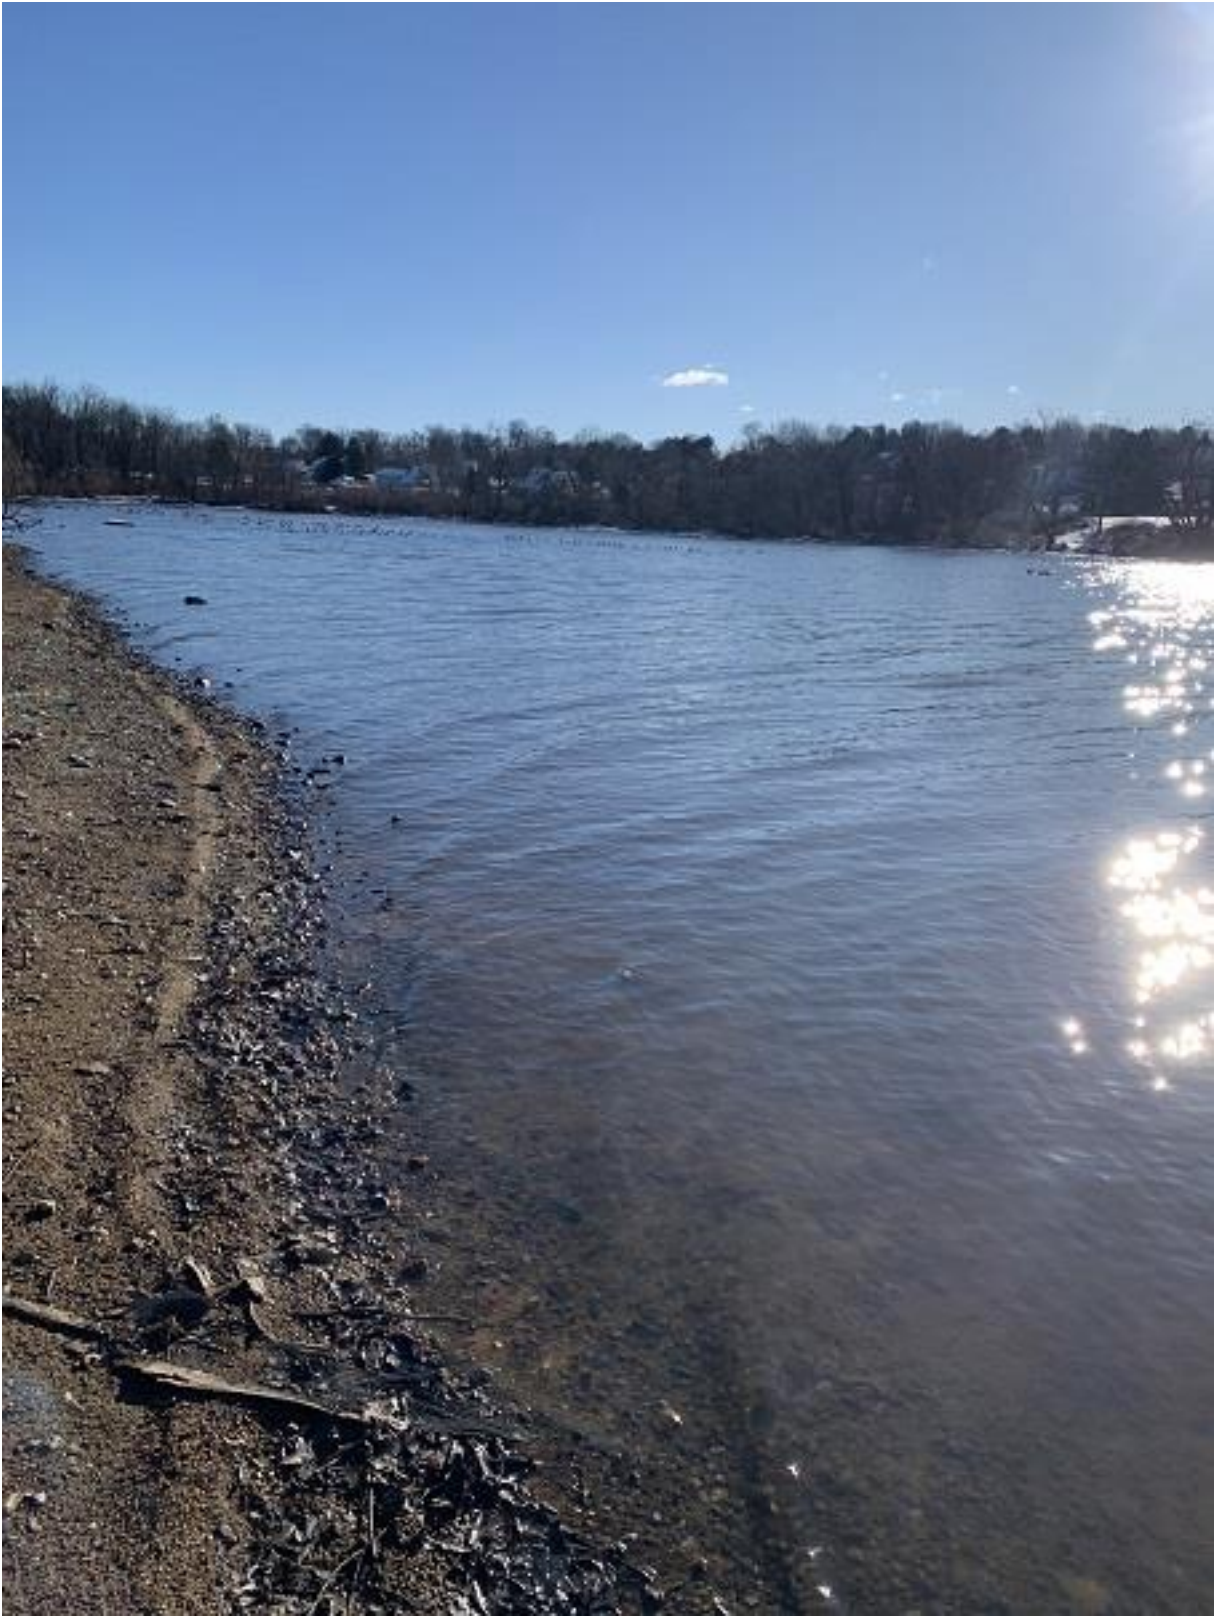
Shoreline of “Ranger Cove”

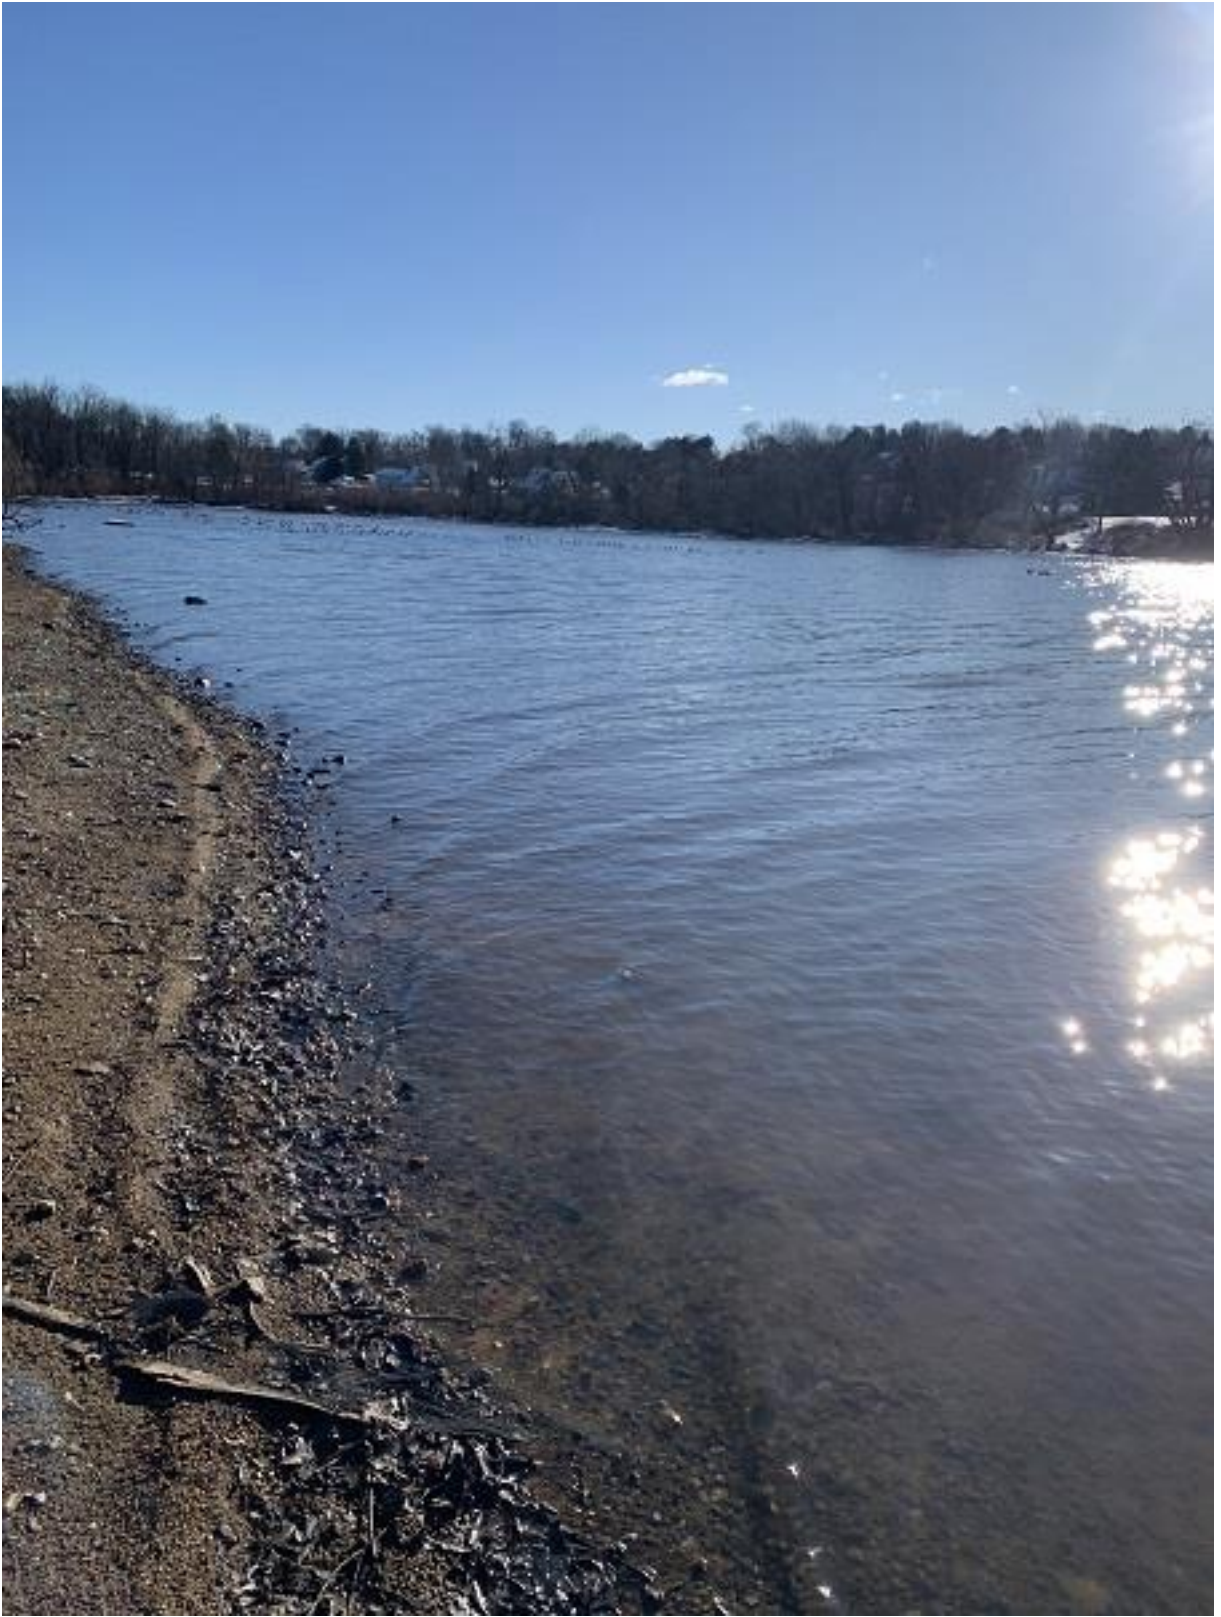
Shoreline of “Ranger Cove”

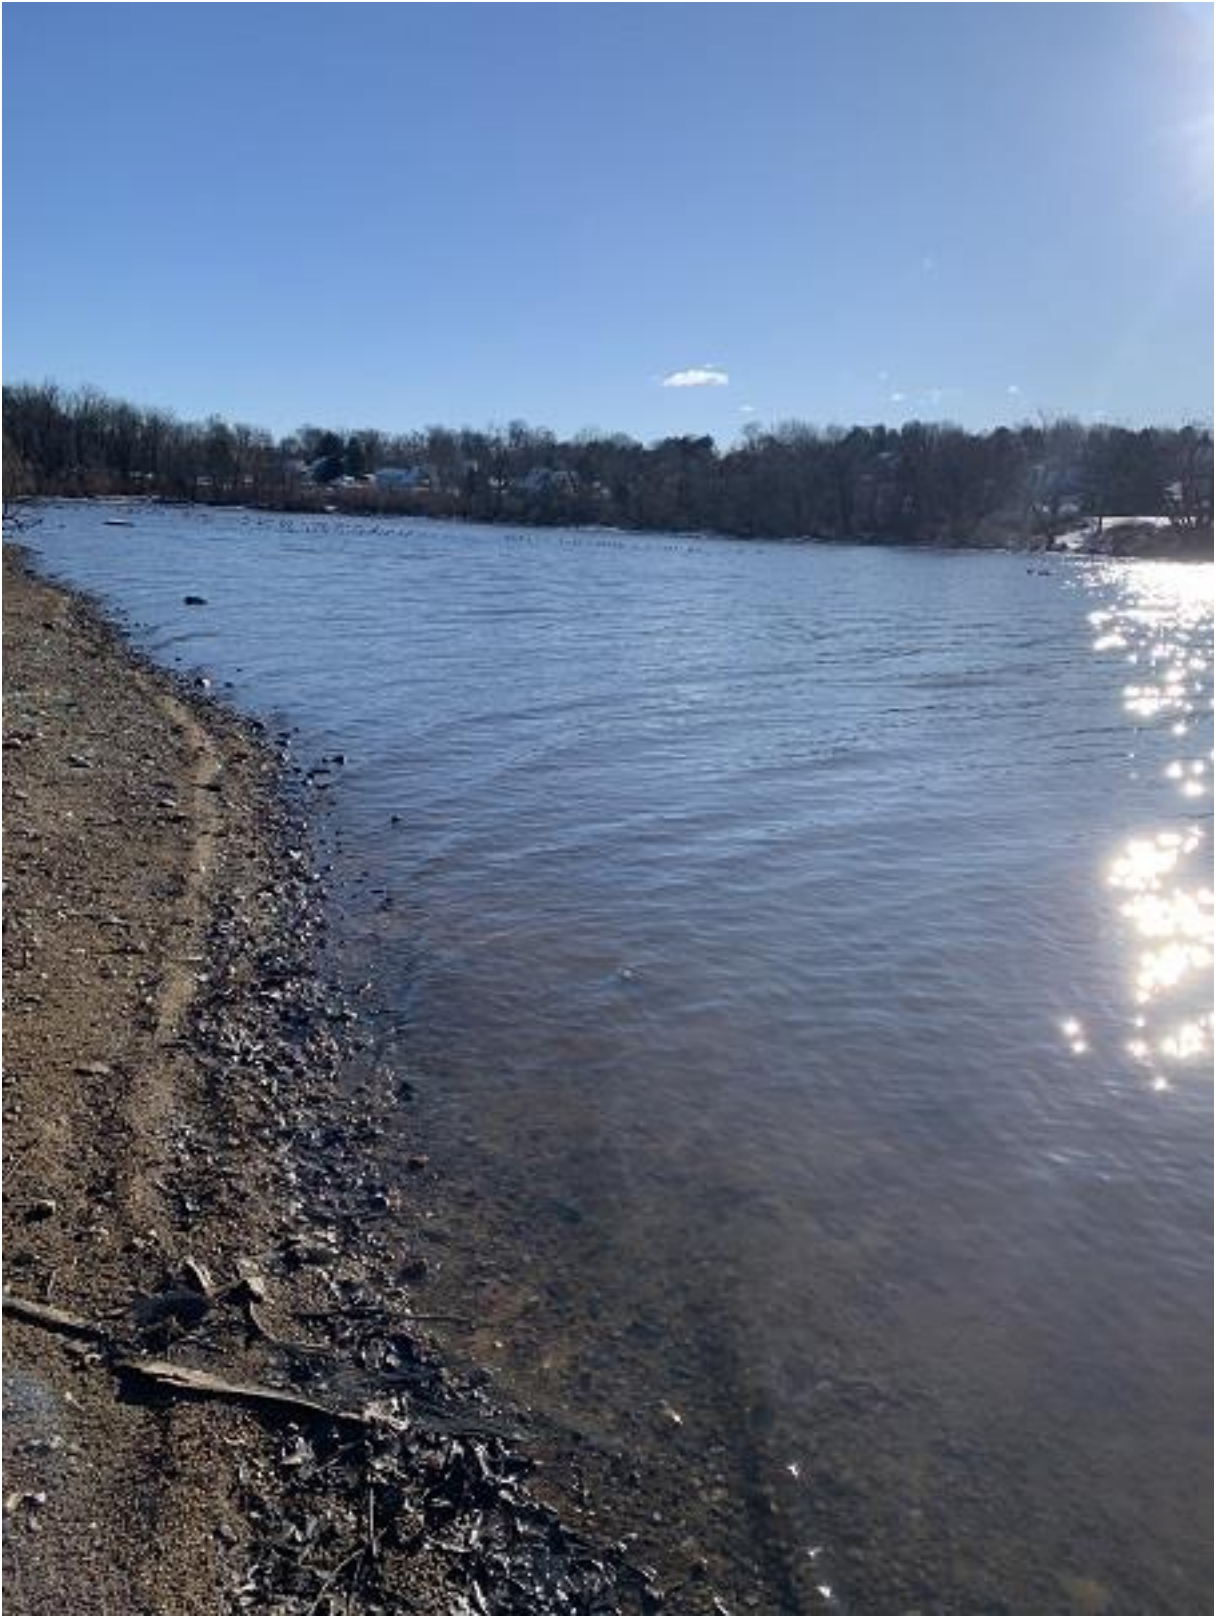
Shoreline of “Ranger Cove”

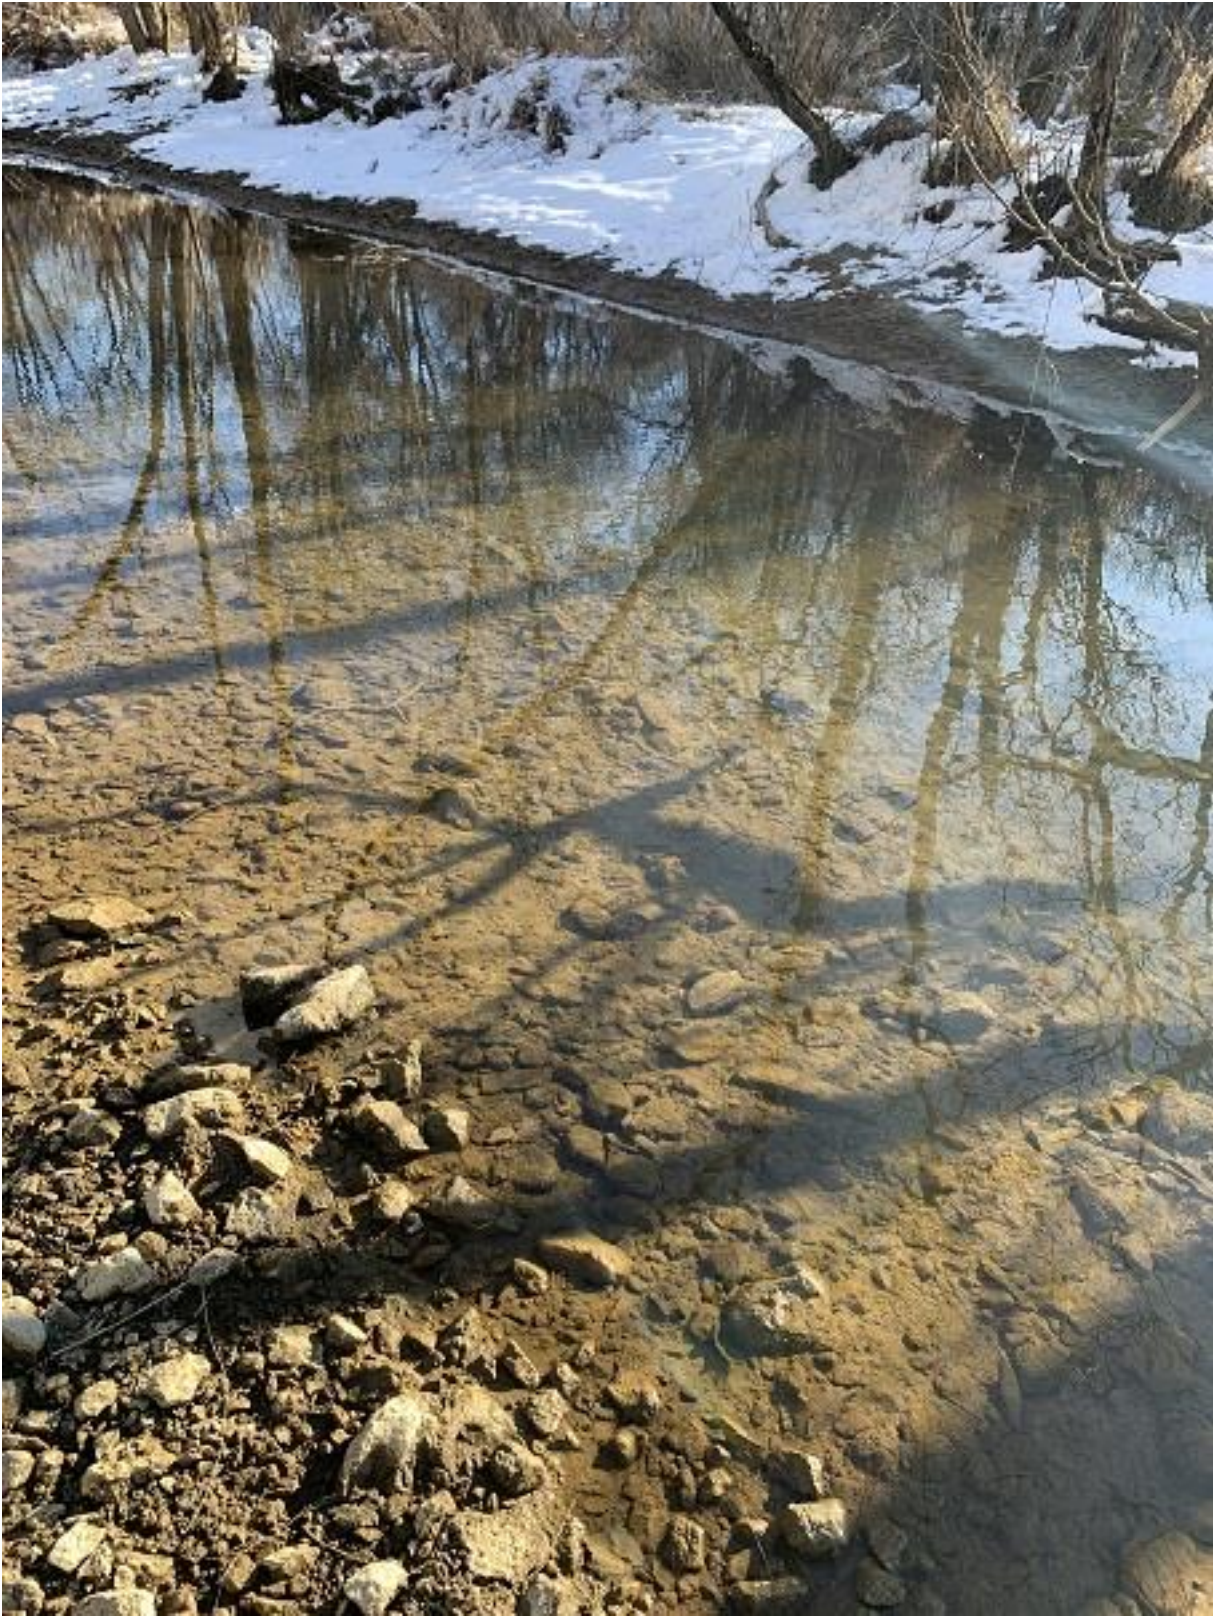
Tributary entering “Ranger Cove”

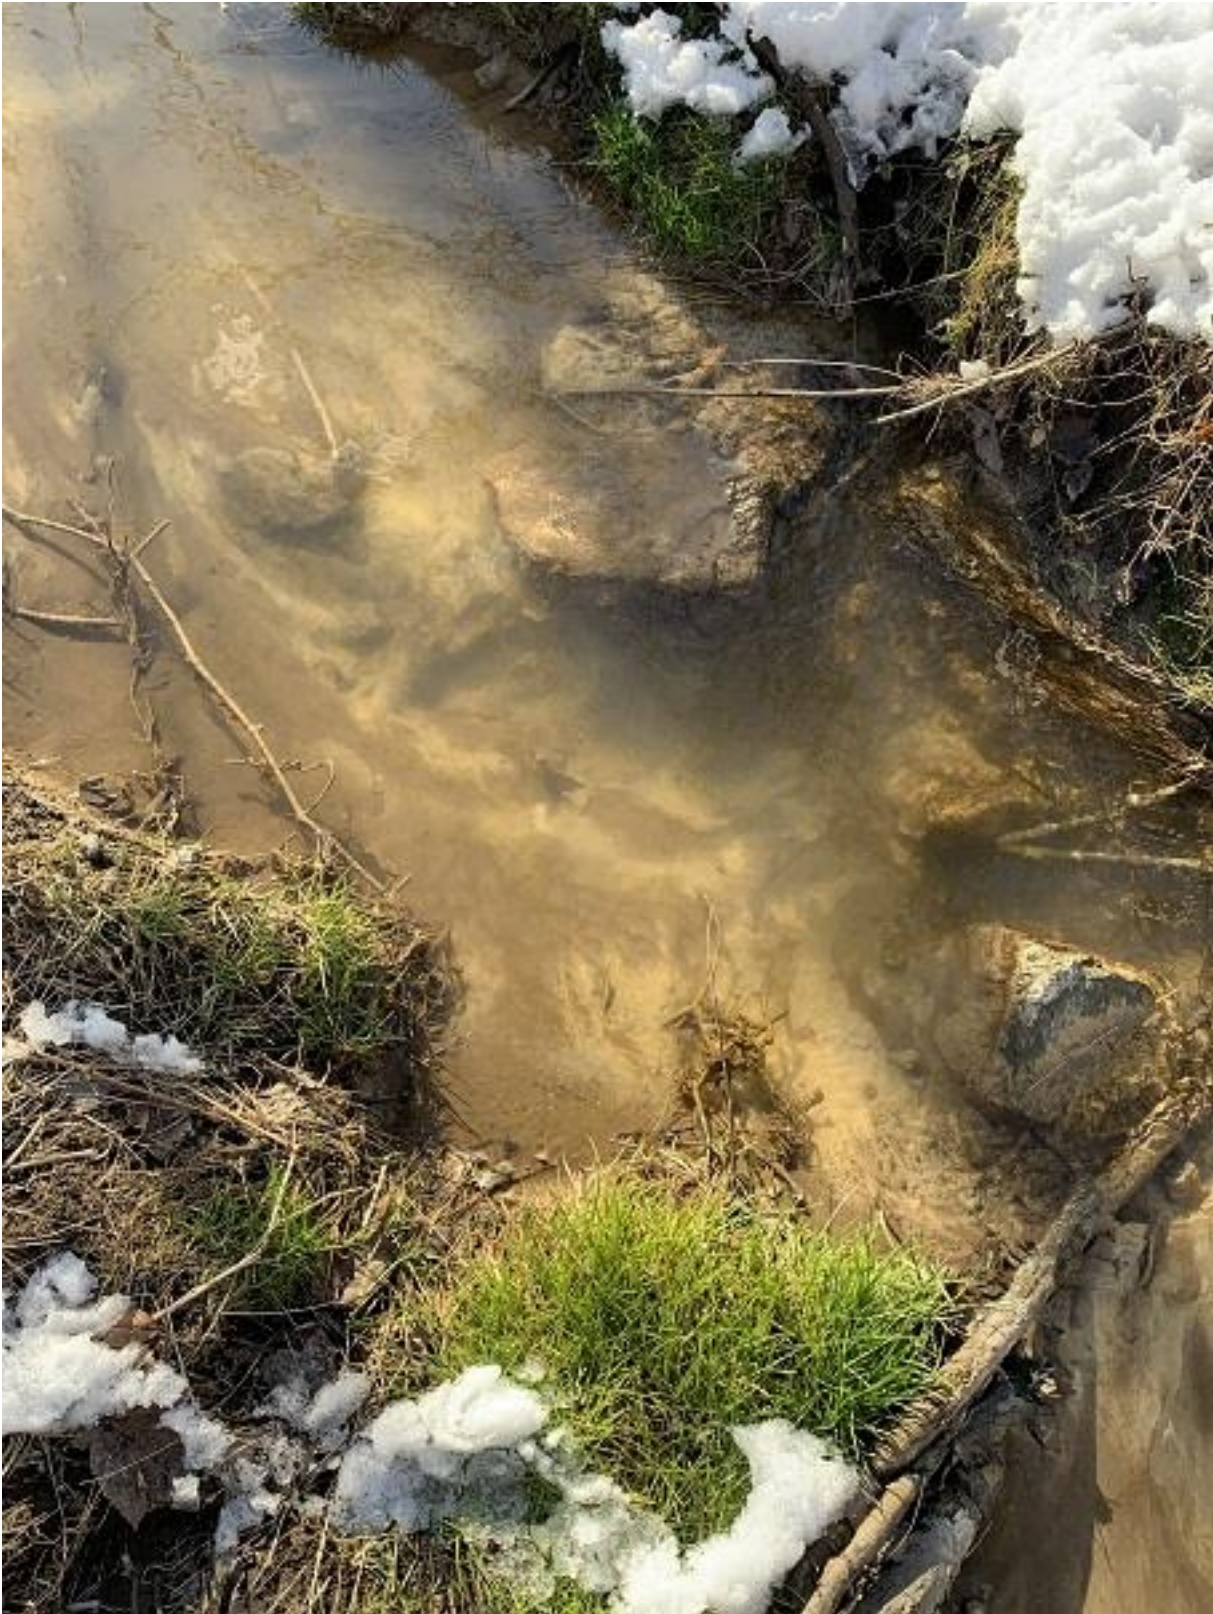
White coloration in tributary behind homes on Waterview Road

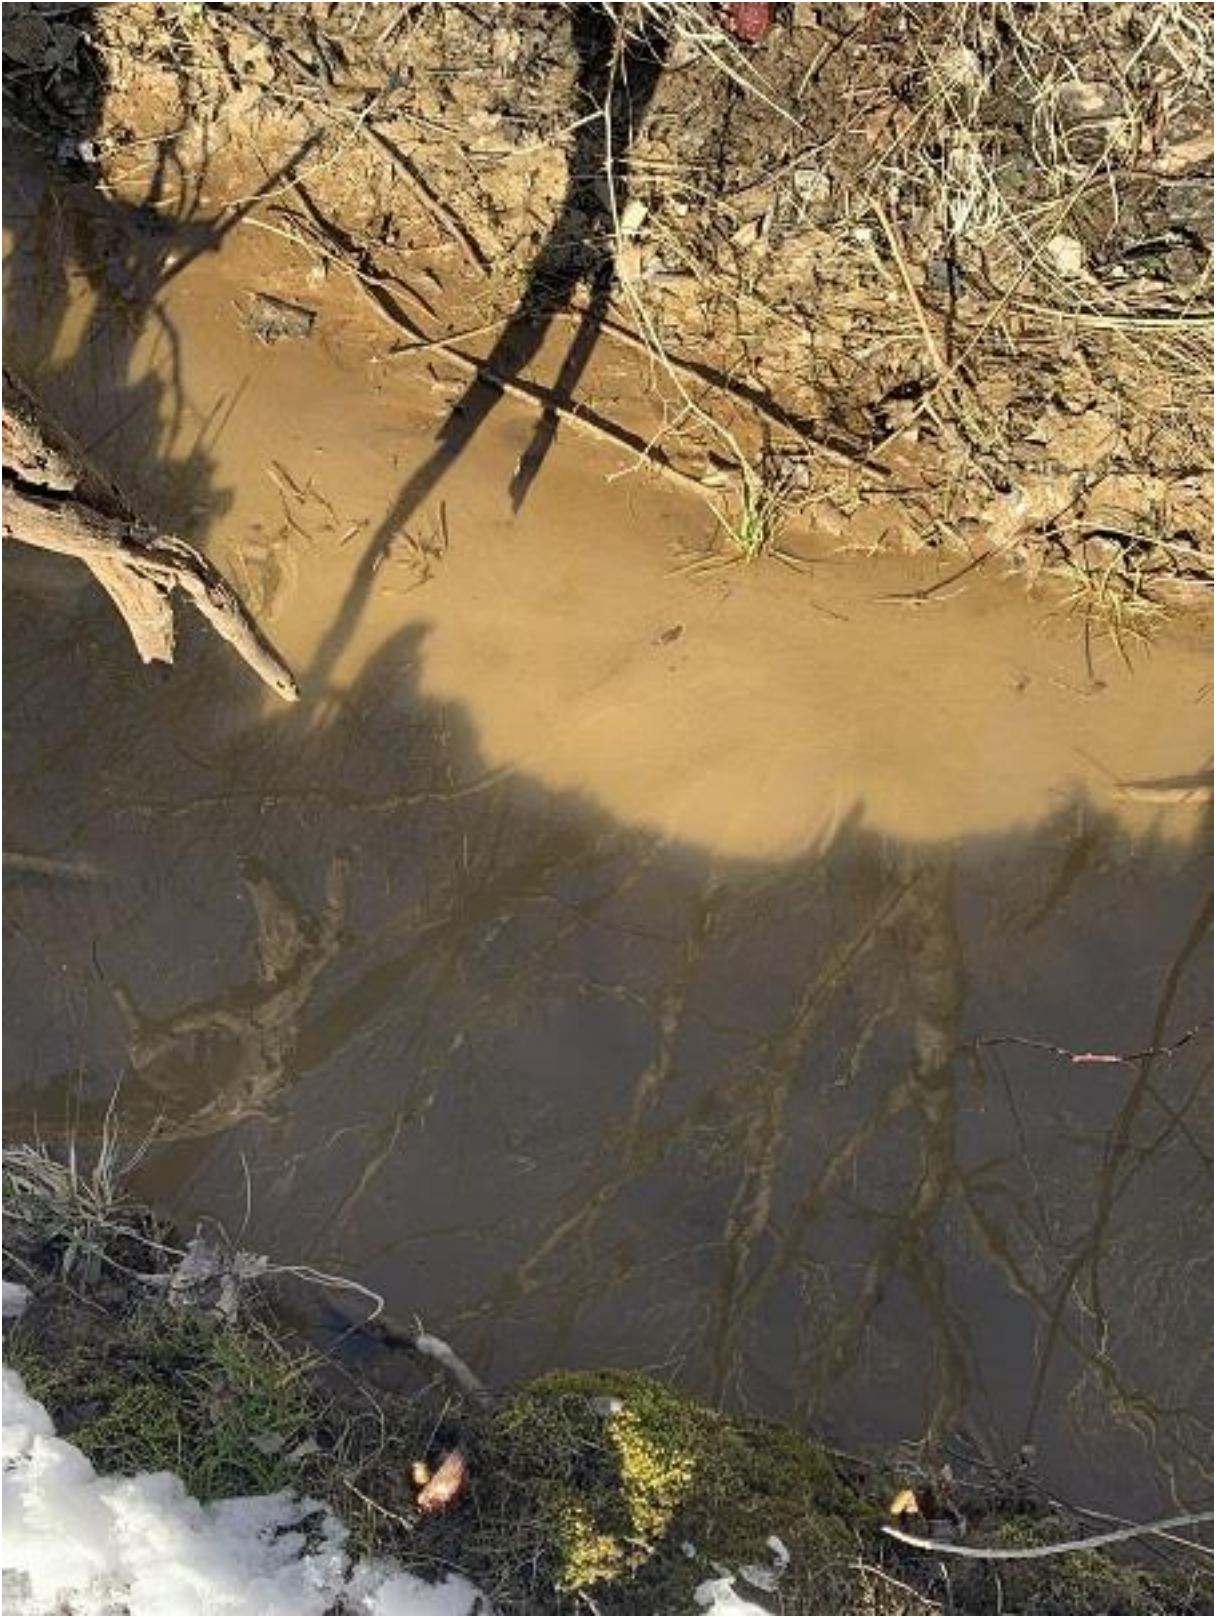
Tributary below wetland area

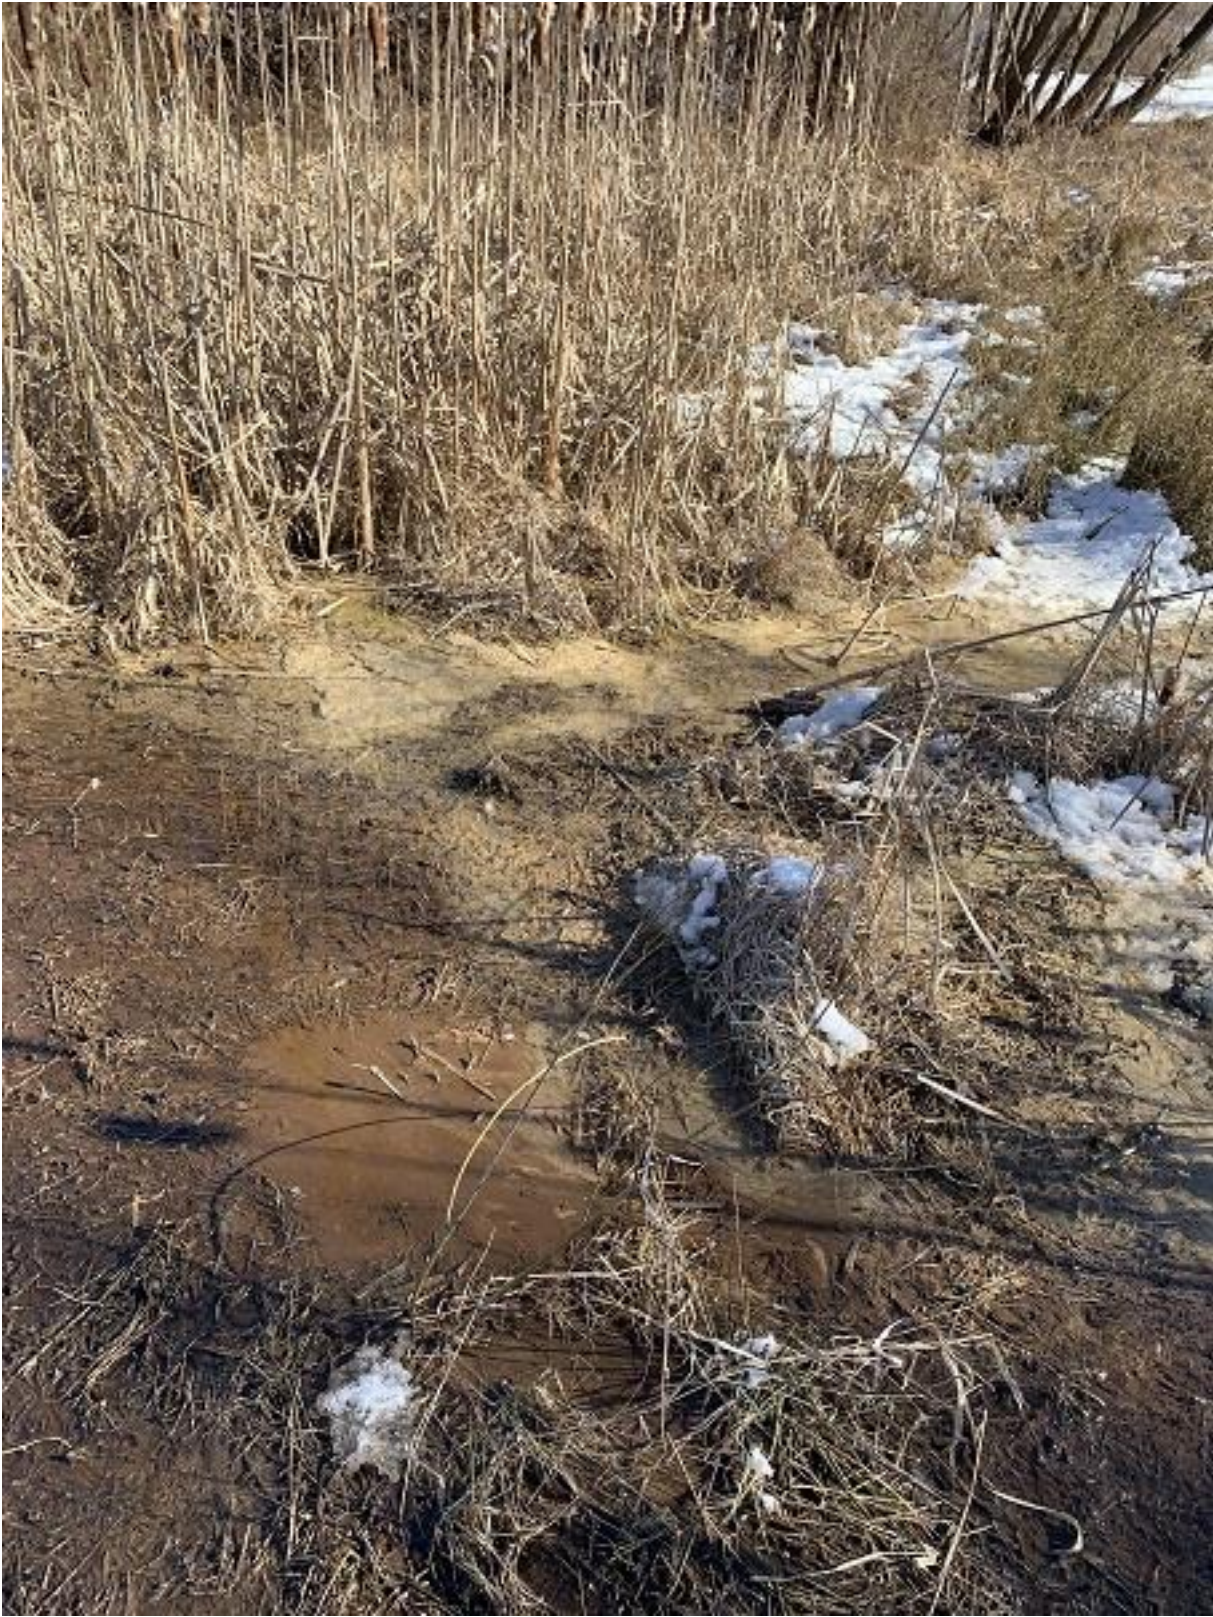
Wetland area

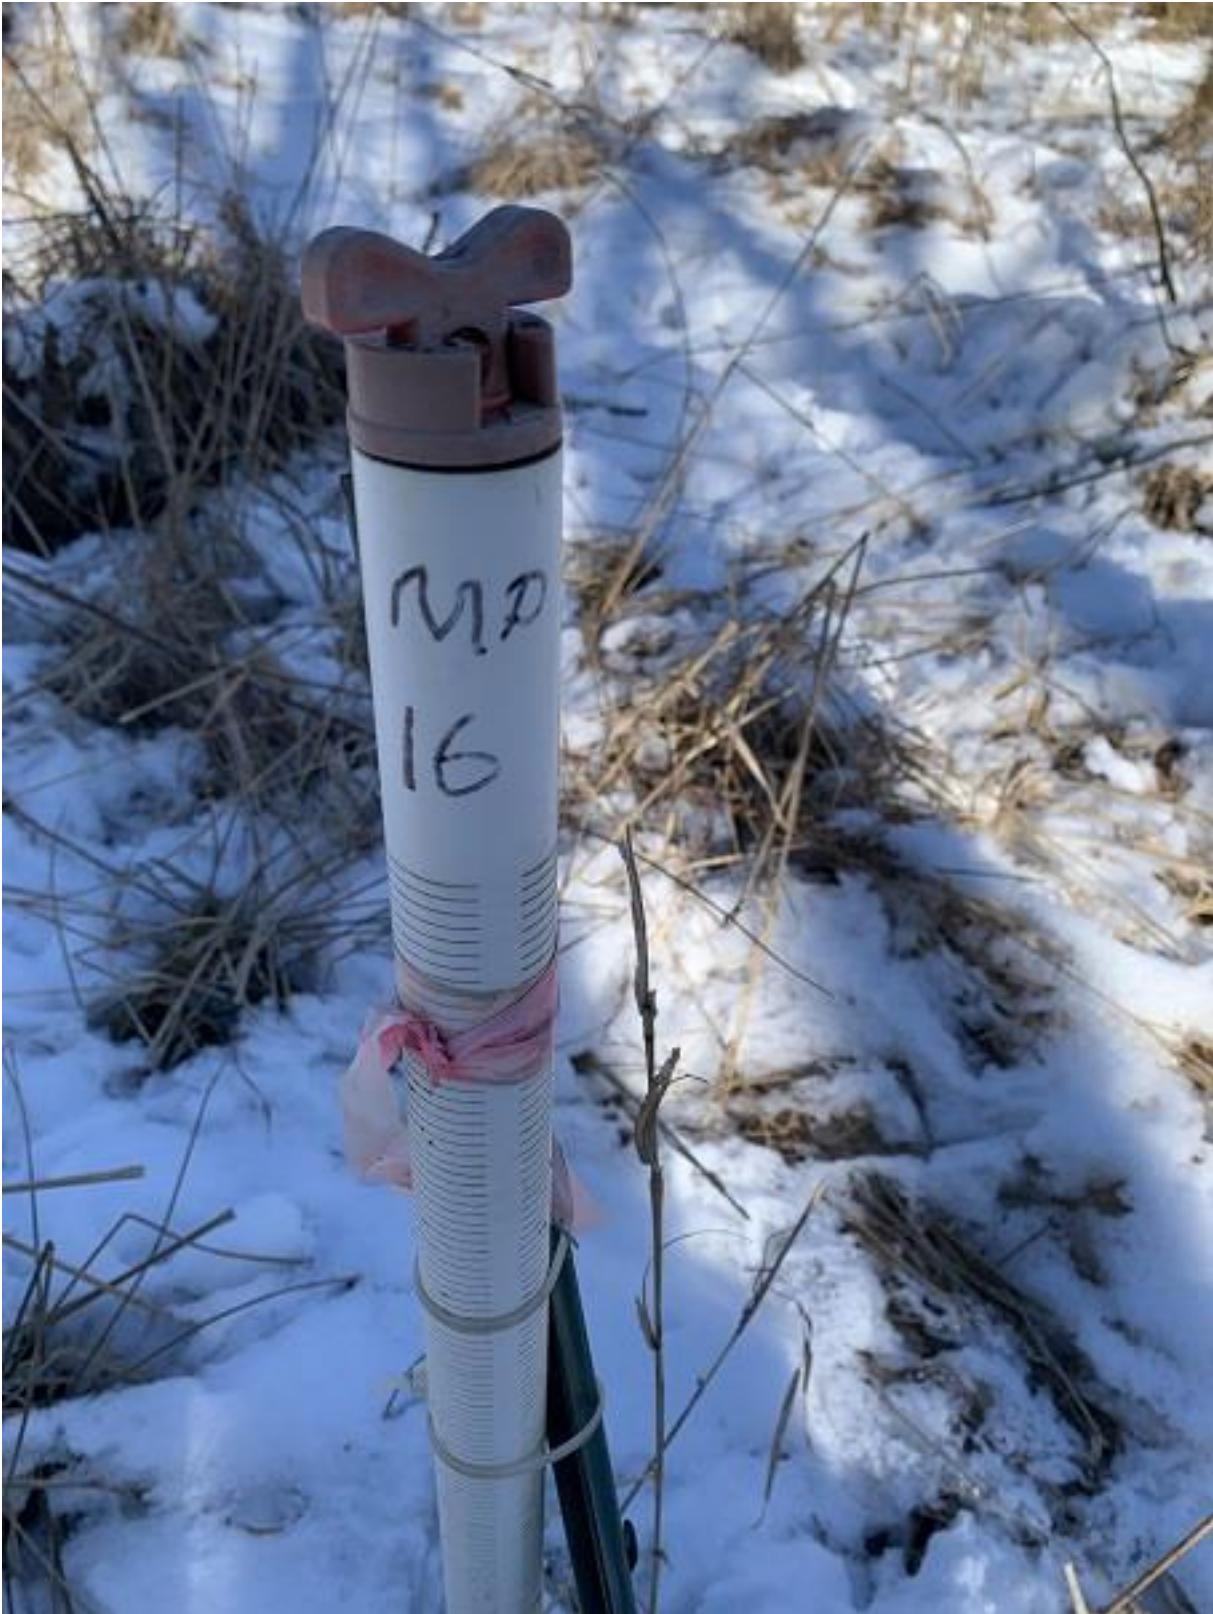
Piezometer

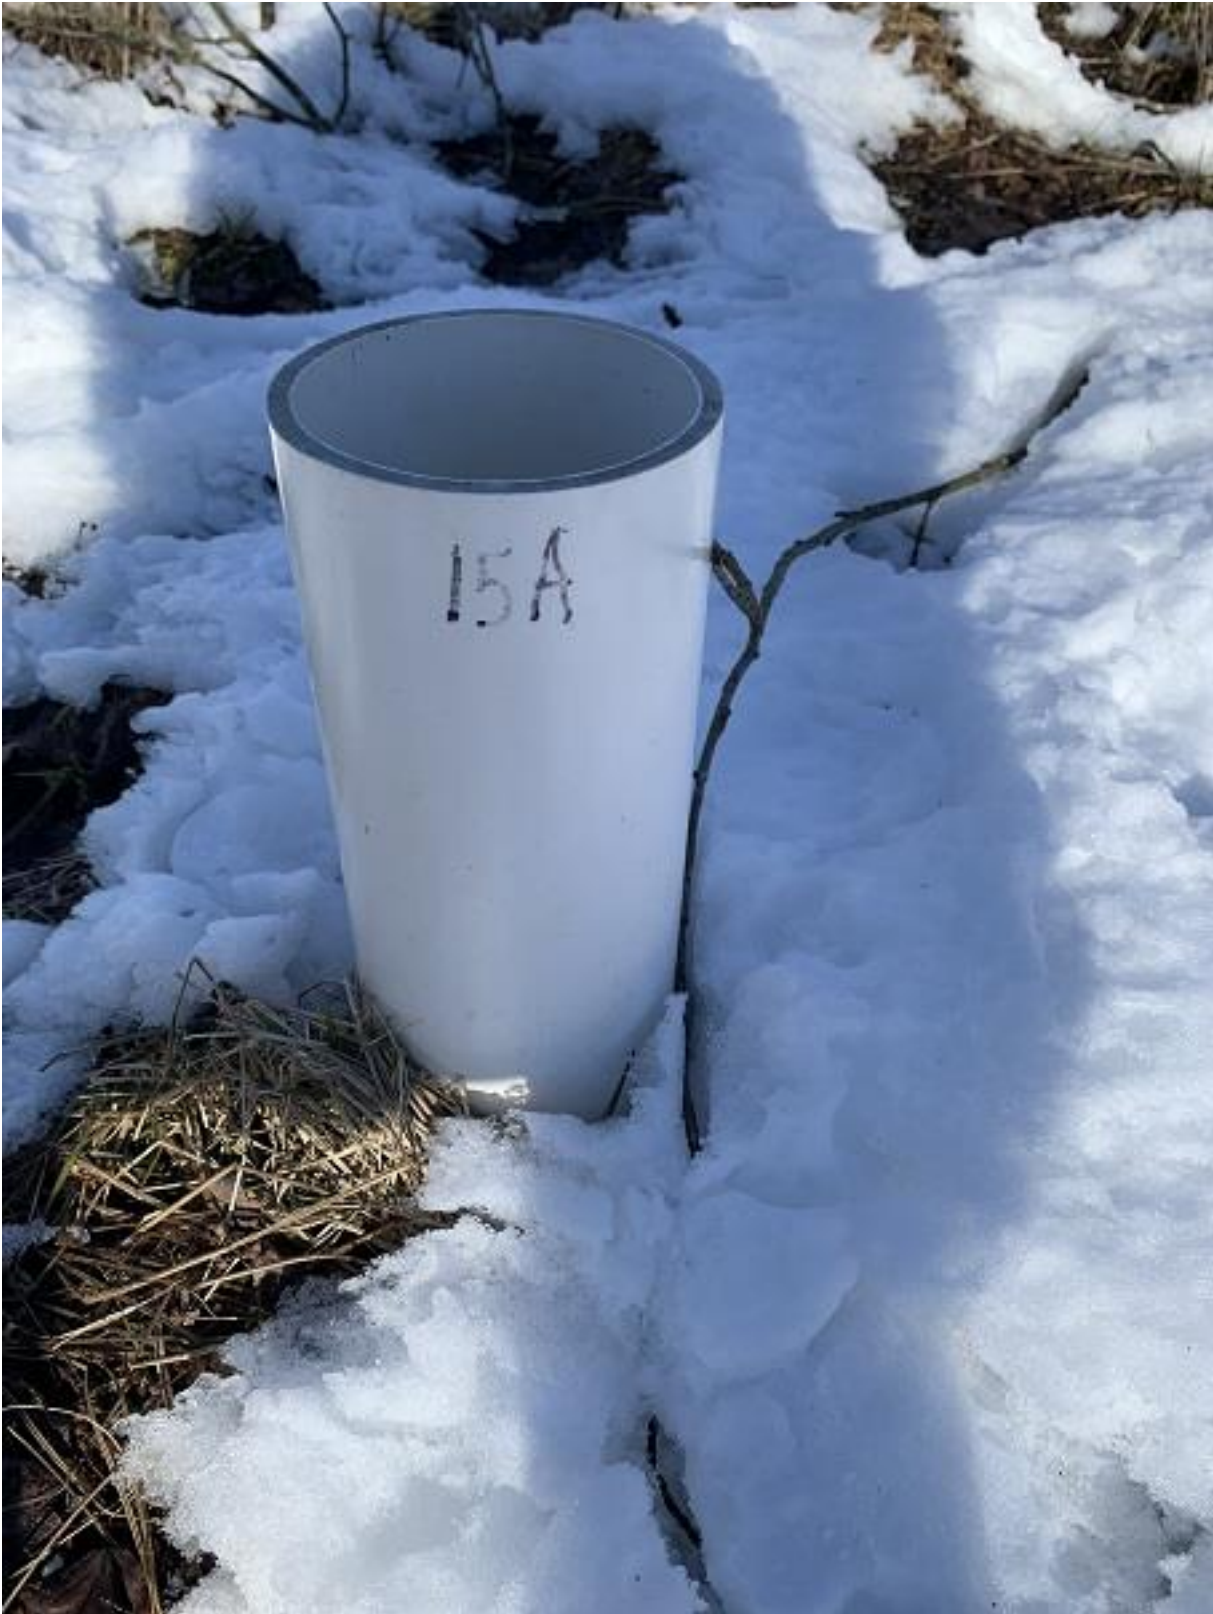
PVC Pipe next to piezometer
