COMMONWEALTH OF PENNSYLVANIA
 DEPARTMENT OF ENVIRONMENTAL PROTECTION
 BUREAU OF WATER SUPPLY AND WASTEWATER MANAGEMENT

FIELD NARRATIVE FORM

NAME Tributary to Marsh Creek Lake	DATE 02/16/2024	COUNTY Chester County	PROGRAM WQ
SITE ADDRESS/LOCATION Tributary behind homes along Waterview Road, Downingtown, PA 19335		MUNICIPALITY (TWP. BORO) Upper Uwchlan Township	
ACTIVITY <input type="checkbox"/> PLANNING <input type="checkbox"/> CONSULTATION <input type="checkbox"/> ENFORCEMENT <input type="checkbox"/> INVESTIGATION <input type="checkbox"/> INSPECTION <input checked="" type="checkbox"/> COMPLAINT <input type="checkbox"/> PROGRAM EVALUATION <input type="checkbox"/> OTHER, _____		FOLLOW UP ACTIVITY <input type="checkbox"/> NONE <input type="checkbox"/> REINSPECTION <input type="checkbox"/> LETTER <input type="checkbox"/> RETURN <input checked="" type="checkbox"/> OTHER, Contact ETP _____	
NARRATIVE: (Include as appropriate: direction to site; indicate all individuals present; list points discussed; describe conditions observed; diagram site; note sampling activities.) On 02/15/2024 @ 1535 hours, The Department of Environmental Protection received a complaint from a Downingtown reside

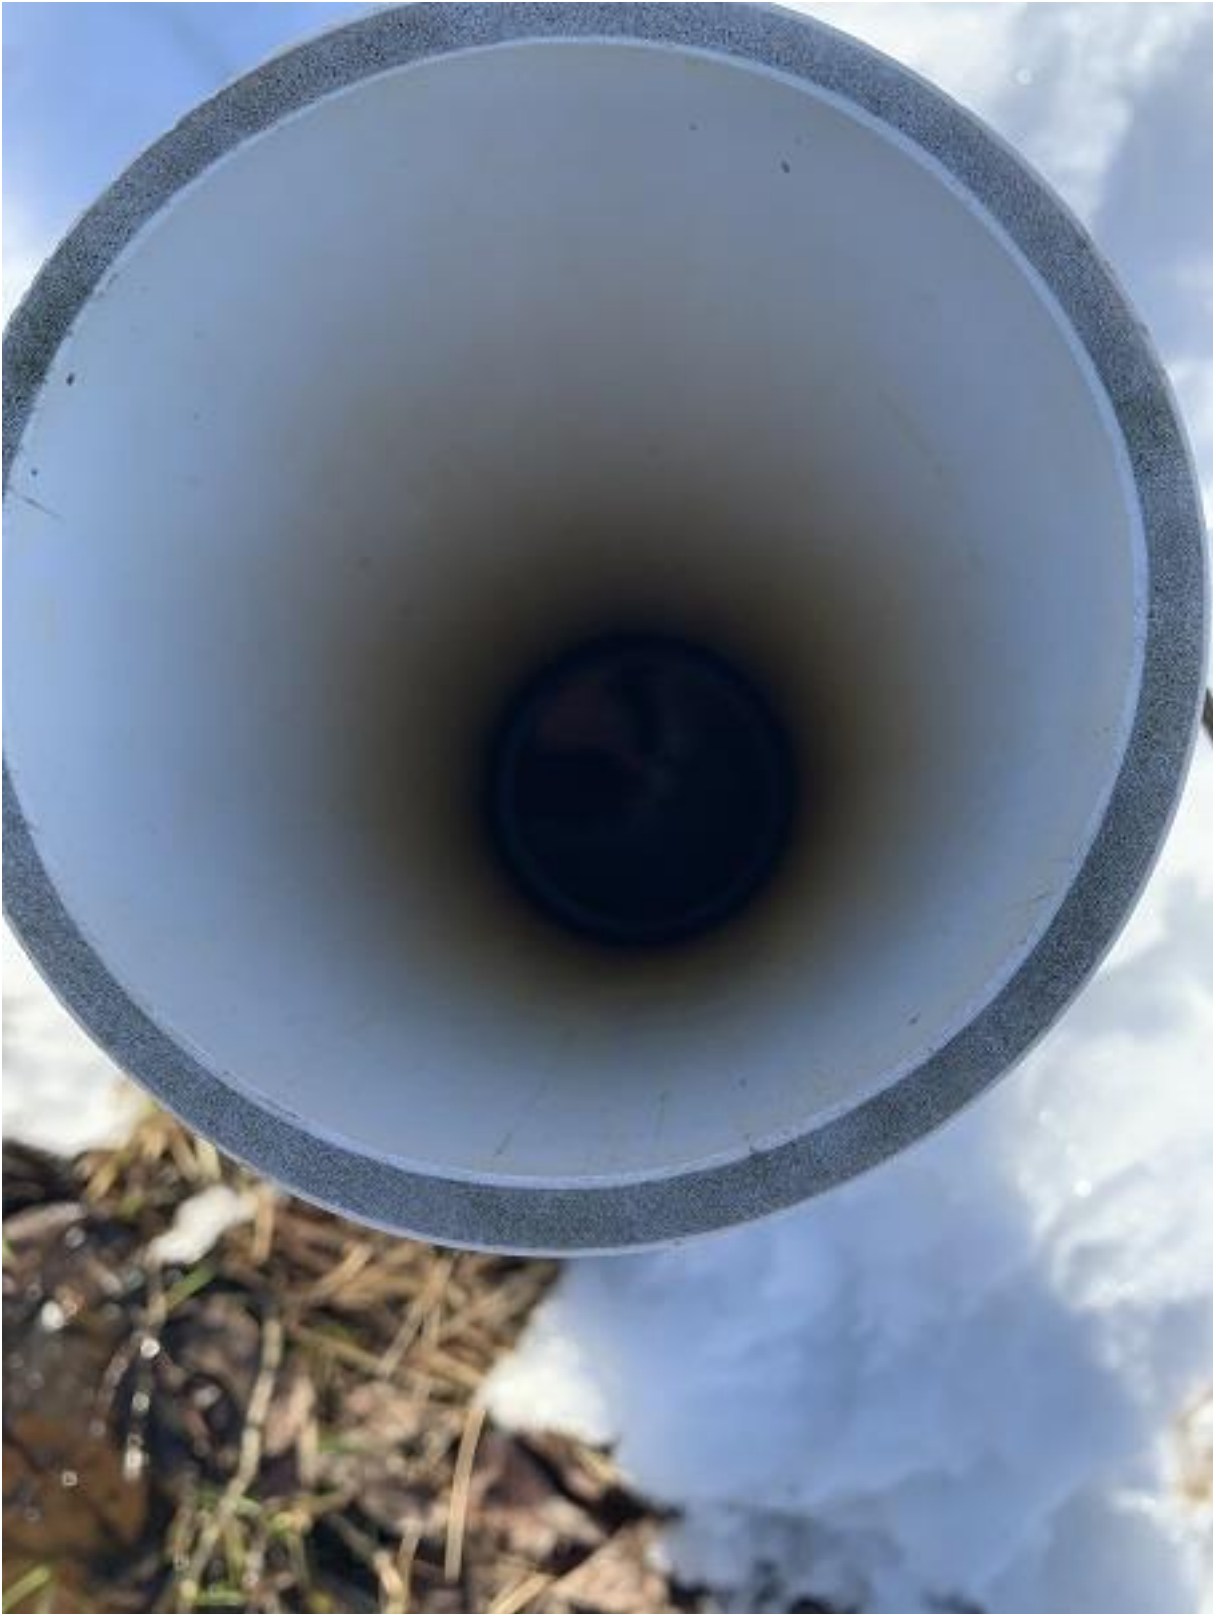
Water level in PVC pipe

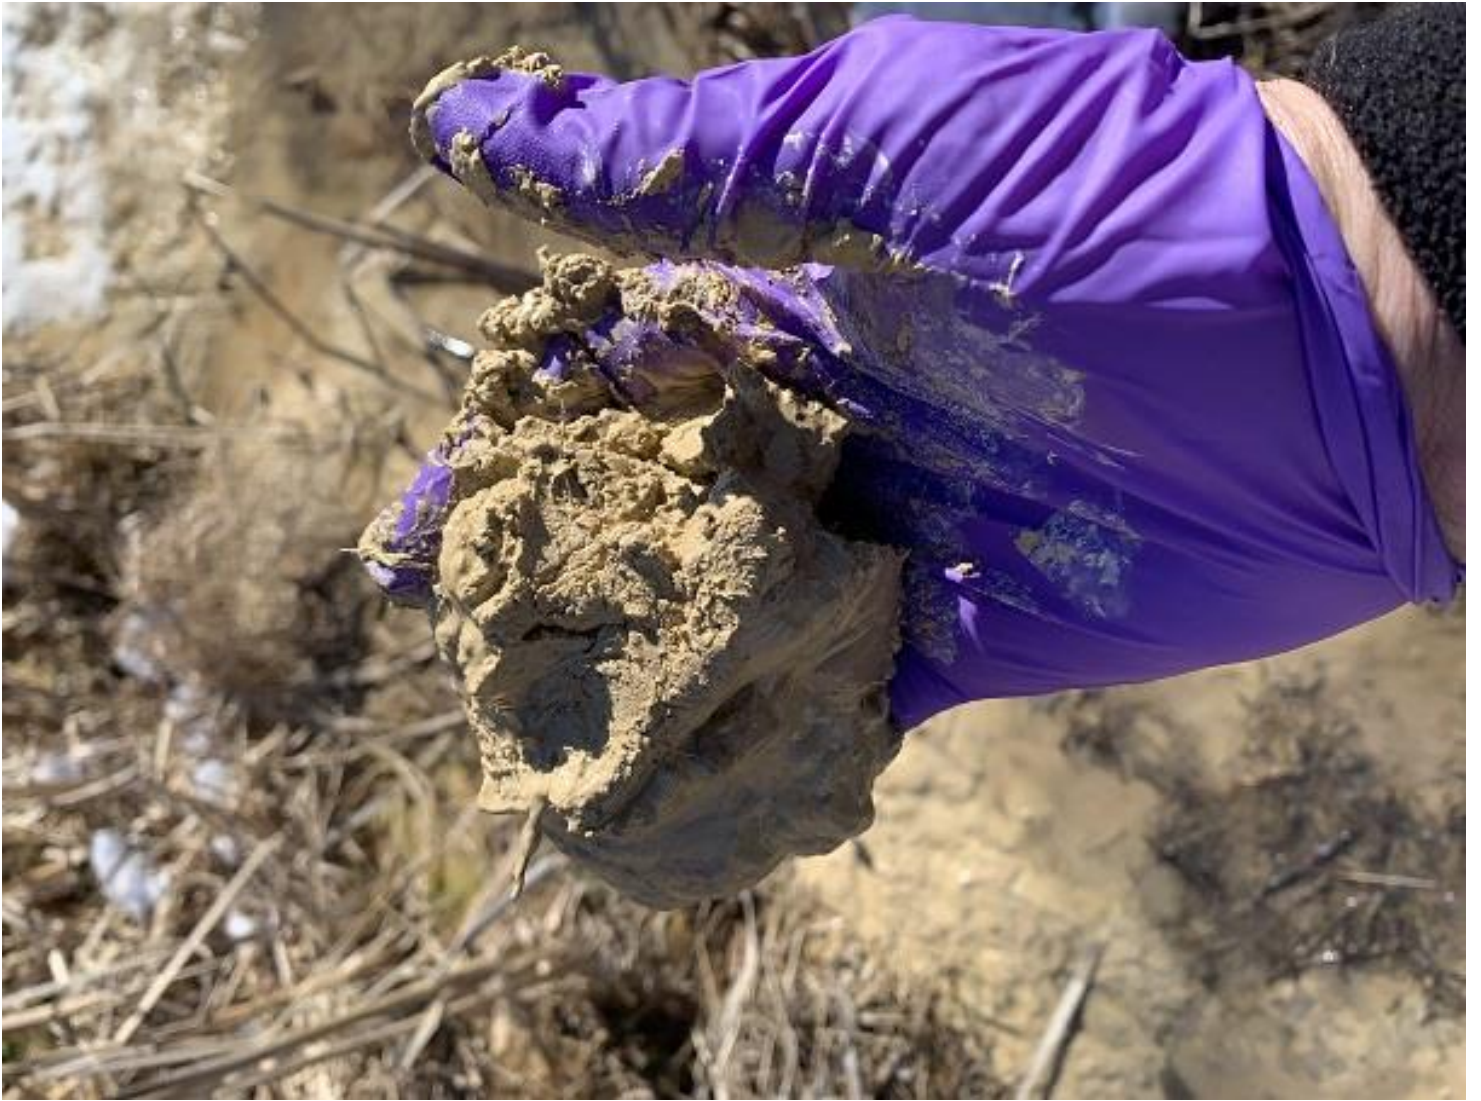
Material in wetland area

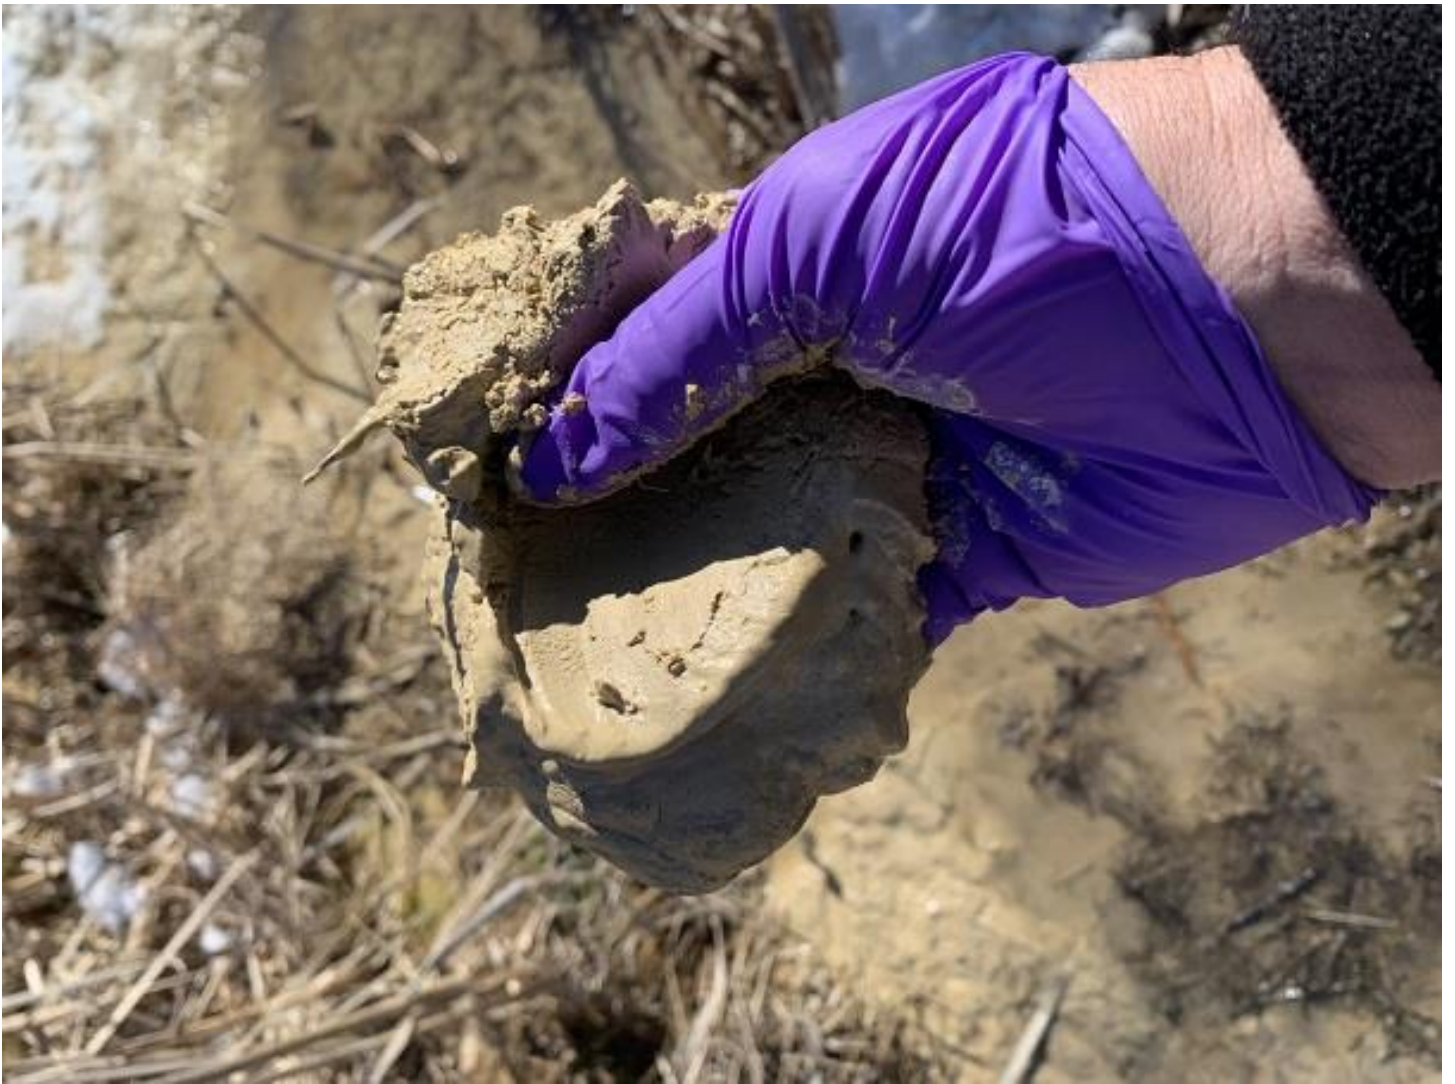
Material in wetland area

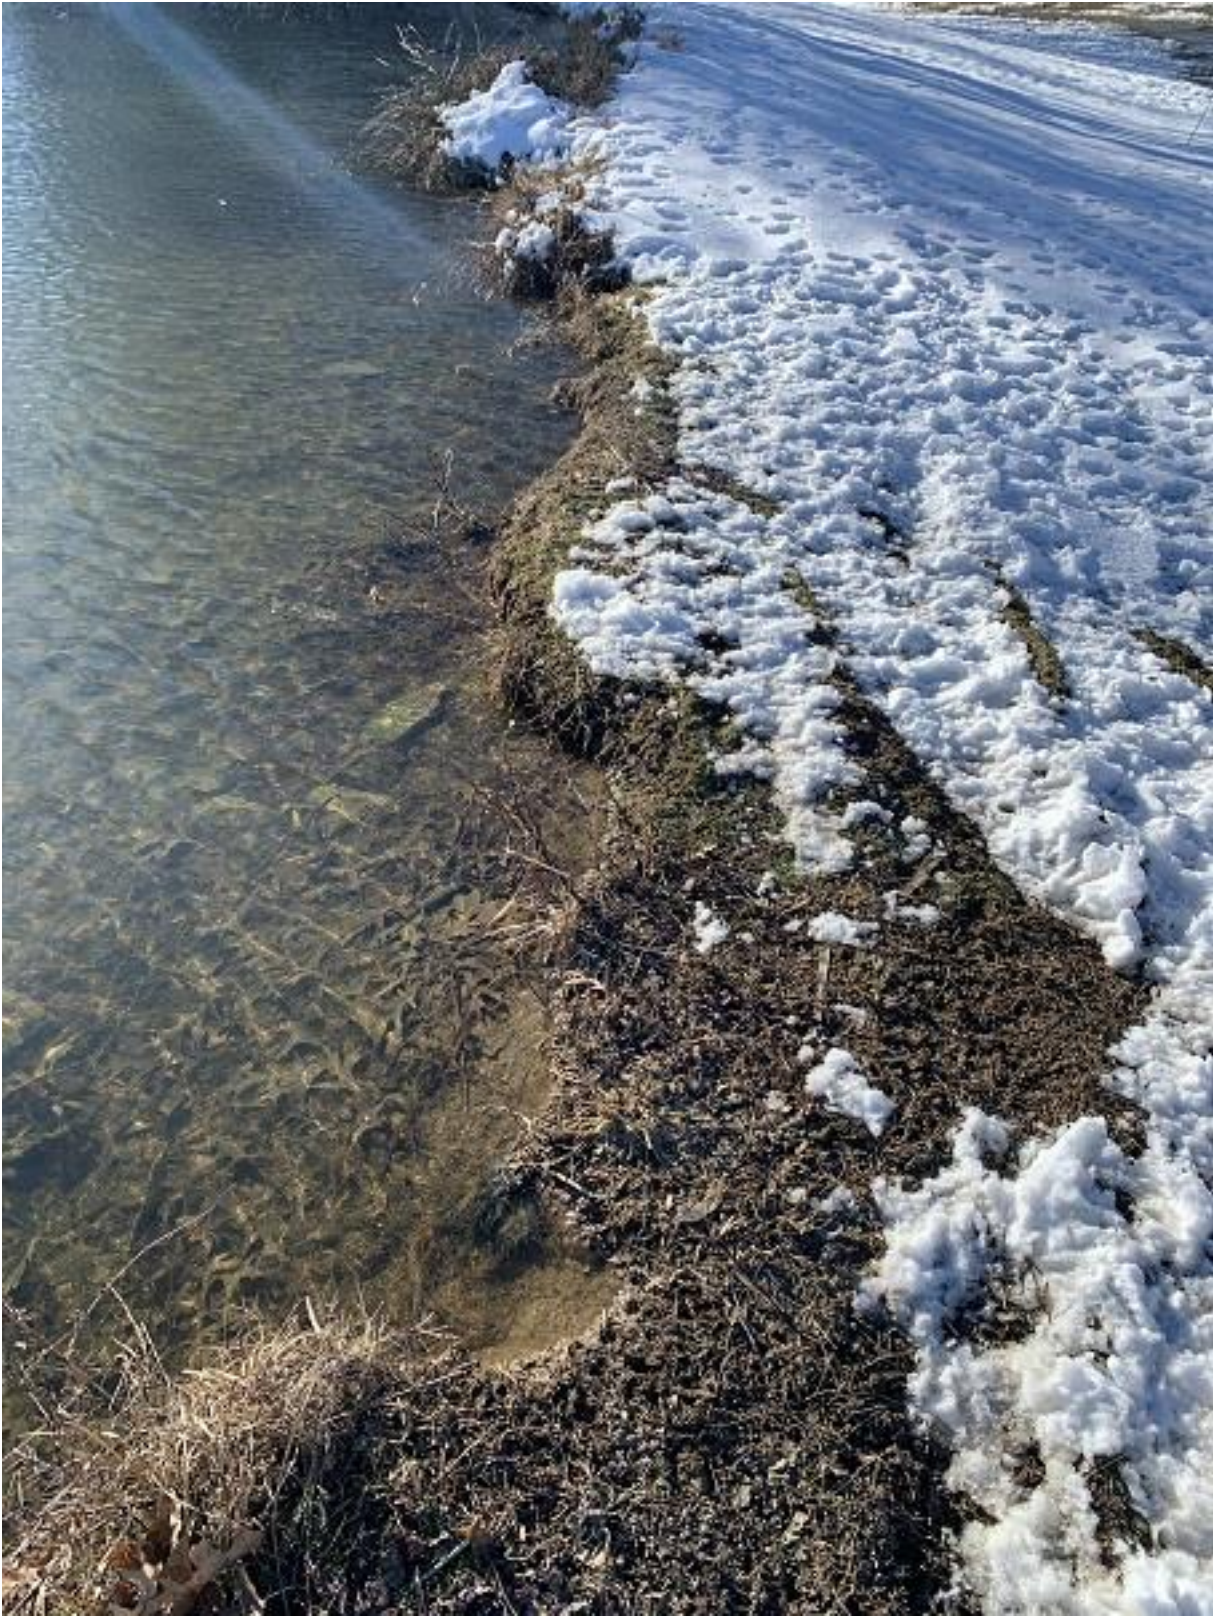
Pond upgradient of wetland area
