COMMONWEALTH OF PENNSYLVANIA  
 DEPARTMENT OF ENVIRONMENTAL PROTECTION  
 BUREAU OF WATER SUPPLY AND WASTEWATER MANAGEMENT

## FIELD NARRATIVE FORM

<b>NAME</b> Tributary to Marsh Creek Lake	<b>DATE</b> 02/22/2024	<b>COUNTY</b> Chester County	<b>PROGRAM</b> WQ
<b>SITE ADDRESS/LOCATION</b> Tributary behind homes along Waterview Road, Downingtown, PA 19335		<b>MUNICIPALITY (TWP. BORO)</b> Upper Uwchlan Township	
<b>ACTIVITY</b> <input type="checkbox"/> PLANNING <input type="checkbox"/> CONSULTATION <input type="checkbox"/> ENFORCEMENT <input type="checkbox"/> INVESTIGATION <input type="checkbox"/> INSPECTION <input checked="" type="checkbox"/> COMPLAINT <input type="checkbox"/> PROGRAM EVALUATION <input type="checkbox"/> OTHER, _____		<b>FOLLOW UP ACTIVITY</b> <input type="checkbox"/> NONE <input type="checkbox"/> REINSPECTION <input type="checkbox"/> LETTER <input type="checkbox"/> RETURN <input checked="" type="checkbox"/> OTHER, Contact ETP _____	
<b>NARRATIVE: (Include as appropriate: direction to site; indicate all individuals present; list points discussed; describe conditions observed; diagram site; note sampling activities.)</b>  <p>On 02/15/2024 @ 1535 hours, the Department

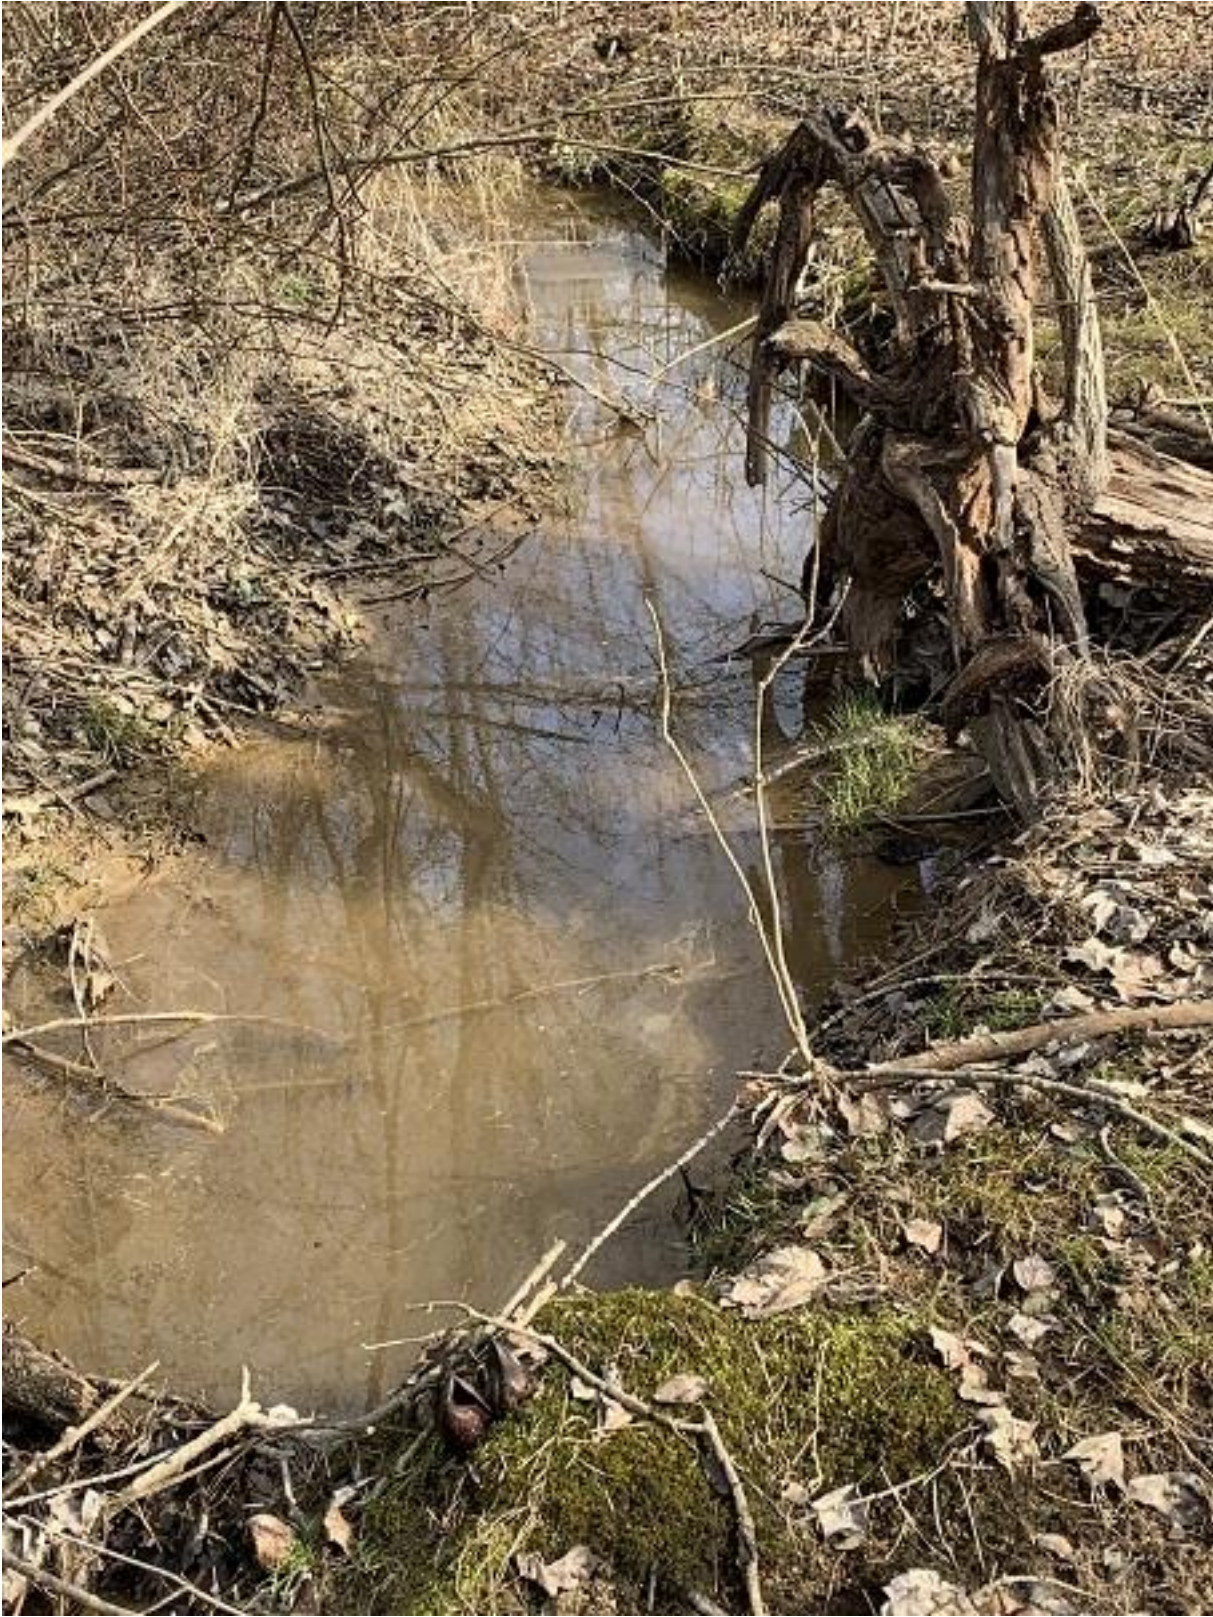
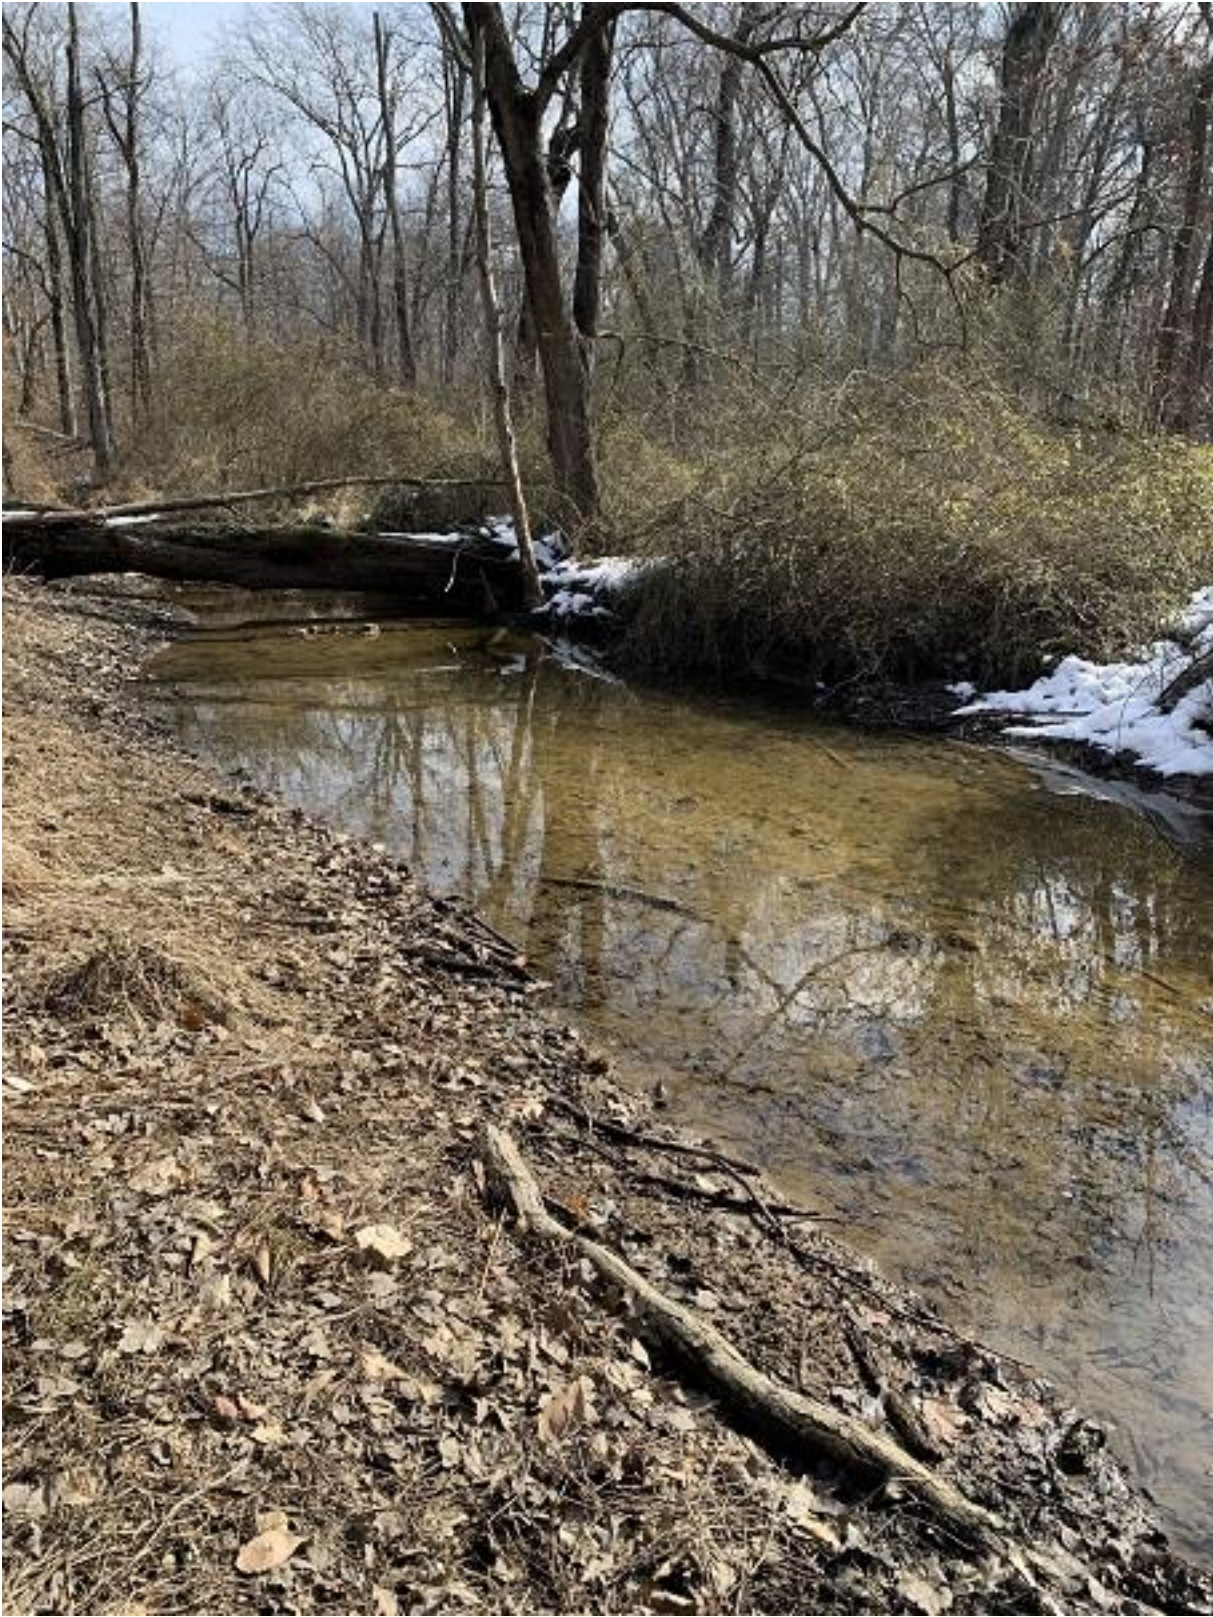
Condition of tributary behind homes on Waterview Road

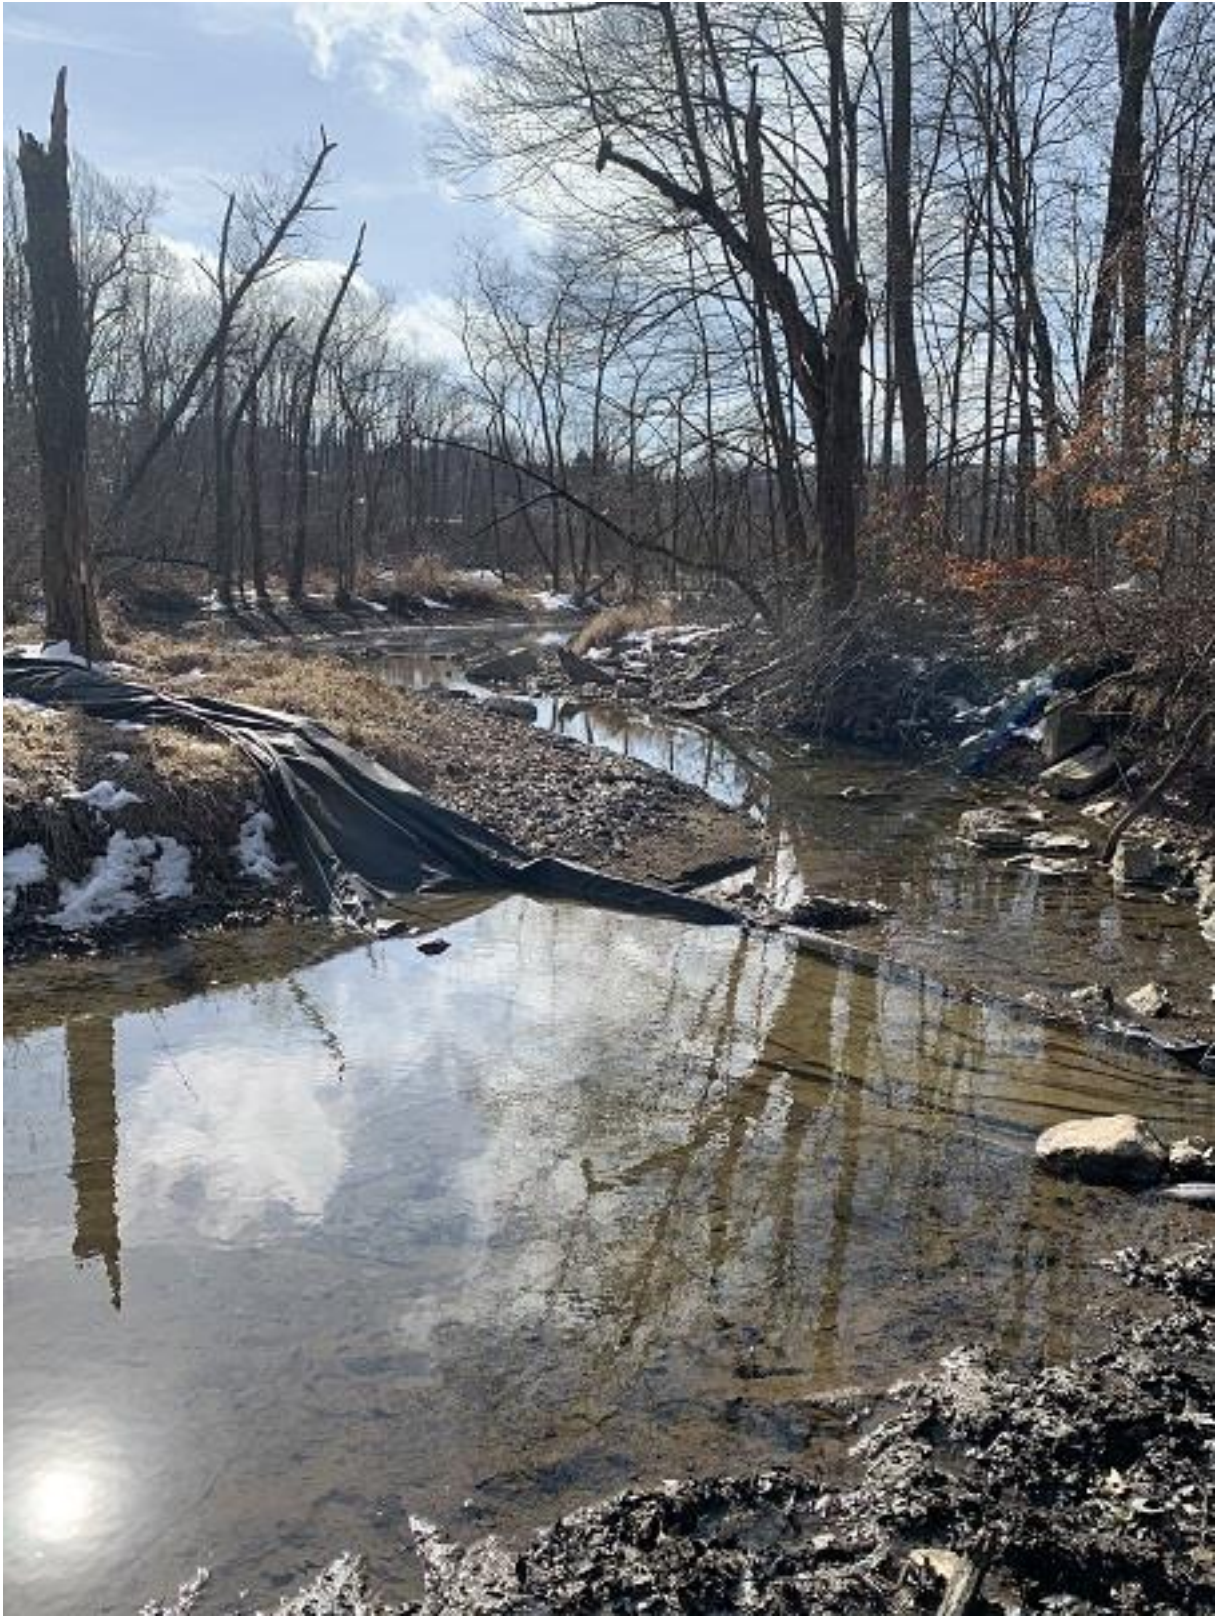
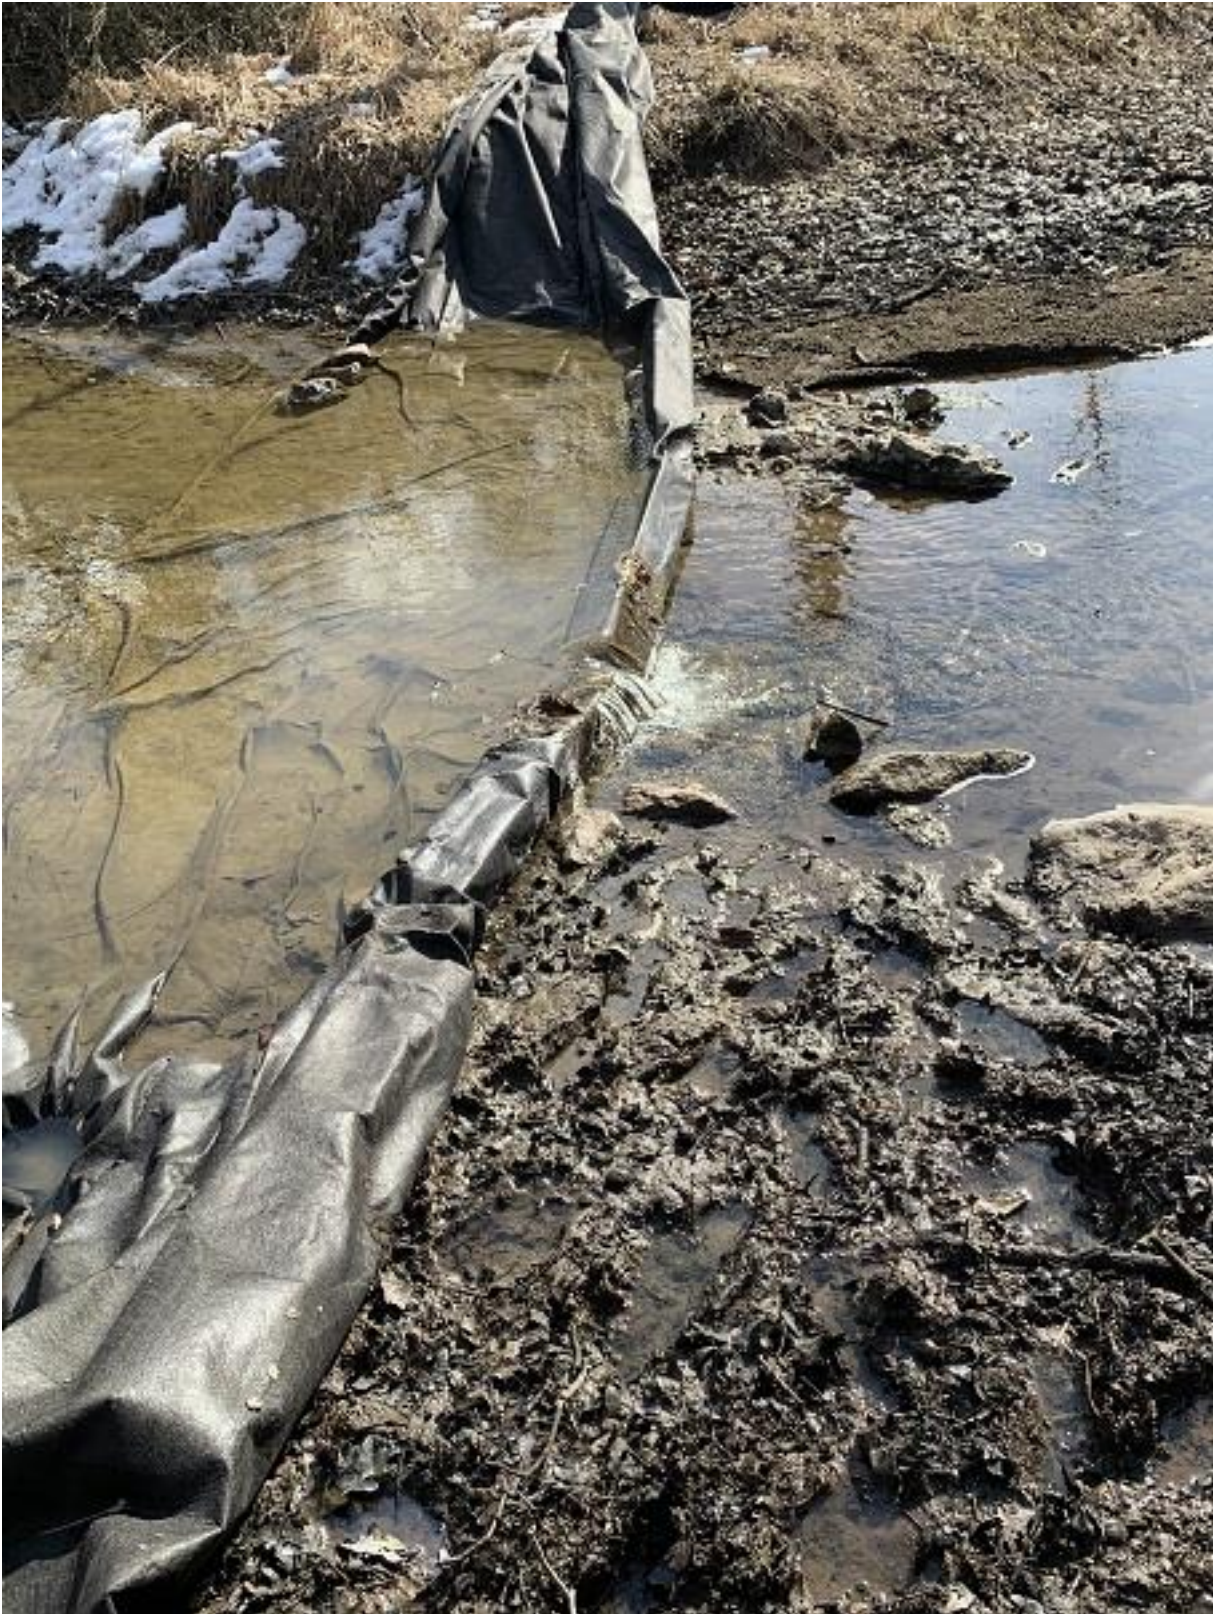
Turbidity Curtain prior to confluence with Ranger Cove

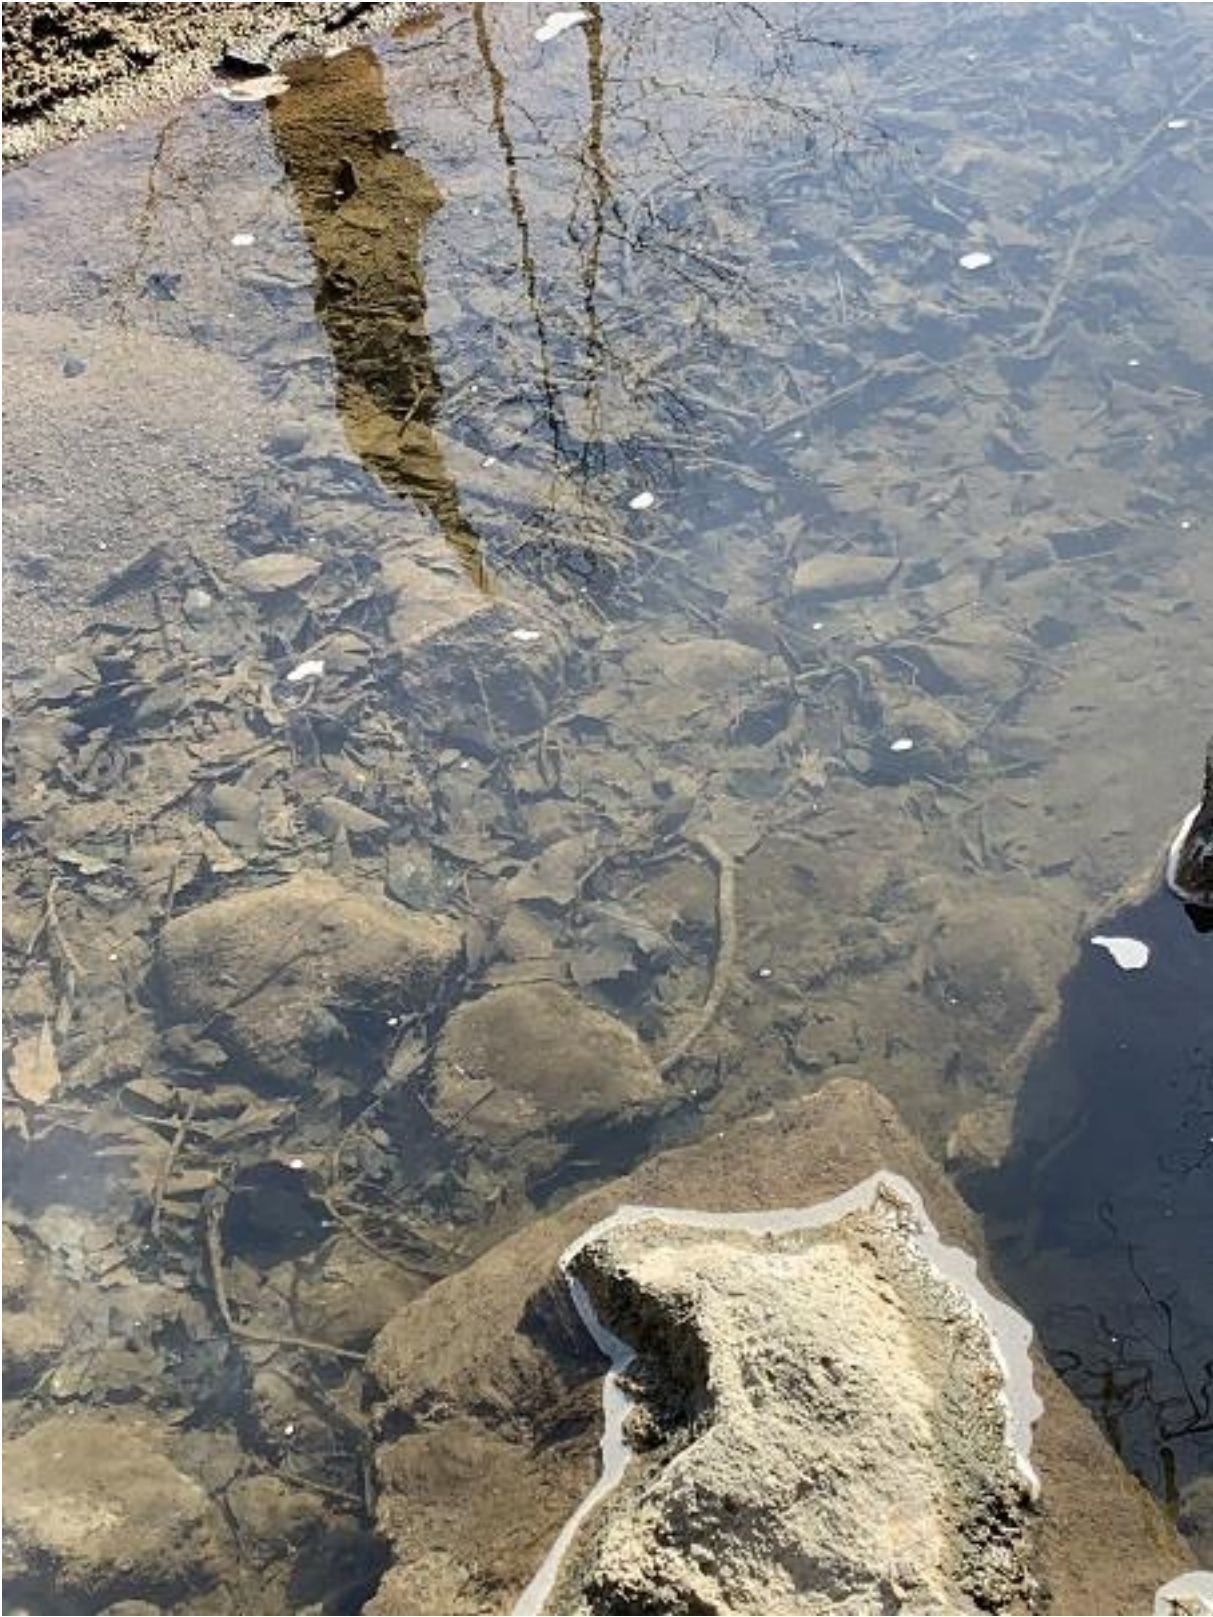
Tributary downstream of turbidity curtain prior to confluence with Ranger Cove

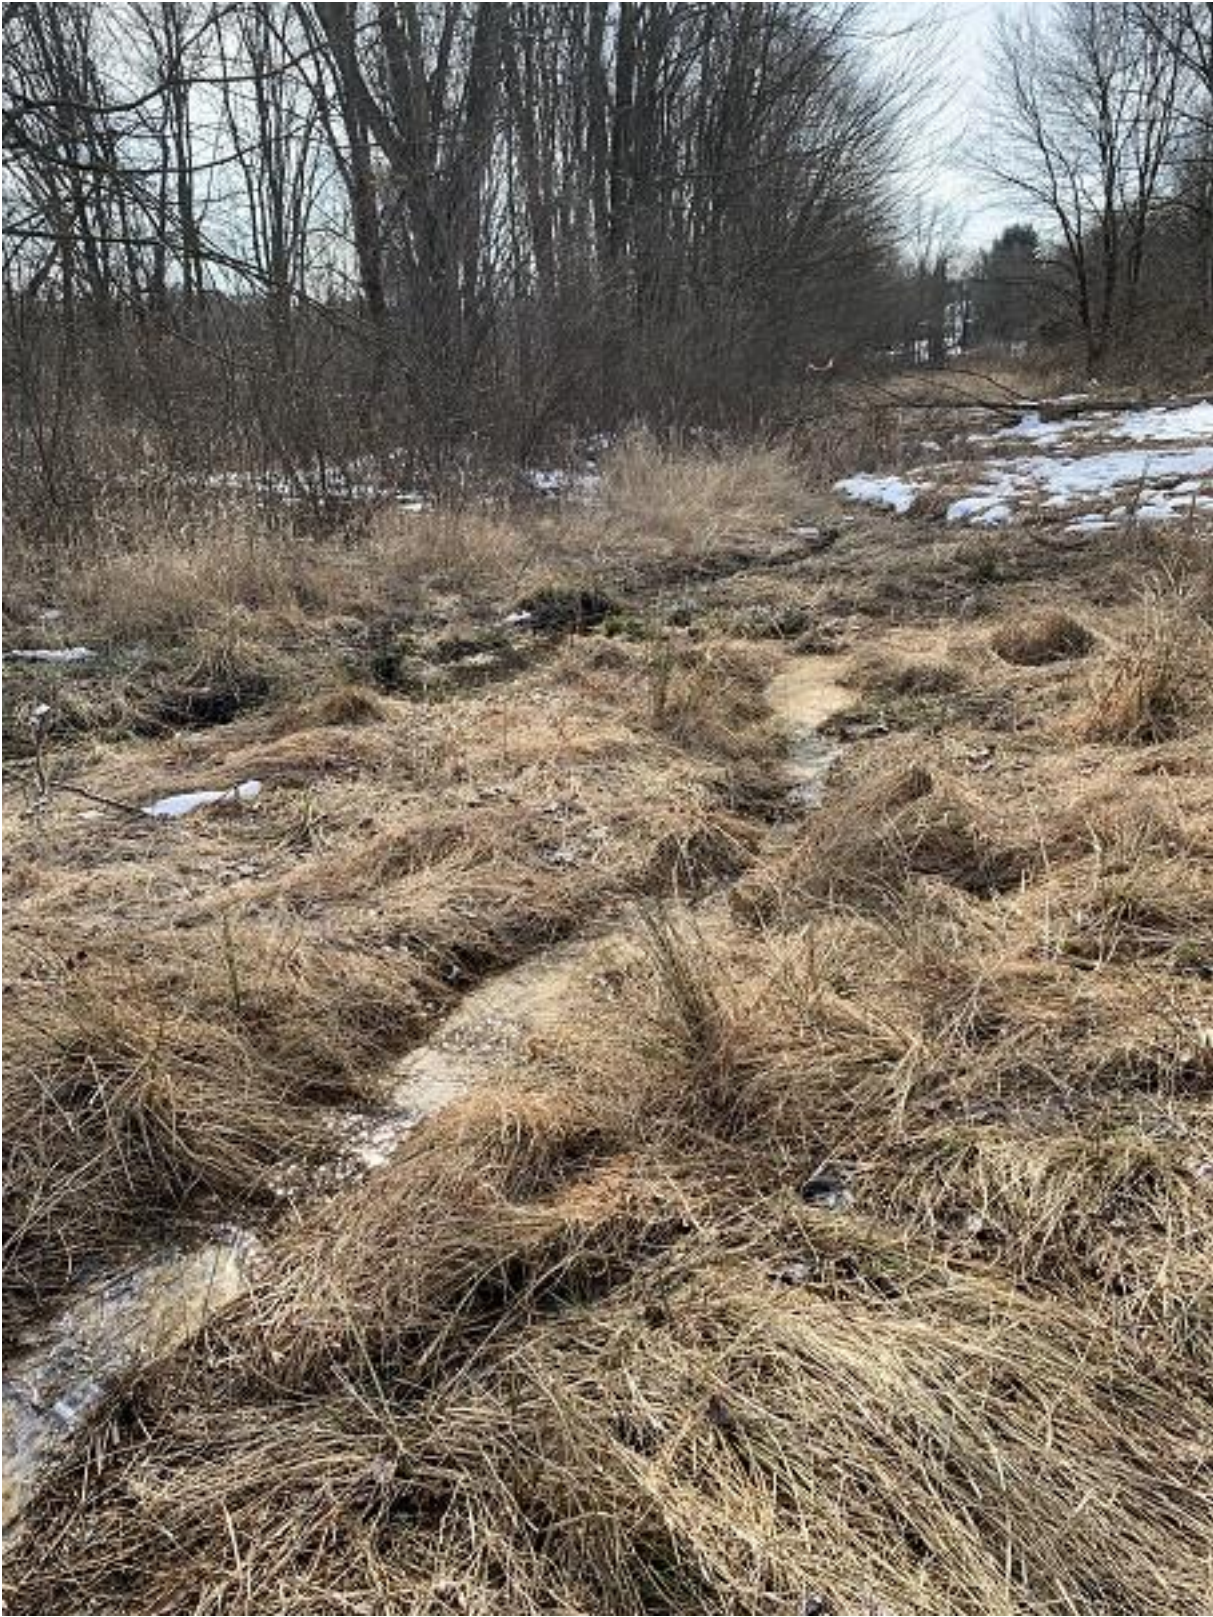
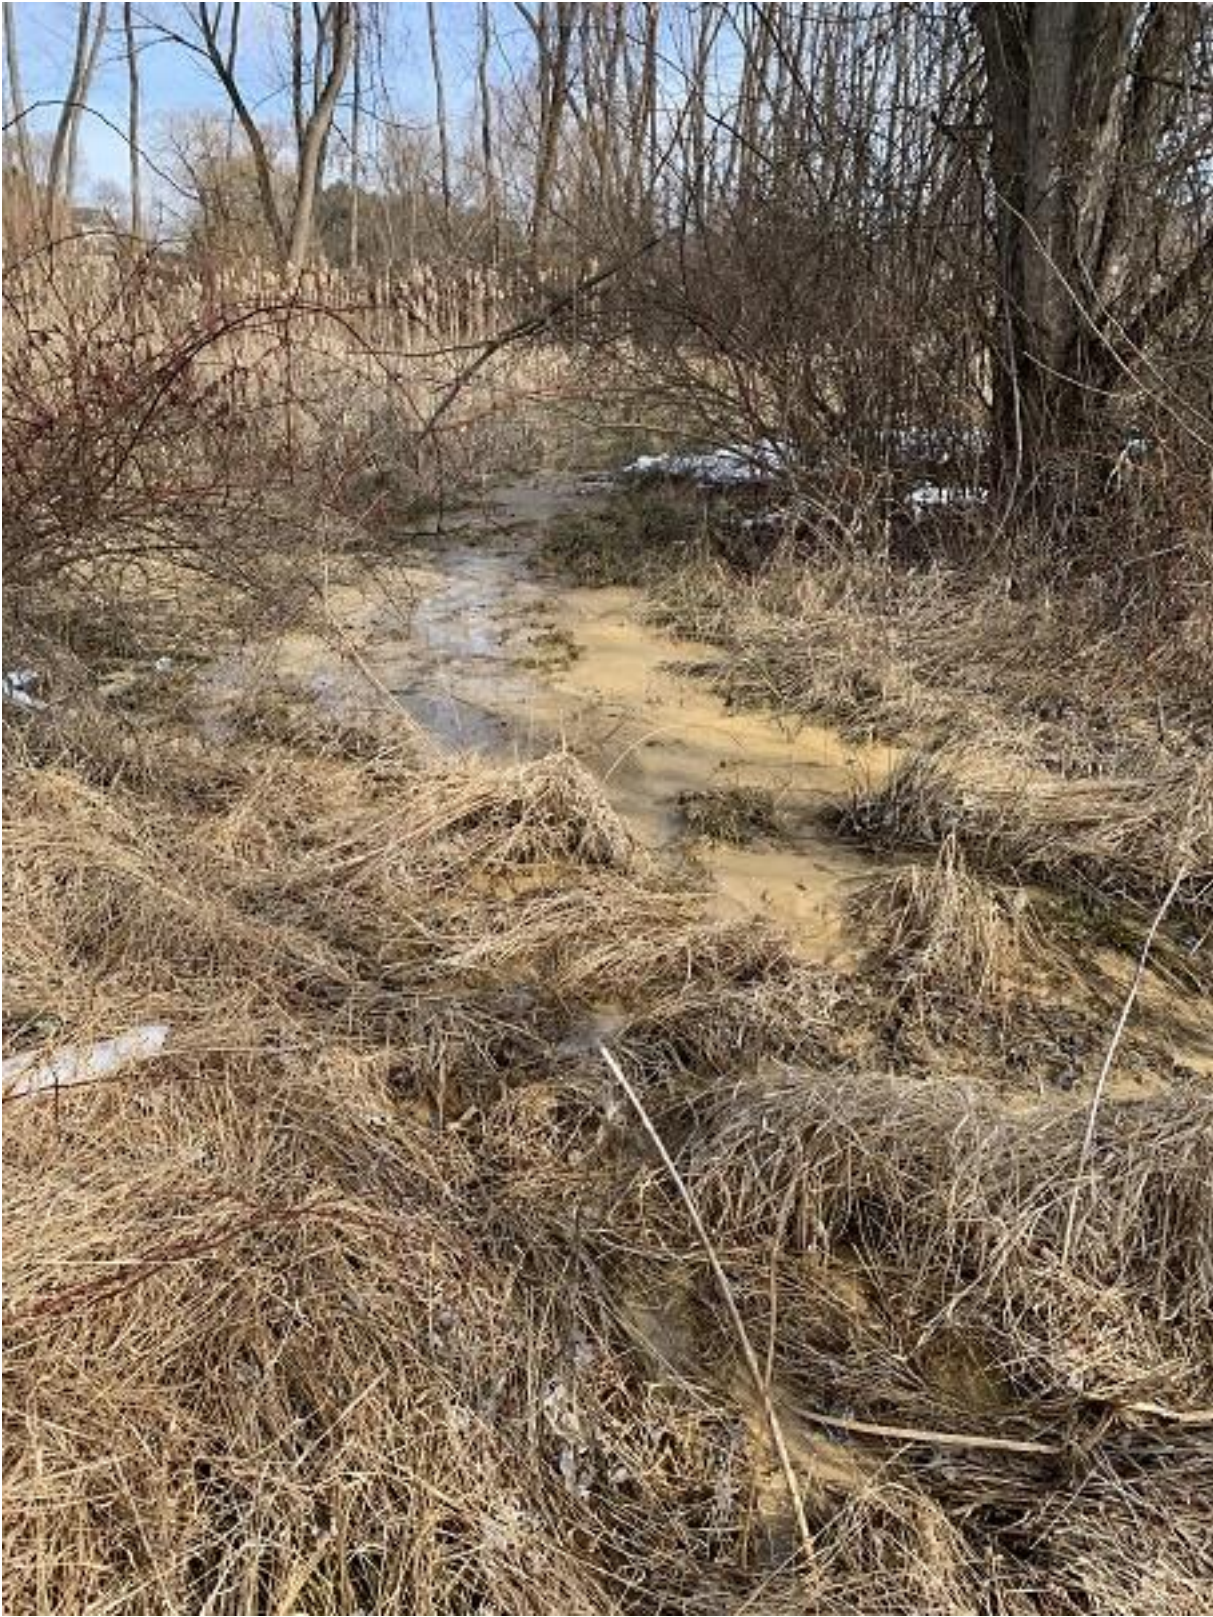
Tributary downstream of the wetland area

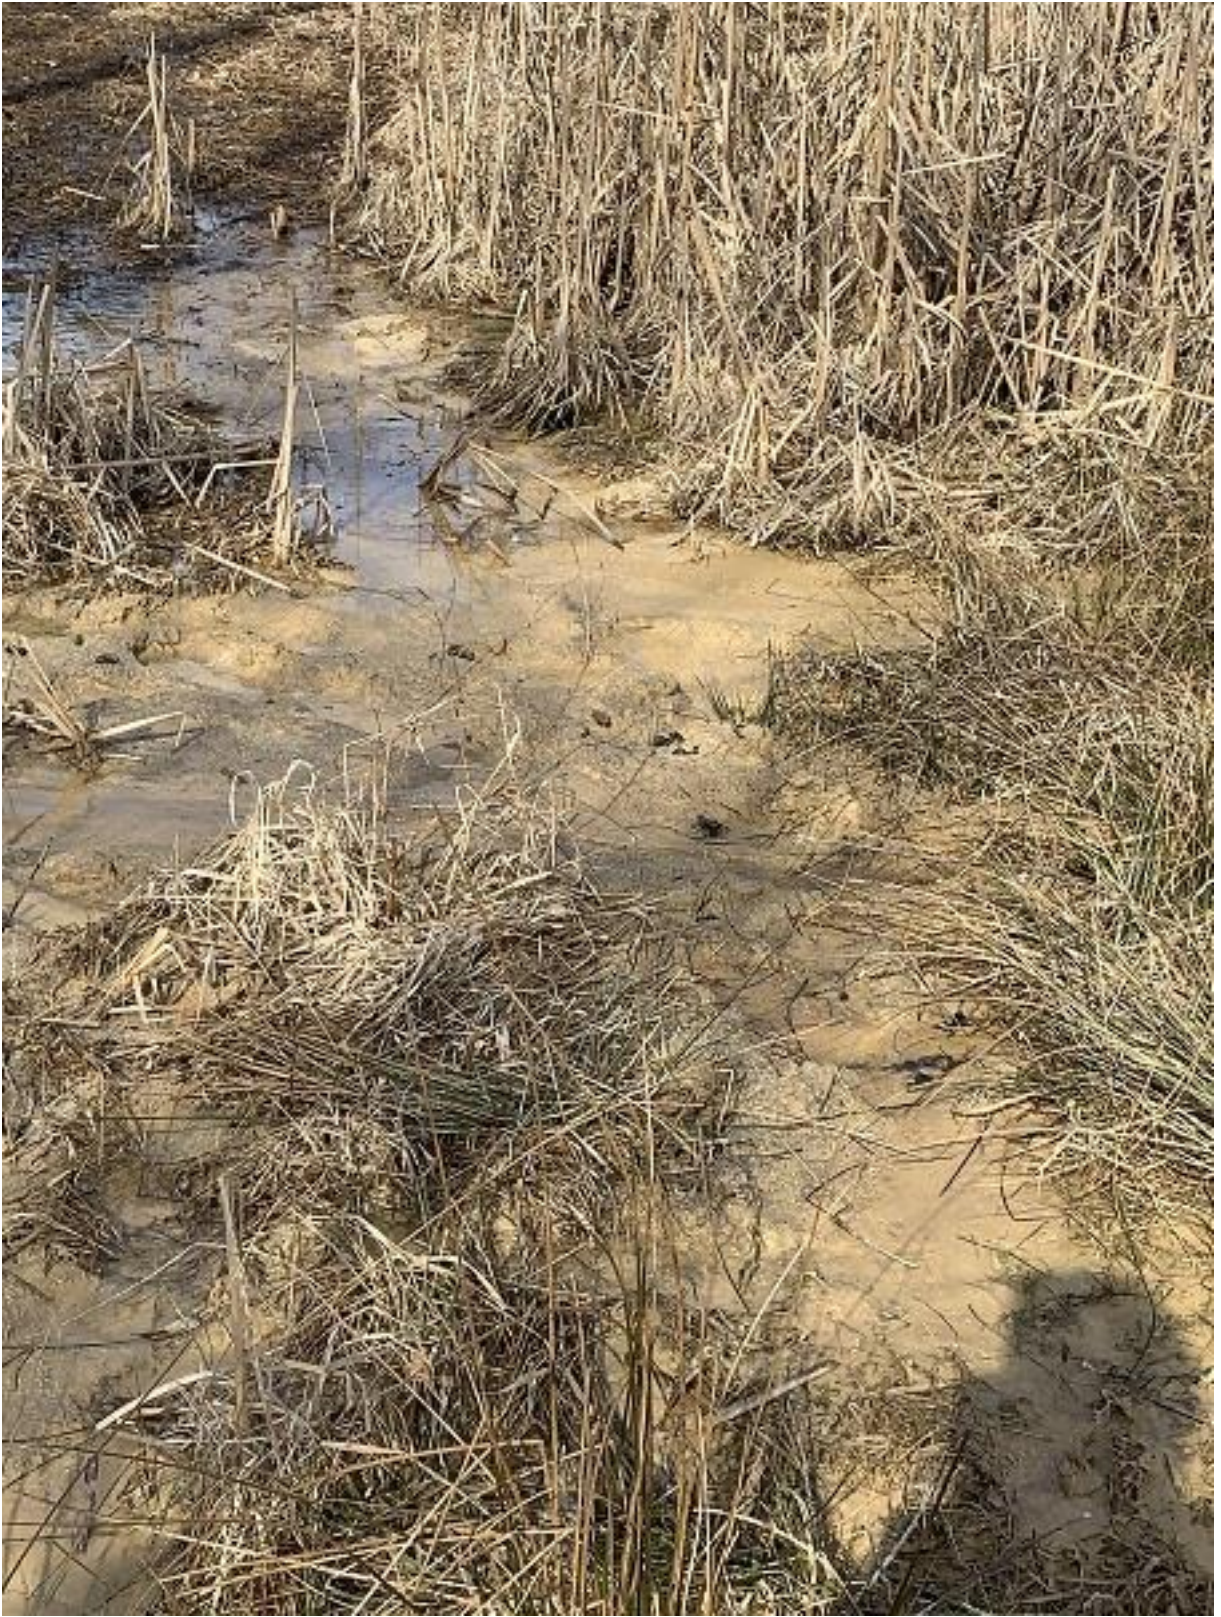
Wetland area

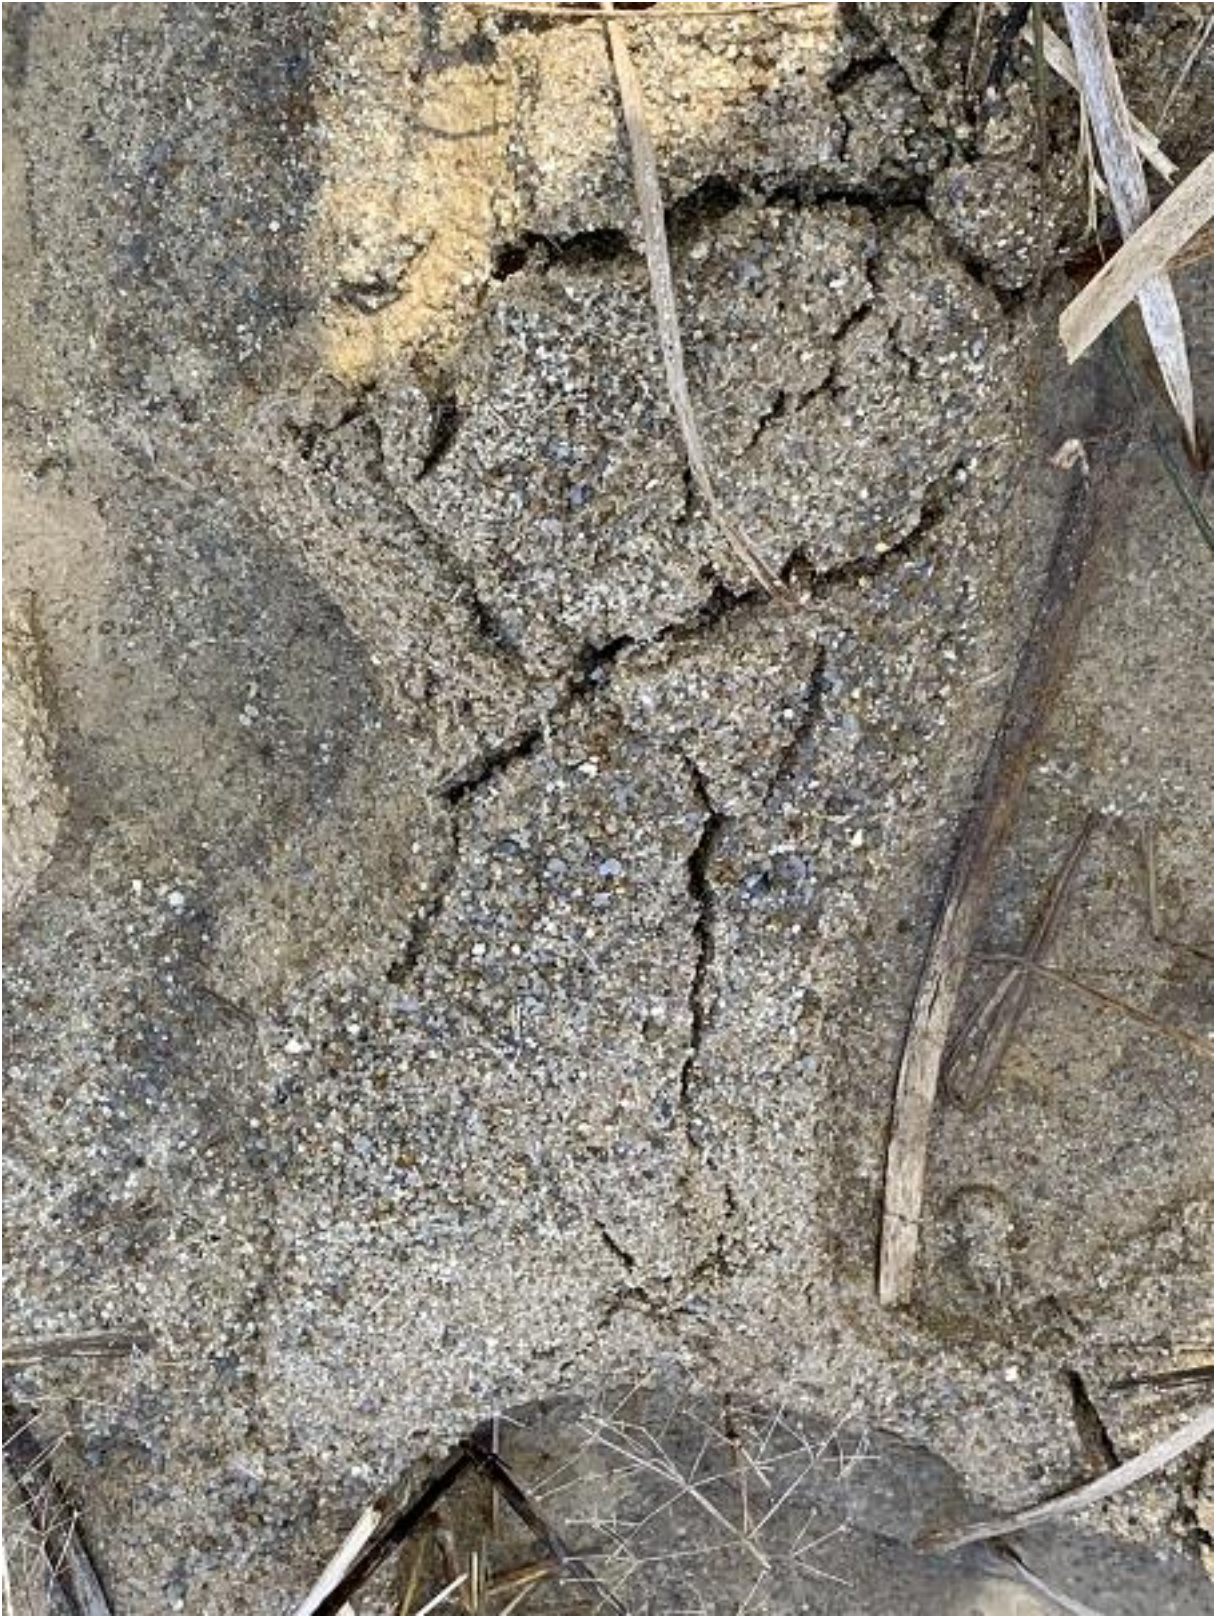
Sand-like material found in the wetland area

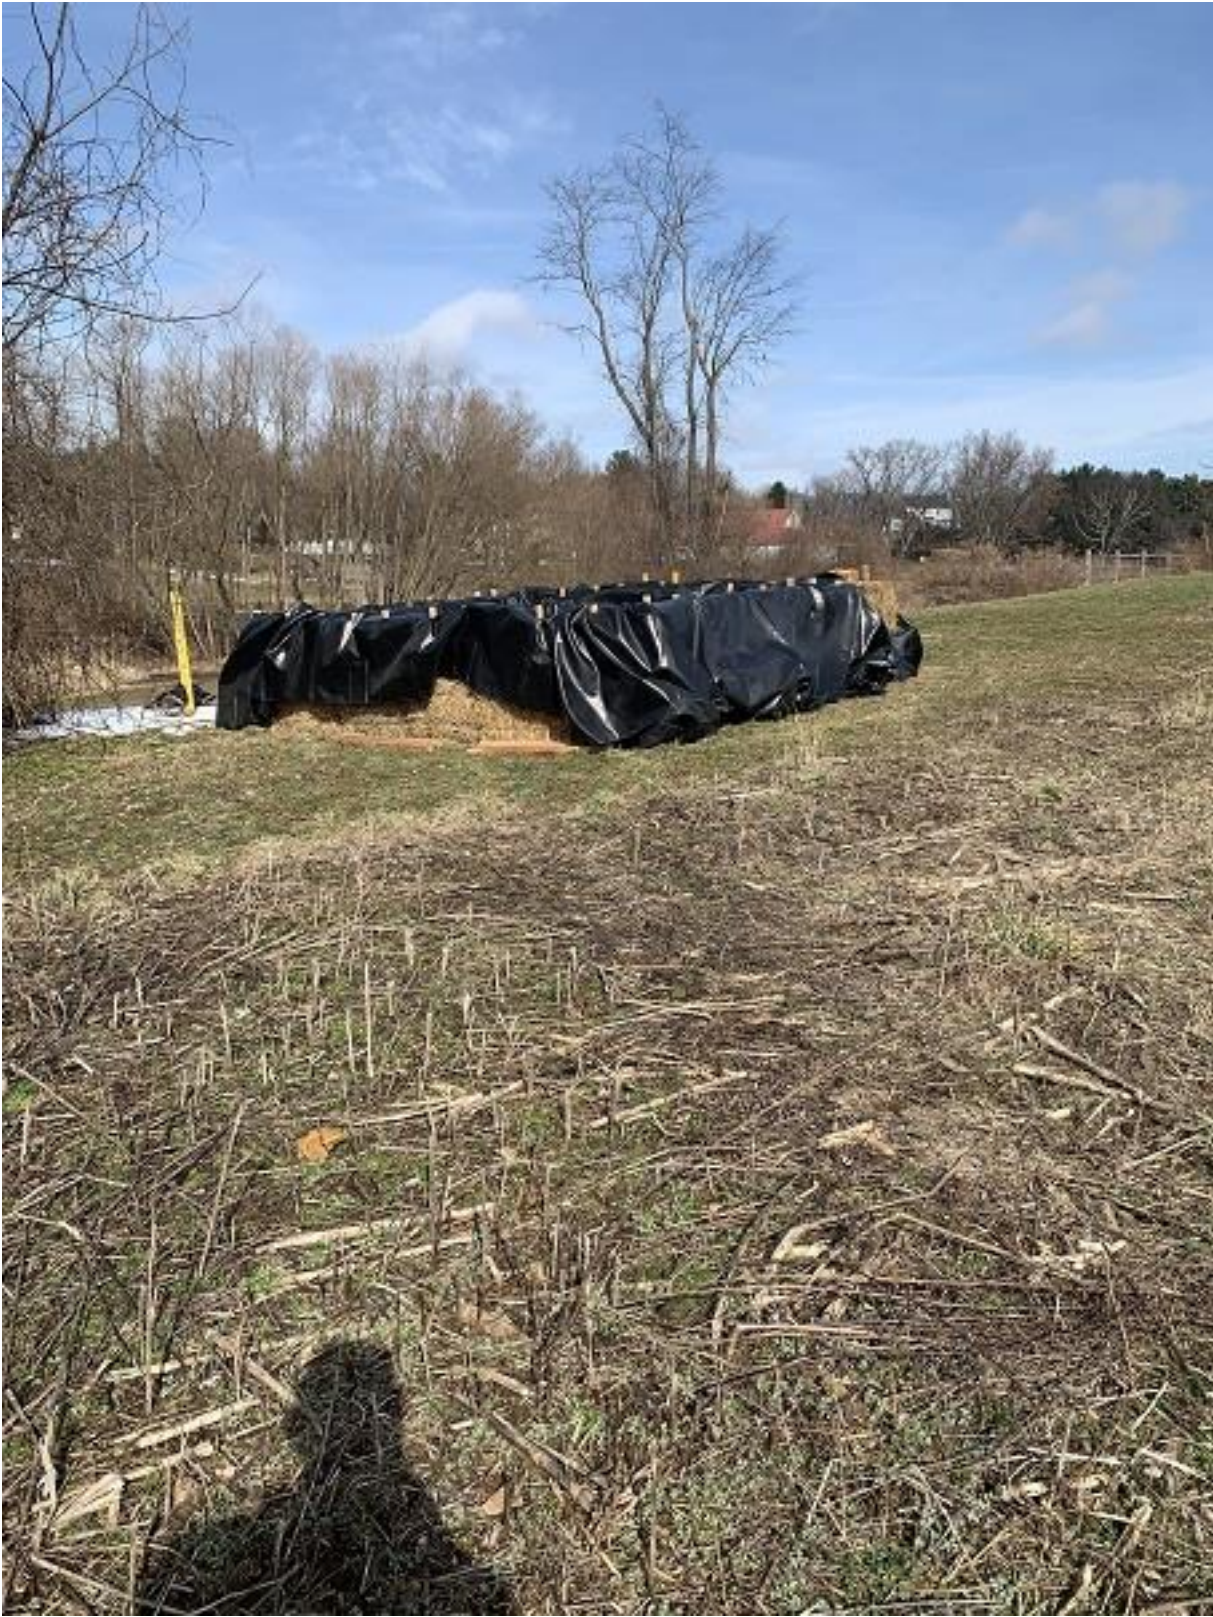
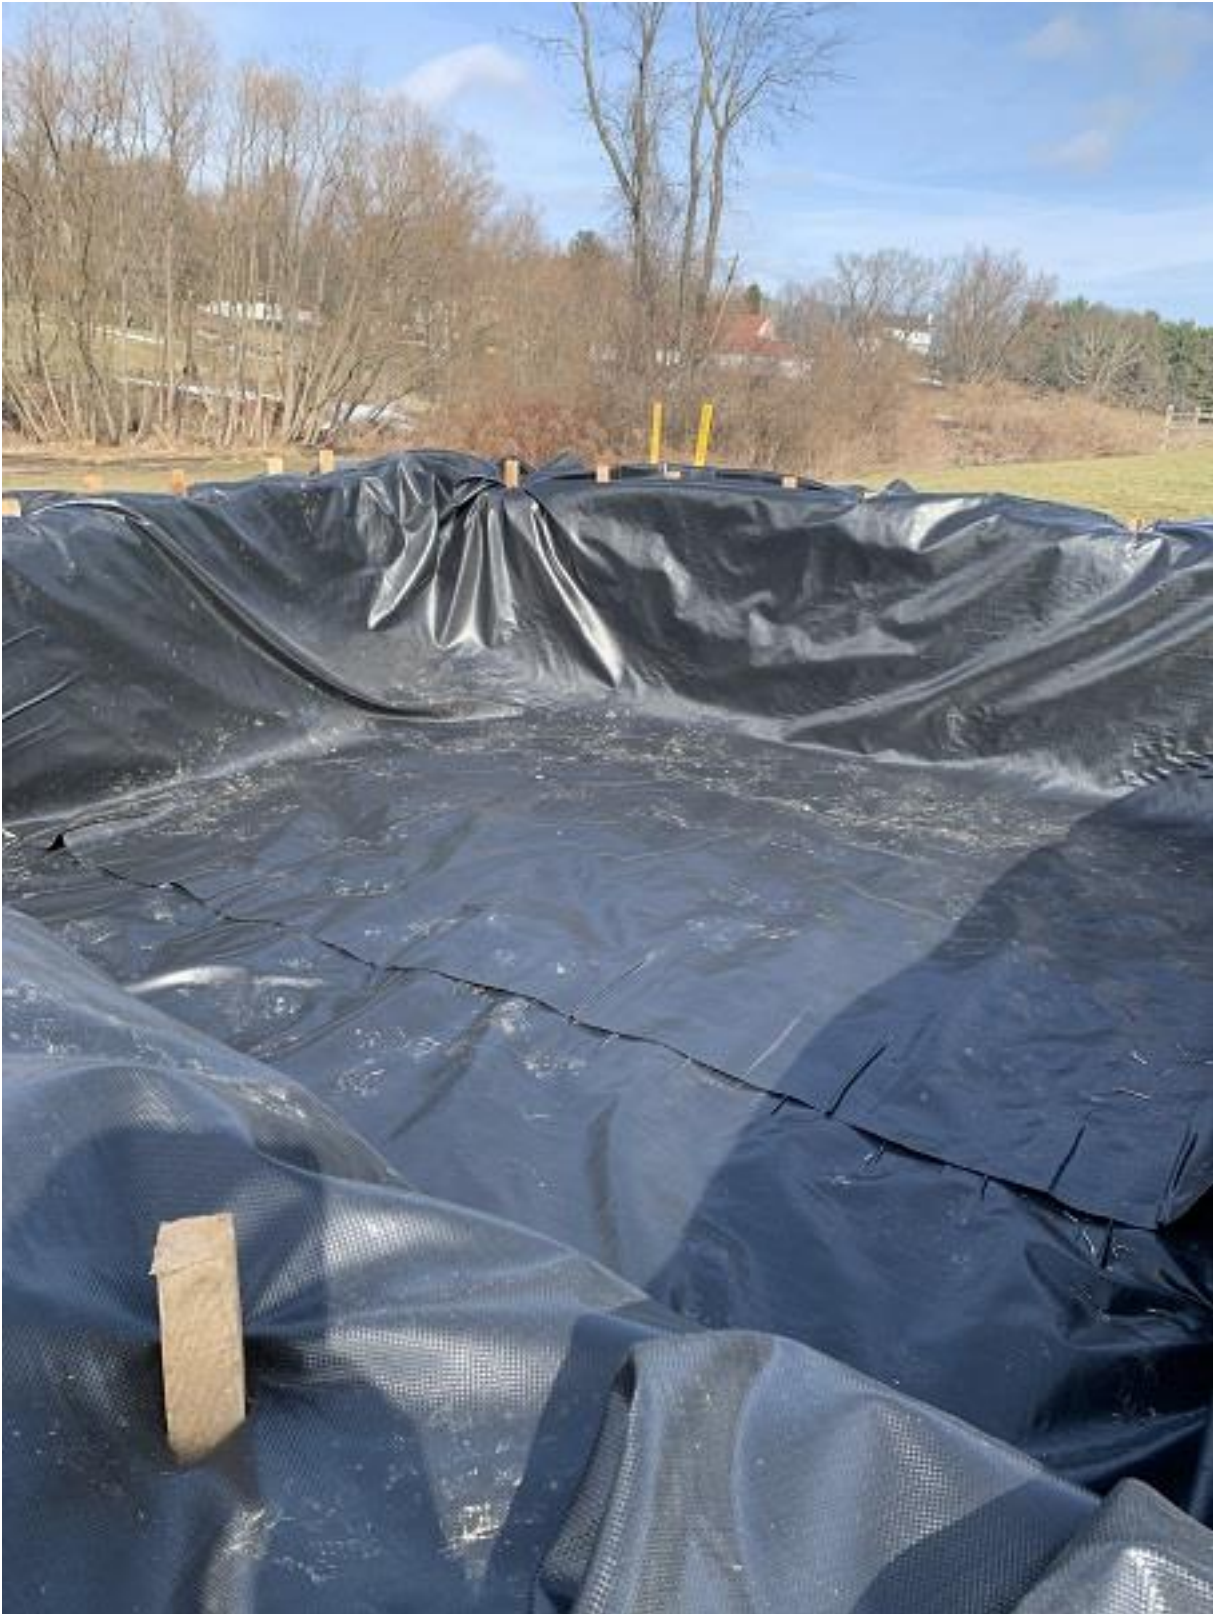
Containment structure
