Sunoco Pipeline L.P. - Pennsylvania Pipeline Project
HDD Inspection Daily Report

Date: 08/11/20	Utility Inspector: DS/Brad Golay: 580.304.9871 US/Leslie Gray: 870.217.2714	PG Inspector: Brian Lipinski, PG PG Support:			
Spread #: 6		Company: GES, Inc			
HDD#/Name: S3-0290-20 (US-DS)/Little Conestoga Rd Permit Name: Milford Rd/Little Conestoga Rd DS address: Green Valley Road, Downingtown, 19335 (40.079037, -75.711695). Look for RCE. US address: Little Conestoga Rd & Milford Rd, 19355 (40.082544, -75.716790)		Weather AM: 75-86 °F, partly cloudy PM: 86-90 °F, partly cloudy Wind: SW, 5-10 mph Prior 24-hrs Precip: 0 inches			
HDD Plan #: PA-CH-0100.0000-RD County/Township: Chester/Upper Uwchlan Twp.					
Drilling Supervisor: Company: Michels		HDD Path Length (ft): 2,641 (HD) / 2,686 (MD) Drilling Direction: NW to SE [] SE to NW [X]			
		Station start (SE): 14828+04 Starting Elev: 377.76	Station end (NW): 14801+68 Ending Elev: 494.056		
Steerhand/Surveyor: n/a during ream		Daily Claimed Footage per UI Report	Start	End	Total

HDD Location: S3-0290-20 (US-DS)

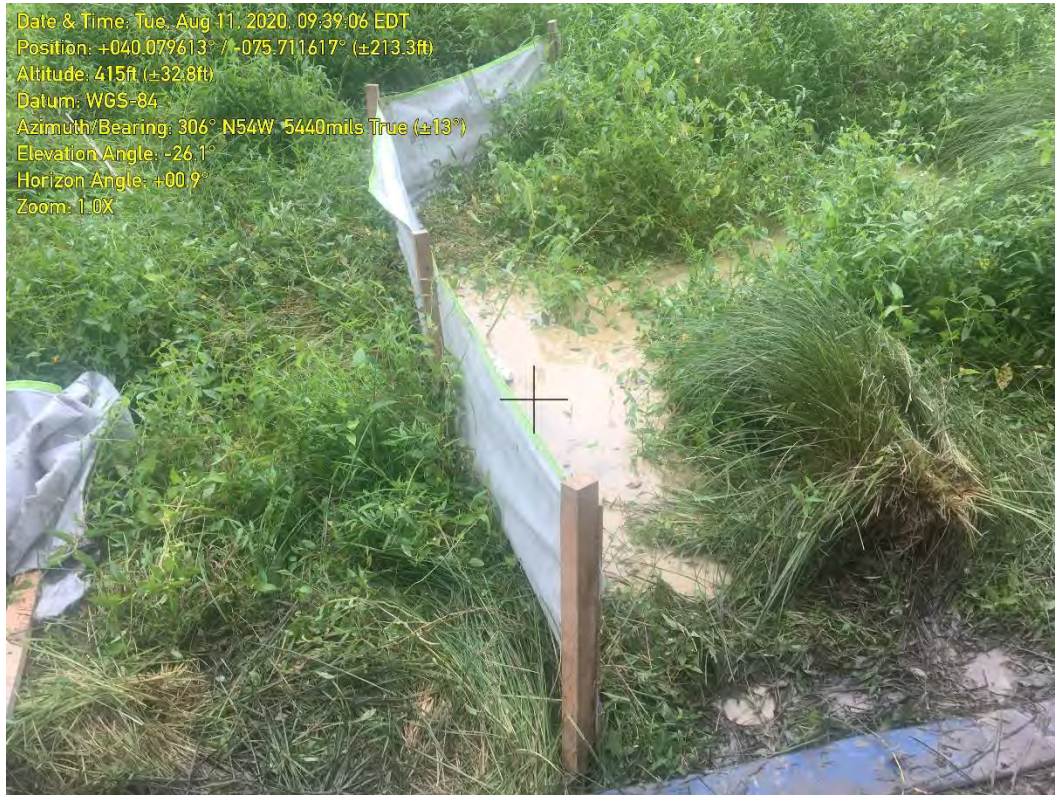
Comments: (Morning) View of containment in stream S-H10

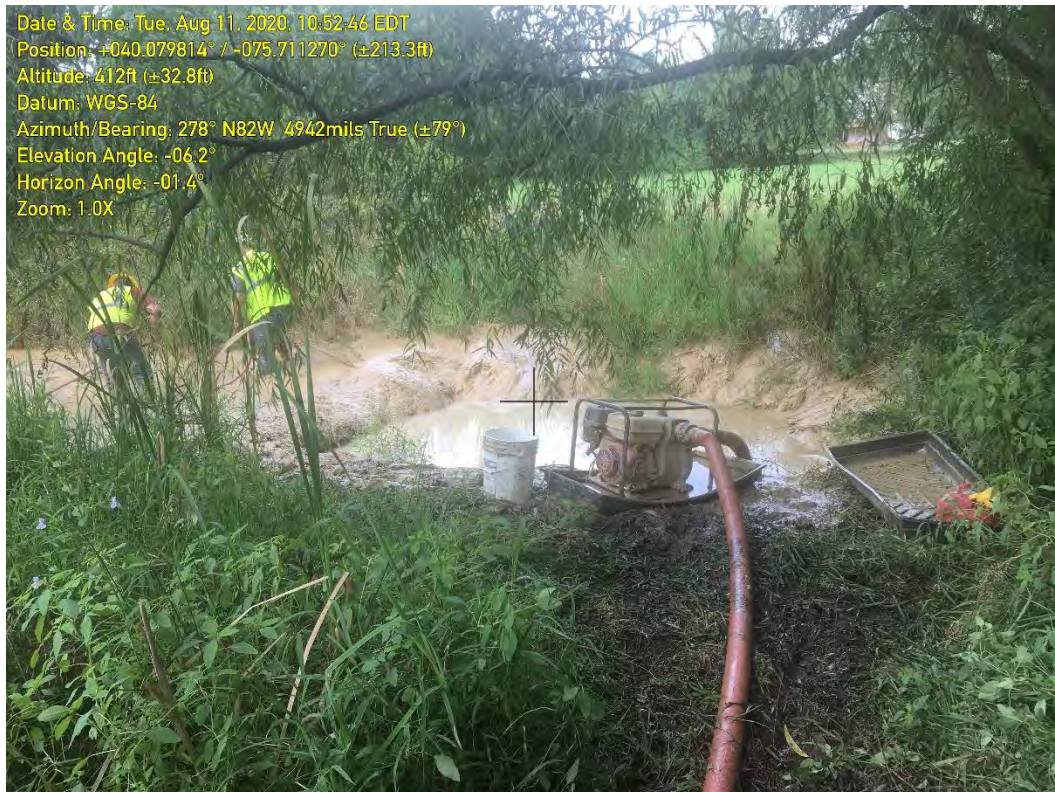
Comments: (Morning) View of the main IR area after pumping.

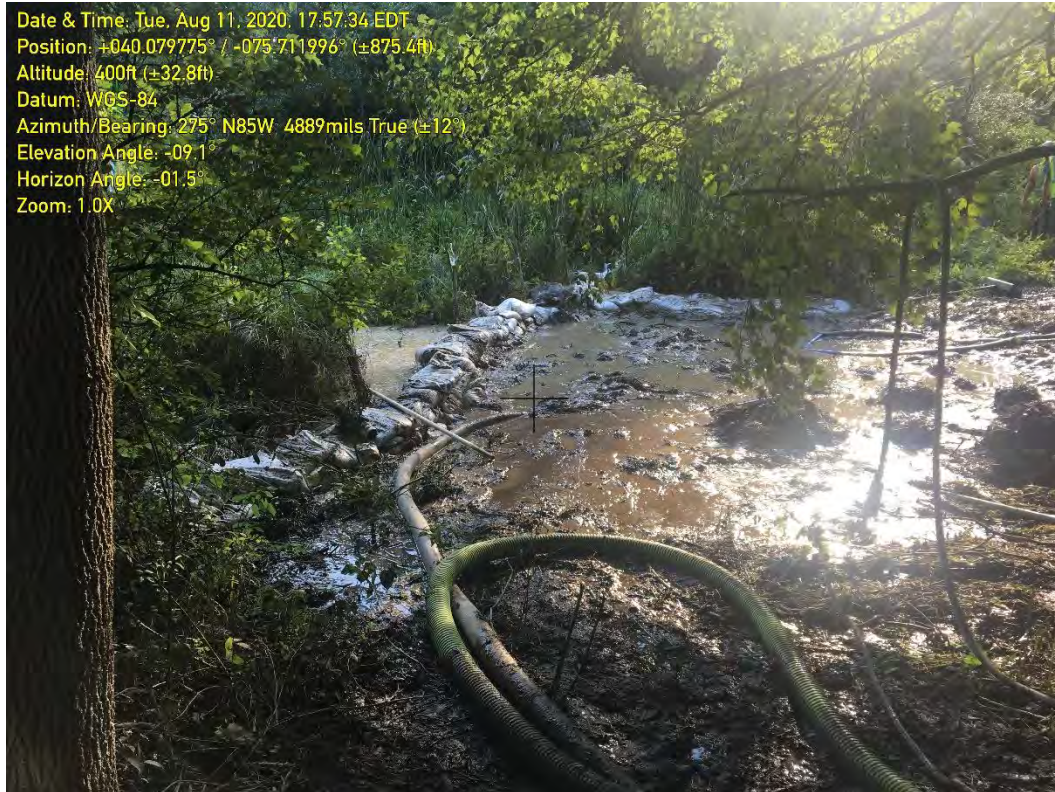
Comments: (Evening) View of containment in stream S-H10 approximately 100ft downgradient of IR point.

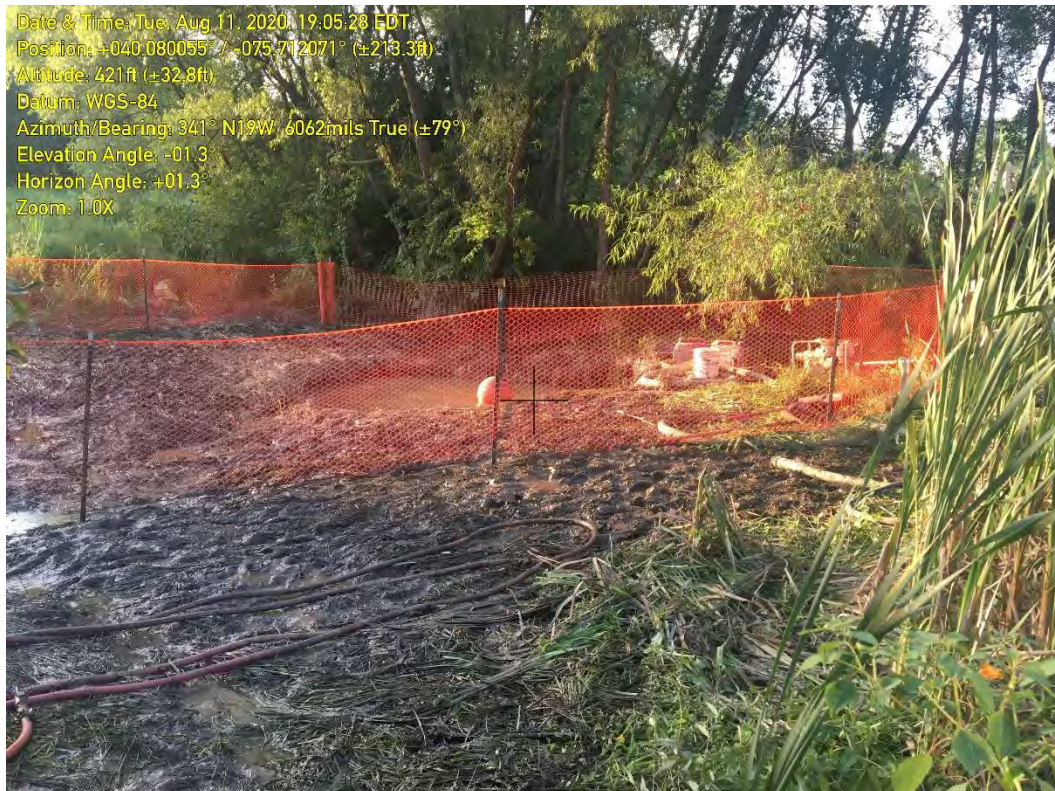
Comments: (Evening) Main IR with fence enclosure near the end of the day.
