**Sunoco  
Pipeline L.P.**

# Sunoco Pipeline L.P. - Pennsylvania Pipeline Project

## HDD Inspection Daily Report

HDD No.: S3-0290-20 (US-DS)  
HDD Name: Little Conestoga Rd  
HDD Permit Name: Milford Rd/Little Conestoga Rd

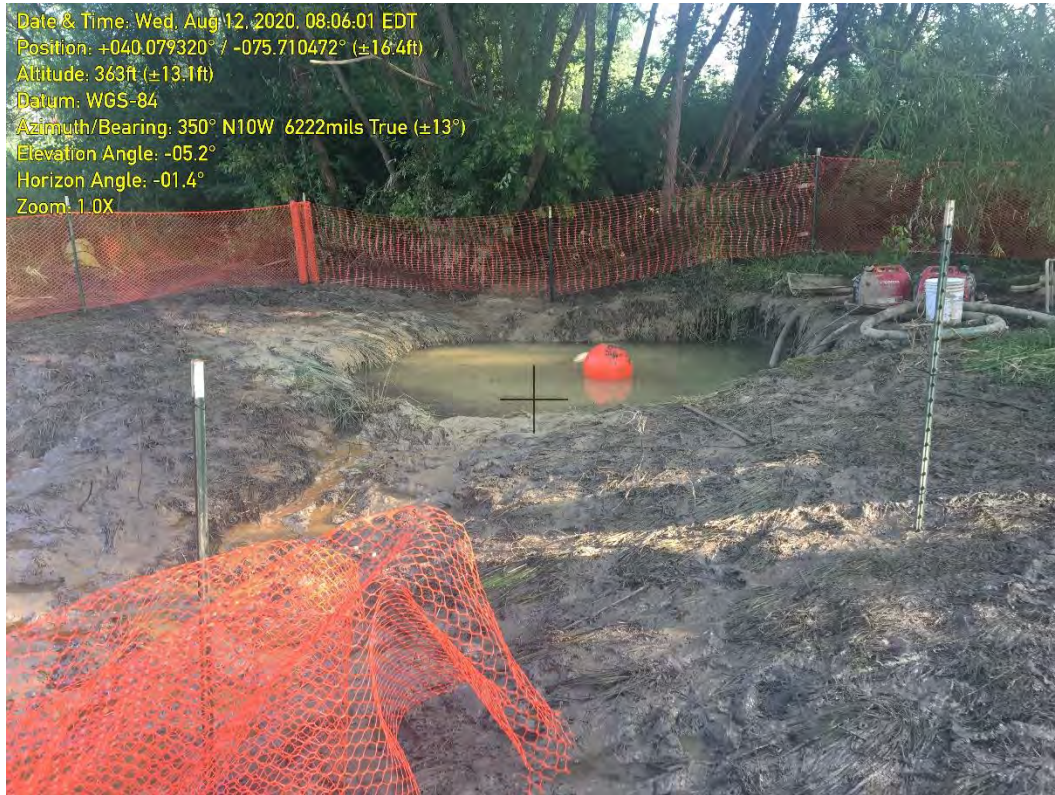
Comments: (Morning) View of IR site.

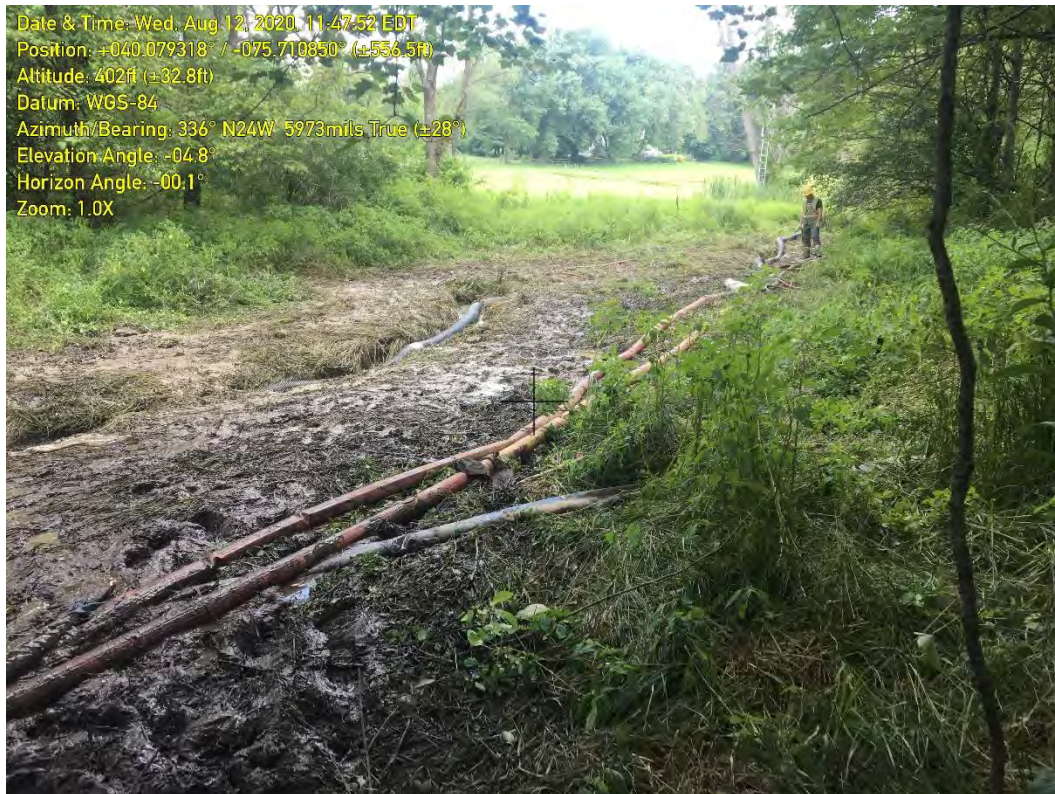
Comments: (Morning) View of stream S-H10 approximately 100ft downgradient of main IR. .

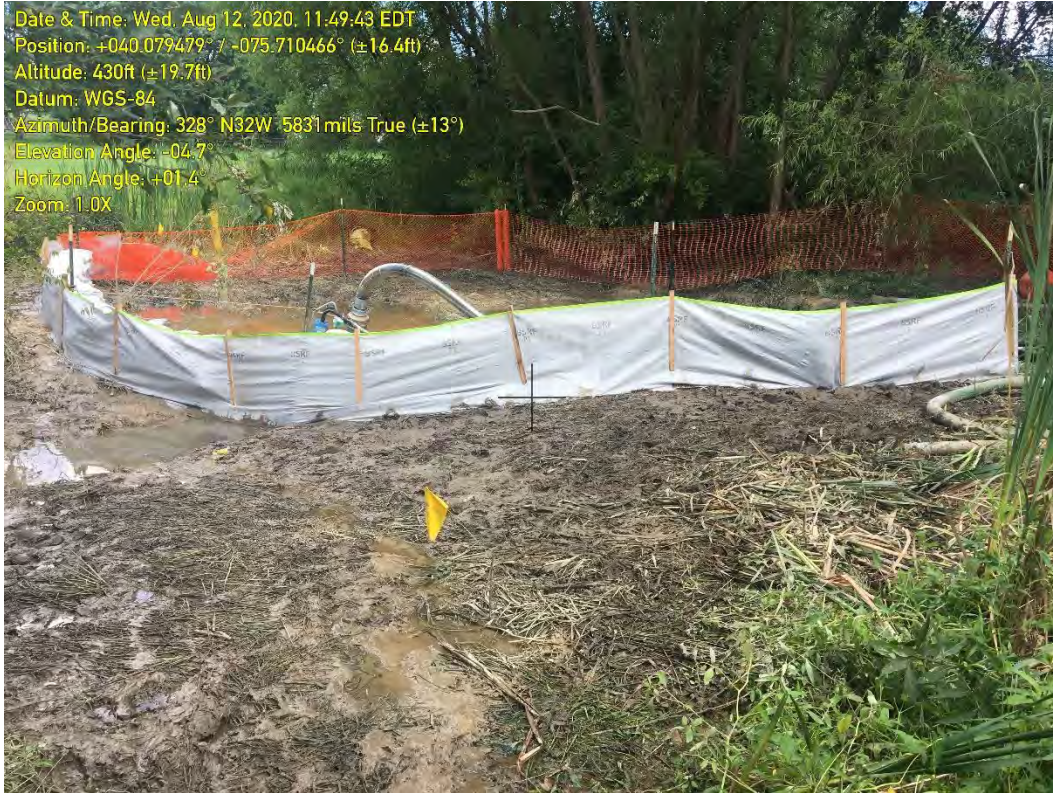
Comments: (Morning) View of containment around IR point.

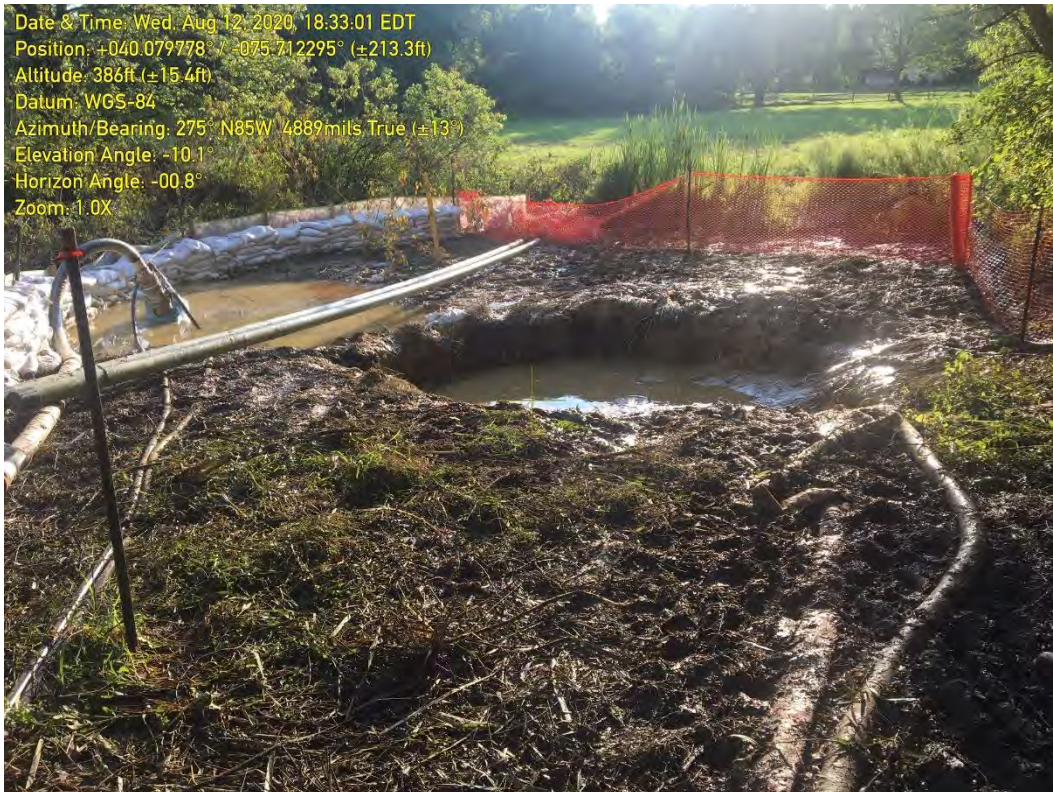
Comments: (Evening) View of IR prior to being filled with grout.

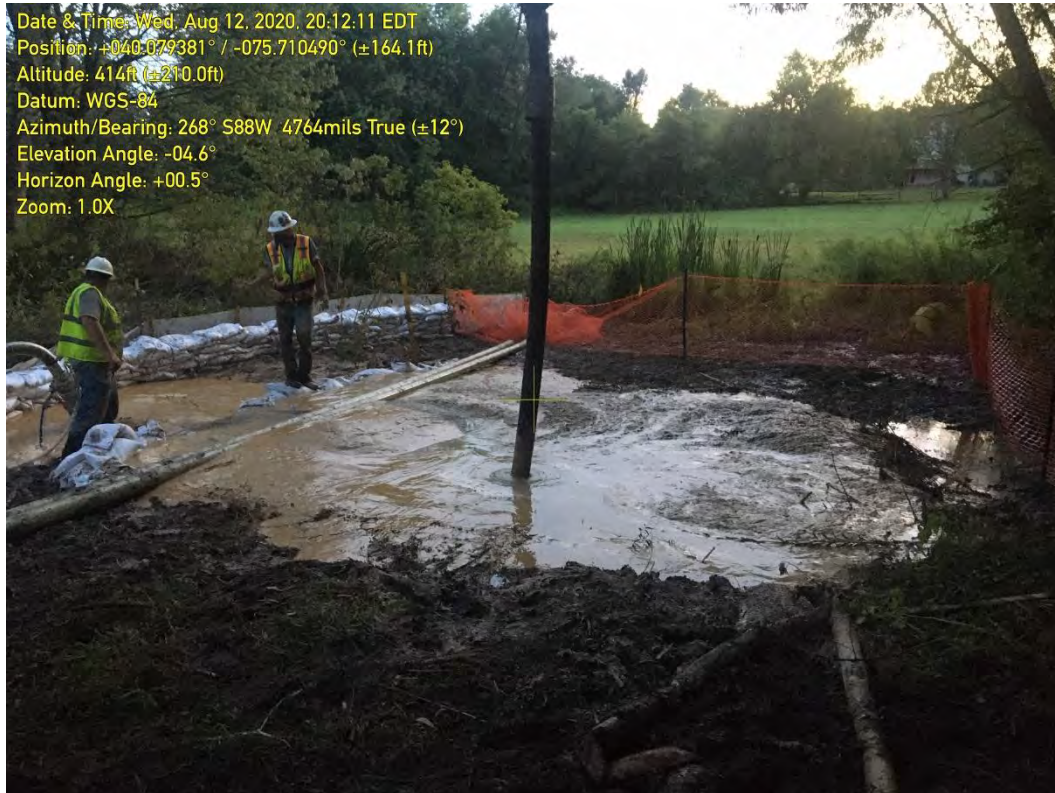
Comments: (Evening) View of IR after being filled with grout.
