## Pennsylvania Pipeline Project Mariner East II

### PROBLEM AREA / INCIDENT REPORT

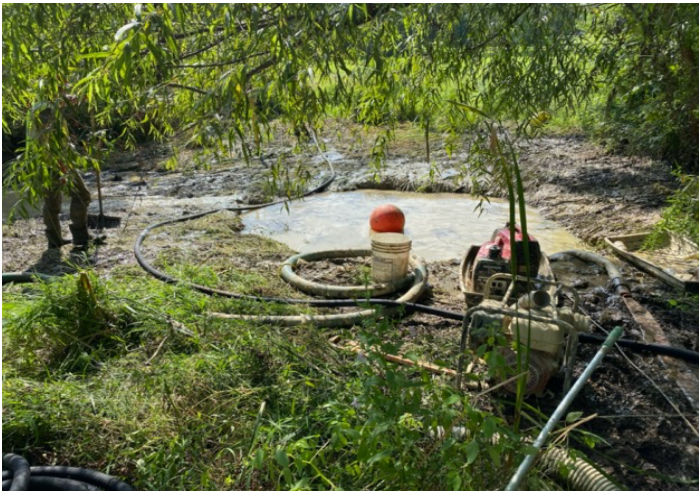
<b>Station #:</b>	14824+00		
<b>Direction:</b>	Northwest		
View of subsidence feature discovered within wetland WL-H17 (PEM) on August 11, 2020.

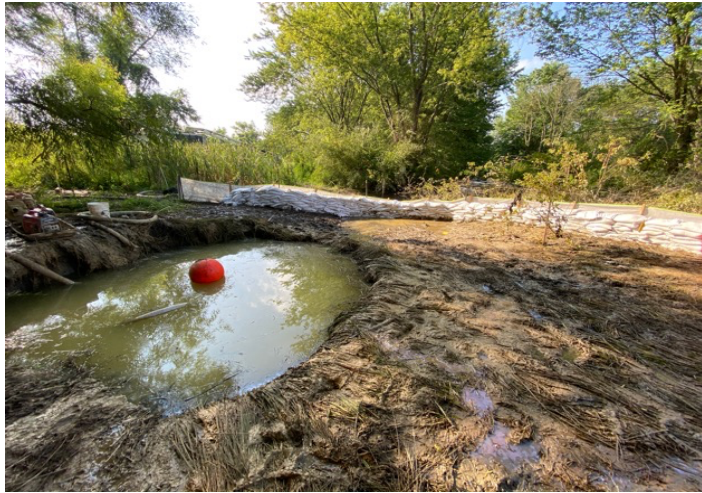
**Station #:** 14824+00

**Direction:** Southwest

View of subsidence feature discovered within wetland WL-H17 (PEM) on August 11, 2020.

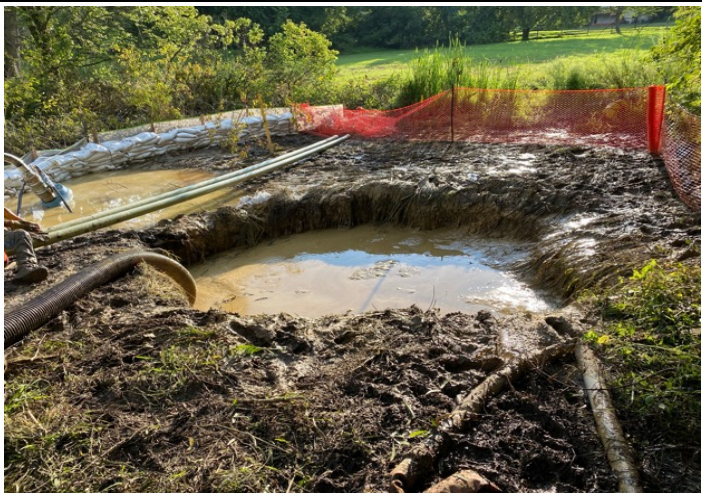
**Station #:** 14824+00

**Direction:** Northwest

View of subsidence feature within wetland WL-H17 (PEM) following pumping of fluid. Dimensions were 15' in diameter and 3' deep.

<b>CORRECTIVE ACTION REQUIRED:</b>			
<p>On August 12, 2020, following the recovery of the 30-inch ream tool from the downstream HDD location, fluid within the subsidence feature was pumped out using a vacuum truck. It was discovered at this time that the subsidence feature was 15' in diameter with a depth of 3', not 8' as reported on August 10, 2020. Because of the proximity to the existing active SPLP 8" underground pipeline, it was decided by SPLP Operations and PUC personnel that any/all subsidence features be stabilized with flowable fill. On August 12, 2020, 26 cubic yards of flowable were placed within the subsidence feature using a pump truck. The area will continue to be monitored by Professional Geologists, Environmental Inspection and contractor.</p>			
<b>PHOTOS</b>

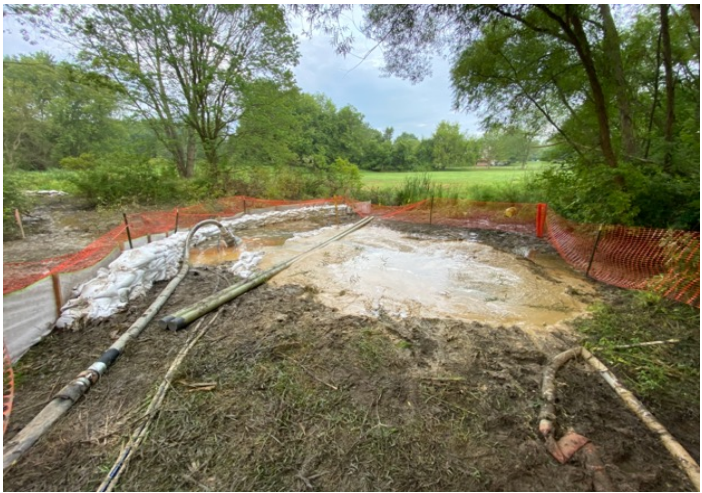
**Station #:** 14824+00

**Direction:** Northwest

View of subsidence feature within wetland WL-H17 (PEM) following placement of 26 cubic yards of flowable fill. The subsidence feature is located approximately 5' east of the existing active SPLP 8" underground pipeline.
