**COMMONWEALTH OF PENNSYLVANIA
DEPARTMENT OF ENVIRONMENTAL PROTECTION
BUREAU OF MINING PROGRAMS**

Inspection Report

Inspection Type	RTNC - Routine/Complete Inspection	Permit Number	7974SM1
DEP Office	EP DMO Pottsville Dstr Mng Off	NPDES Number	PA0594121
Permittee Name	HEIDELBERG MATERIALS NE LLC	PF Name	HEIDELBERG MATERIALS NE ROCK HILL QUARRY
Address 1	7660 IMPERIAL WAY	Permit Type	IMMO - Industrial Mineral Mining Operation
Address 2		Permit Kind	LARGE - Surface Large
City	ALLENTOWN	License Number	24143
State/ZIP Code	PA 18195-1040	Permit Status	ACTIV - Active
Arrival Date / Time	08/22/2023 08:05 AM	Municipality	East Rockhill Township
Depart Date / Time	08/22/2023 02:50 PM	County	Bucks
Inspection ID	3603889	GP12 Permit Number	
Contract Operator Name		Contract Operator License Number	
		Complaint Number

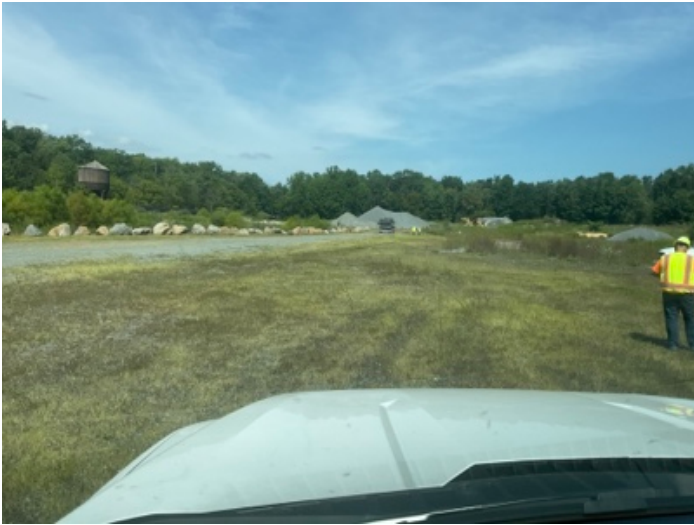
Photo #

Triaxle travelling NW to loading area

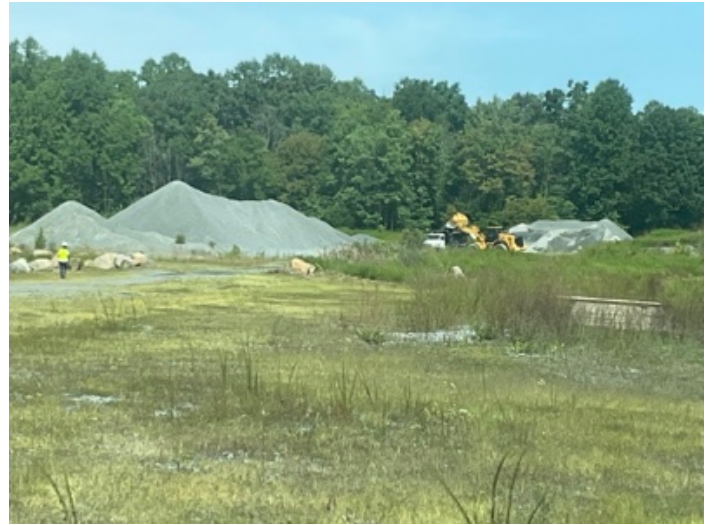
Photo #

FEL loading triaxle with product from NW area of site
