| 2700-FM-BAQ0023 2/2015<br><b>pennsylvania</b><br>DEPARTMENT OF ENVIRONMENTAL PROTECTION | | | <h2 style="margin: 0;">INSPECTION REPORT</h2> | | | Commonwealth of Pennsylvania<br>Department of Environmental Protection<br>Air Quality Program | | | | | |
| Company Name:<br><b>Richard E. Pierson Materials Corp</b> | | | | Municipality:<br><b>East Rockhill Twp</b> | | | | County:<br><b>Bucks</b> | | | |
| Plant Name:<br><b>East Rockhill Quarry</b> | | | | Physical Location:<br><b>Same as below</b> | | | | Federal ID — Plant Code #: | | | |

## PHOTO LOG FORM

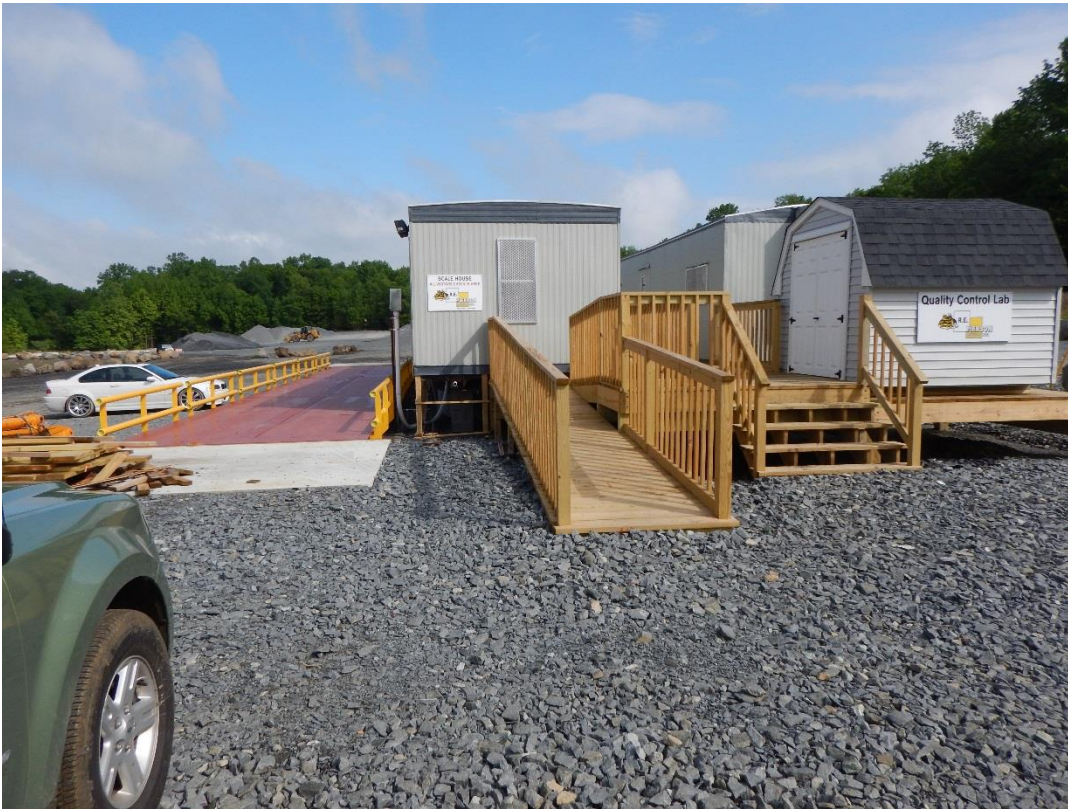
| Photo ID # | Time | Description/Observations |
|---|---|---|
| DSCN0088 | 9:28 AM | New site offices and weigh scale (scale not yet in use). |

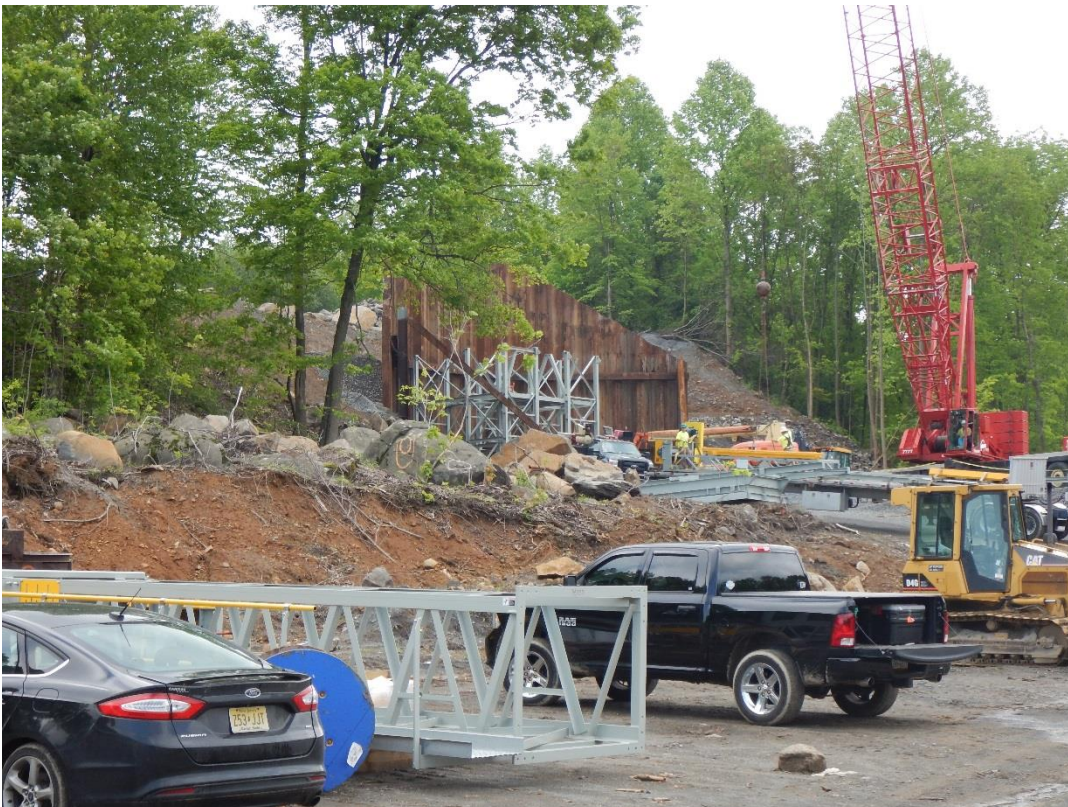
| Photo ID # | Time | Description/Observations |
|---|---|---|
| DSCN0089 | 9:45 AM | Looking east at location of construction of primary crusher. |

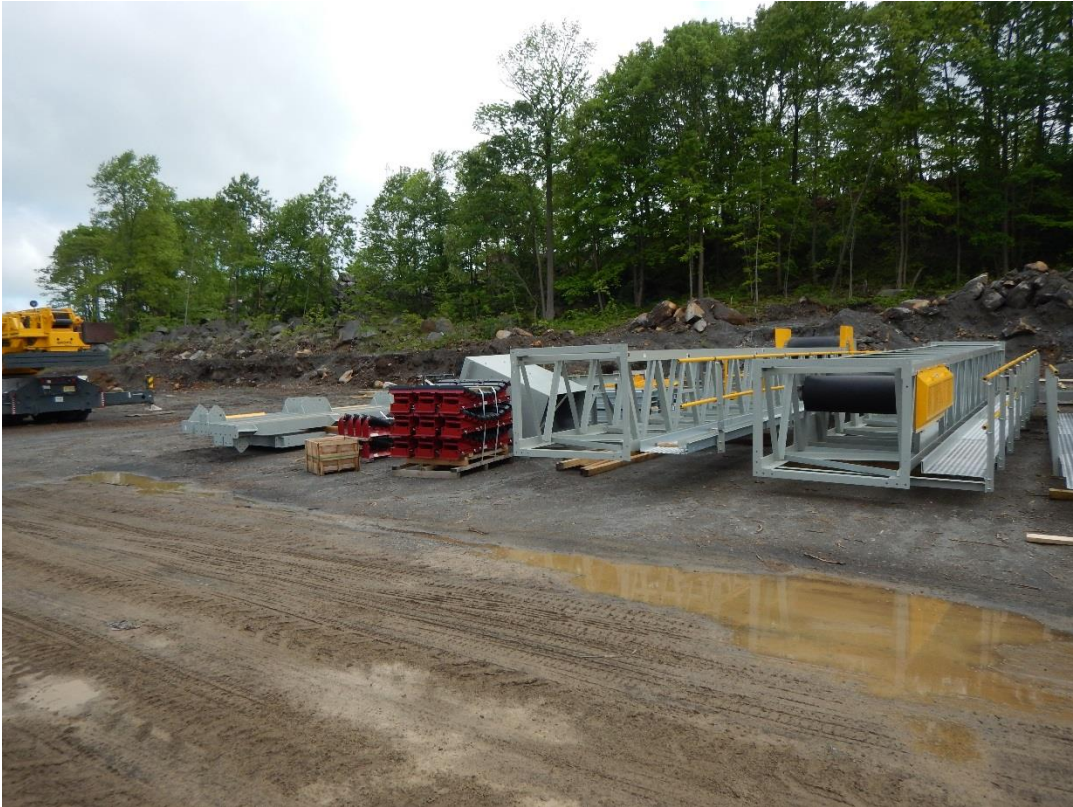
| Photo ID # | Time | Description/Observations |
|---|---|---|
| DSCN0090 | 9:45 AM | Conveyor and scalper screen (primary) components on-site. |

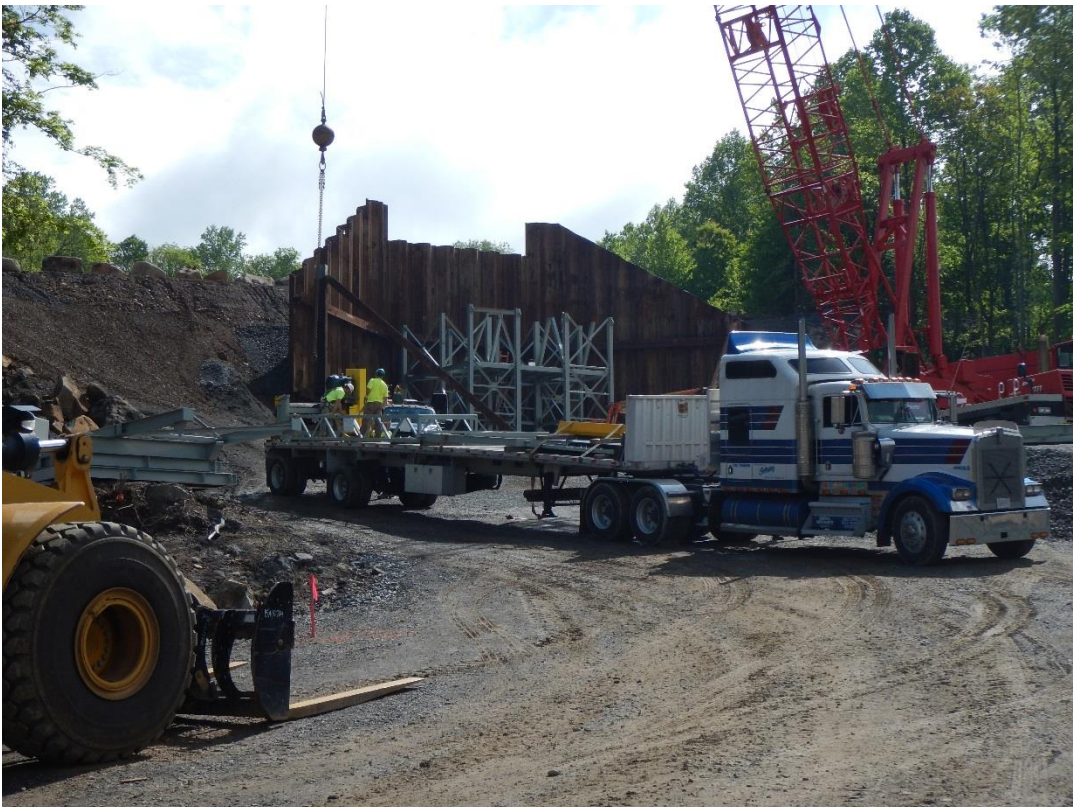
| Photo ID # | Time | Description/Observations |
|---|---|---|
| DSCN0091 | 9:53 AM | Site construction for primary crusher. Note retaining wall and structural steel for 'rock box' (the primary crusher feed hopper). |

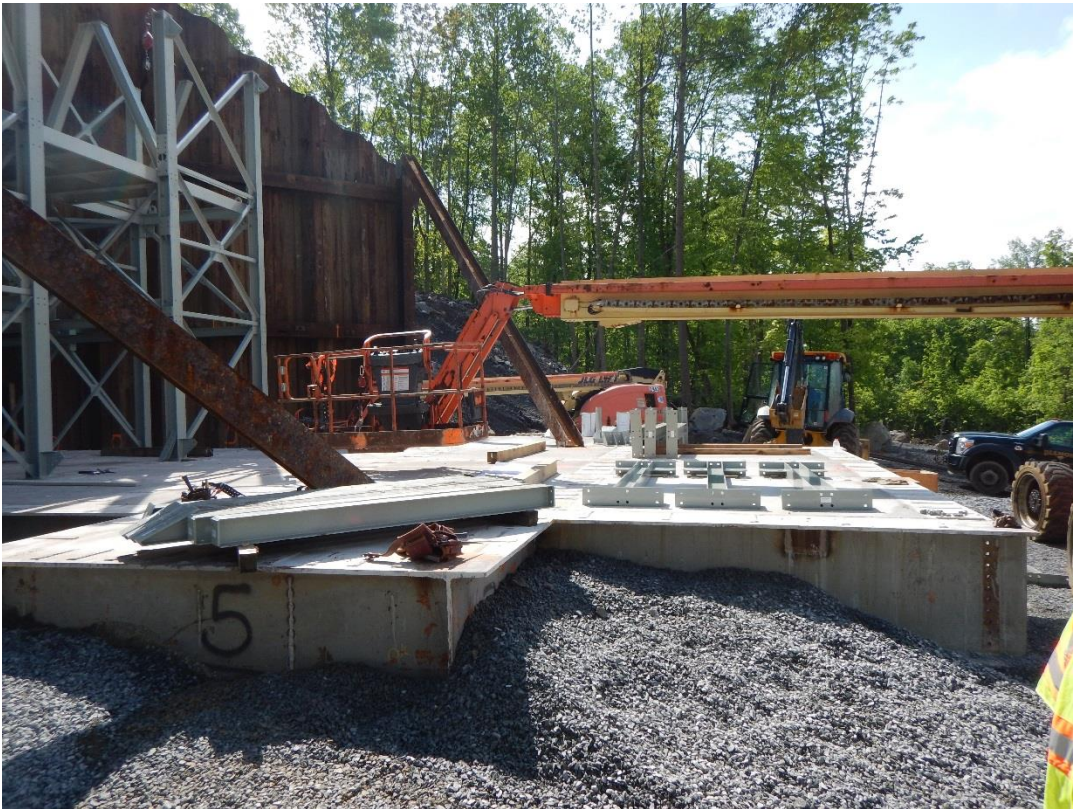
| Photo ID # | Time | Description/Observations |
|---|---|---|
| DSCN0092 | 9:55 AM | Foundation slab for primary crusher. |

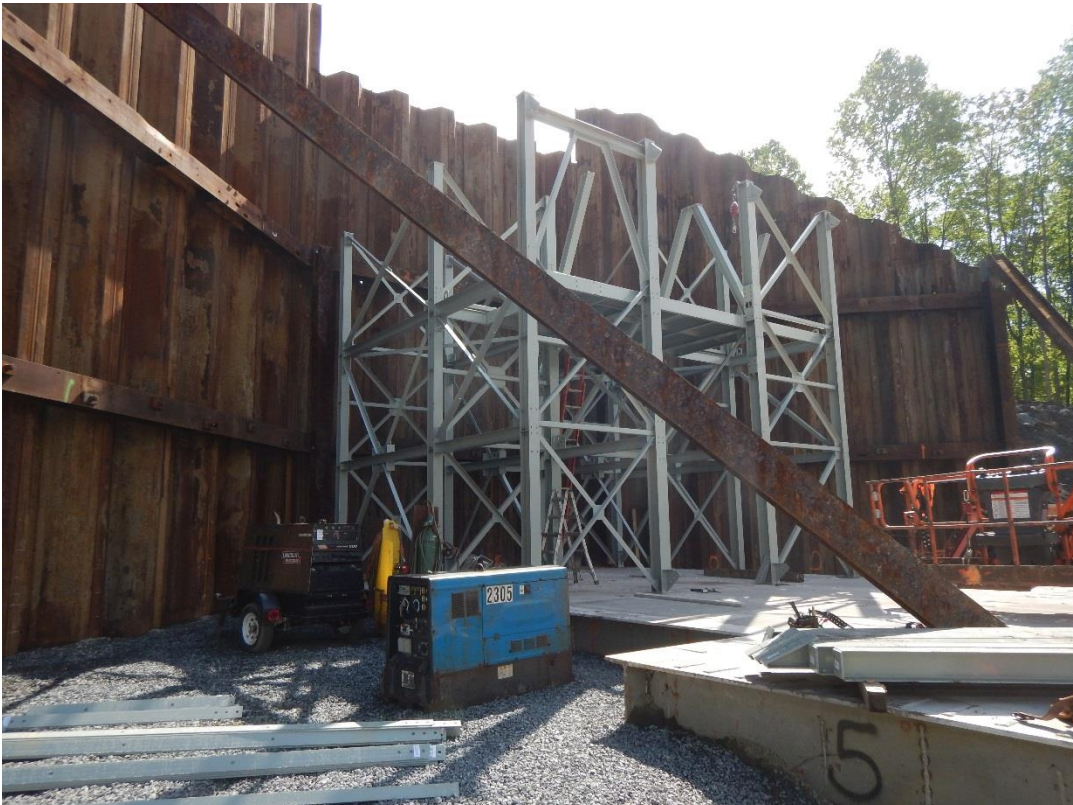
| Photo ID # | Time | Description/Observations |
|---|---|---|
| DSCN0093 | 9:55 AM | Foundation slab for primary crusher and structural support for 'rock box'. |

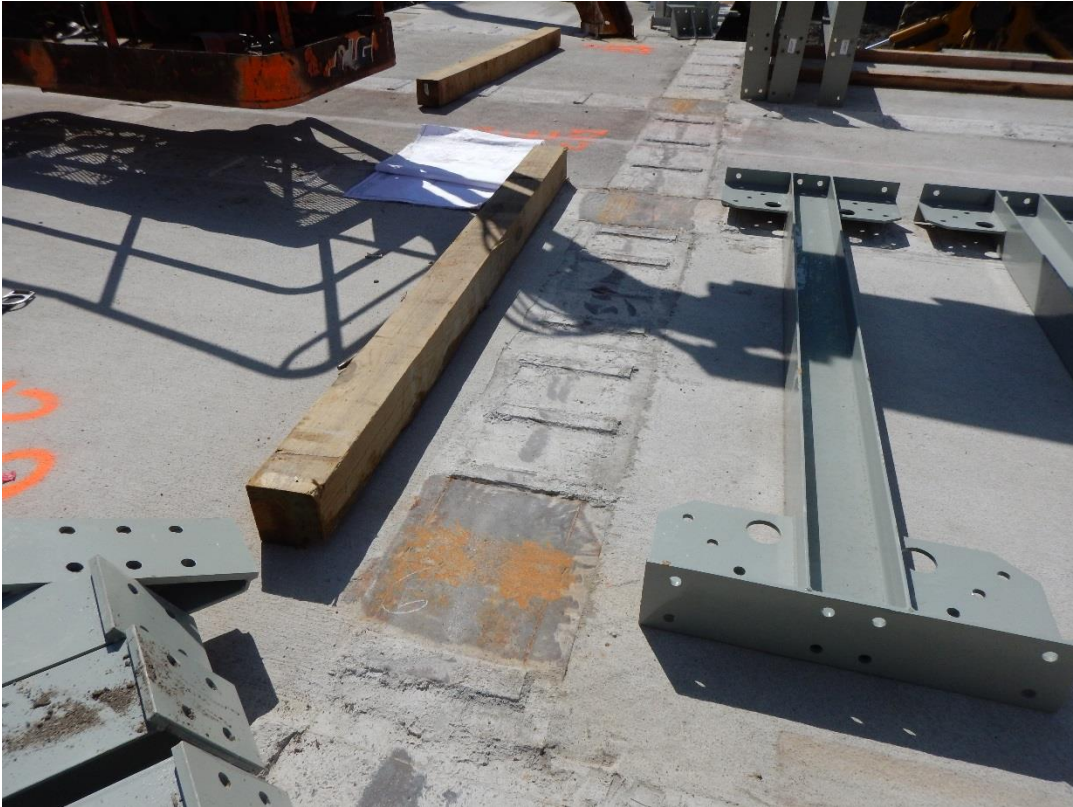
| Photo ID # | Time | Description/Observations |
|---|---|---|
| DSCN0094 | 9:56 AM | Foundation slab for primary crusher. Note embedded, exposed steel beams that crusher will be welded to when installed. |

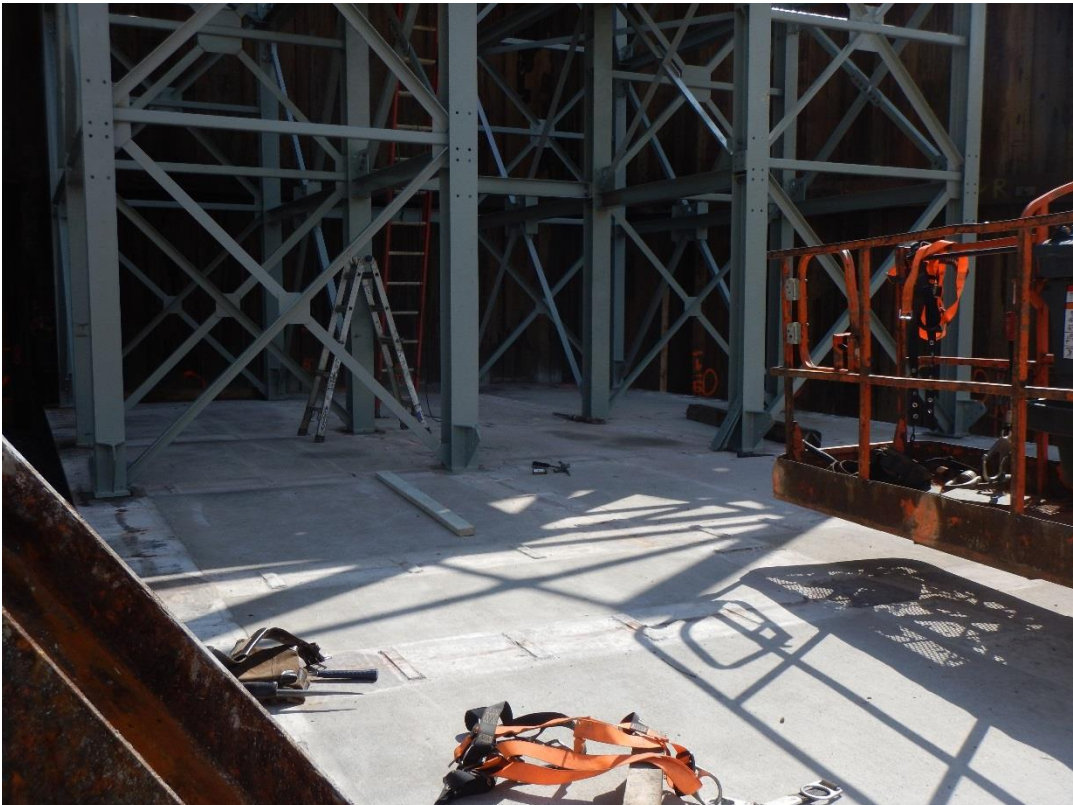
| Photo ID # | Time | Description/Observations |
|---|---|---|
| DSCN0095 | 9:56 AM | Foundation slab for primary crusher and attached structural supports for the 'rock box'. |

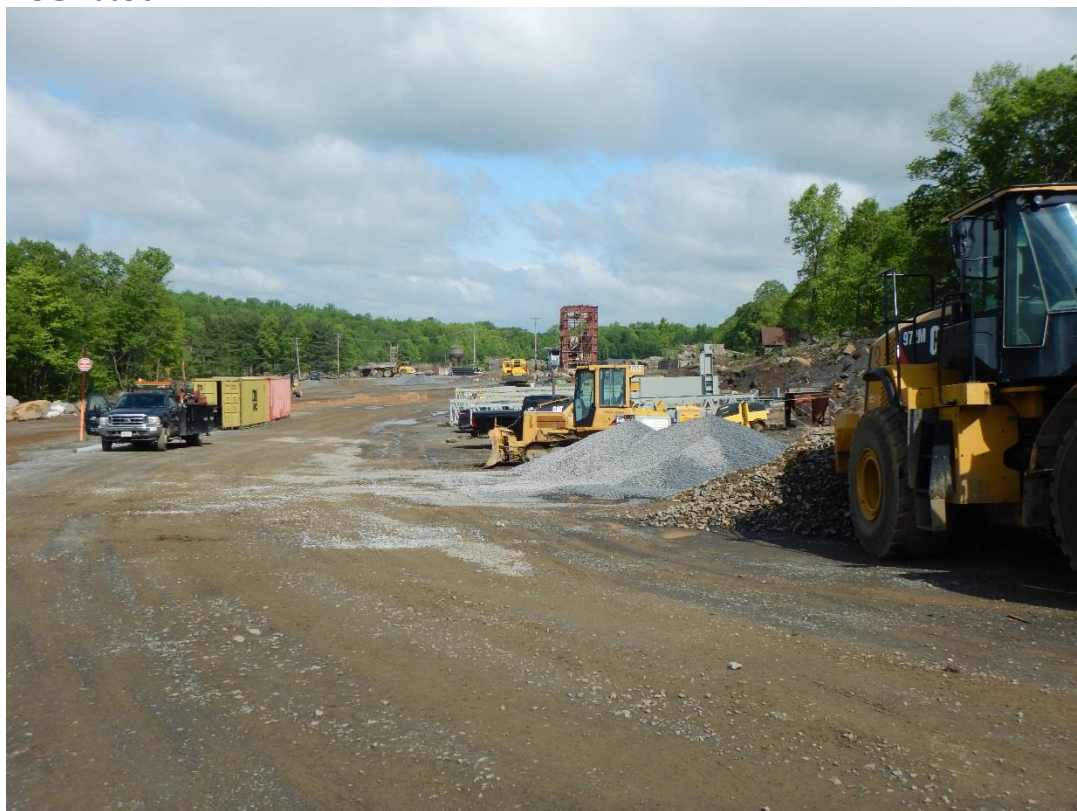
| Photo ID # | Time | Description/Observations |
|---|---|---|
| DSCN0096 | 9:58 AM | View standing southwest of primary crusher looking northwest in direction of planned surge pile/surge tunnel and planned secondary crusher. |

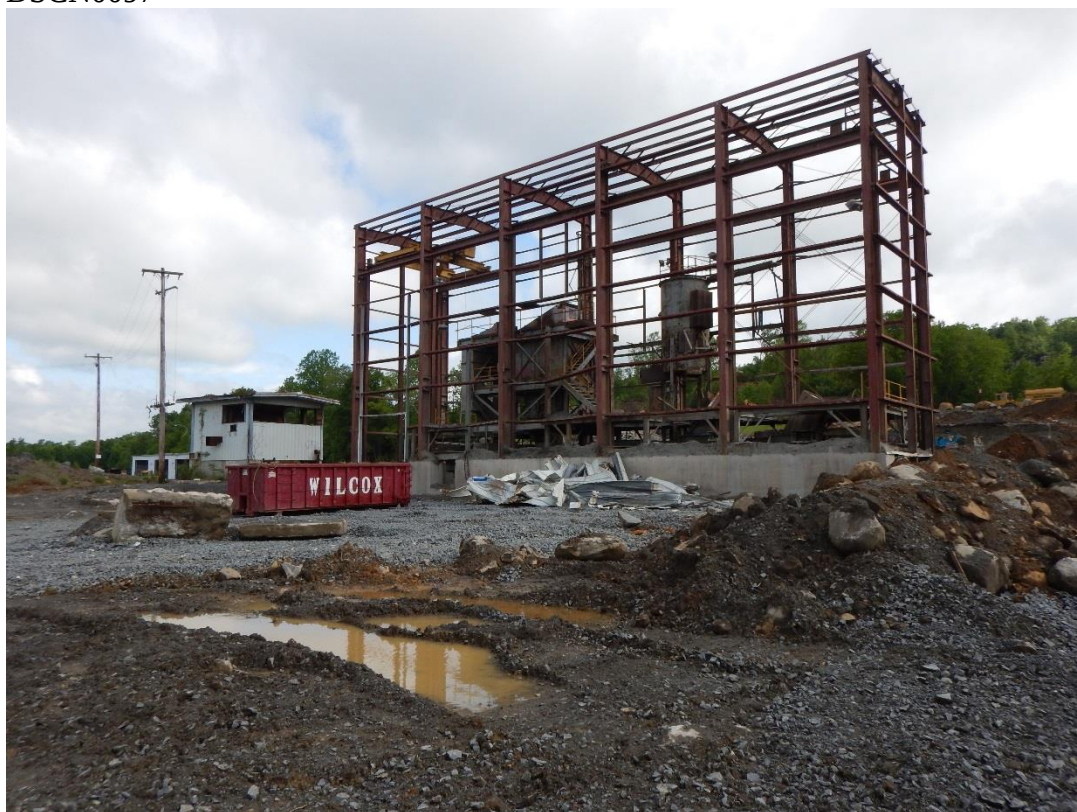
| Photo ID # | Time | Description/Observations |
|---|---|---|
| DSCN0097 | 10:05 AM | Pre-existing secondary crusher building that has had the siding removed. |

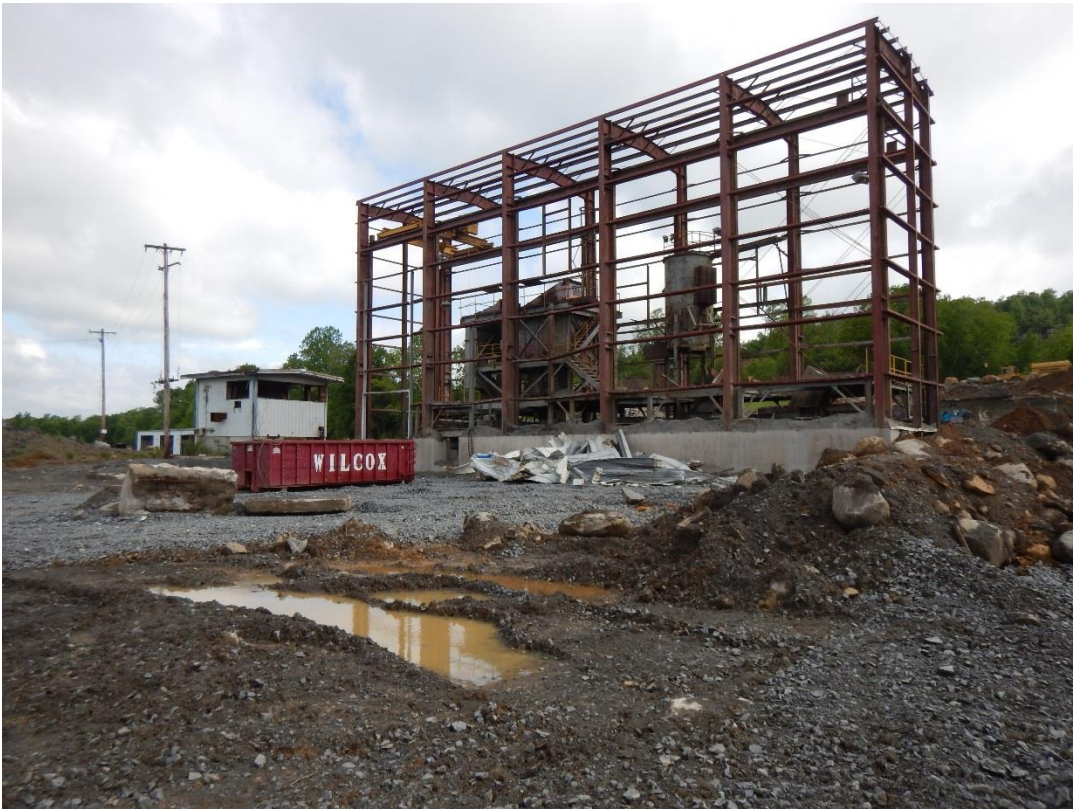
| Photo ID # | Time | Description/Observations |
|---|---|---|
| DSCN0098 | 10:06 AM | Pre-existing secondary crusher building that has had the siding removed. |

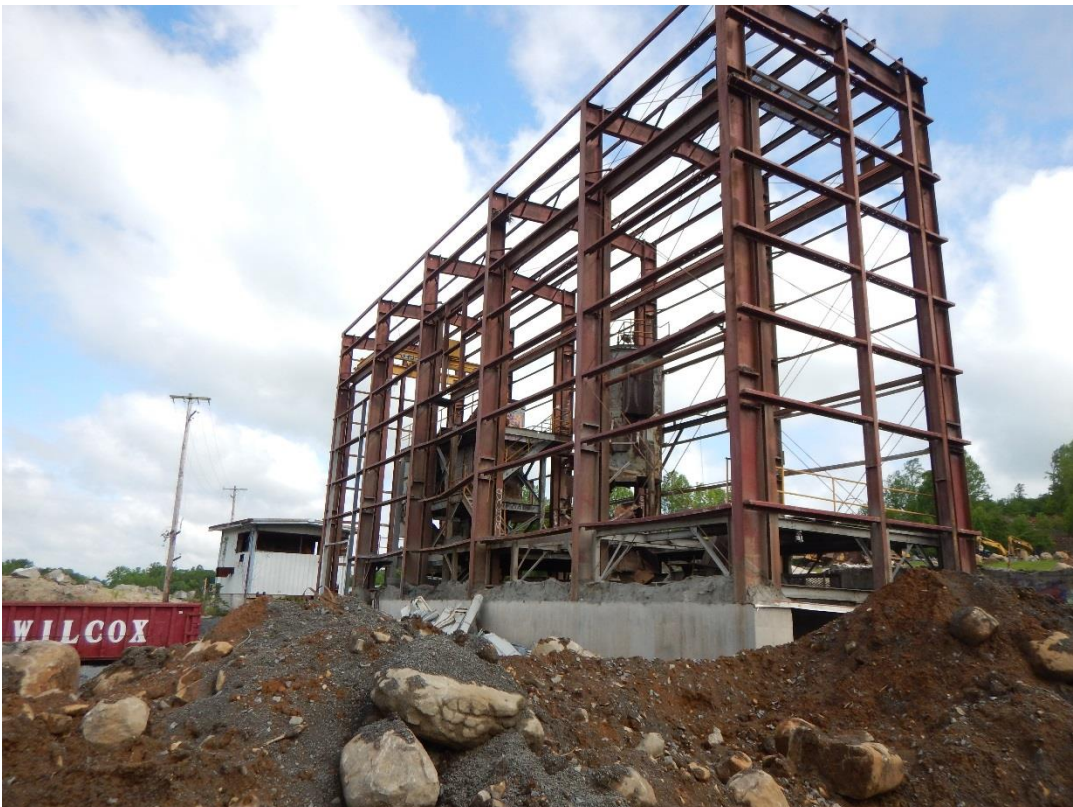
| Photo ID # | Time | Description/Observations |
|---|---|---|
| DSCN0099 | 10:07 AM | Pre-existing secondary crusher building that has had the siding removed. |

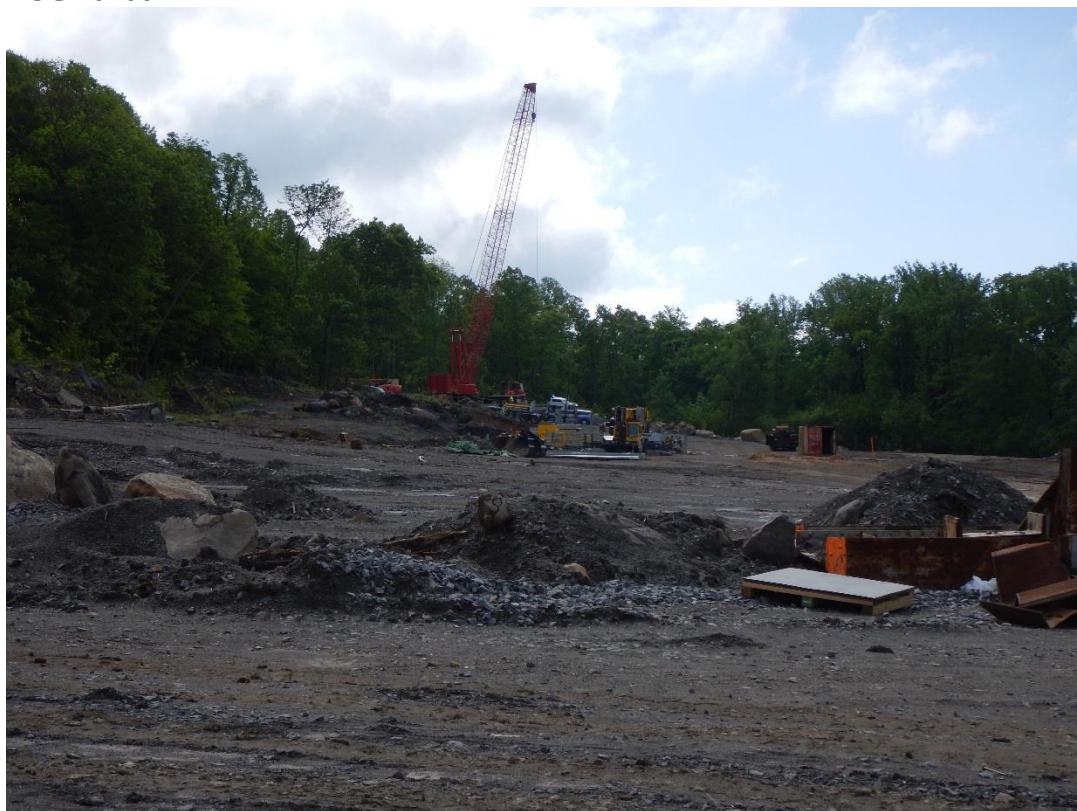
| Photo ID # | Time | Description/Observations |
|---|---|---|
| DSCN0100 | 10:08 AM | Standing at pre-existing secondary crusher building looking southeast towards primary crusher area and active construction. |

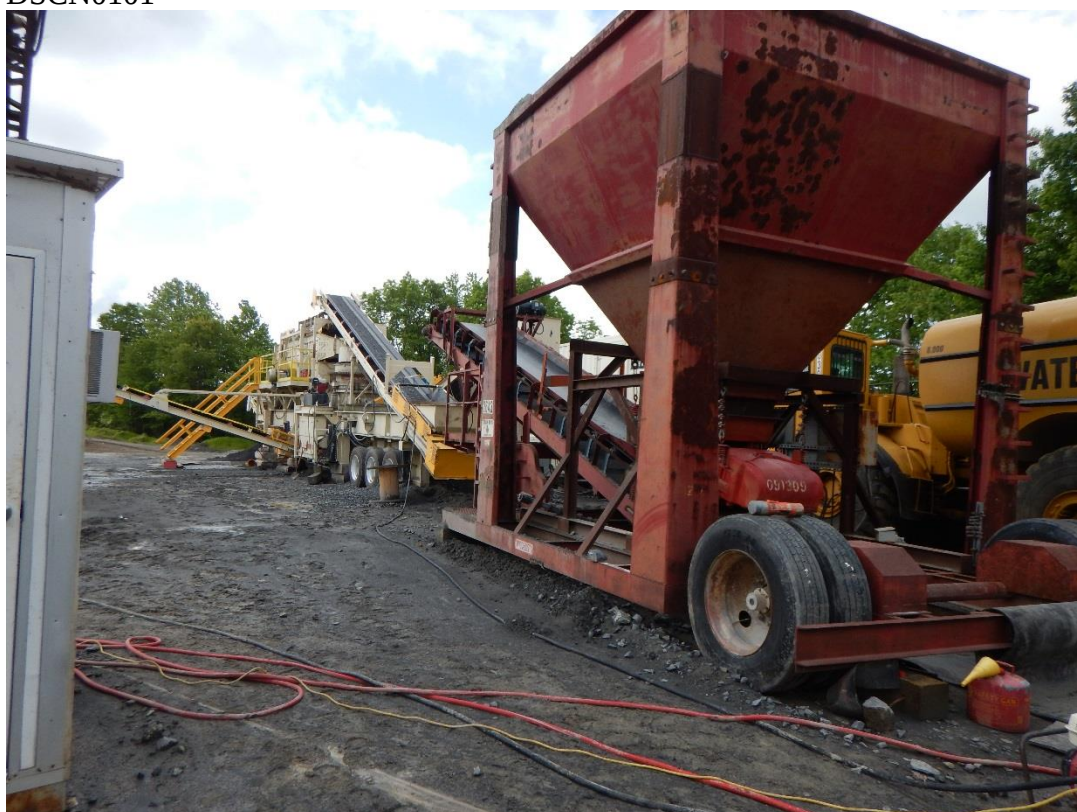
| Photo ID # | Time | Description/Observations |
|---|---|---|
| DSCN0101 | 10:15 AM | Norberg HP300 cone crusher with feed hopper. |

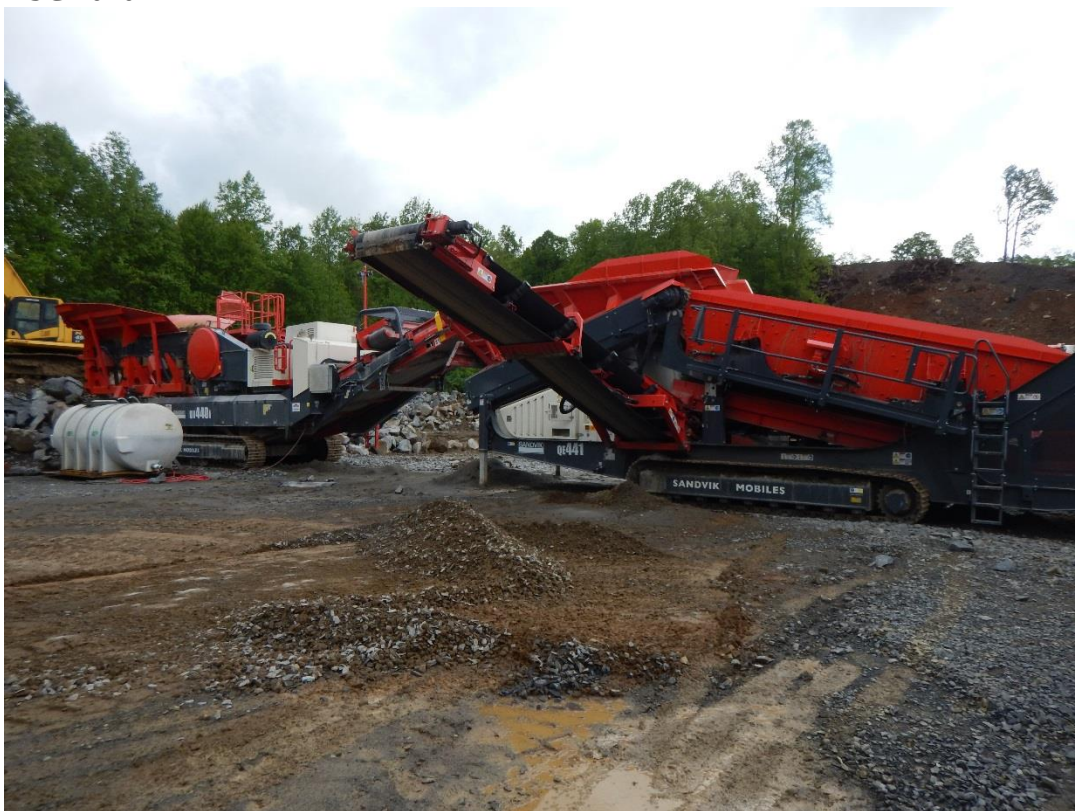
| Photo ID # | Time | Description/Observations |
|---|---|---|
| DSCN0102 | 10:15 AM | Sandvick primary crusher and first screening unit. |

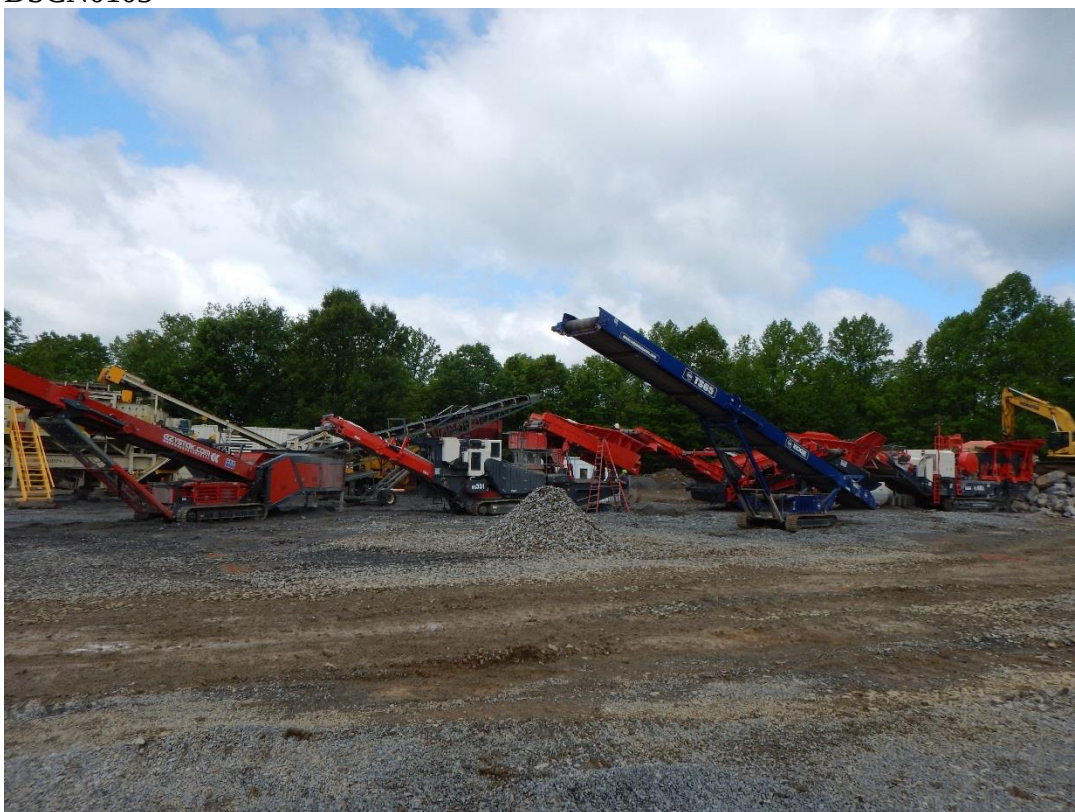
| Photo ID # | Time | Description/Observations |
|---|---|---|
| DSCN0103 | 10:20 AM | Crushing line. From right to left: primary crusher, primary screen, secondary crusher, secondary screen. |

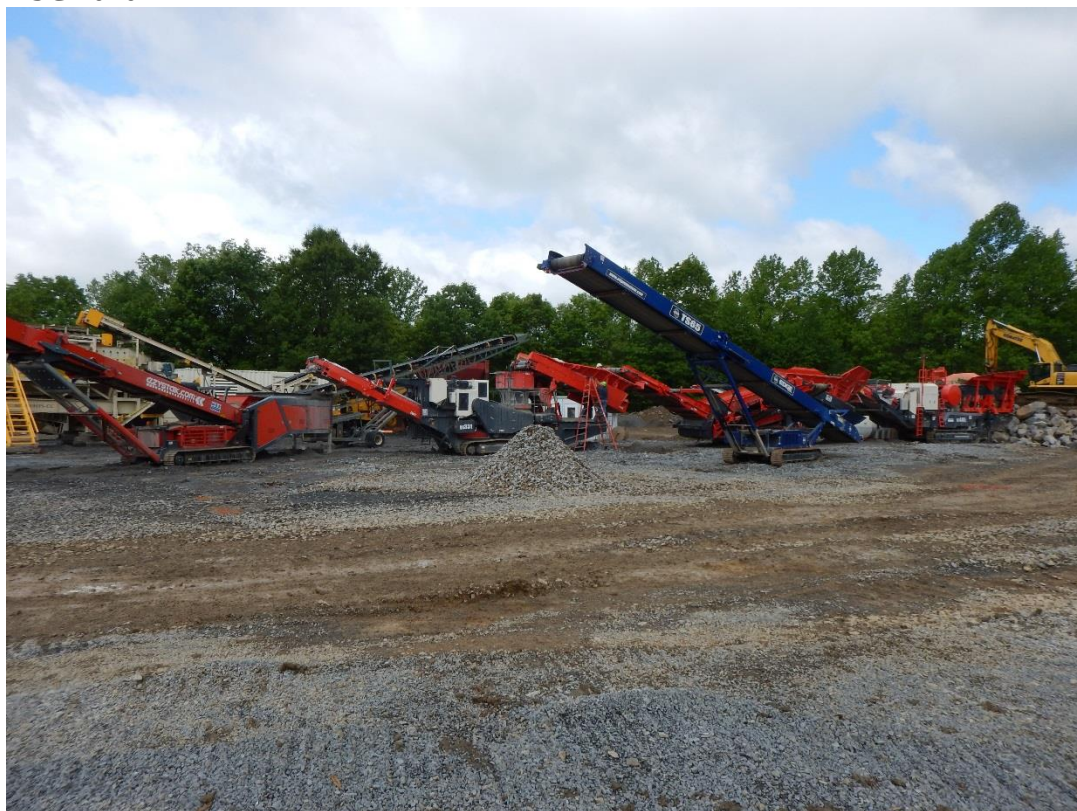
| Photo ID # | Time | Description/Observations |
|---|---|---|
| DSCN0104 | 10:20 AM | Crushing Line. From right to left: primary crusher, primary screen, secondary crusher, secondary screen. |

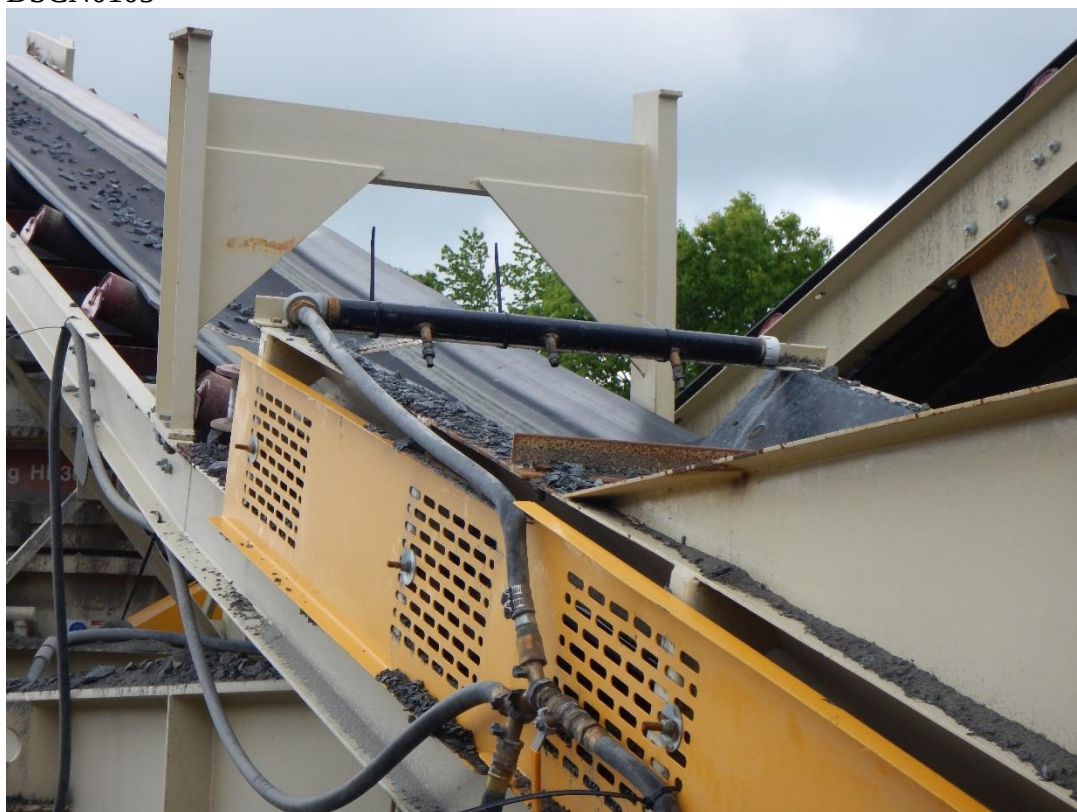
sprays installed. conveyors and screens do not. the Norberg AP 300 cone crusher did not have factory installed sprays. R.E. Pierson installed sprays. they were drilling blast holes while we were on site and it was causing some dust. the drill rig has particulate filters and water for dust control. the installation of the primary crusher, associated equipment, foundations without a permit or plan approval is a violation. Richard Pierson Sr. arrived on site during the inspection. we took photos while we were on site. we plan to email a copy of this report to Andrew Gattshall.

| Photo ID # | Time | Description/Observations |
|---|---|---|
| DSCN0105 | 10:22 AM | Spray bar on feed conveyor of Norberg HP300 cone crusher. Was fabricated and installed by R.E. Pierson Materials. |

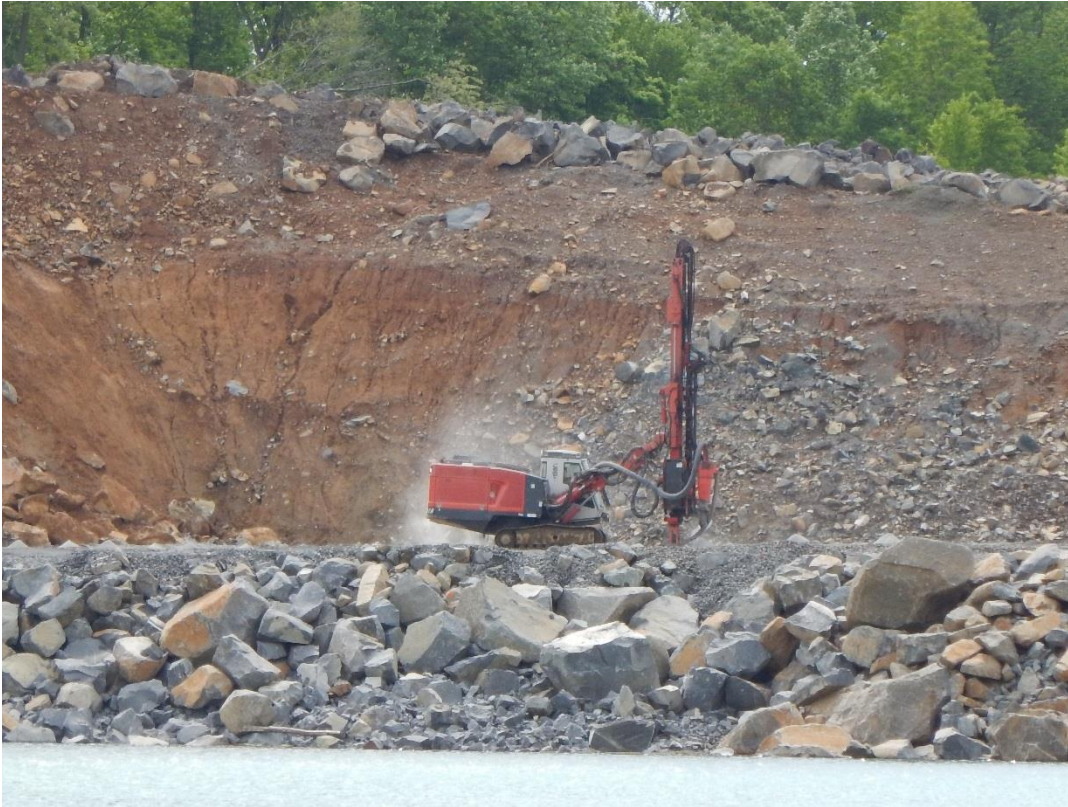
| Photo ID # | Time | Description/Observations |
|---|---|---|
| DSCN0106 | 10:32 AM | Rig drilling blasting holes (outside contractor). Looking east across water filled pit. |

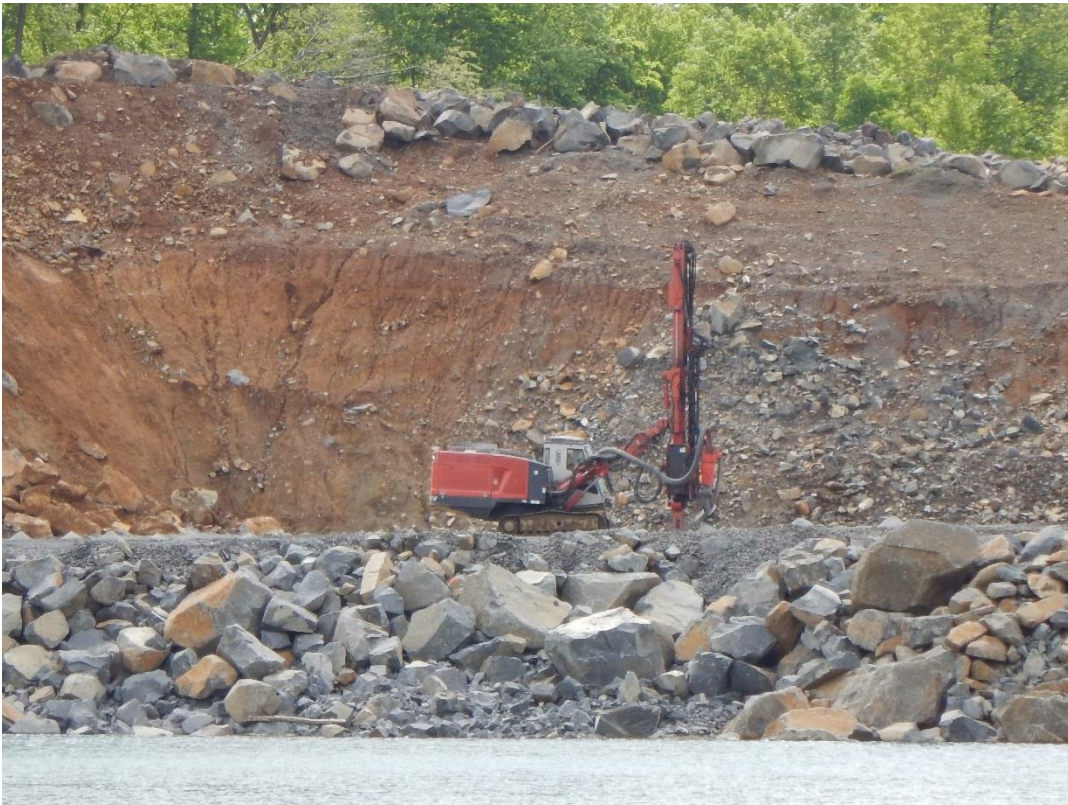
| Photo ID # | Time | Description/Observations |
|---|---|---|
| DSCN0107 | 10:33 AM | Rig drilling blasting holes (outside contractor). Looking east across water filled pit. |

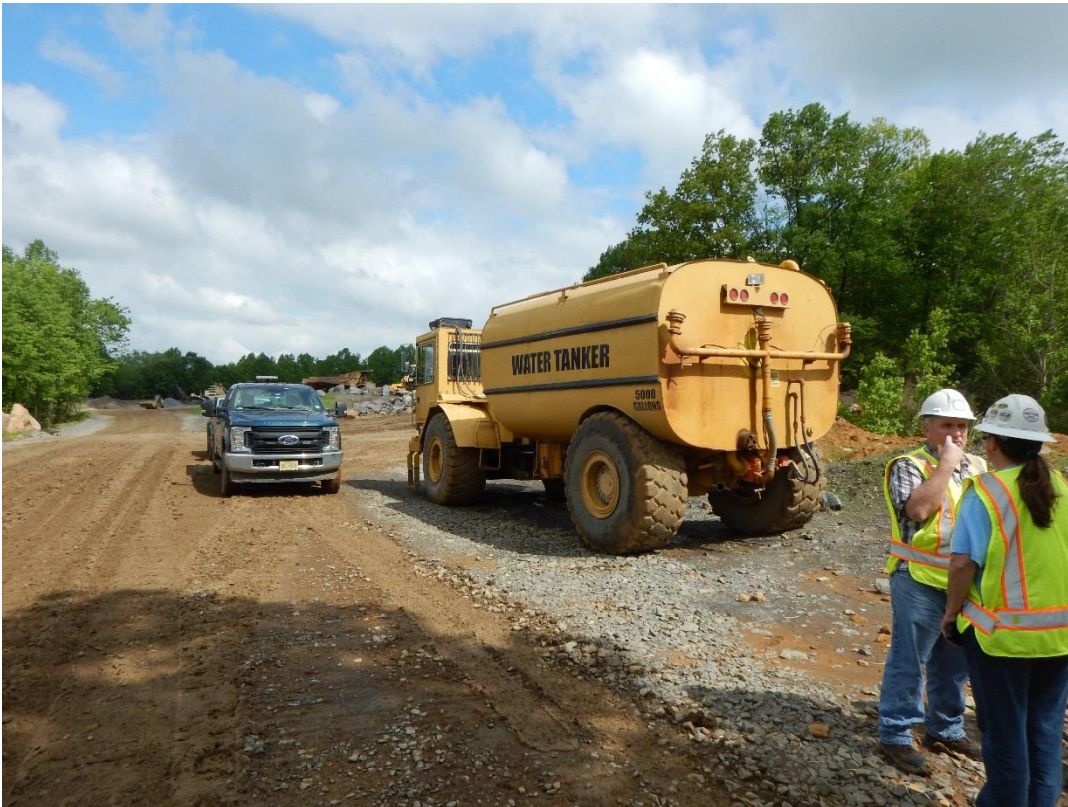
| Photo ID # | Time | Description/Observations |
|---|---|---|
| DSCN0108 | 10:34 AM | Water truck used on site to control dust on roads. |

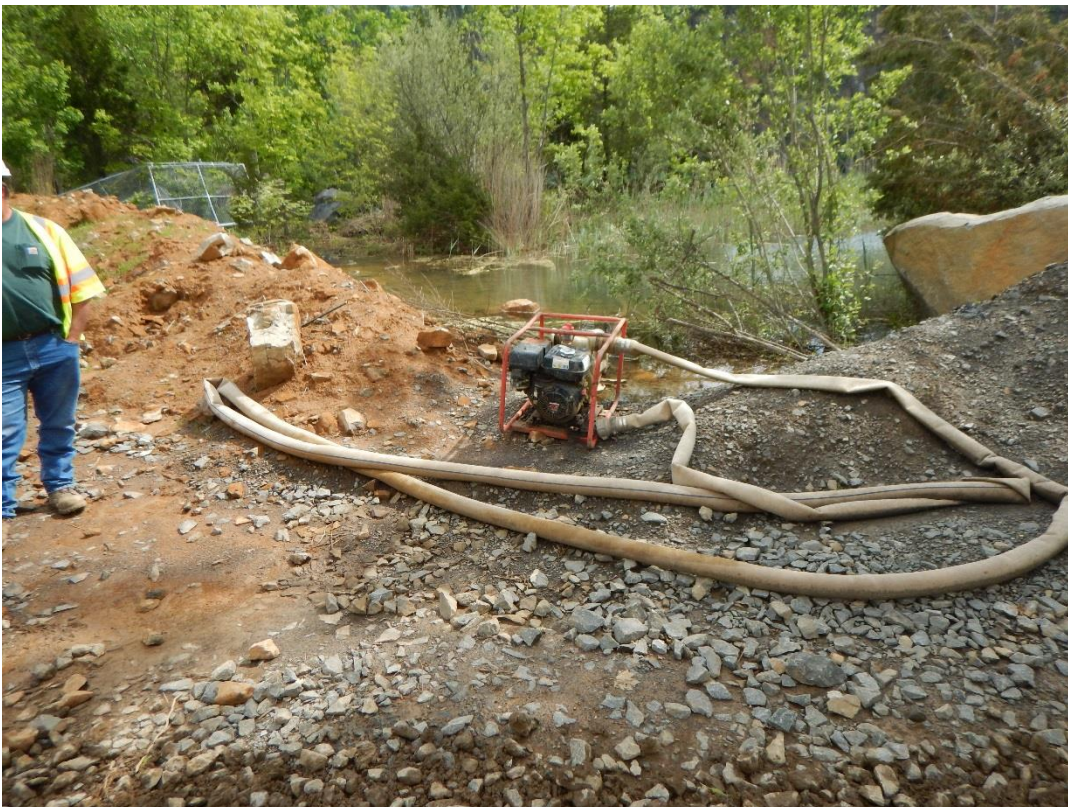
| Photo ID # | Time | Description/Observations |
|---|---|---|
| DSCN0109 | 10:34 AM | Pump used to fill water truck from water filled pit. Note water level is near overflow. |

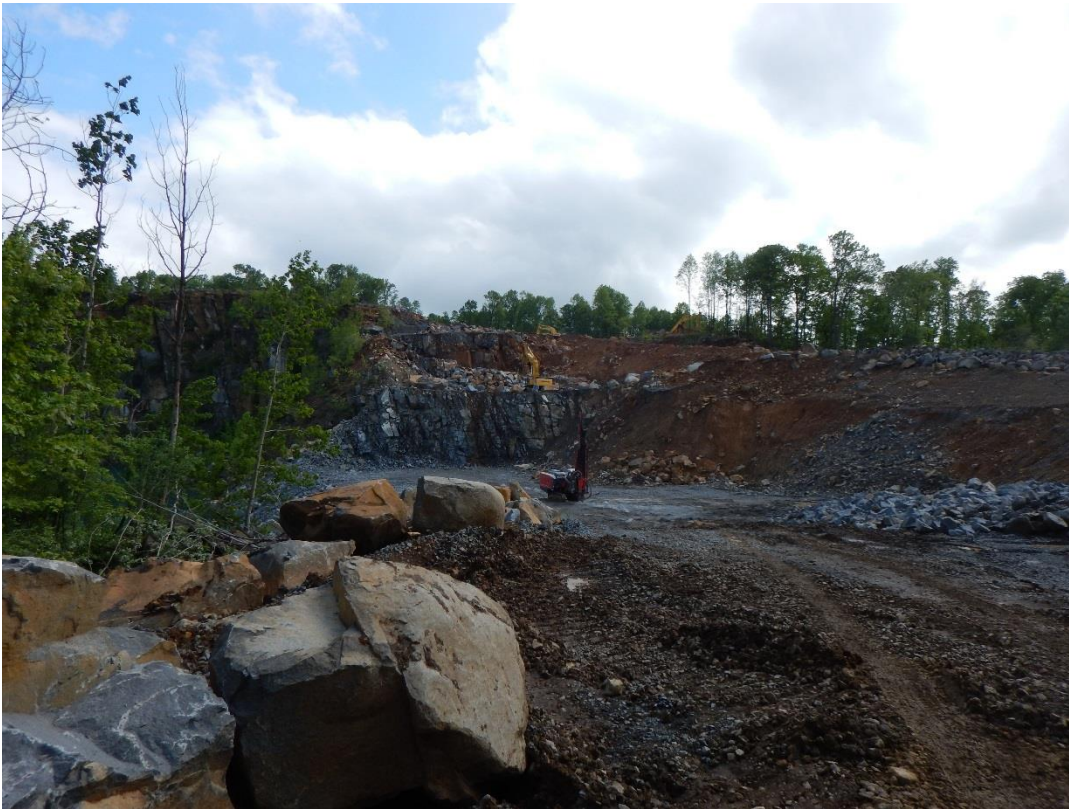
| Photo ID # | Time | Description/Observations |
|---|---|---|
| DSCN0110 | 10:44 AM | Rig drilling blasting holes. Looking northeast onto bench. |

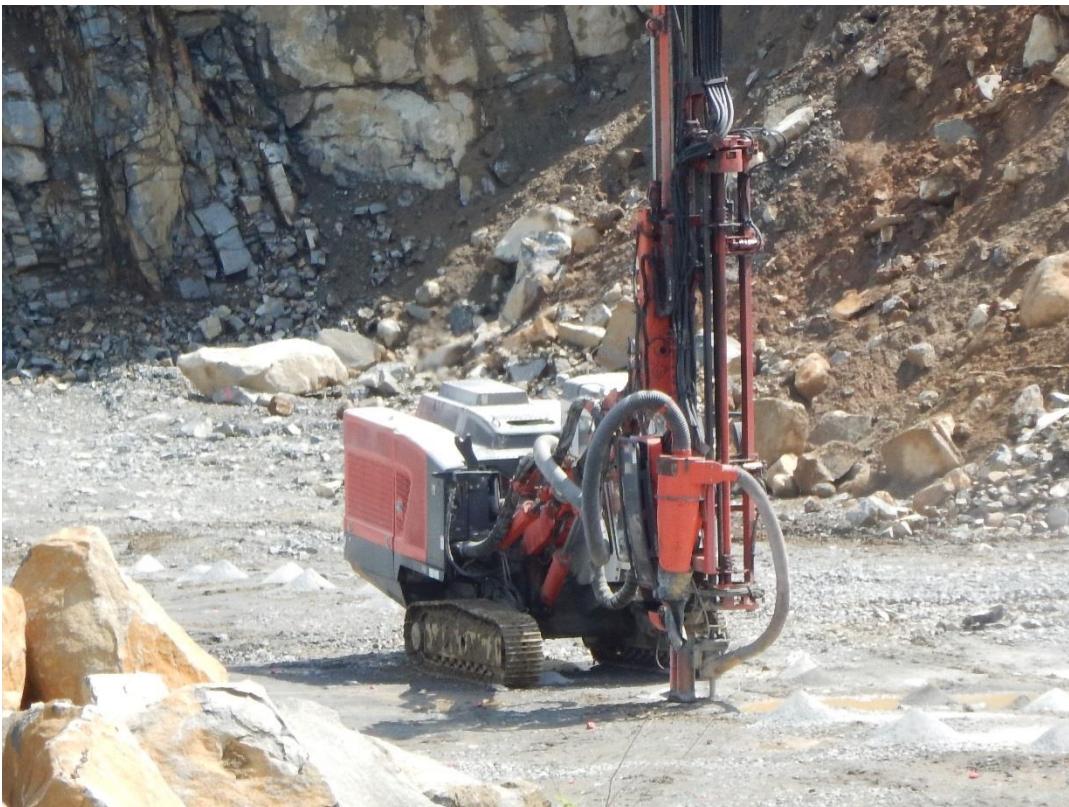
| Photo ID # | Time | Description/Observations |
|---|---|---|
| DSCN0111 | 10:45 AM | Rig drilling blasting holes. Looking northeast onto bench. |

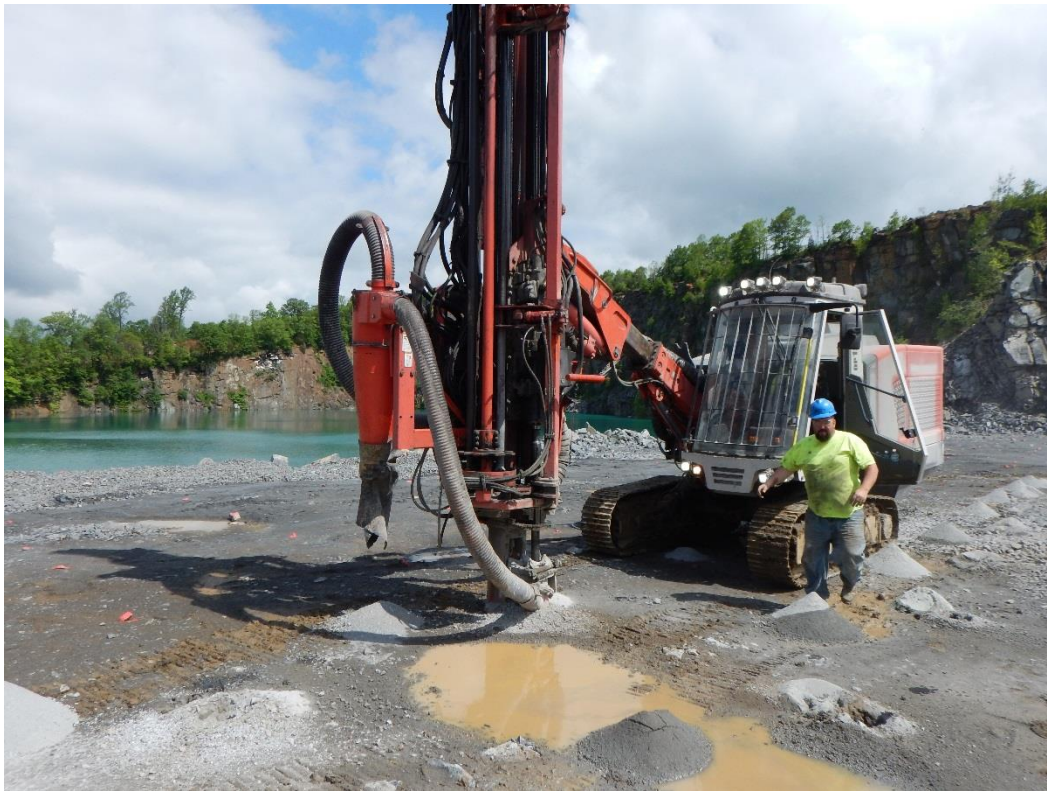
DSCN0112 – erroneous video  
DSCN0113

| Photo ID # | Time | Description/Observations |
|---|---|---|
| DSCN0113 | 10:50 AM | Drill rig with operator. |
