| 2700-FM-BAQ0023 2/2015<br><b>pennsylvania</b><br>DEPARTMENT OF ENVIRONMENTAL PROTECTION | | | <h2 style="margin: 0;">INSPECTION REPORT</h2> | | | Commonwealth of Pennsylvania<br>Department of Environmental Protection<br>Air Quality Program | | | | | |
| Company Name:<br><b>Richard E. Pierson Materials Corp</b> | | | | Municipality:<br><b>East Rockhill Twp</b> | | | | County:<br><b>Bucks</b> | | | |
| Plant Name:<br><b>East Rockhill Quarry</b> | | | | Physical Location:<br><b>Same as below</b> | | | | Federal ID — Plant Code #: | | | |

## PHOTO LOG FORM

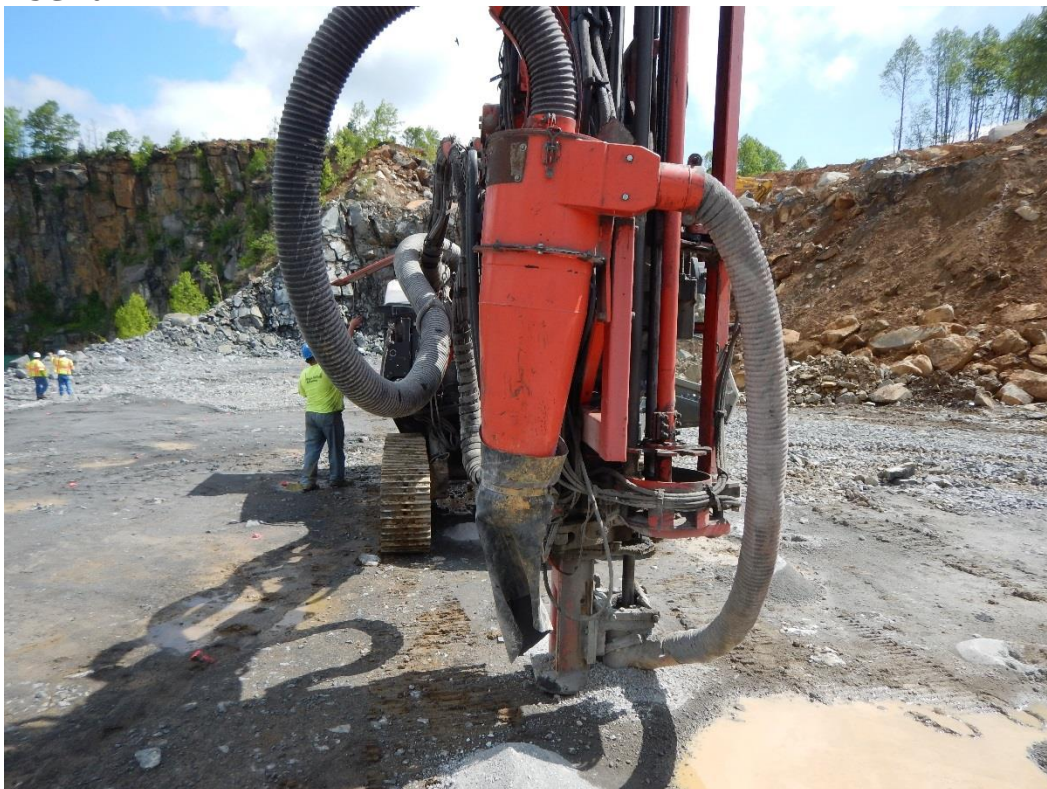
| Photo ID # | Time | Description/Observations |
|---|---|---|
| DSCN0114 | 10:56 AM | Drill assembly with solids collection cyclone and dust collection ducts/hoses. |

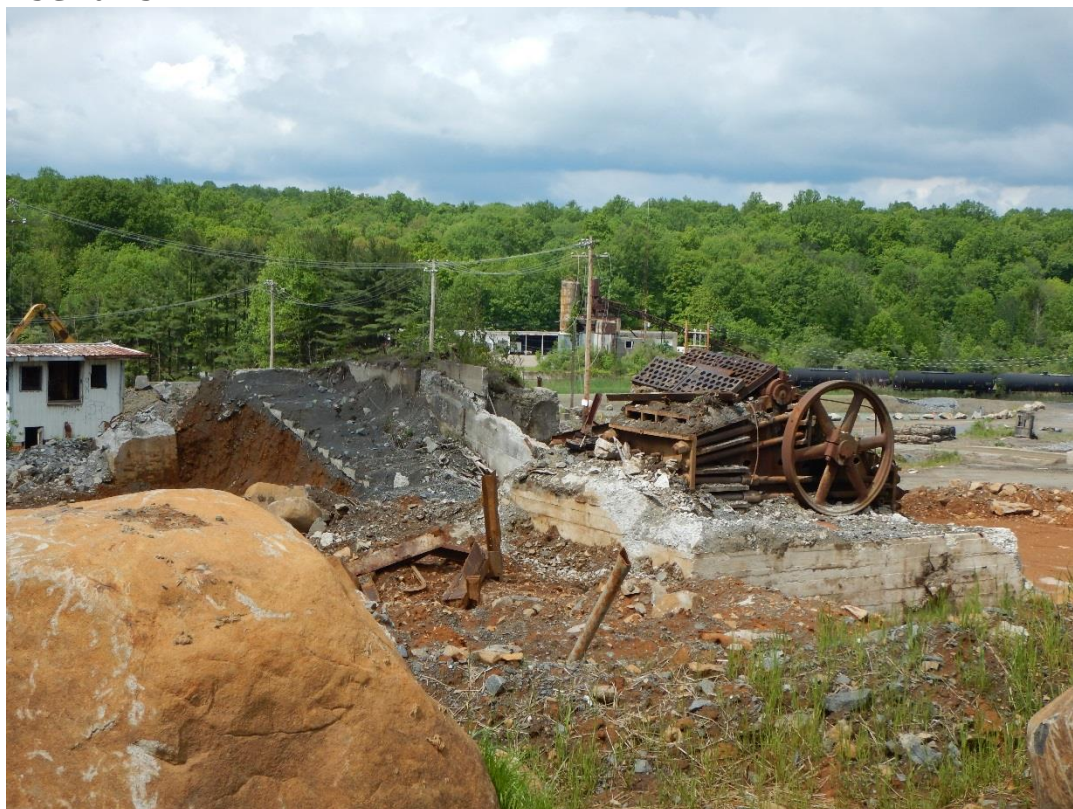
| Photo ID # | Time | Description/Observations |
|---|---|---|
| DSCN0115 | 11:07 AM | Pre-existing primary crusher. Looking west from water filled pit. |

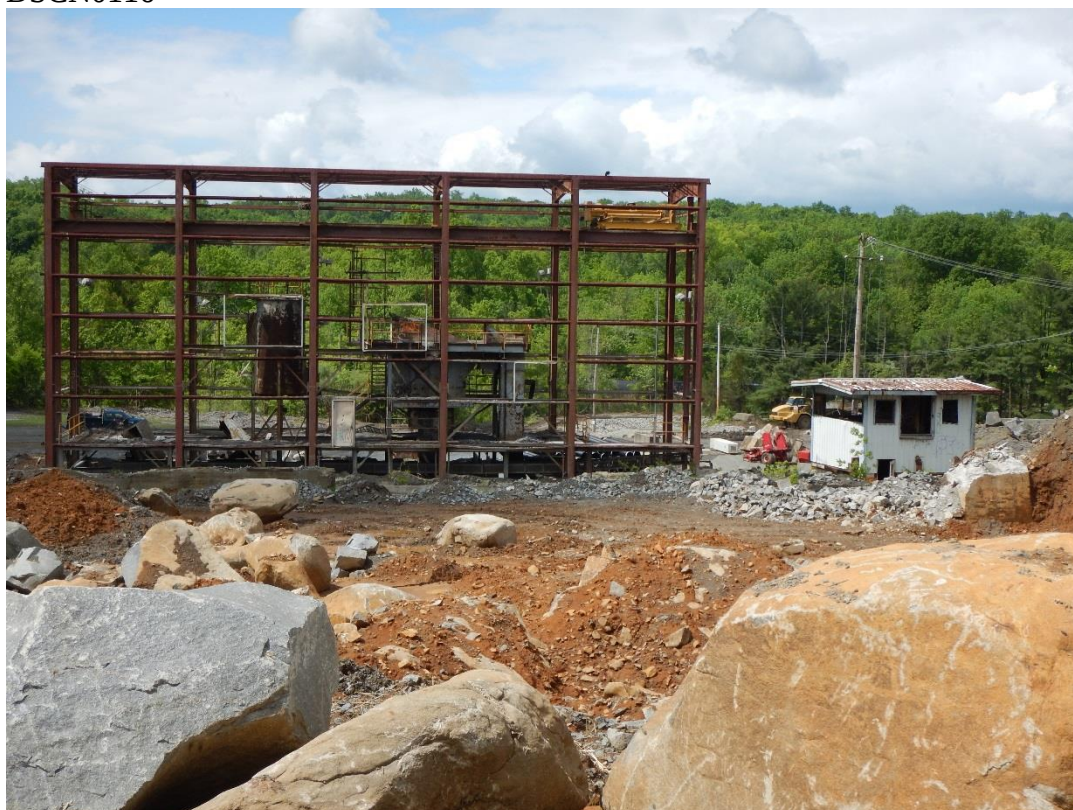
| Photo ID # | Time | Description/Observations |
|---|---|---|
| DSCN0116 | 11:07 AM | Pre-existing secondary crusher building that has had the siding removed. Facing southwest from water filled pit. |

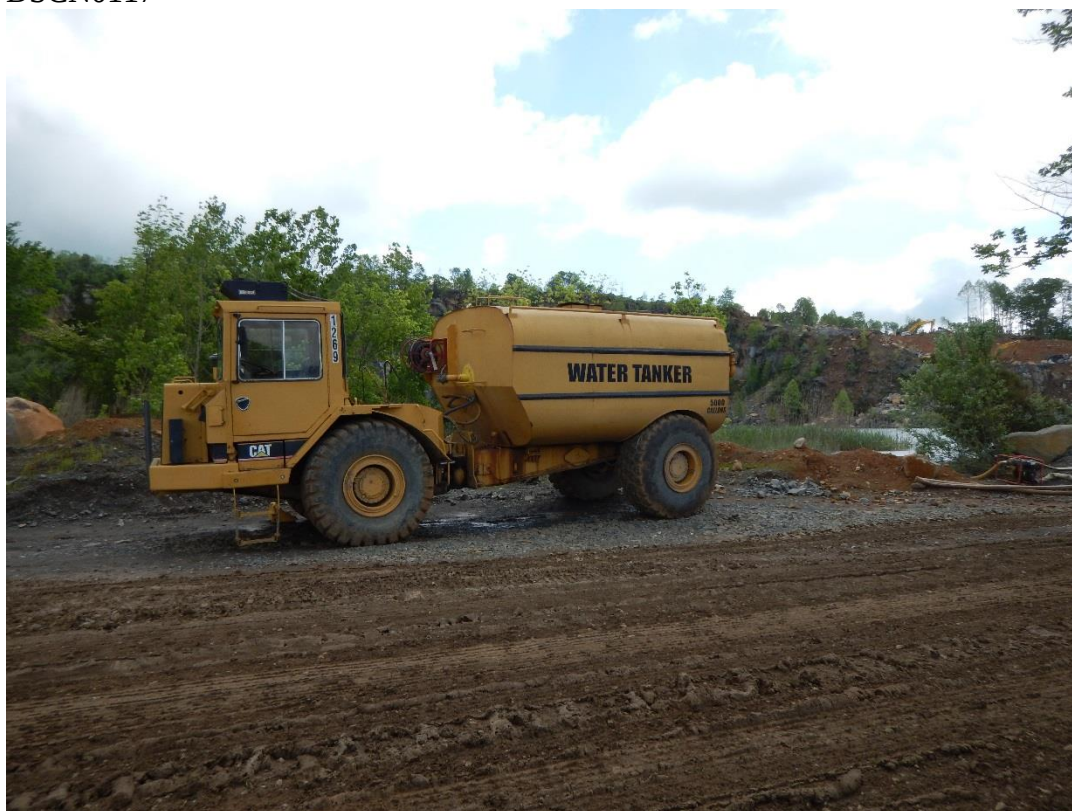
| Photo ID # | Time | Description/Observations |
|---|---|---|
| DSCN0117 | 11:09 AM | Water truck and pump at pit. |
