**COMMONWEALTH OF PENNSYLVANIA
DEPARTMENT OF ENVIRONMENTAL PROTECTION
BUREAU OF MINING PROGRAMS**

Inspection Report

Inspection Type	RTNC - Routine/Complete Inspection	Permit Number	7974SM1
DEP Office	EP DMO Pottsville Dstr Mng Off	NPDES Number	PA0594121
Permittee Name	HANSON AGGREGATES PA LLC	PF Name	HANSON AGGREGATES PA ROCK HILL QUARRY
Address 1	7660 IMPERIAL WAY	Permit Type	IMMO - Industrial Mineral Mining Operation
Address 2		Permit Kind	LARGE - Surface Large
City	ALLENTOWN	License Number	24143
State/ZIP Code	PA 18195-1016	Permit Status	ACTIV - Active
Arrival Date / Time	05/28/2021 09:57 AM	Municipality	East Rockhill Township
Depart Date / Time	05/28/2021 10:57 AM	County	Bucks
Inspection ID	3200195	GP12 Permit Number	
Contract Operator Name		Contract Operator License Number

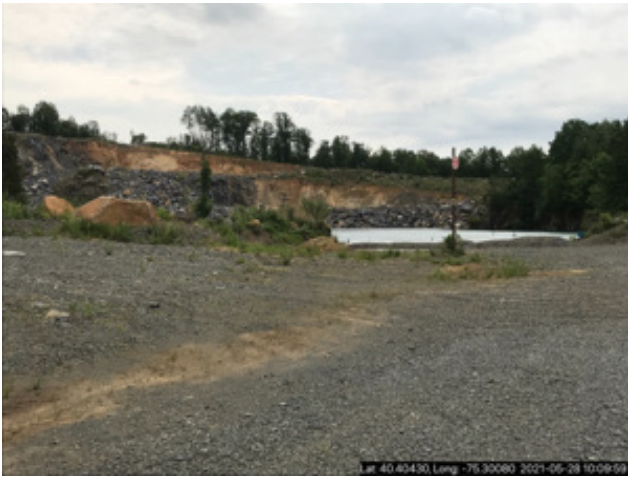
No activity observed. Erosion and sedimentation controls observed to be in good condition. Discharge was clear. Vegetation on areas seeded was good except for two areas along the NE side of the pit. Spoke with operator about reseeding this area (photo 1). Will continue to monitor.

Looking NW at quarry face

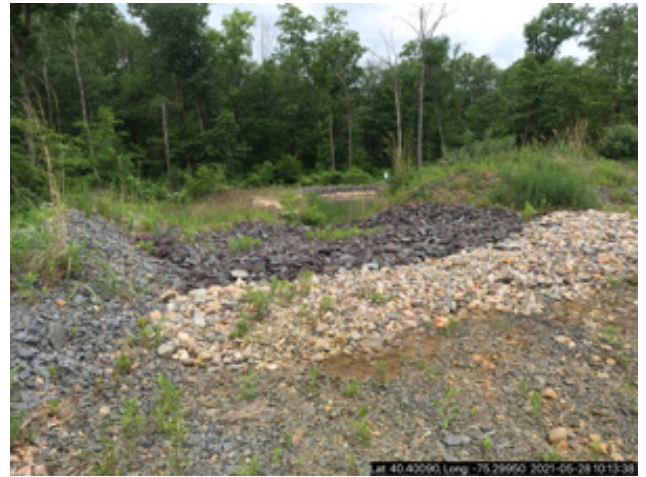
Looking S at inlet for sed trap in S corner

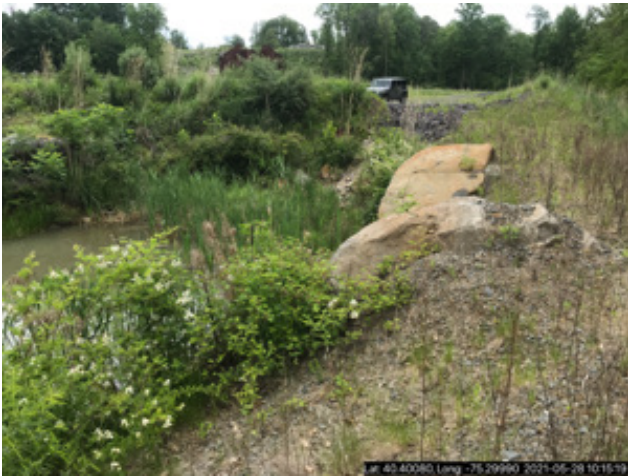
Looking W at vegetation in sed trap

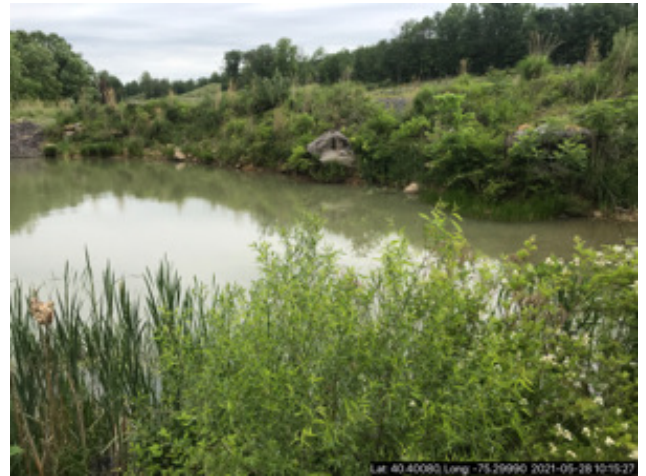
Looking W at water in sed trap

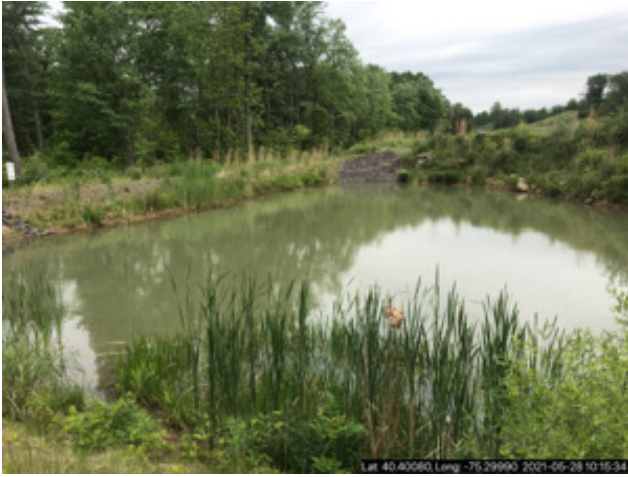
Looking W at water in sed trap

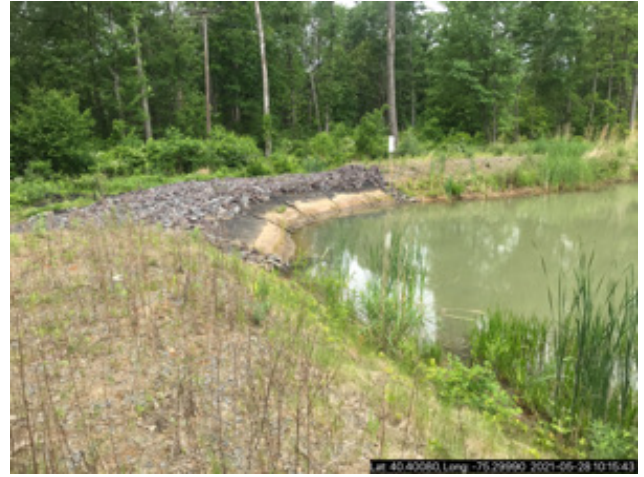
Looking S at emergency spillway

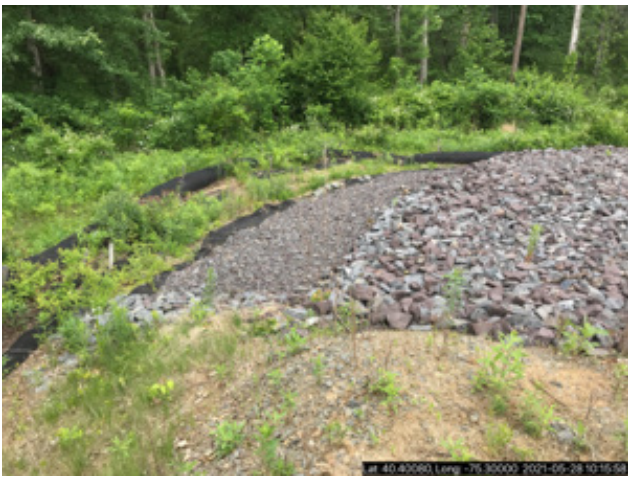
Looking S at area behind sed trap

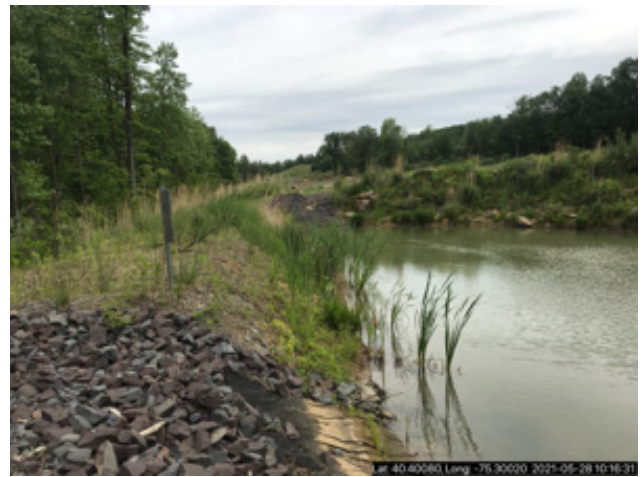
Looking W at second inlet

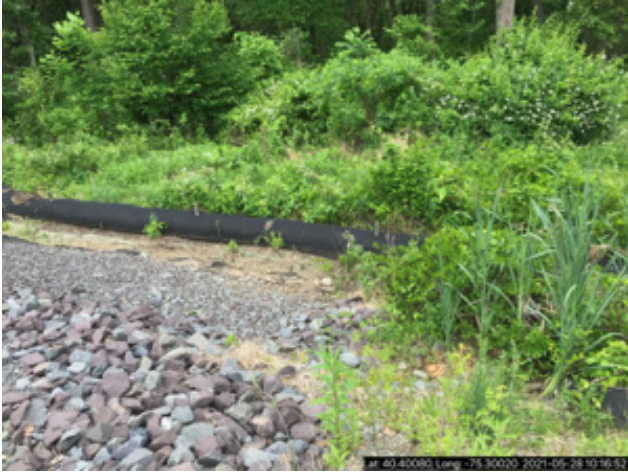
Looking S at silt sock

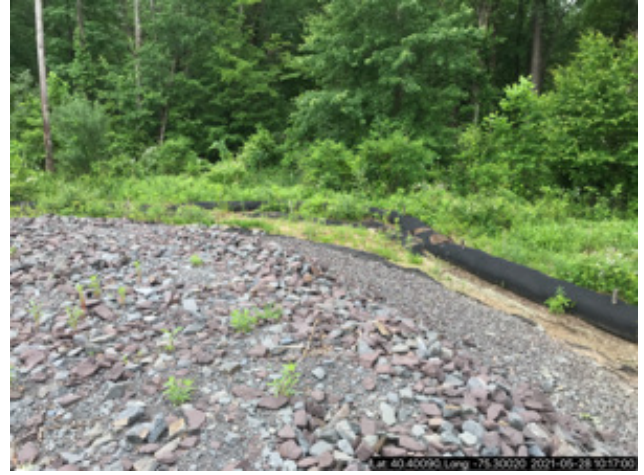
Looking at silt sock along bottom of sed trap

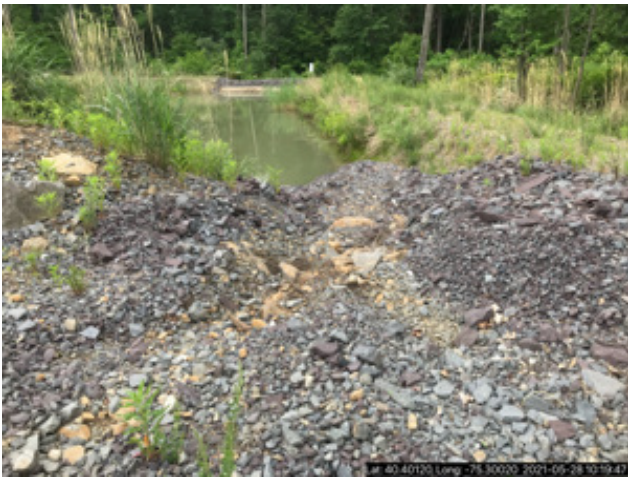
Looking E at second inlet for sed trap

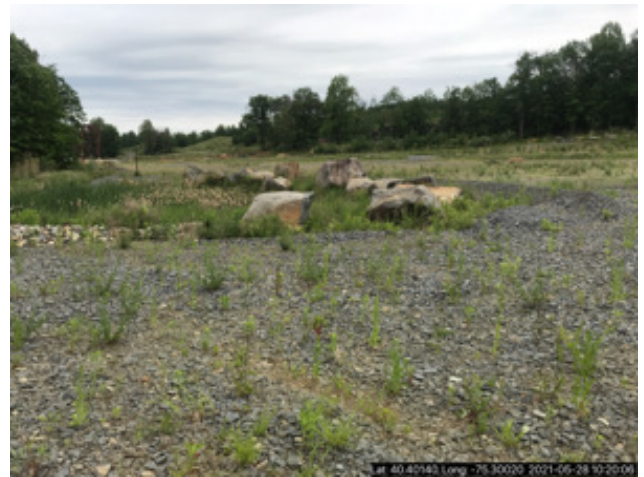
Looking W at smaller sed trap

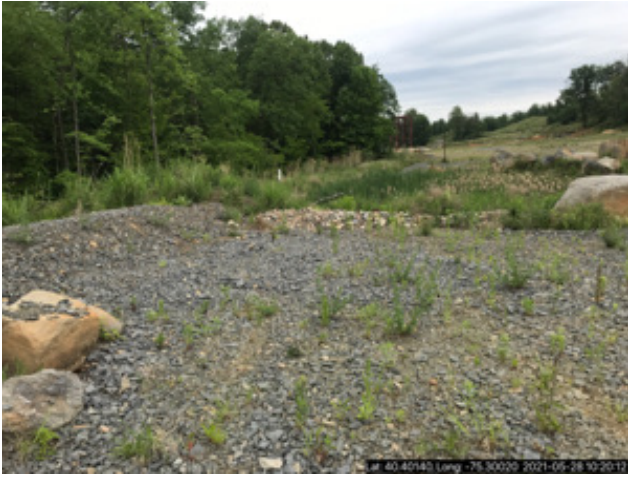
Looking W at smaller sed trap

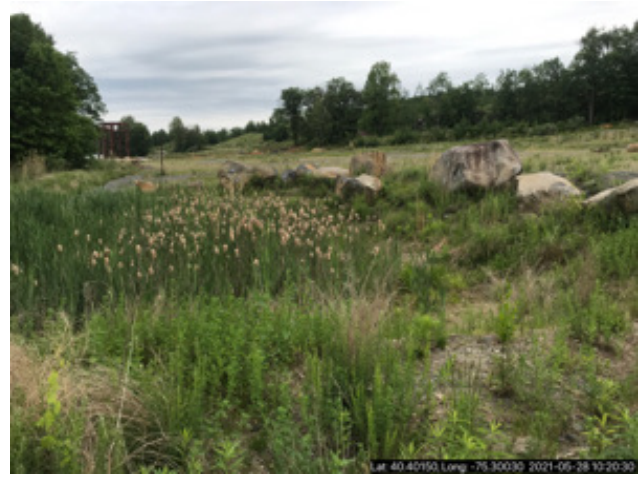
Looking W at vegetation in smaller sed trap

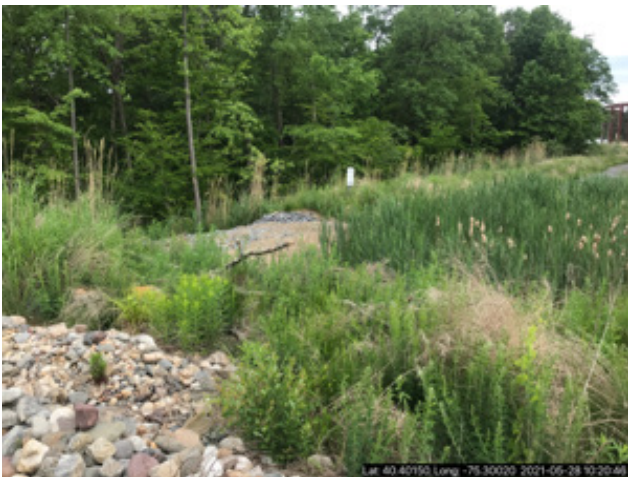
Looking W at emergency spillway for smaller sed trap

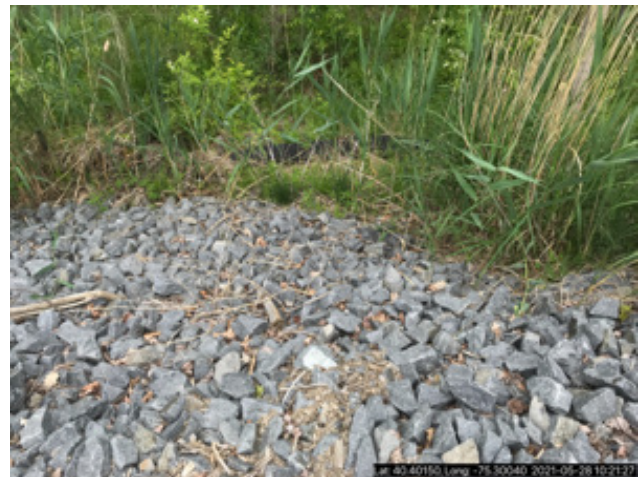
Looking S at silt sock around smaller sed trap

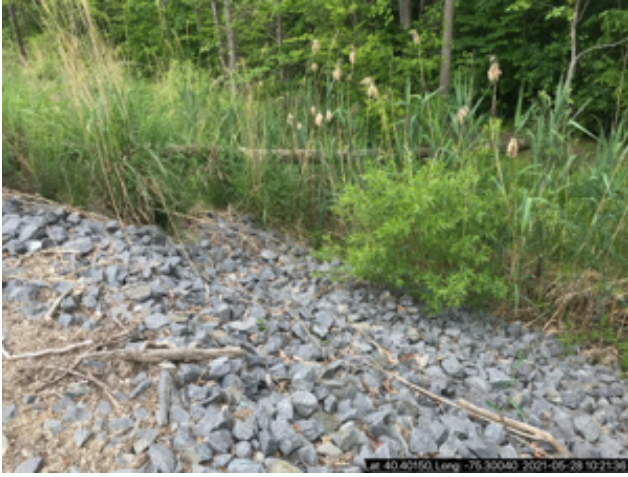
Looking S at silt sock around smaller sed trap

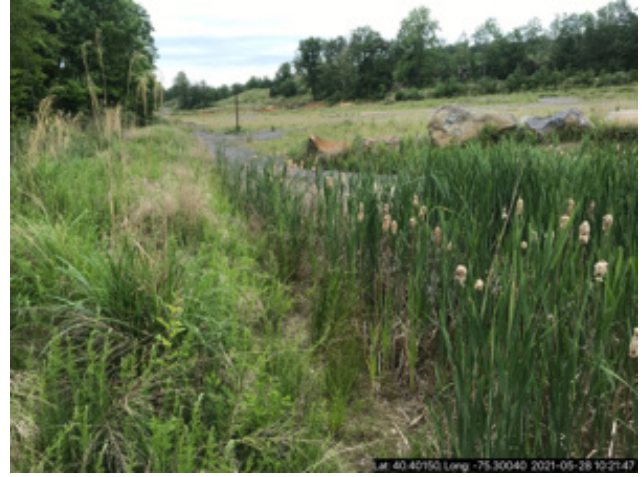
Looking W at second inlet for smaller sed trap

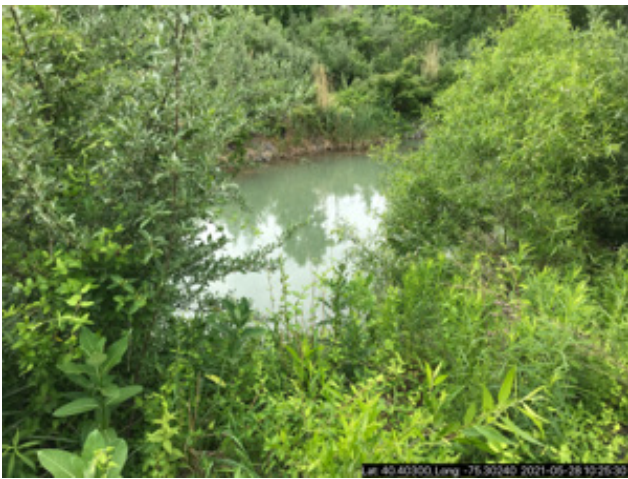
Looking S at sed trap at pine trees

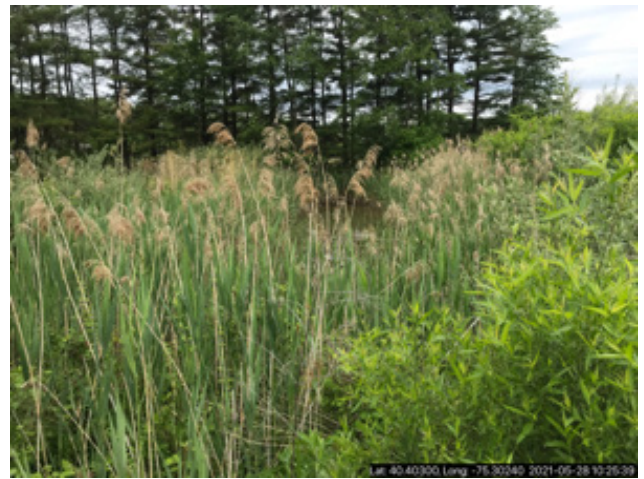
Looking N at sed trap at pine trees

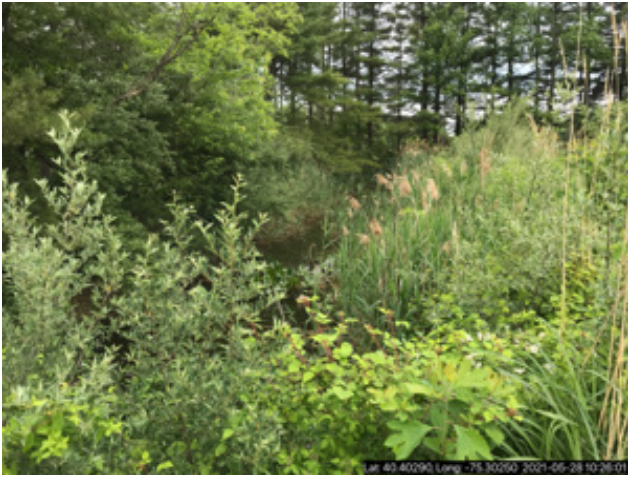
Looking N at sed trap at pine trees

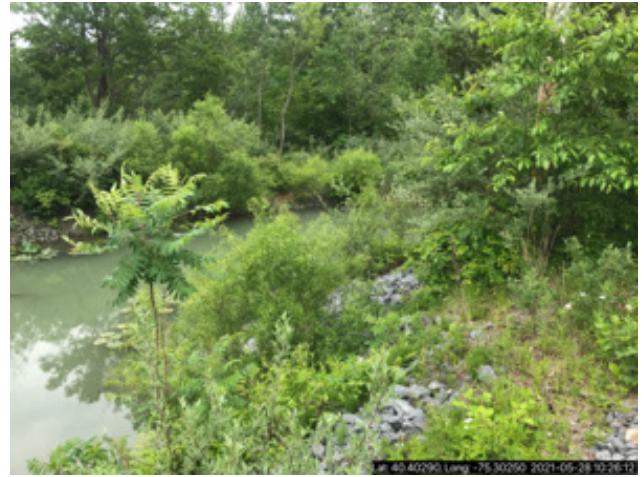
Looking S at water in sed trap at pine trees

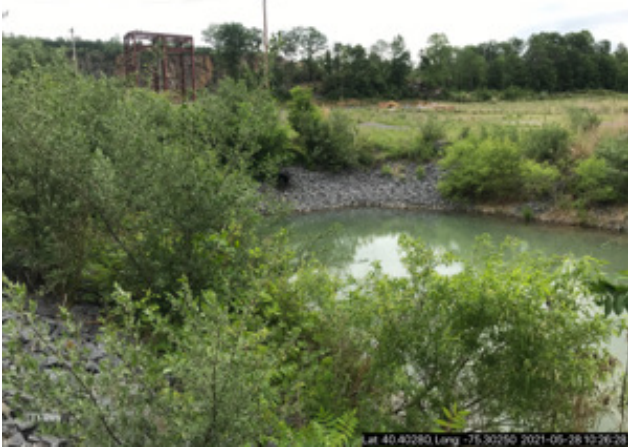
Looking NW at inlet for sed trap at pine trees

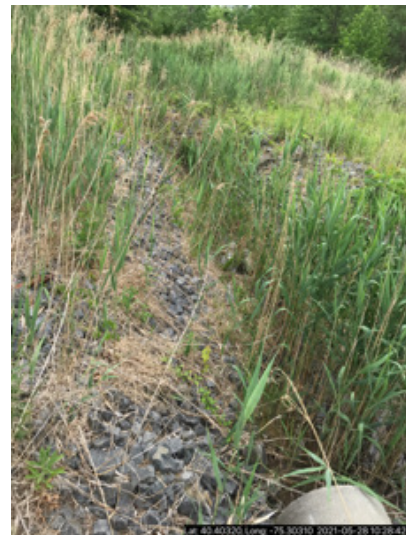
Looking S at outlet of sed trap next to pine trees

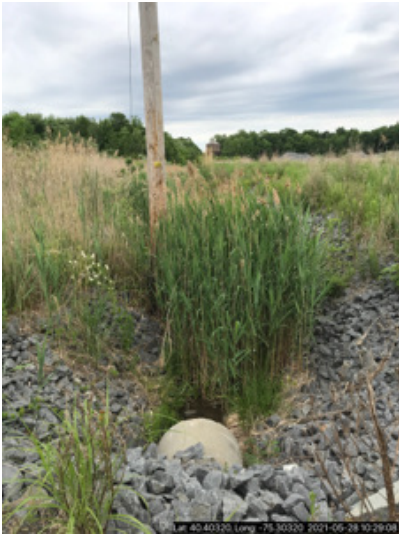
Looking N at inlet for basin by entrance

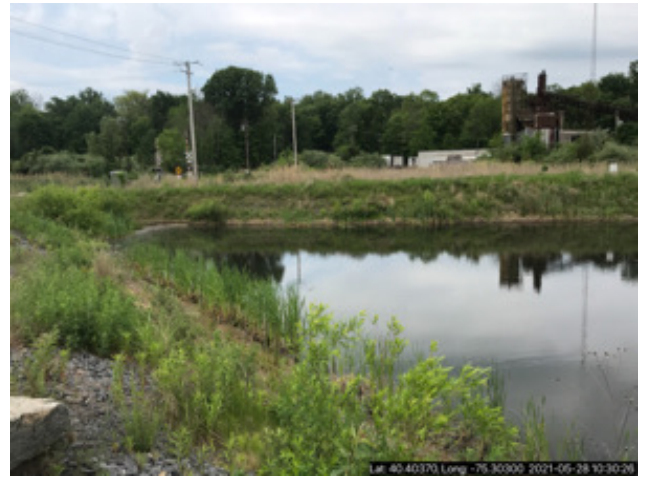
Looking S at basin by entrance

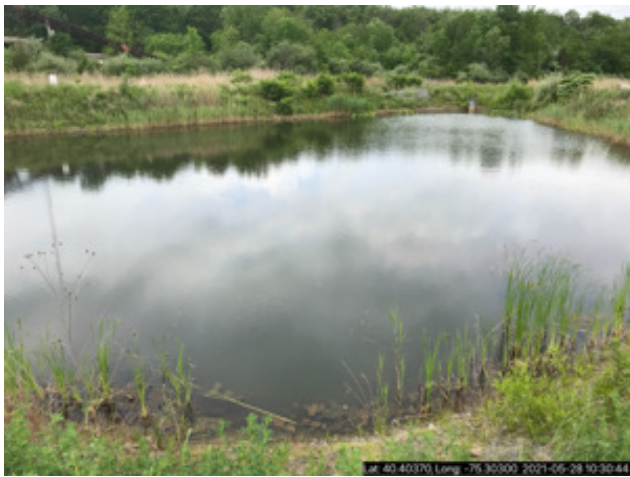
Looking NW at basin by entrance

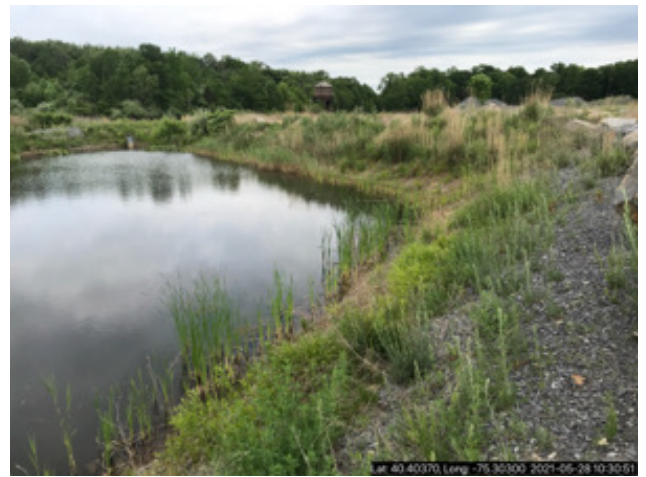
Looking W at basin by entrance

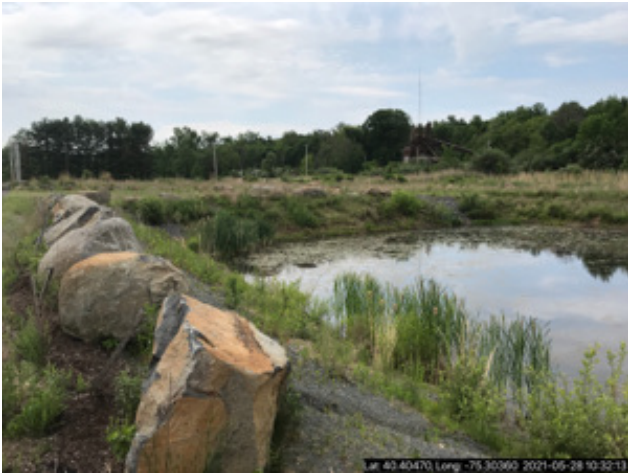
Looking SE at middle basin

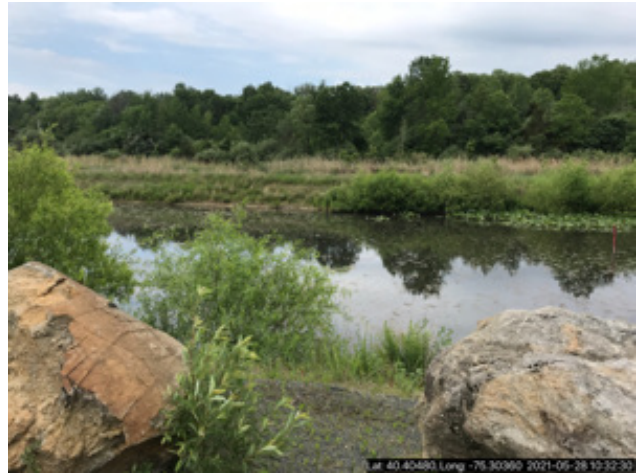
Looking W at middle basin

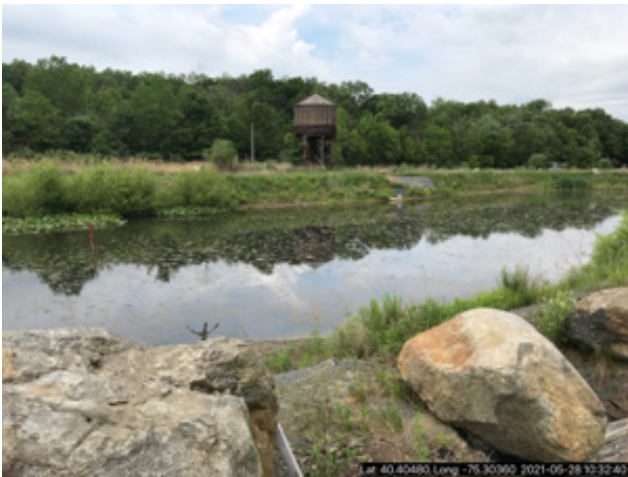
Looking W at middle basin

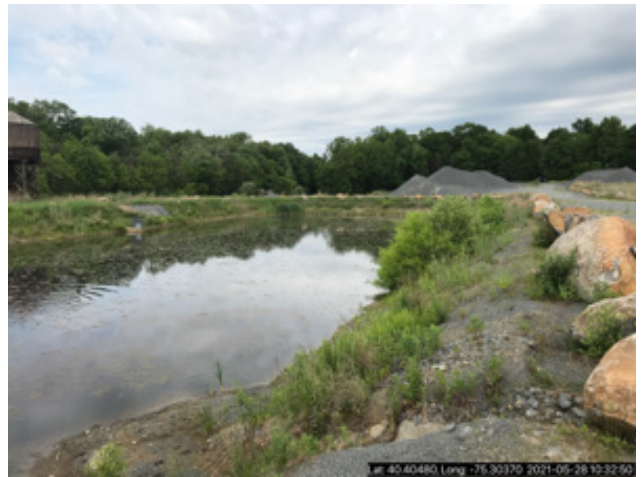
Looking NW at middle basin

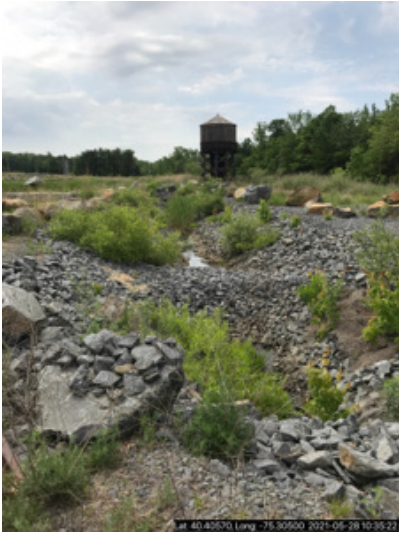
Looking S at channel behind second basin

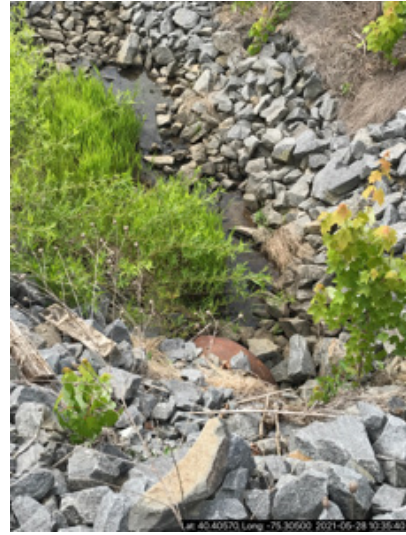
Looking S at inlet to discharge channel

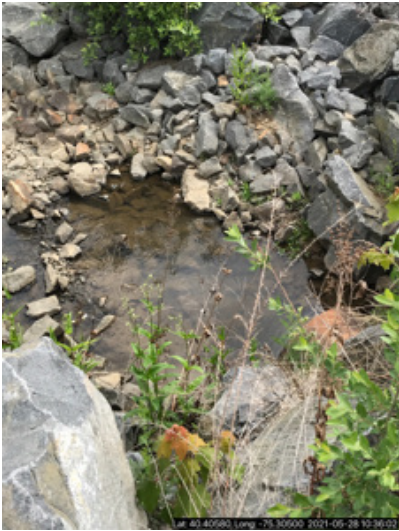
Looking N at inlet pipe to discharge channel

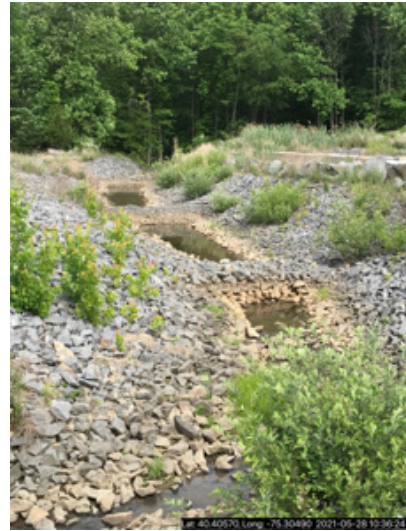
Looking N at discharge channel

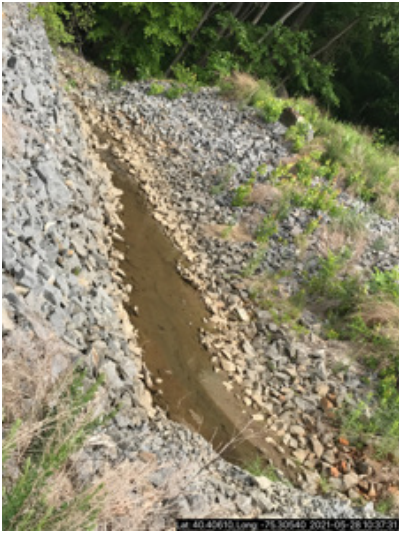
Looking N at last section of discharge channel

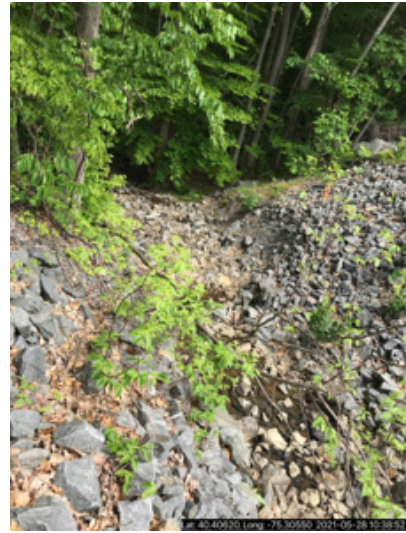
Looking N at outfall

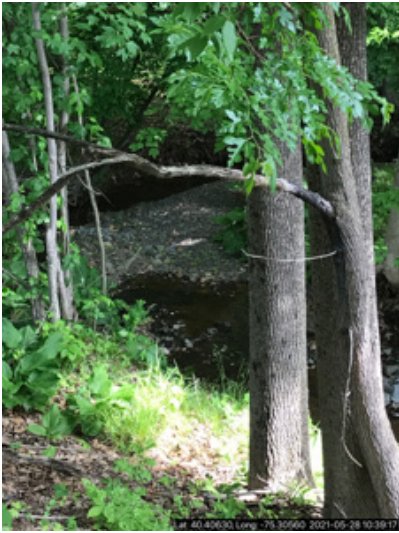
Looking N at water discharged
