COMMONWEALTH OF PENNSYLVANIA DEPARTMENT OF ENVIRONMENTAL PROTECTION BUREAU OF MINING PROGRAMS

Inspection Report

| Inspection Type | RTNC - Routine/Complete Inspection | Permit Number | 7974SM1 |
|---|---|---|--|
| Permittee Name | HANSON AGGREGATES PA LLC | PF Name | HANSON AGGREGATES PA ROCK HILL QUARRY |
| Arrival Date / Time | 08/23/2022 08:57 AM | Municipality | East Rockhill Township |

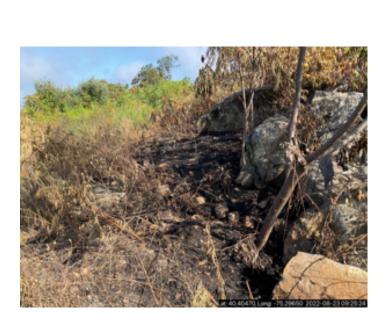
Gate was locked upon arrival. No activity was observed and all erosion and sedimentation controls were in good working order. I traveled to the top level to look at the area where a fire was started by three individuals who trespassed on the property. On 8/22/2022 Mr. Andrew Gutshall (Area Environmental Manager/Hanson) called me to notify the Department of the fire that occurred on 8/19/2022. Fire crews cut the lock on the gate and were able to access the area to extinguish the fire. No injuries were reported and the fire was not related to mining activity. Photos of the area of the fire are attached.

Area on top level SE side where fire was on 8/19/2022

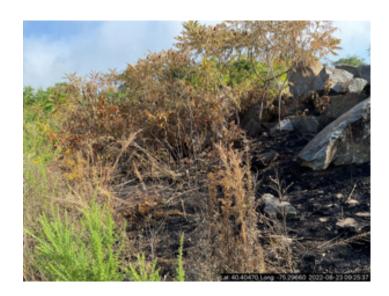
Area on top level SE side where fire was on 8/19/2022

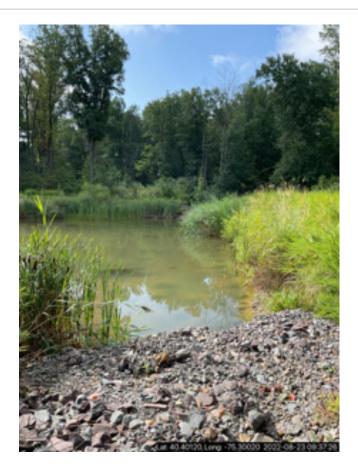
Sediment trap in SW corner of permit

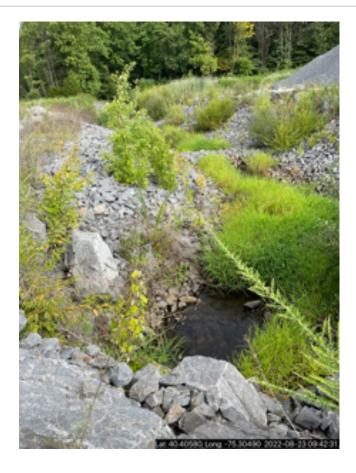
Discharge channel with clear water flowing in
