## NARRATIVE REPORT FORM

**Facility Name:** Glenwood Drive and Walker Road
**Primary Facility ID:** 881609 \_\_\_\_\_

| <b>Purpose:</b> Oversight of potable well installation at [REDACTED] | | | | | |

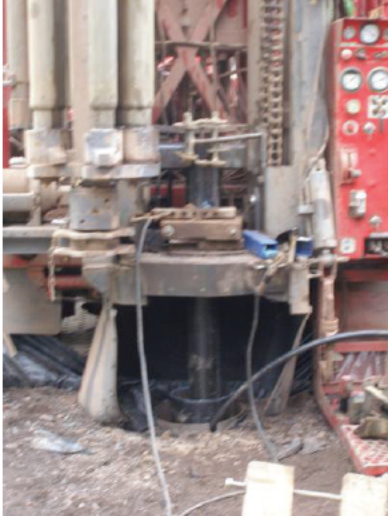
Drill rig set up at [REDACTED]  
9-17DR-25 @ 10:36am

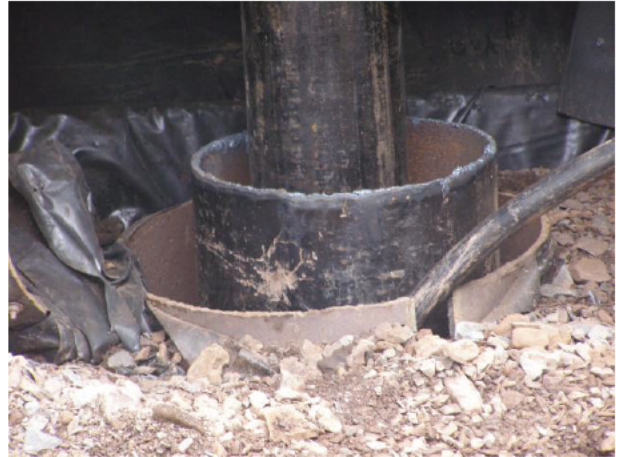
Close up of drill set up at [REDACTED] – side view  
9-17-25 @ 9:39

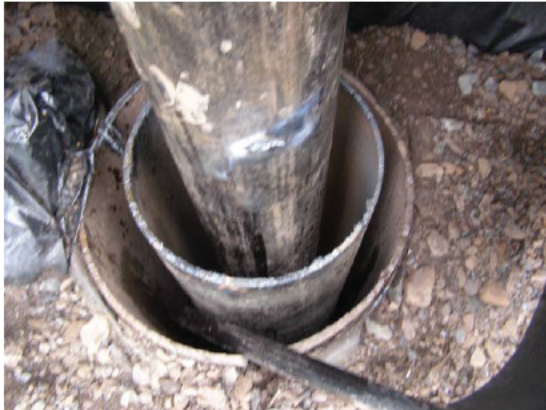
Hose pumping grout into the well – top view  
9-17-25 @ 11:55

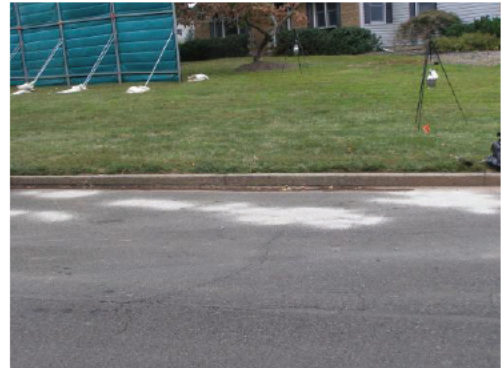
Oil dry applied to where hydraulic oil had leaked from the drilling  
vehicles  
9-17-25 @ 13:27
