Shell Chemical Appalachia LLC
300 Frankfort Rd
Monaca, PA 15061

July 11, 2024

RE: PA-04-00740C Source ID 205B HP Ground Flare #2 Visible Emissions Malfunction Report

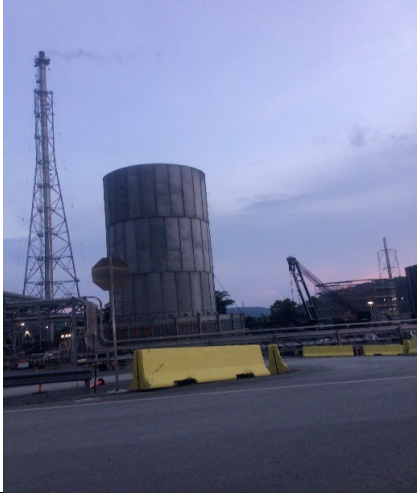
Observer Name: [REDACTED]
 Observer Title: Field Operator
 Date and Time (MM/DD/YY XX:XX): 6/17/24 18:30
 Sky Conditions: See Notes
 Precipitation: Rain
 Wind Direction (direction from): S 187
 Wind Speed (m/s): 7.64
[Site MET Data \(Wind Direction 500QT-060A and Speed 500QT-050A\)](#)
 Visible Emissions Source: High Pressure Ground Flare B (A-59001B)
 Observation Location: R (HPGF A/HPGF B)
 Observation Picture: Picture from west side of flare area

Observed Emissions for 2 hours. Observations started by day shift operator and finished by night shift operator. Sky was cloudy and it was raining at the time. TEGF was smoking for approximately 5 min and then was clear for the two hour period.
