Shell Chemical Appalachia LLC  
300 Frankfort Rd  
Monaca, PA 15061

**RE: PA-04-00740C Source ID 205A and B HP Ground Flare #1 and #2 Visible Emissions Malfunction Report**

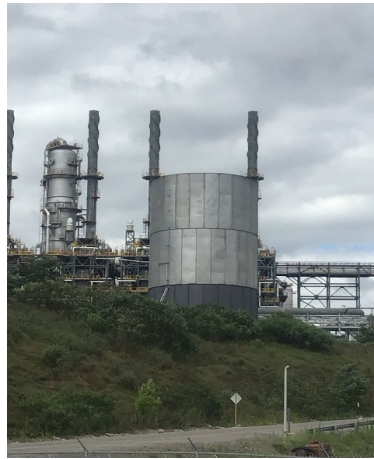
Observation Picture:

Smoking was observed prior to the method 22 being performed. No smoking was observed during method 22.
