Wastewater Treatment System Operational Review

**Rayne Township Elementary School
Wastewater Treatment Facility
PA0204498**

Rayne Township, Indiana County, Pennsylvania

January 16, 2013

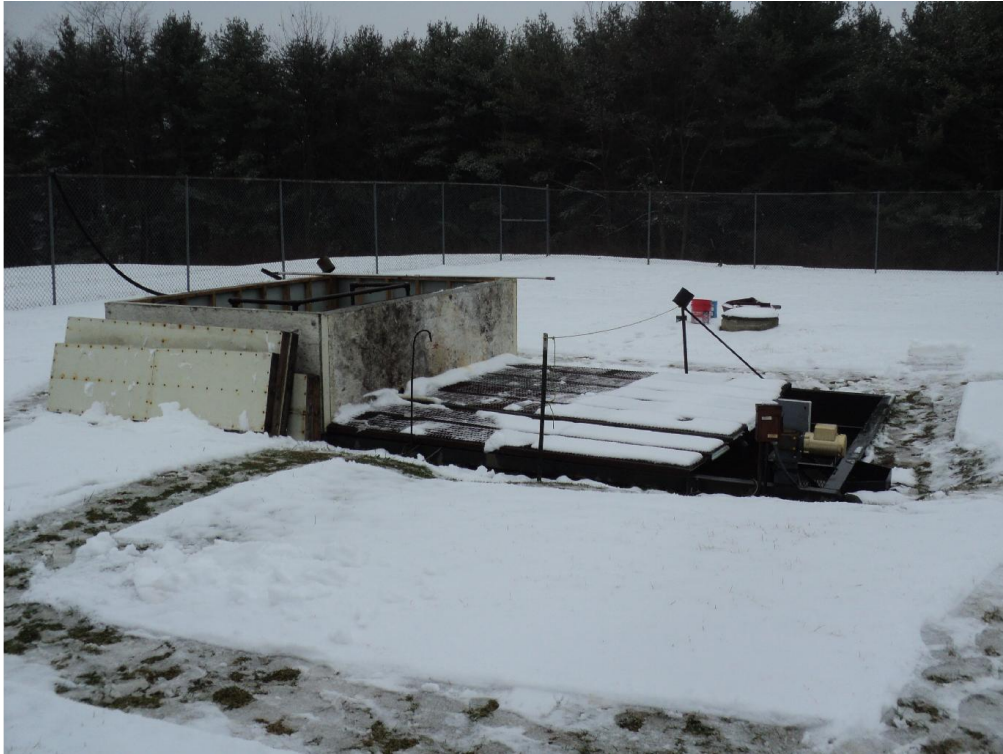
The treatment plant consists of a comminutor, aeration tank, clarifier, chlorine contact tank and sludge holding tank. Sludge solids are removed in liquid form via waste hauler.
