**WASTEWATER TREATMENT EVALUATION
BENEZETTE TOWNSHIP STP
PART II – HIGH TOURIST SEASON
BENEZETTE TOWNSHIP, ELK COUNTY, PA
NPDES #PA0263711**

Bureau of Clean Water

December 2016

Wastewater Treatment Evaluation, September - October 2016:

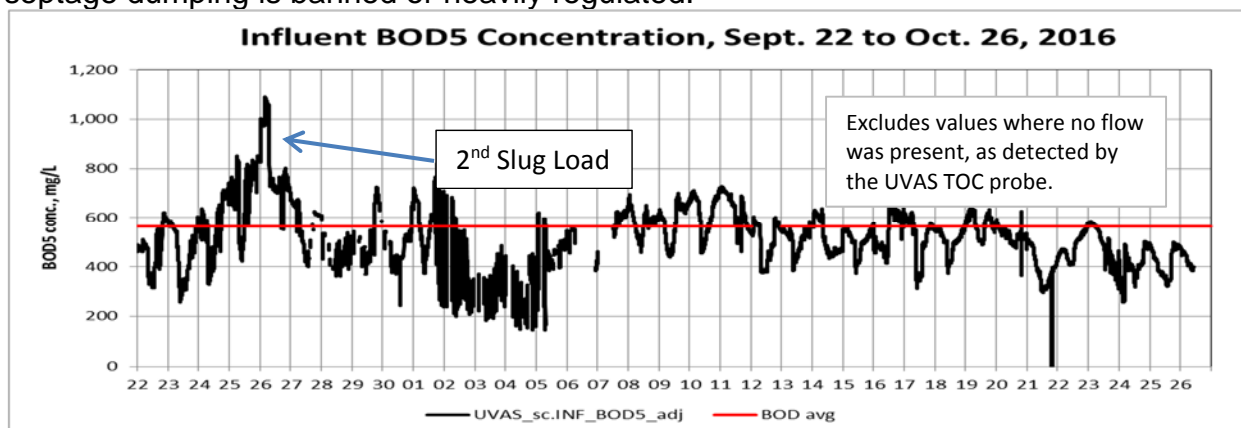
Figure 1: High Tourist Season Influent BOD₅ Concentrations at Benezette Twp STP. In the chart, one sees that the average BOD₅ had been 565 mg/L, compared to a design average concentration of 400 mg/L.

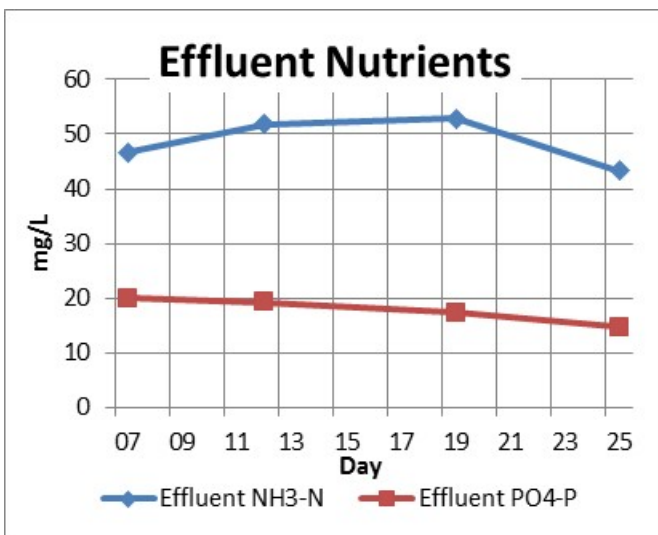
Figure 2: Effluent NH3-N & TP

Dissolved oxygen levels in the oxic zones remained well-below the recommended minima of 1.0 to 1.5 mg/L, and Oxidation / Reduction Potential in the oxic zone remained in the “anoxic” zone, while in the denitrification (anoxic mixing) zones, the ORP remained in the “anaerobic” zone (instead of “anoxic.”) The consequence of this is that the high-strength organic waste remained relatively untreated; the ammonia-nitrogen spiked as high as 70 mg/L in the disinfection tank, with effluent ammonia-nitrogen grab test results in the high forties and low fifties.

Effluent phosphorus grab-tested in the mid-to-upper teens. What chlorine was available for disinfection was rapidly consumed by settled solids and by nitrites. Effluent at Outfall 001 had a distinctive brown, cloudy appearance and smelled strongly of ammonia and organic acids.

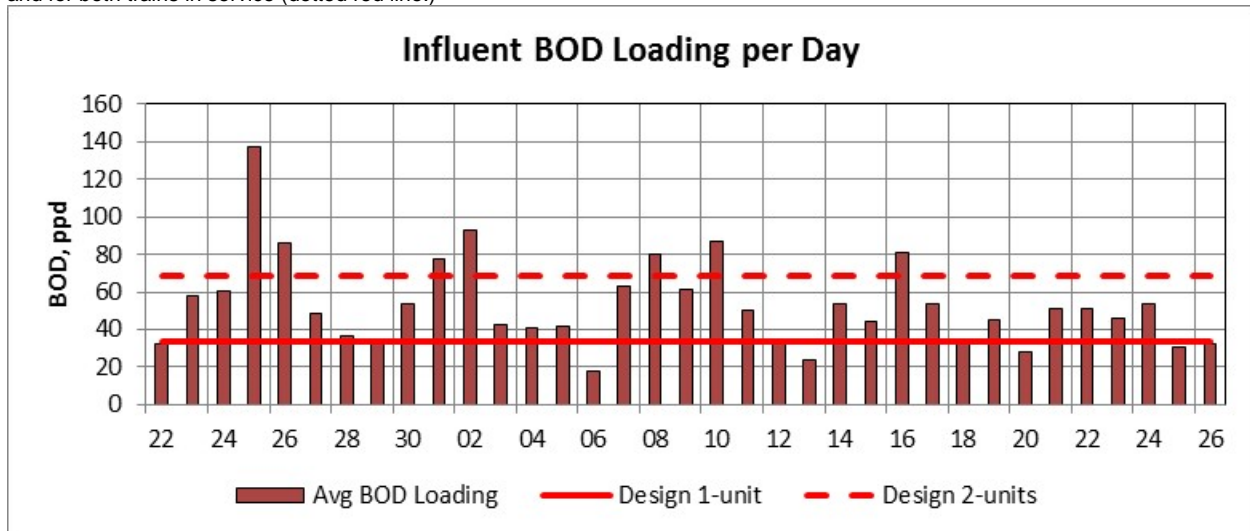
Figure 4: High Tourist Season Influent BOD5 Loading at Benezette Twp STP, with loading limits shown for 1 train (solid red line,) and for both trains in service (dotted red line.)

The preceding chart depicts the organic loading to the facility between Sept. 22 and Oct. 26, 2017. The organic loading limit for the facility is 68 lb. BOD₅/day, and if one train is in service (approx. 50% of aeration capacity,) this limit is halved to 34 lb./day. For many days of the evaluation, the operators were using only one train for treatment and employing the other as an extended holding tank for septage. As seen in the chart, where only one train was in service, the facility experienced sustained organic overload, and this chart does not display data for the initial slug load which occurred around Sunday, September 18. Perry Hretzik set aside a sample of raw influent from that date, and its chemical oxygen demand (COD) tested at 3,100 mg/L. (If, according to Mecal + Eddy, BOD₅ is 50% of COD, then the concentration of the slug load sample would have been 1,550 mg.BOD₅/L.¹

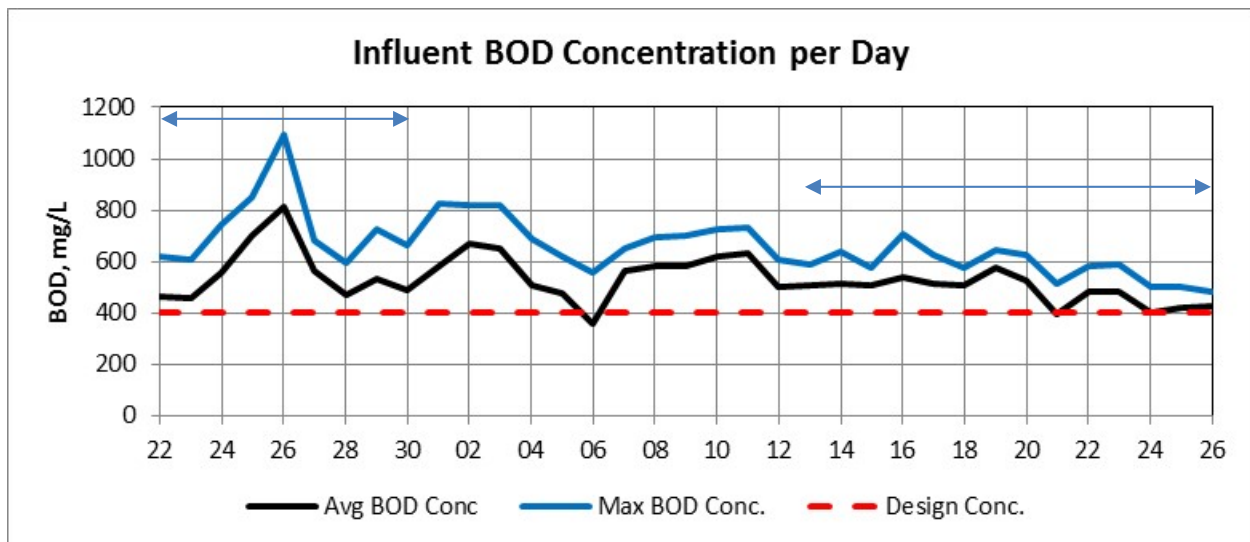
Figure 5: High Tourist Season Influent BOD₅ concentration at Benezette Twp STP, showing the original design BOD₅ concentration as a dotted red line.

In the chart above, where the average BOD₅ had been 565 mg/L, compared to a design average concentration of 400 mg/L. Note for the period from Sept. 22 –Sept. 30, the average BOD₅ concentration was about 660 mg/L, where maximum daily average peaked at 820 mg/L during the final weekend of September, tapering to average concentration of c. 480 mg/L for the last two weeks during the evaluation (Oct. 13-26.) The instantaneous maximum concentration was 1,093 mg/L and occurred on Monday, Sept. 26, 2016, representing the high volume of dumping of caravan and RV waste tanks. This peak follows on a slug load reported by the operators during the previous weekend of Sept. 18, which is alleged to have been equal or higher. (That observation

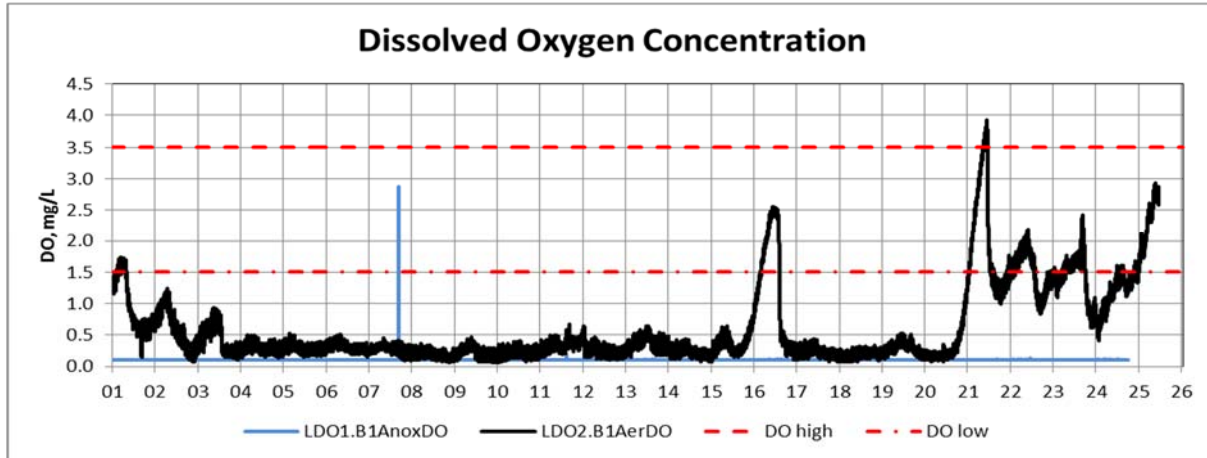
Subsequent effects upon the wastewater treatment system and its operation were, without a doubt, calamitous. For this BNR package plant, the sustained slug loads nullified every consideration that had gone into facility design. Dissolved oxygen concentrations in the oxic zones dropped below 0.5 mg/L and remained there for much of October. Recovery of DO levels began around October 21 as the facility became stable.

Figure 6: DO graph showing insufficient aeration until late October.

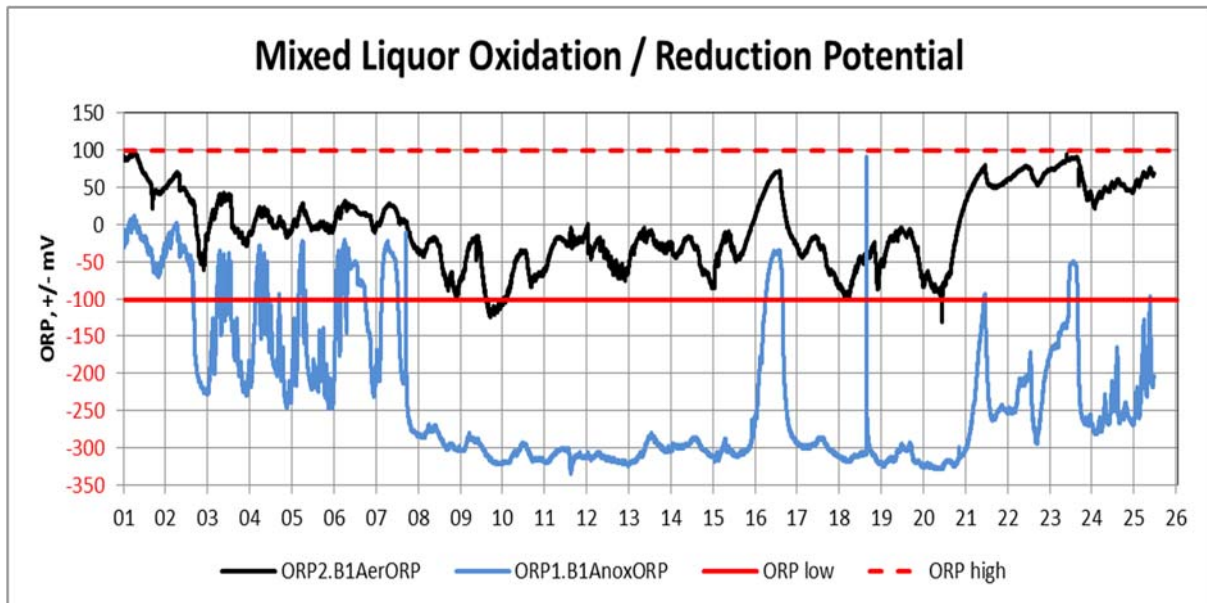
Figure 7: ORP chart for October, showing that Oxidation zone ORP was insufficient for nitrification, while Anoxic zone ORP remained largely within the anaerobic zone. This is further proof that the aeration system, as presently configured, has been insufficient.

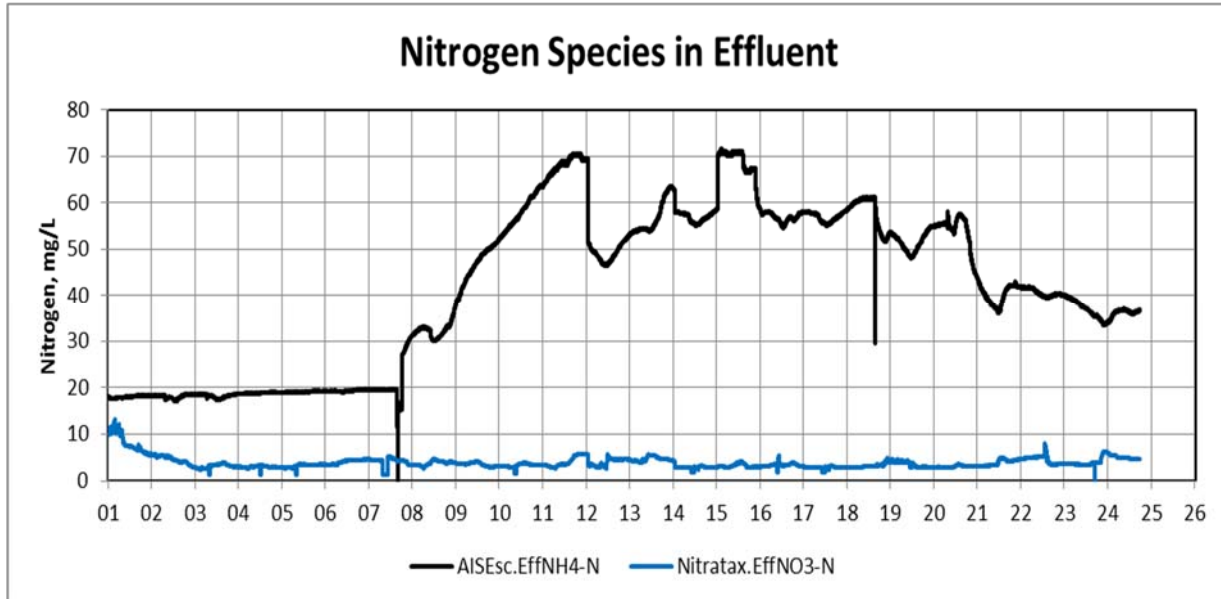
Ammonium and Nitrate probes were located in the disinfection tank. Despite the presence of calcium hypochlorite tablets, ammonia registered as high as 70 mg/L in this tank. Nitrate concentration was low not because of working denitrification but because ammonium remained untreated:

Figure 8: Ammonium and Nitrate concentrations in the Disinfection Tank (Effluent balance tank) showed that ammonia predominated for much of the month, and denitrification will not occur where there is no nitrification to begin with.

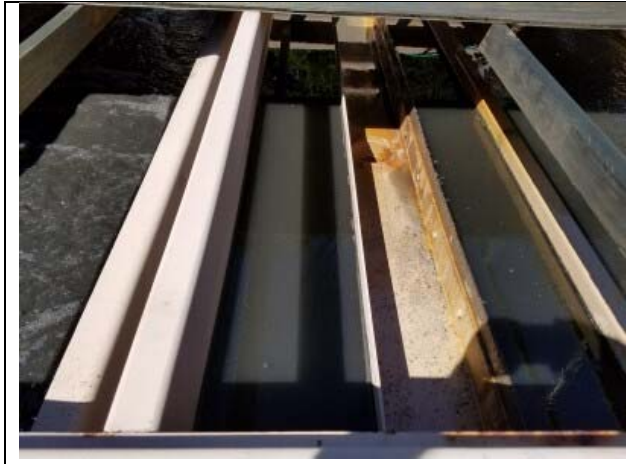
Photo: Grey Water of Clarifier Effluent

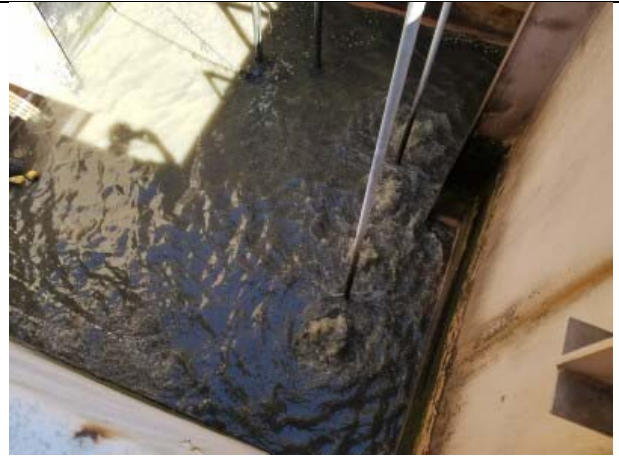
Photo: Surge Tank—Septage and Low Level

- The facility operators should operate both treatment trains during high tourist season. They should adjust the level controls in the surge tank to provide storage capacity and attenuation of high organic loading, insofar as it is possible to do so. Alternatively, the Township may wish to expand the surge tank or replace it in order to attenuate the flow of wastewater into its treatment process or contract hauling of excess wastewater to other treatment facilities where capacity is available.

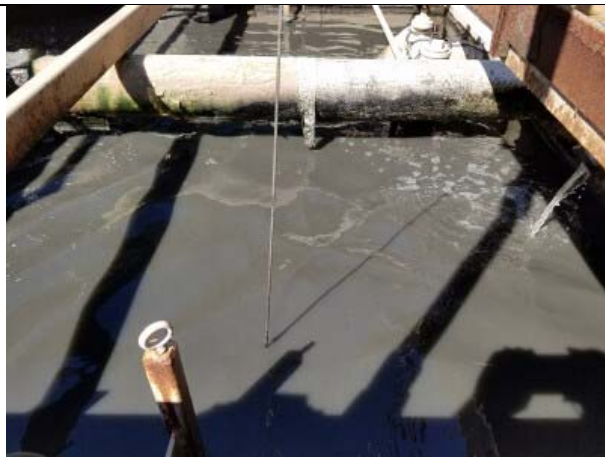
Dead, Grey Biomass in Anoxic Zone

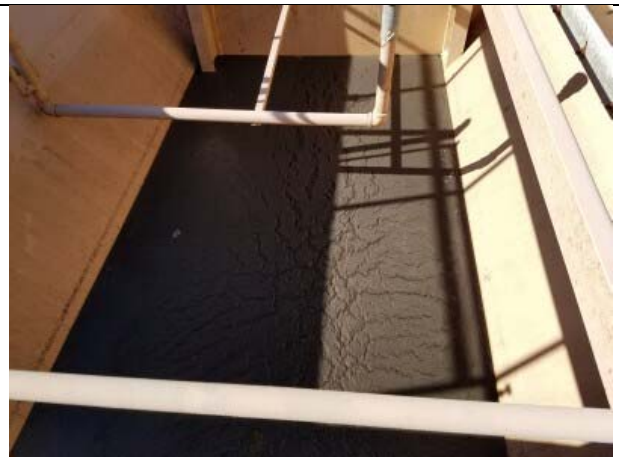
Instead, the operators attempted to sequester high-strength waste into the A-side treatment train, which had been idle, half-empty, and unaerated. They wasted much of the damaged biomass and some of the raw wastewater to the existing reed bed that was not large enough for this sustained amount of loading. The diminished biosolids in B-side treatment were unable to thrive under conditions of low dissolved oxygen and repeated slug loads, and biosolids remained over wasted at about 500 mg/L through the remainder of September. The operators and owners initially resisted the evaluator’s recommendation to transfer in biomass from another treatment plant to stabilize the facility, but eventually, this expense was permitted by the facility owners.

Sequestered Biosolids in A-Side

The evaluator suggested that A-side be put into service, and aeration was restarted. Also, some of the biomass seed sludge was placed in A-side to stabilize the wastewater that had been stored there. The recommendation was to run both treatment trains throughout the remainder of the high-tourist season.

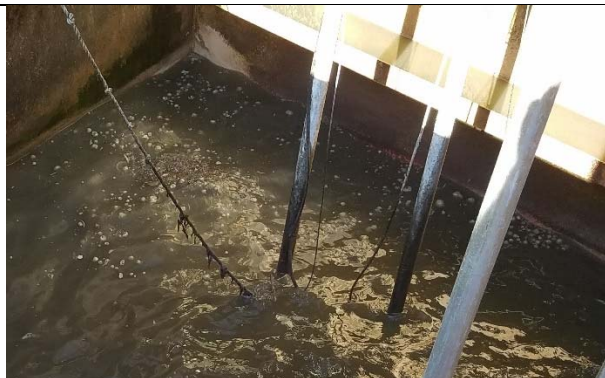
Oil & Grease accumulation in Surge Tank

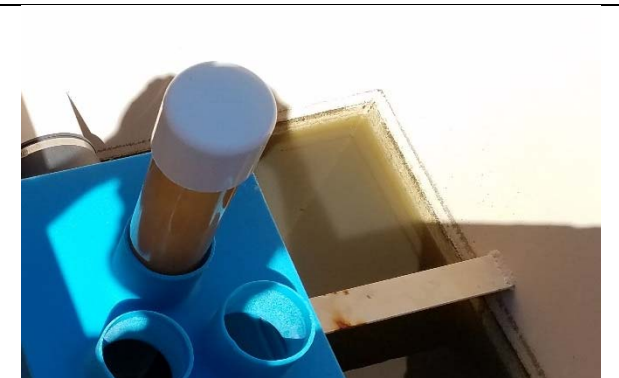
Brown effluent / Sulfonator

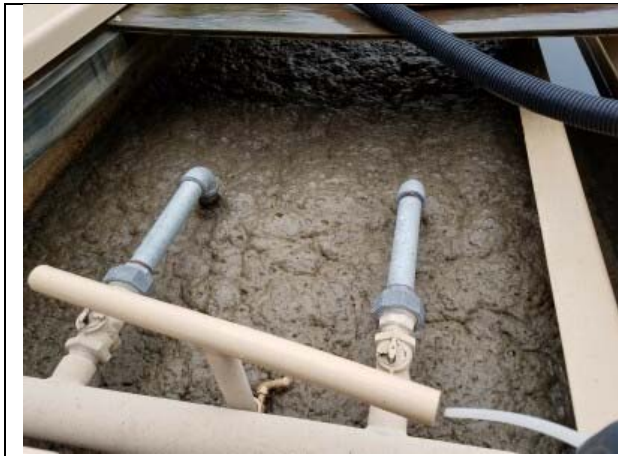
High Organic Load Foaming

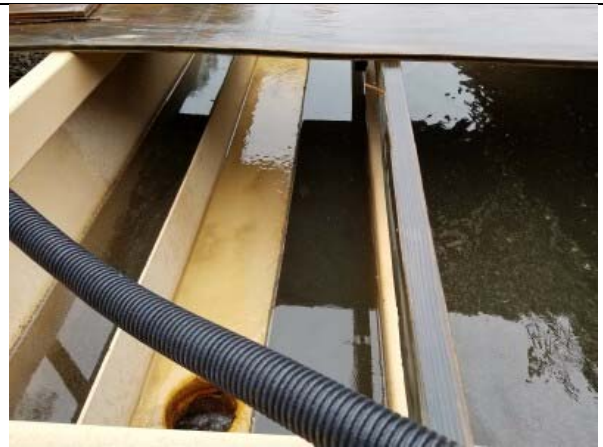
MLSS Carryover in Clarifier Trough

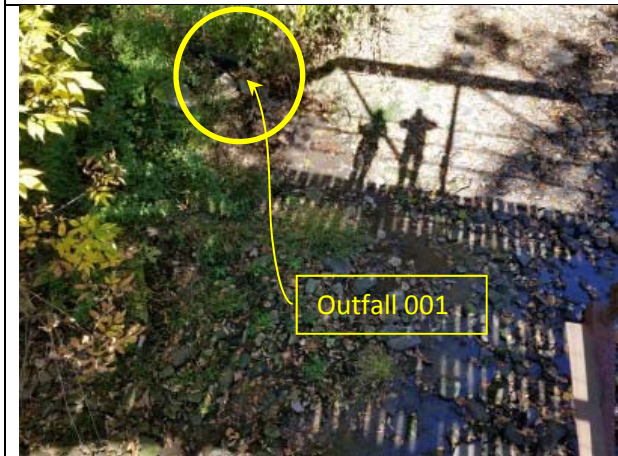
Unlabeled Outfall Pipe / Grey Discharge

During the evaluation, the regional inspector reiterated the evaluator’s request that the outfall pipe be clearly designated as non-potable discharge. The plume was clearly visible along the bank of the receiving stream, approximately one hundred feet below the outfall. This condition persisted throughout the evaluation.

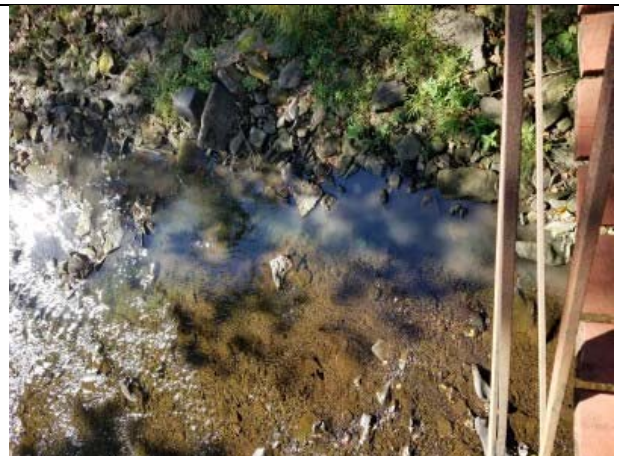
Grey Plume Downstream of Outfall

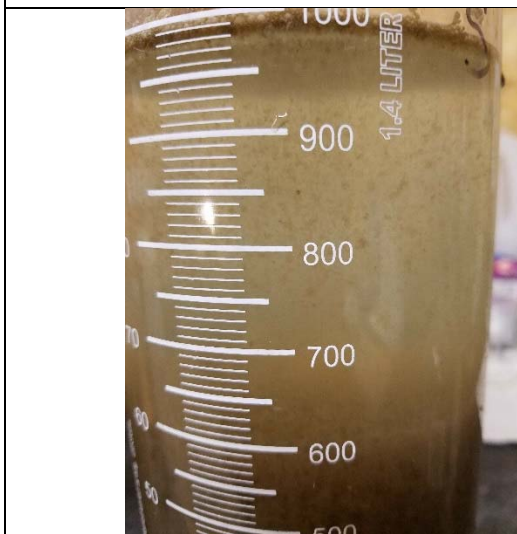
Impaired Settleability

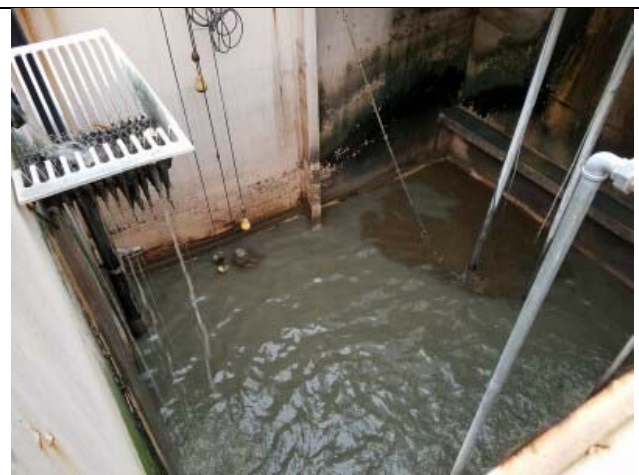
During the evaluation, it appeared that a large quantity of oil-based paint had been illicitly dumped into the sewer, finding its way into the surge tank.

Alleged Paint Dumping (balled oil paint in corner)

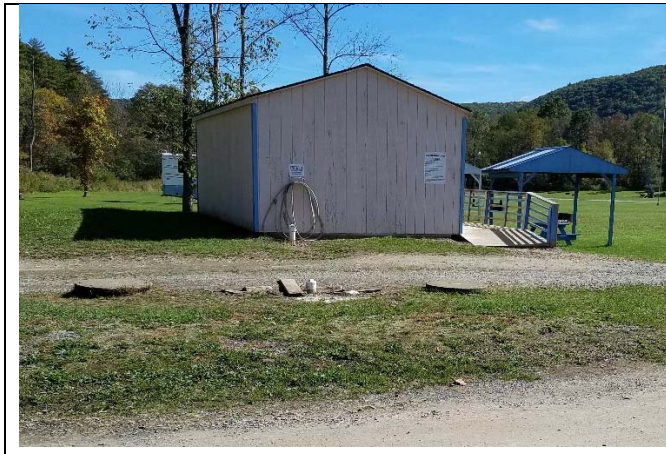
Benezett Campground (4 EDU Assigned)

- The facility owner should vigorously reassess the assignment of EDU to commercial facilities, especially the campground, and enforce prohibitions of discharges in excess of those assignments, up to and including surcharges, fines, and prohibition of motor home and travel trailer septage.
- The facility owner should enforce a ban on any property owners from connecting or allowing the connection of motor homes or travel trailers to the existing sewer system through existing residential lateral cleanouts.

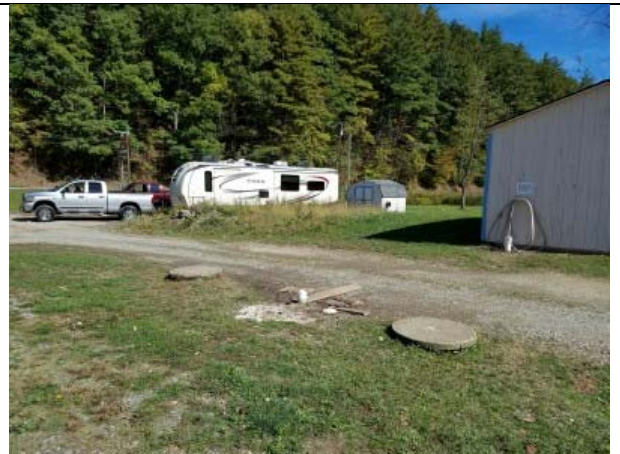
Unregulated / Misregulated Trailer Dump Site (Campground)

- The campground dumping stations should at least be limited by their owners to paying guests only, no longer open to anyone passing through with a full tank and a few dollars to pay for the privilege; it is up to the campground owners to come up with a working enforcement system for their patrons;

- The Township has the right to enforce prohibition of the dumping of trailer and motorhome septage at these campgrounds or at sewer line cleanouts at private cabins. They may require the installation of holding tanks at the campgrounds, where private haulers would be responsible for removing septage wastes. This may require the Township to develop and enforce rigorous local limits on the quantity of septage, if not a total ban, permitted into the collection system at the parks or by sewer customers allowing the dumping of septage into their residential sewer cleanouts.

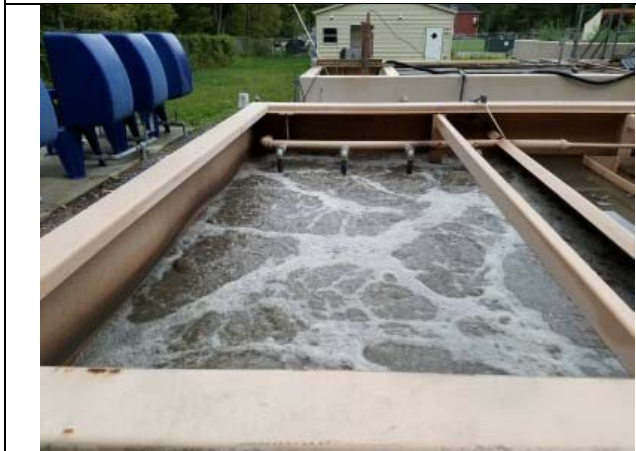
A-Side Under Aeration

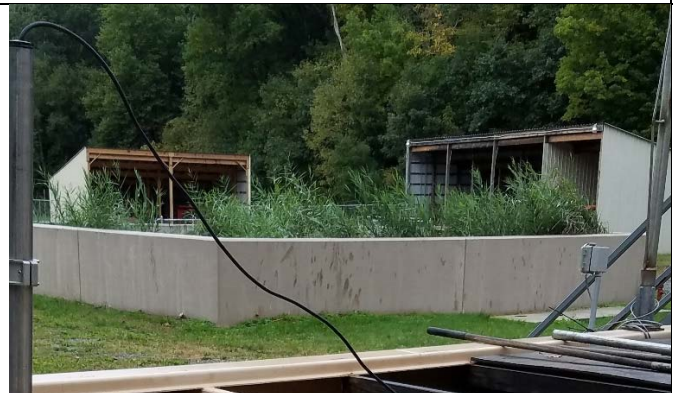
Existing Single Reed Bed
