BENNETTS BRANCH

Abandoned Mine Reclamation Project

Contract No. OSM 24(0522)101.1

FACT SHEET

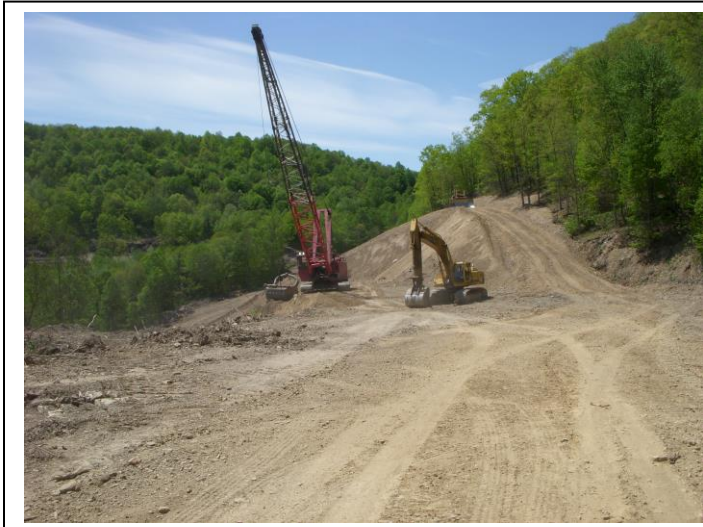
Some of the equipment used to set the grade.

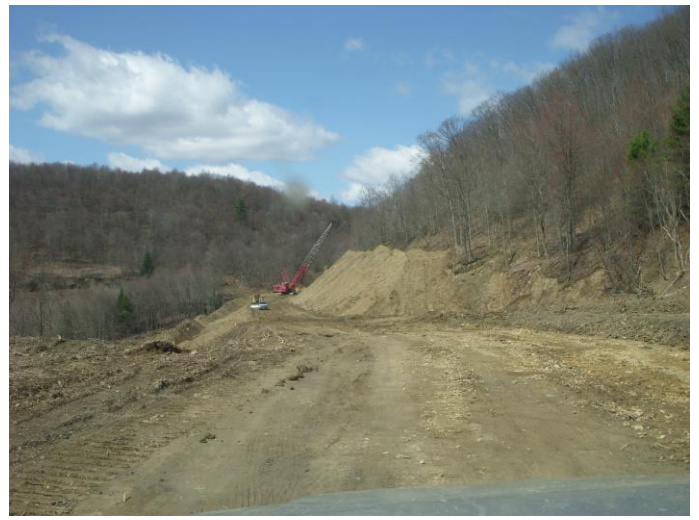
Building up of the grade.

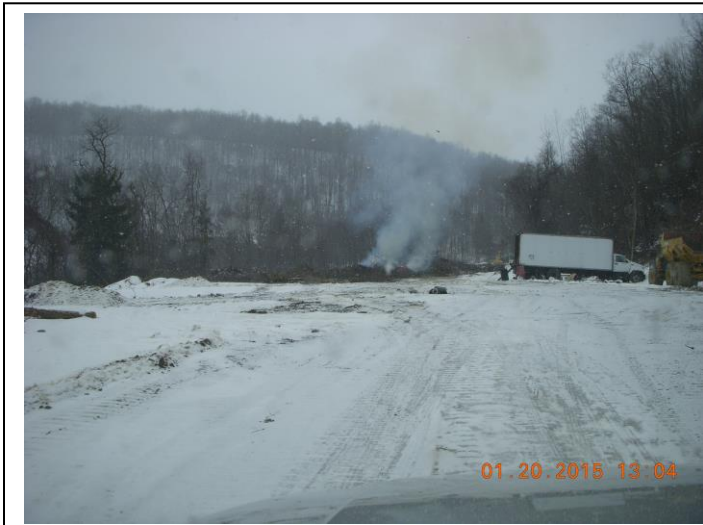
Burning brush.

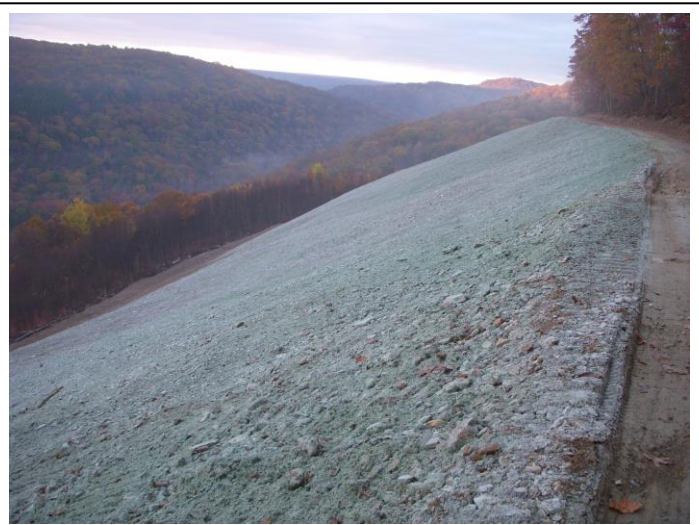
Hydroseeded.

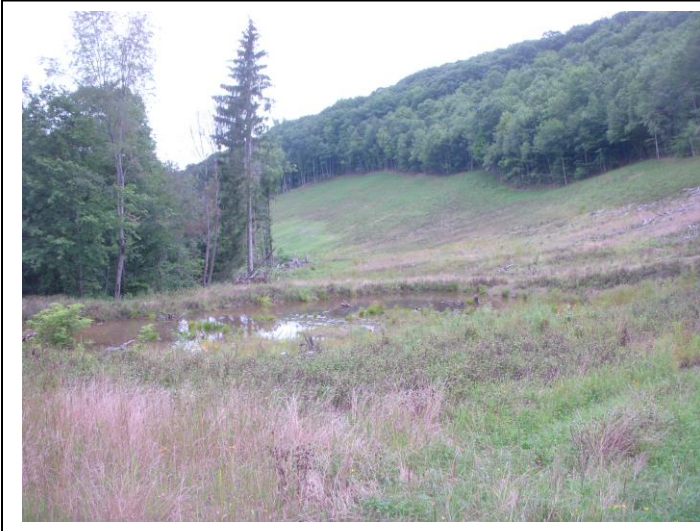
Elk wallow.

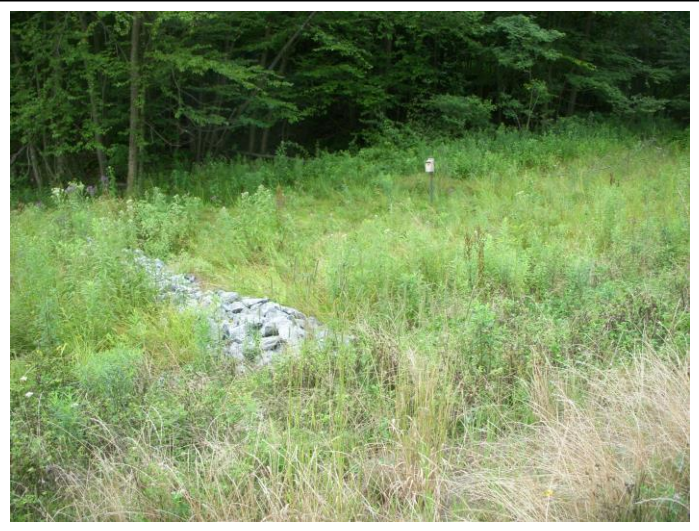
Rock check dam.

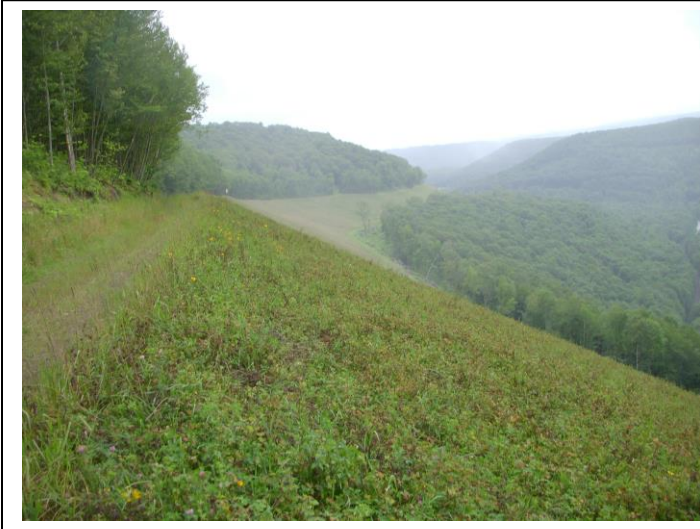
Finished slope.

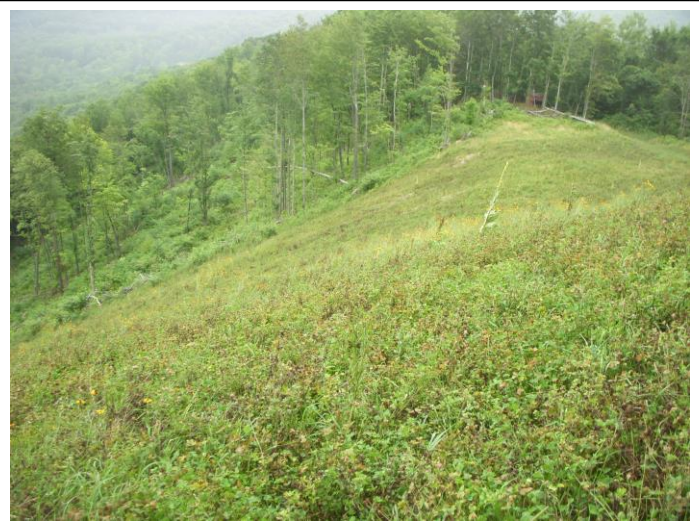
Finished slope.
