HAZLETON AIRPORT
Abandoned Mine Reclamation
Contract No. OSM 40(3211)101.1

HAZLETON AIRPORT
ABANDONED MINE RECLAMATION PROJECT
CONTRACT NO. OSM 40(3211)101.1

FACT SHEET

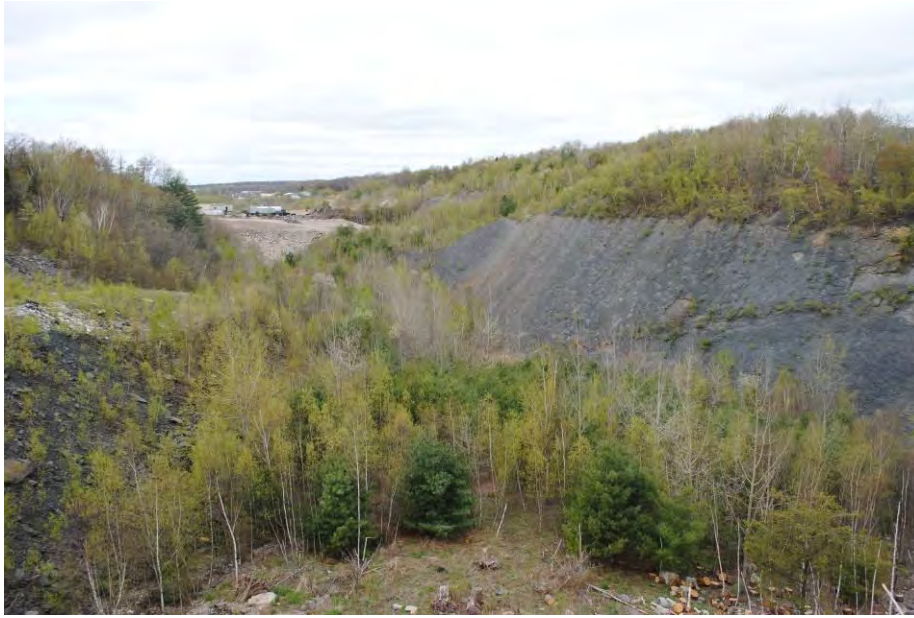
Photo of Dangerous Highwall #1 looking to the west.

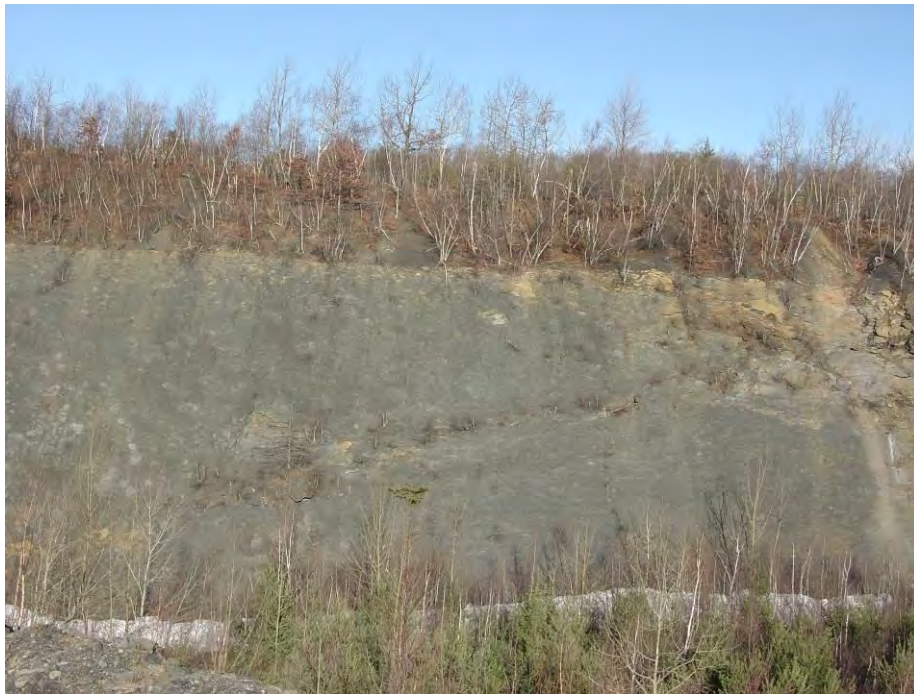
Photo of Dangerous Highwall #1 looking north at northern highwall.
Part of Dangerous Pile Embankment#11 is visible on top of highwall.

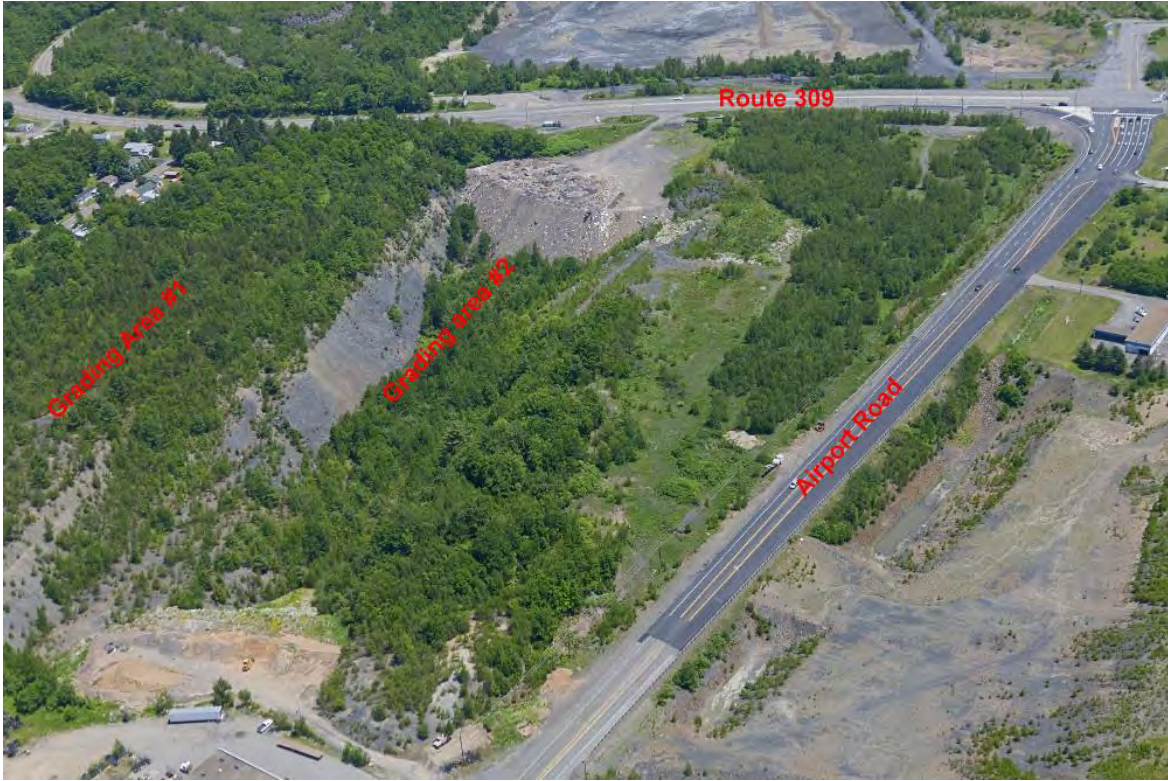
Photo of Dangerous Highwall #1 looking to east.

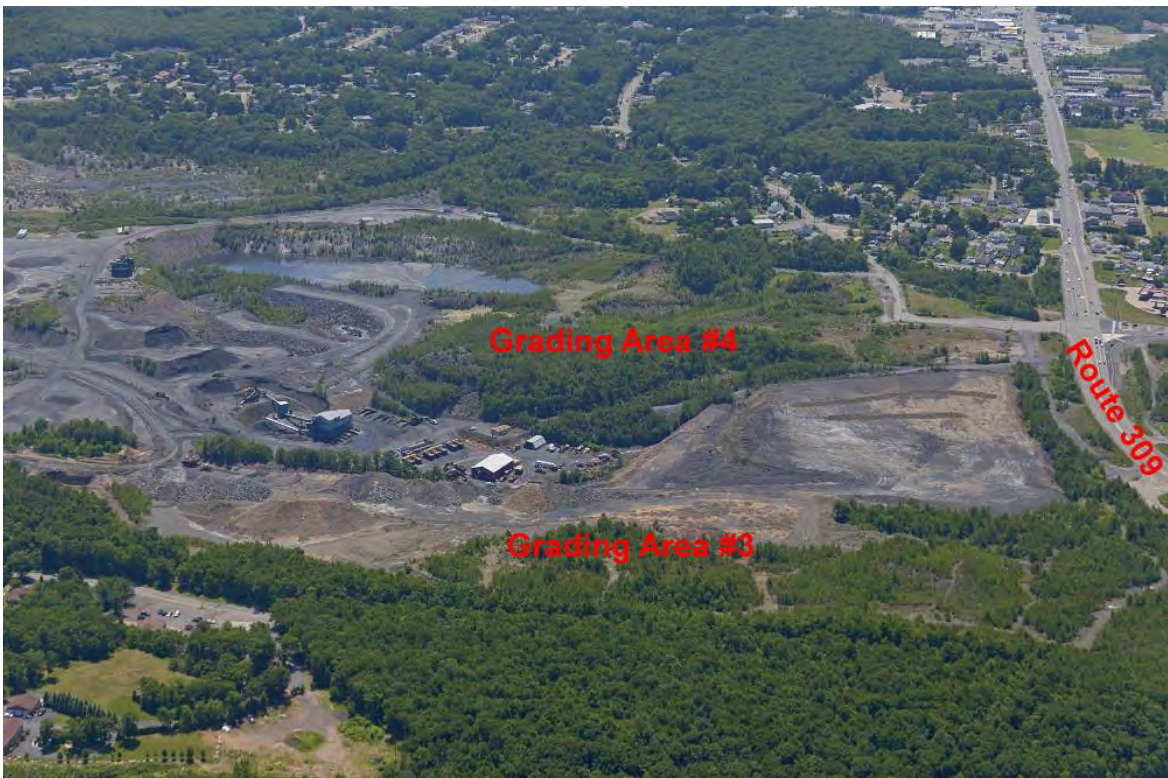
Looking south at Borrow areas, Grading Area #3 and #4

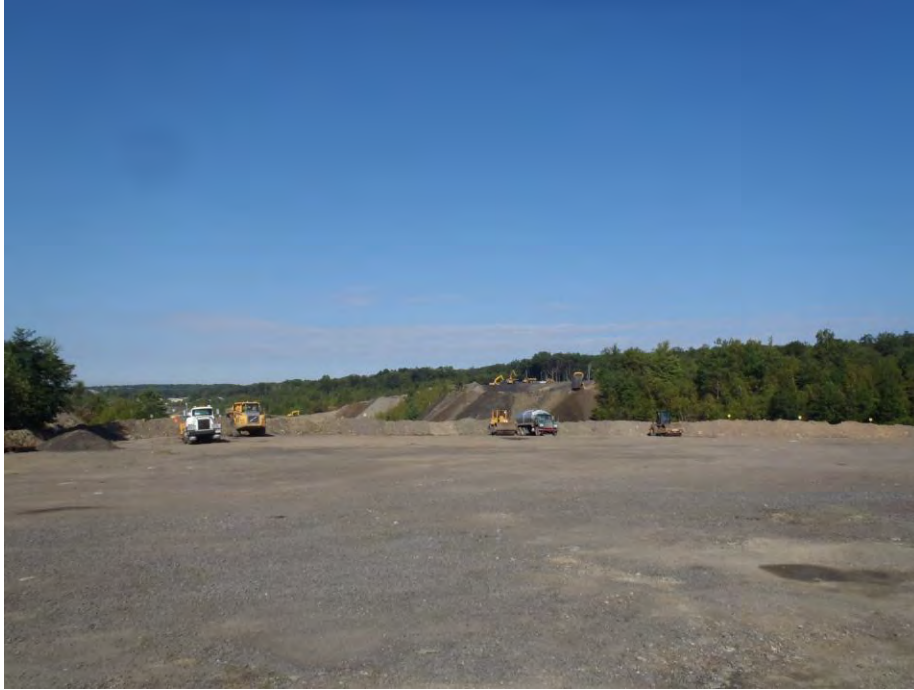
Photo of Dangerous Highwall #1 looking to west.

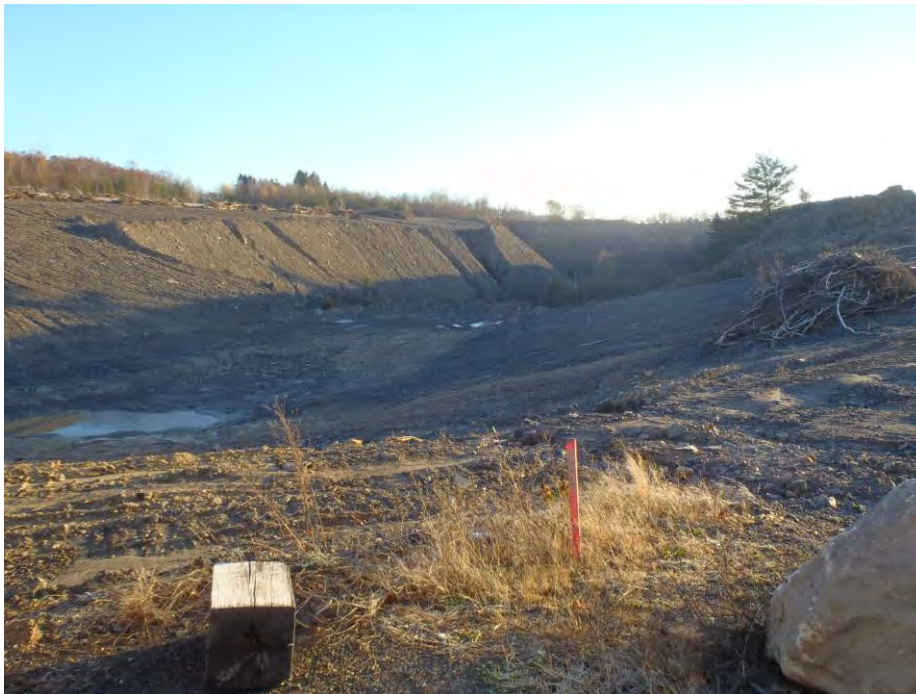
View easterly at abandoned strip pit partially reclaimed.

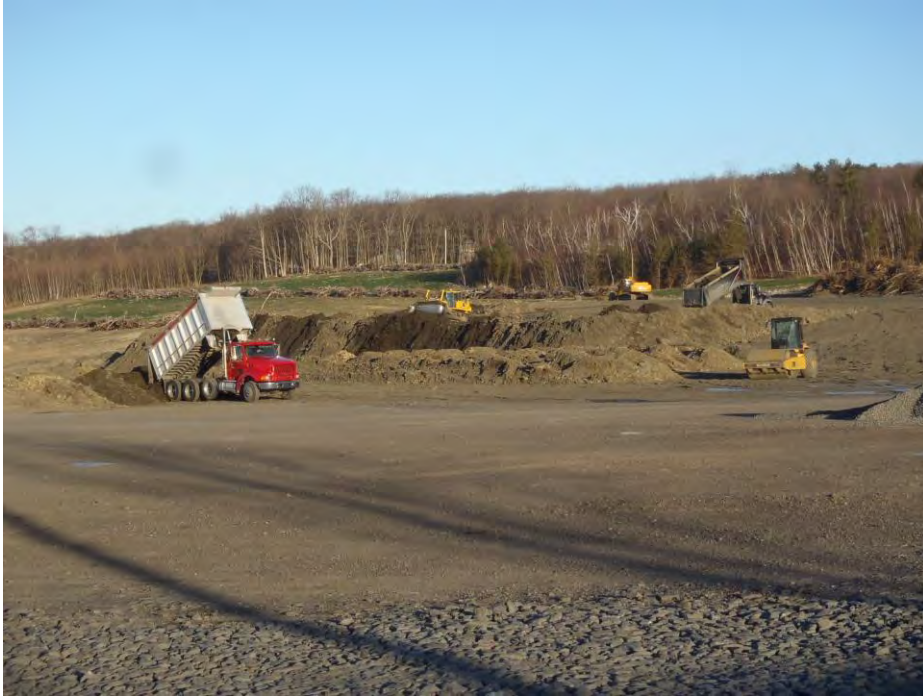
Backfilling of Dangerous Highwall #1 looking northwest.

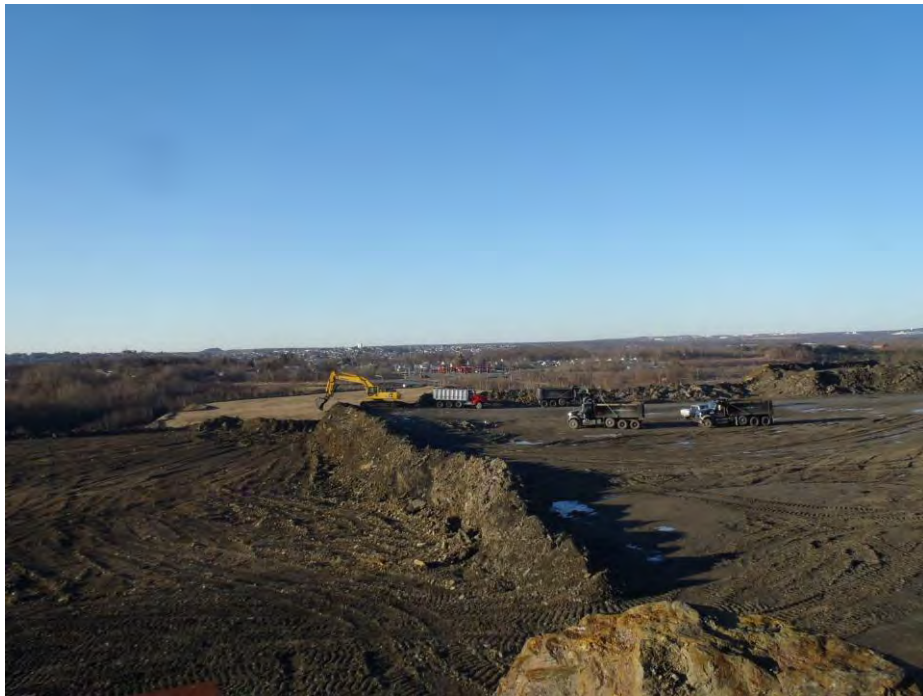
View south at excavation of Grading Area No.3.

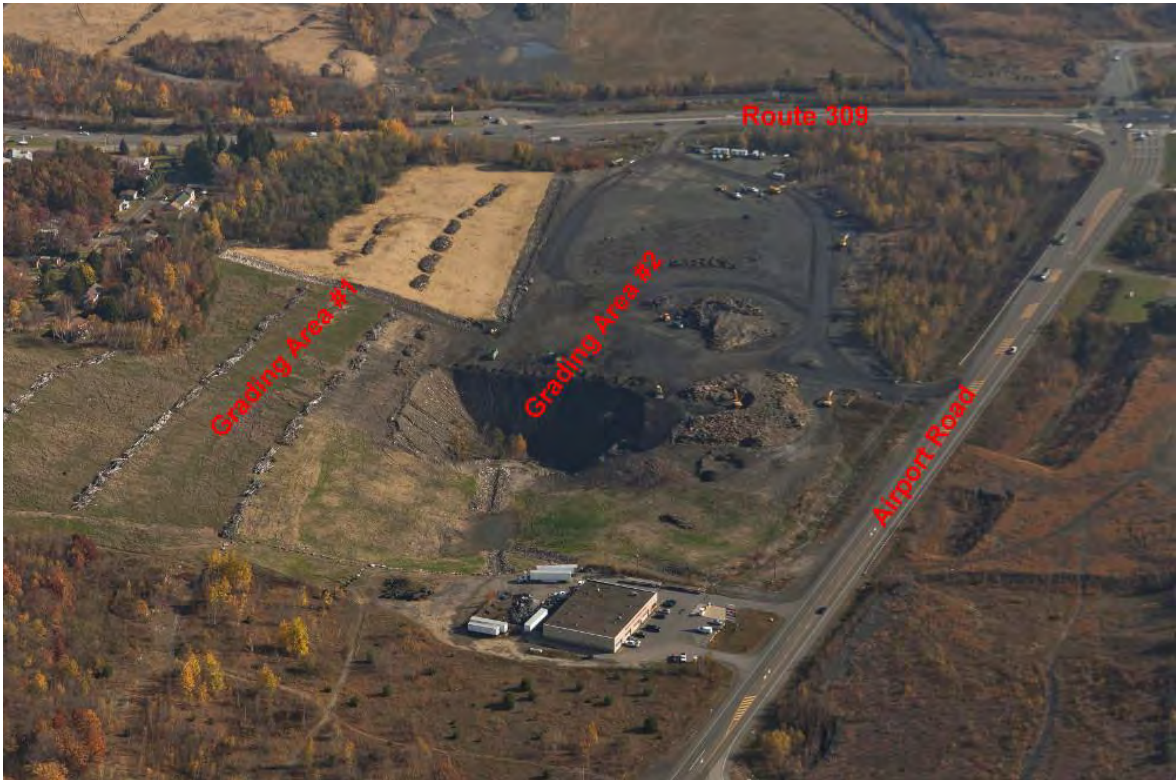
Photo of Dangerous Highwall #1 looking to the east.

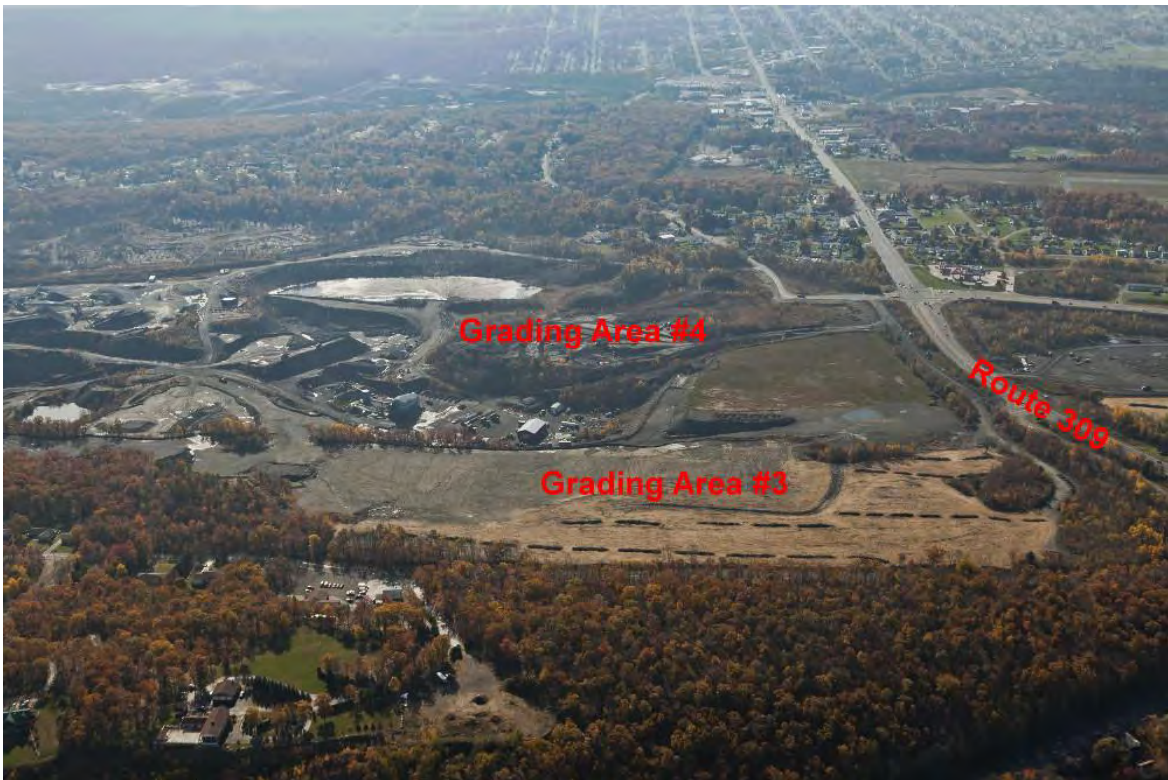
Looking south at Borrow areas, Grading Area #3 and #4

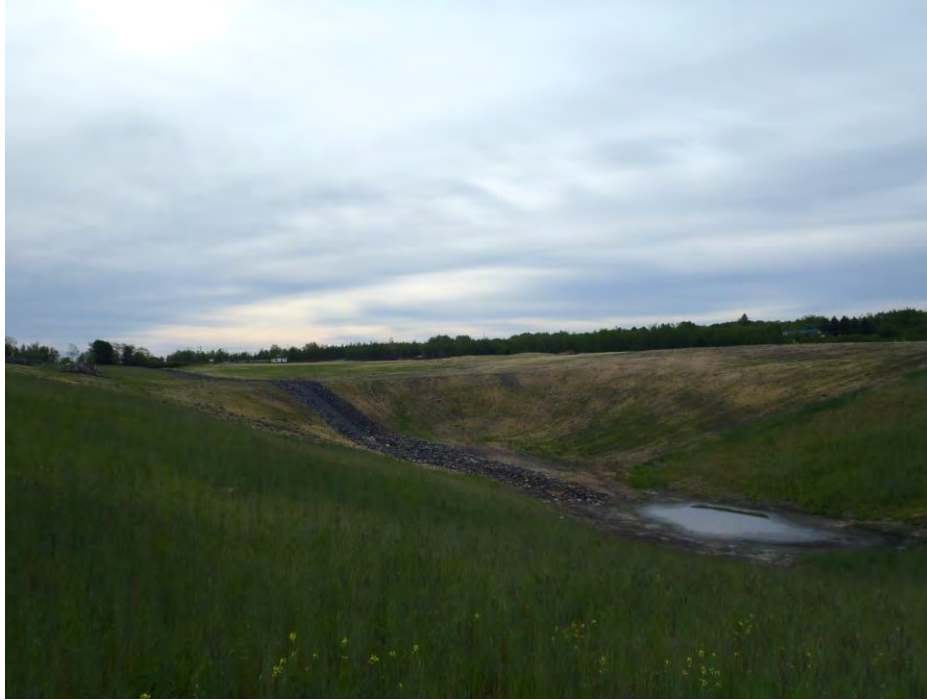
Reclaimed Dangerous Highwall #1 looking southeast.

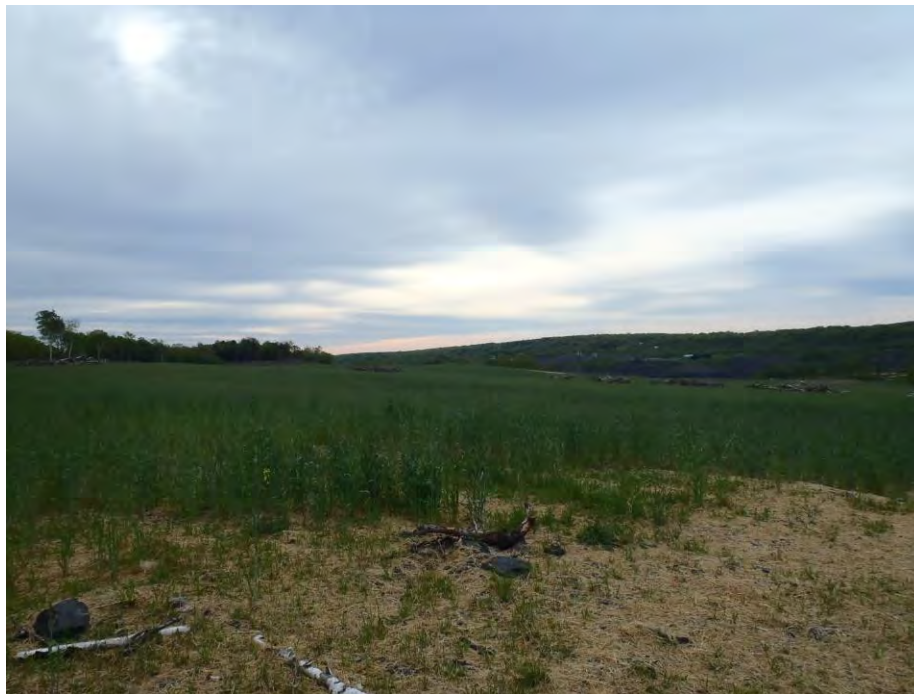
View east at Grading Area No.3.

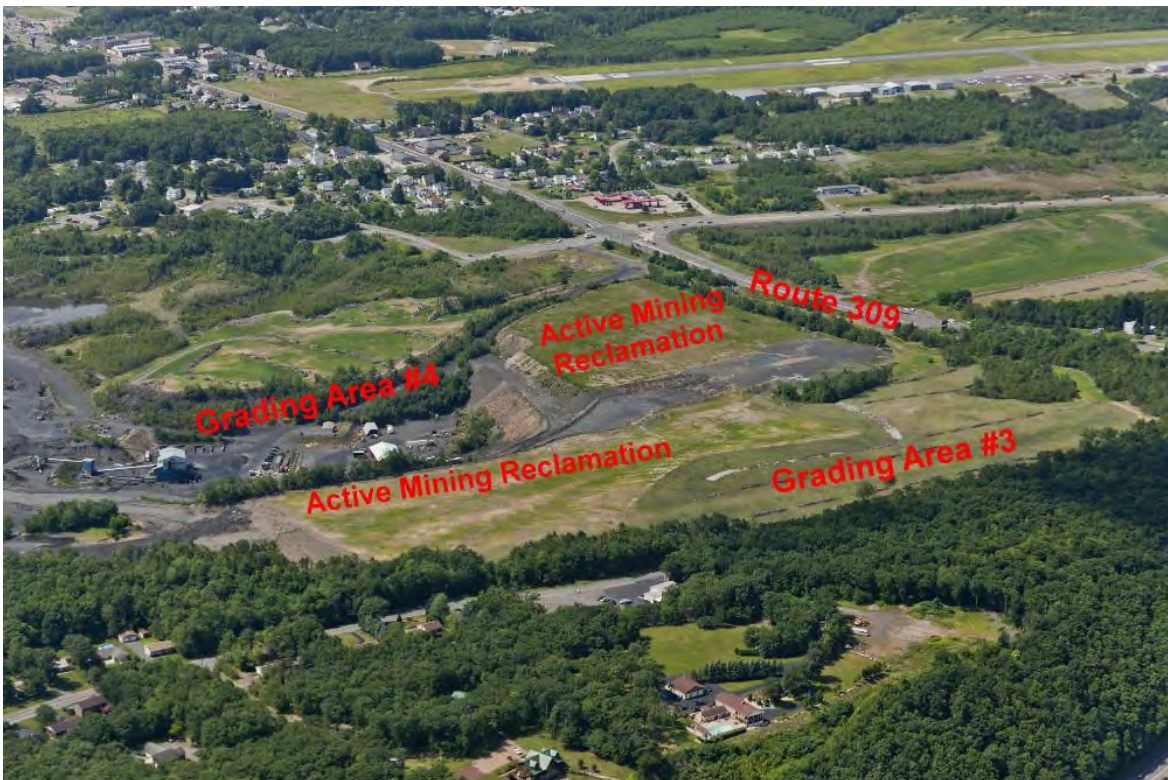
Looking south at Reclaimed Borrow areas, Grading Area #3 and #4
