ELCO-ALLENPORT
Abandoned Mine Reclamation Project
Contract No. OSM 63(1522)101.1 EMER

DEPARTMENT OF ENVIRONMENTAL PROTECTION OFFICE OF ACTIVE AND ABANDONED MINE OPERATIONS BUREAU OF ABANDONED MINE RECLAMATION

FACT SHEET

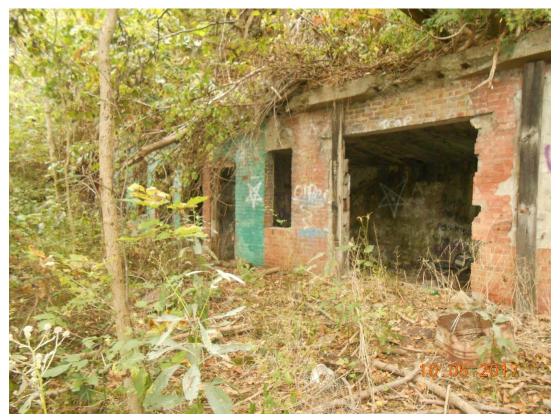
First hazardous abandoned mine structure

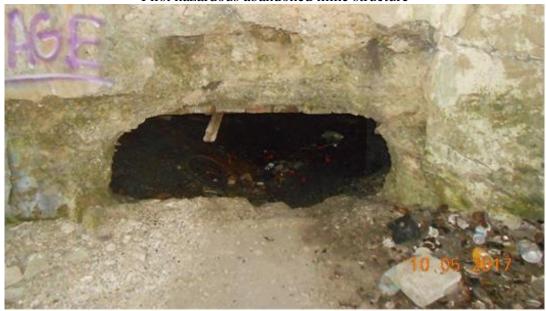
Mine opening within the first hazardous abandoned mine structure

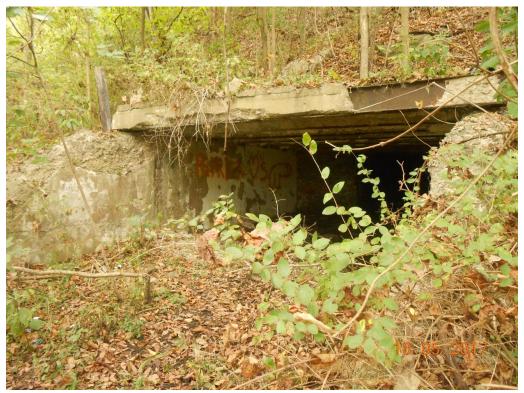
Second hazardous abandoned mine structure

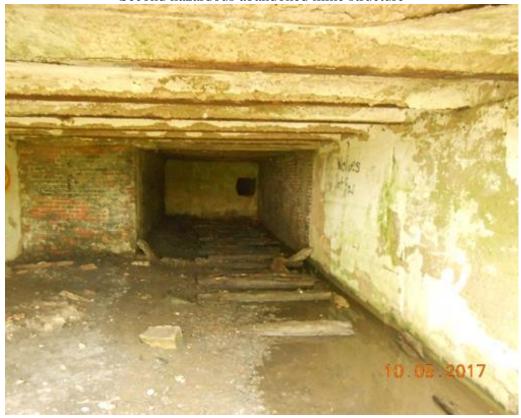
Mine opening within the second hazardous abandoned mine structure

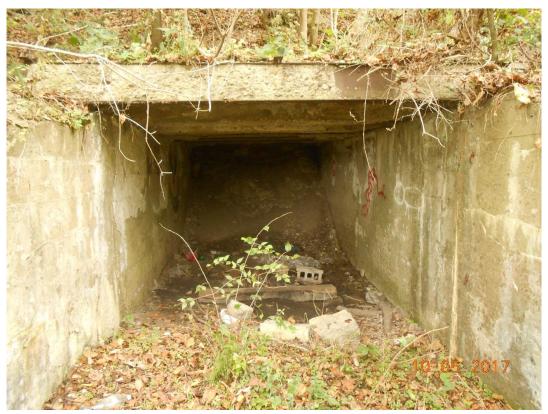
Third hazardous abandoned mine structure
