Appendix D-5
Waterbody Data Forms –Bucks County

CLIENT	PennEast Pipeline Company	SAMPLING POINT	051515_JC_1004_E_MI
PROJECT/SITE	PennEast Pipeline Project	INVESTIGATORS	J. Combs, K. Arndt
COUNTY/STATE	Bucks/PA	STREAM CLASS	Ephemeral

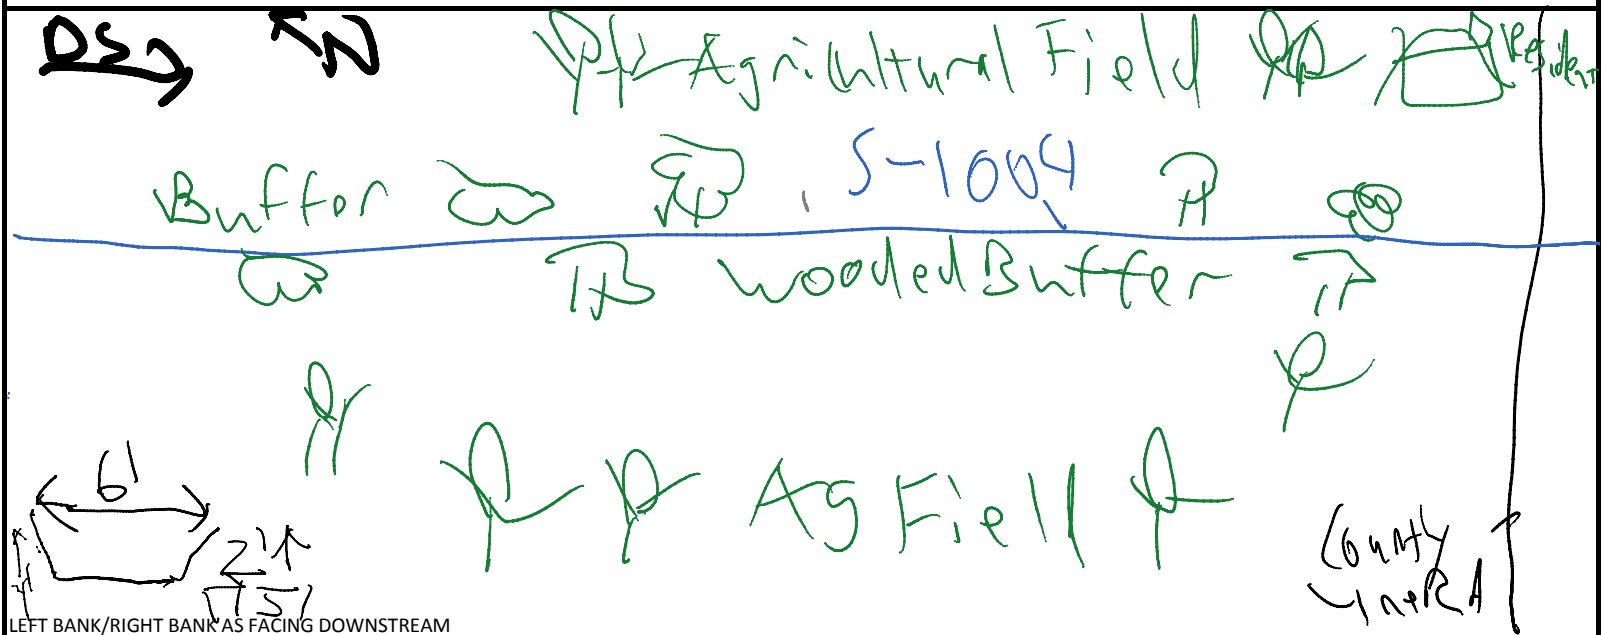
COMMENTS/SKETCH dry streambed flows down slope between ag fields, residential area. Wooded buffer

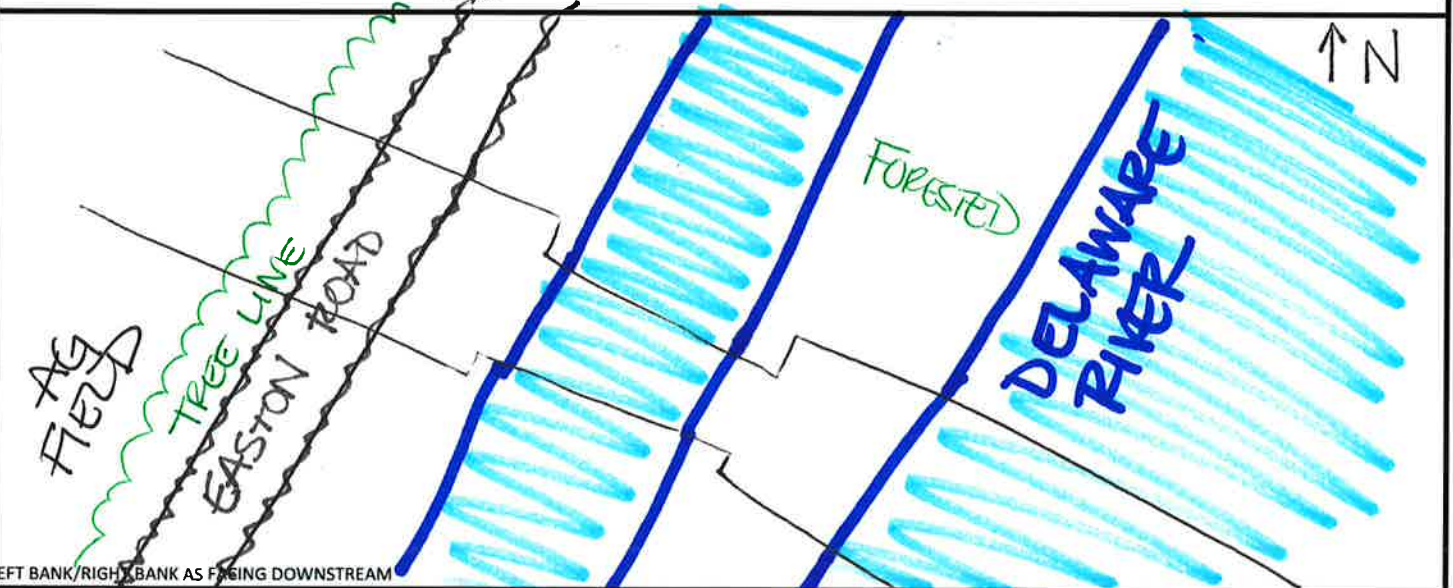
COMMENTS/SKETCH Delaware canal along bike path; deep, full of vegetation, unable to observe substrate
