CHAPTER 6. USE OF COAL ASH CEMENT GROUTS IN ABATEMENT OF ABANDONED MINE HAZARDS AND ACID MINE DRAINAGE

**Daniel J. Koury, Joseph Schueck, Roger J. Hornberger, Kenneth R. Levitz,
William B. Hellier Jr., Keith A. Laslow**

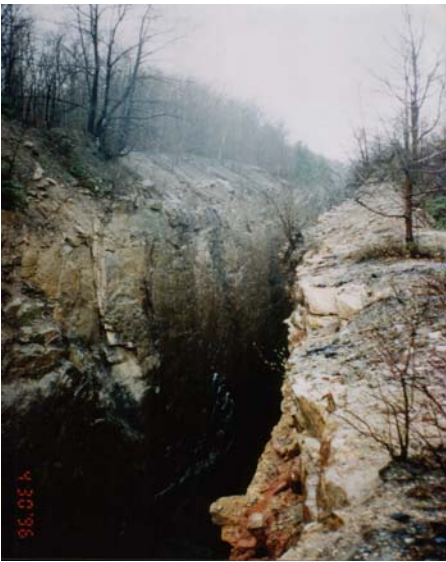
Figure 6.3(a). Narrow cropfall.

Cropfalls are dramatic features that often occur with little warning, resulting in deep narrow voids with near vertical walls as seen in Figure 6.3a. The tremendous underground exploitation of the coal during the industrial revolution and two world wars has created the potential for cropfalls that extend for several miles as seen in Figure 6.3b. The extensive cropfalls in Porter Township in western Schuylkill County shown in Figure 6.3b are in a relatively remote area unlike the cropfalls in the Pottsville area. When seen from the air, the cropfalls appear similar to a narrow surface mine. However, unlike most abandoned surface mines there is no overburden available to fill the hole.

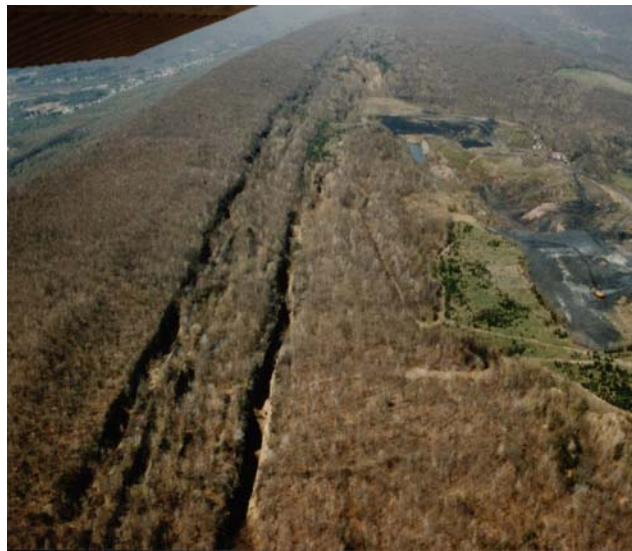
Figure 6.3(b). View of extensive cropfalls on multiple veins.

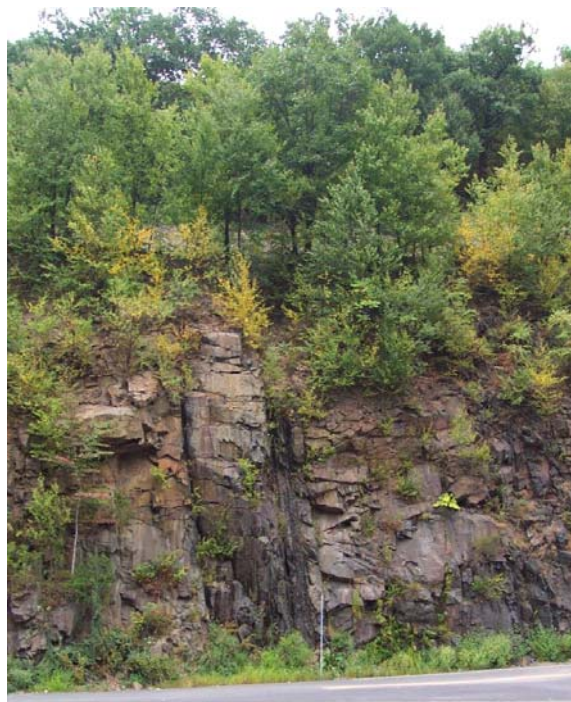
Figure 6.8. Exposure of the Pottsville Formation, along Rt. 61, Pottsville. Note the vertical stop sign at the bottom of the photo.

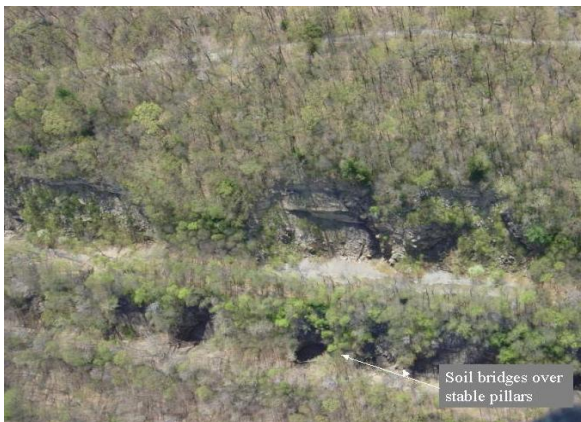
Figure 6.10(a). Recent and more mature subsidences.

The aerial view of the cropfalls in Figure 6.10(a) show very recent subsidences where the breasts collapsed, leaving the pillars intact (soil bridges). The upper “more developed” cropfalls expanded as the pillars failed and the cropfalls matured. In 1993, when a significant collapse occurred, a chainlink fence was installed around a portion of the hole to prevent access and warn the public of the dangerous condition. In a few years the hole expanded and the fence fell into the void as seen in Figure 6.10b. Note the dip and the thickness of the coal outcrop at the far end of the pit.

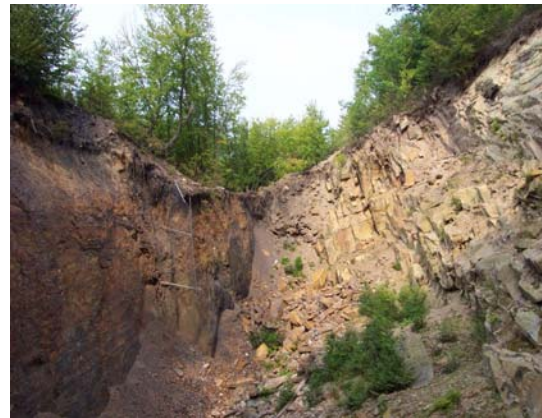
Figure 6.10(b). Expanding subsidence, notice the hanging chainlink fence on the left. Wall at the far end represents a stable pillar.

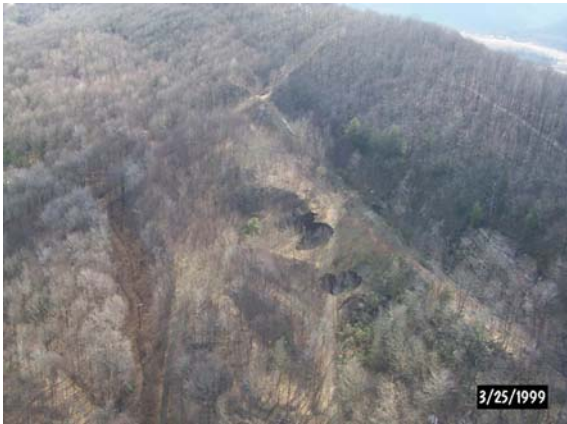
Figure 6.11(a). Emergency cropfalls.

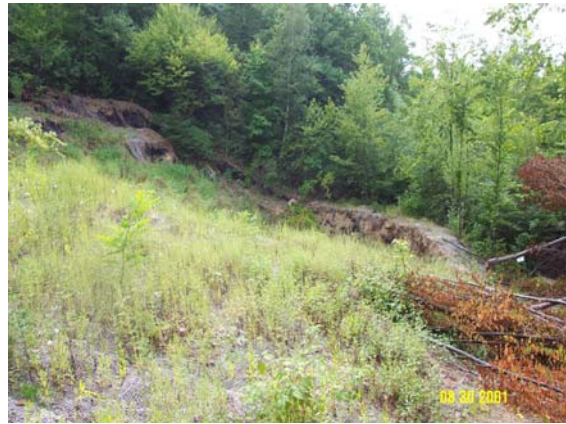
Figure 6.11(b). Sagging of filled area

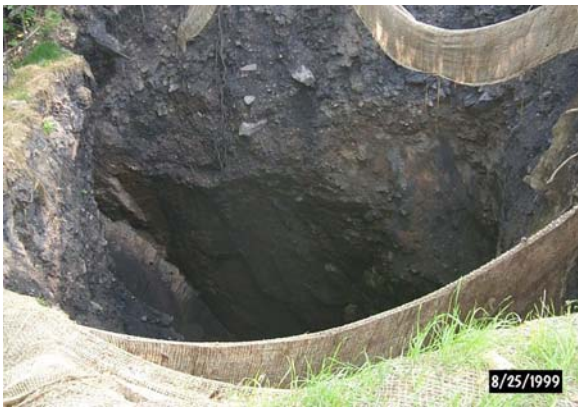
Figure 6.11(c). Severe collapse and loss of fill.

collapses where nearly all of the fill material was lost, Figure 6.11 c. Figure 6.11d shows the area that became the main site of the demonstration project described in Section 6.3.4.

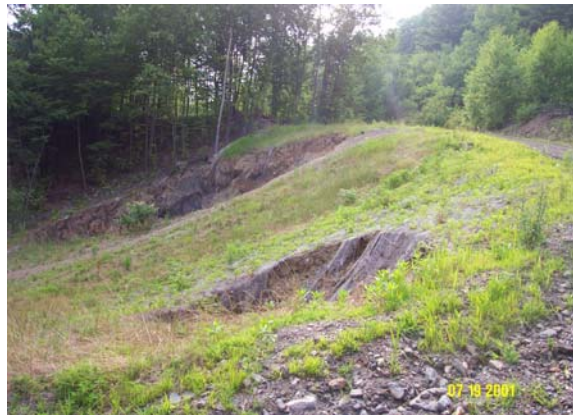
Figure 6.11(d). Subsidence. Site of Demonstration Pit A.

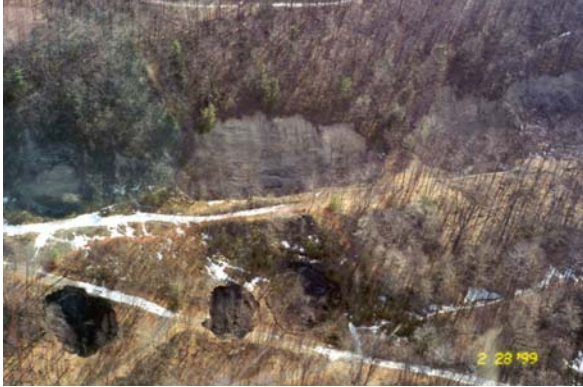
Figure 6.12(a). Subsidence in 1999.

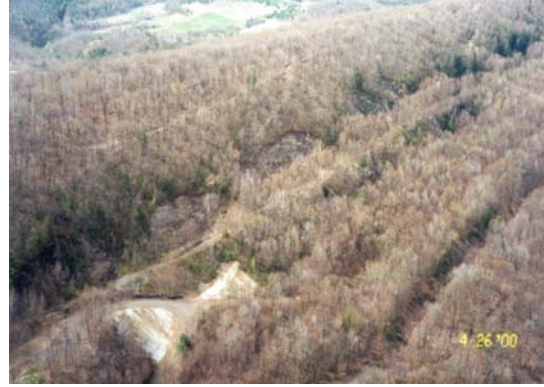
6.12(b). Restoration effort, 2000.

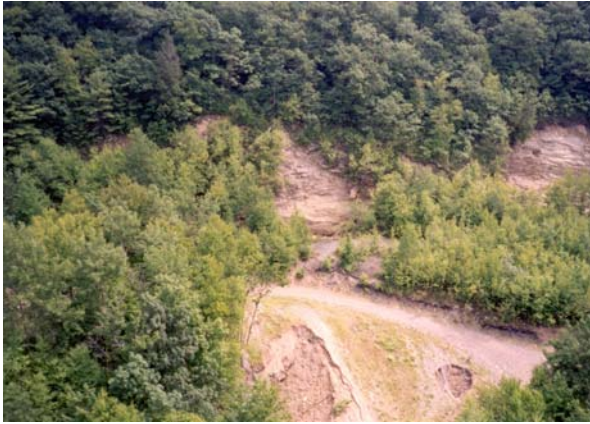
6.12(c). Area resubsides, 2001.

Pit A consisted of 2 subsidences within the previously backfilled area (Fig. 6.12c). The voids, one roughly rectangular, the second circular, were initially 41 feet apart and 64 feet long by 38 feet wide and 30 feet deep and 17 feet in diameter by 6 feet deep, respectively. The presence of tension cracks between the voids suggested that the voids would continue expanding, ultimately forming one cropfall. In order to install the structural plug, the subsidences were further excavated and prepared. Approximately 2,250 cubic yards of material was removed from Pit A to locate solid competent rock adjacent to the subsided coal vein. The excavation resulted in one hole separated into 2 fairly equal sections by a solid coal pillar that was exposed and intact as displayed in Figure 6.13a.

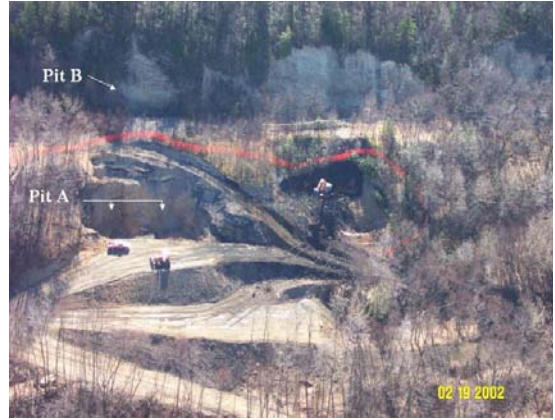
6.12(d). Demonstration Area, 2002. An orange safety fence surrounds the construction area.

Pit B is a subsidence feature on the upper, southern line of cropfalls as seen in Figure 6.12d. This cropfall was not previously addressed in any backfilling attempt. Unlike Pit A, this cropfall appeared somewhat stable. The bottom seemed well choked with large boulders. Therefore, the temporary floor of concrete panels was not used. Both the north and south walls of Pit B were well exposed and required little excavation. Only 180 cubic yards of material were removed from the hole to prepare it for grout placement. There were no reject concrete panels, steel trusses or rebar used in this void. The void was filled solely with 8-10 feet of the ash-based grout mixture. Coal ash was used as a bulk fill material and the area was revegetated. As the grout mixture was added, one load of grout material (8 yards) was lost as it flowed into cracks in the pit floor.

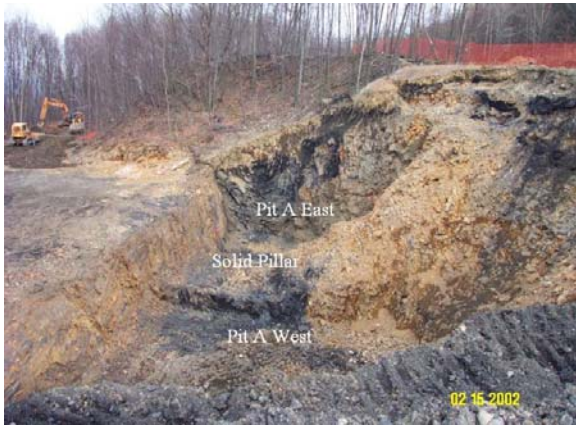
Figure 6.13(a). Pit A prepared.

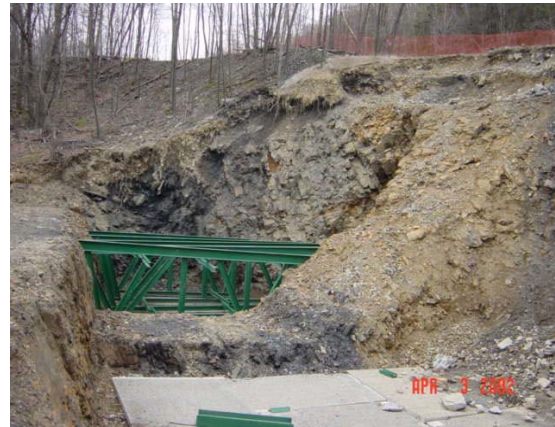
6.13(b). Steel trusses installed in Pit A east.

The method of backfilling in Pit A was to develop a wedge that if the potentially false bottom of the pit would fail, the wedge would become lodged and would not undergo catastrophic failure. Concrete panels were placed on the floor of the excavated pit in both the eastern and western portion of Pit A. The purpose of the concrete panels was not to create an additional structural member of the plug, but to provide a means to retard the flow of the grout until it had time to cure. The concrete panels were originally manufactured to be used as sound barriers along major highways. The panels were flawed or damaged and they were donated by Schuylkill Products, Inc. a nearby concrete fabrication operation. In the eastern portion of Pit A an inverted steel truss was fabricated to act as a structural support member that spanned the void and was wedged into the competent solid rock on the north and south end of the pit (Fig. 6.13b). The self leveling cementitious grout mixture, not unlike controlled low strength flowable fills, was then placed in the eastern portion of Pit A covering the steel member. The grout mixture of FBC ash, approximately 9% Portland cement, and water was blended at Quandel Concrete,

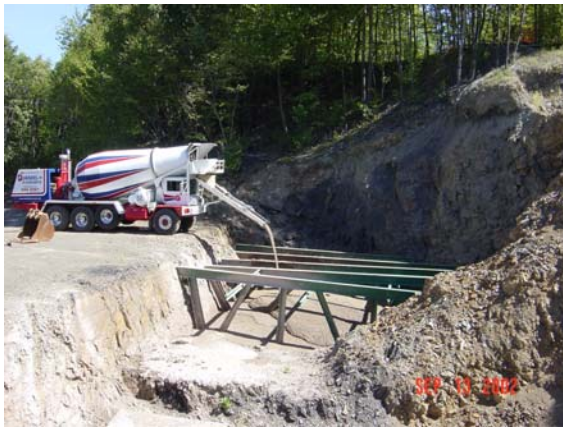
6.13(c). Grout mixture placement, Pit A east.

Minersville and imported to the site in cement mixers (Fig. 6.13c). The consistency of the grout mixture allowed it to flow throughout the east pit and it hardened relatively quickly allowing the vehicles to travel on the grout mixture (Fig. 6.13d).

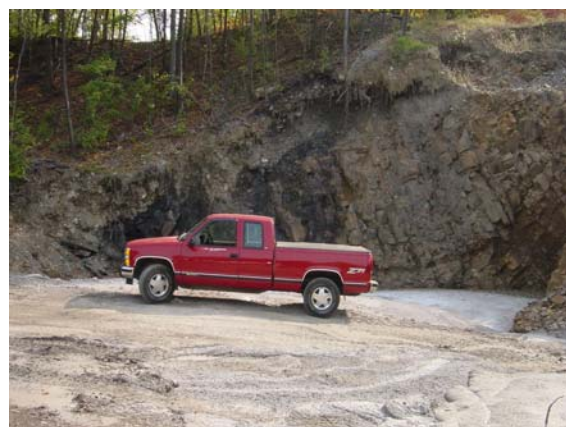
6.13(d). Pit A east grout complete.

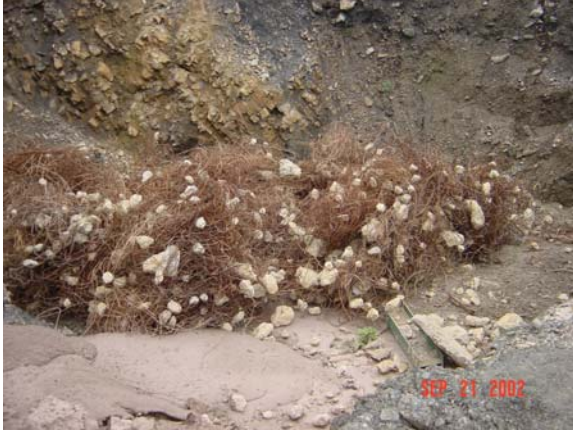
Figure 6.14(a). Scrap rebar in replaces trusses, Pit A west.

The west side of Pit A was prepared similarly in that reject concrete panels were placed in the floor of the pit. Instead of the fabricated steel trusses, recycled reinforcement bar (rebar) was imported from Glasgow, Inc. to form a wire mat similar to a large expanded Brillo pad in the grout mixture for structural support (Fig. 6.14a). The rebar was loosely packed and it allowed the grout to flow through it. The grout was placed and leveled with the eastern portion of Pit A. Grout depth in all of Pit A was approximately 10 feet. The remainder of the pit was then filled with coal ash from PPL Montour Station to serve as a bulk fill material that will also be beneficial due to its cementitious properties (Fig. 6.14b). As with the Northampton ash, PPL donated the ash and delivered it to the site. Once the area was backfilled and graded to the adjacent contours, topsoil was added and the area was vegetated, Figure 6.14c-d.

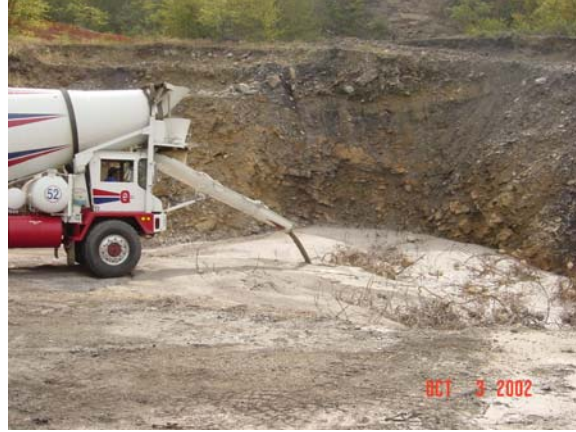
6.14(b). Grout added. Notice the mixer is driving on previously poured grout.

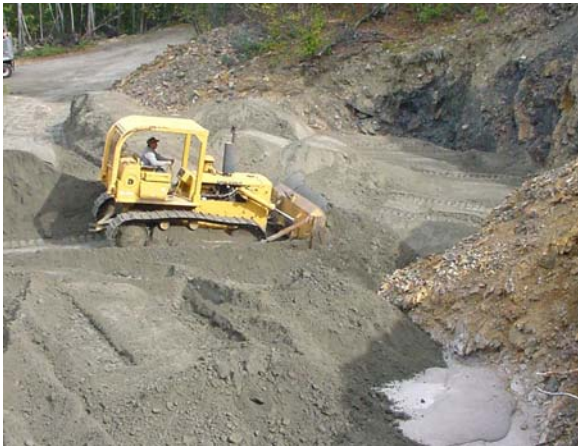
6.14(c). Ash bulk fill placed.

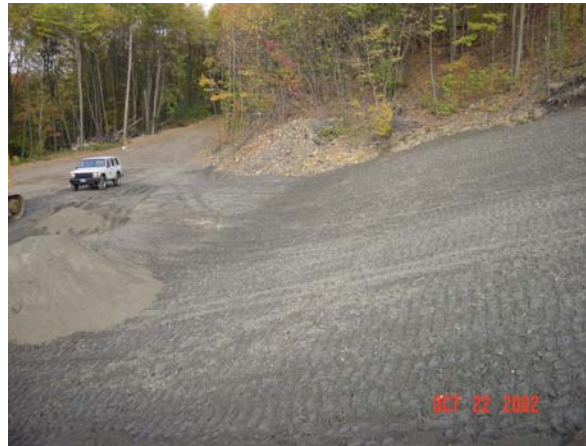
6.14(d). Prepared for topsoil. Pit A complete.

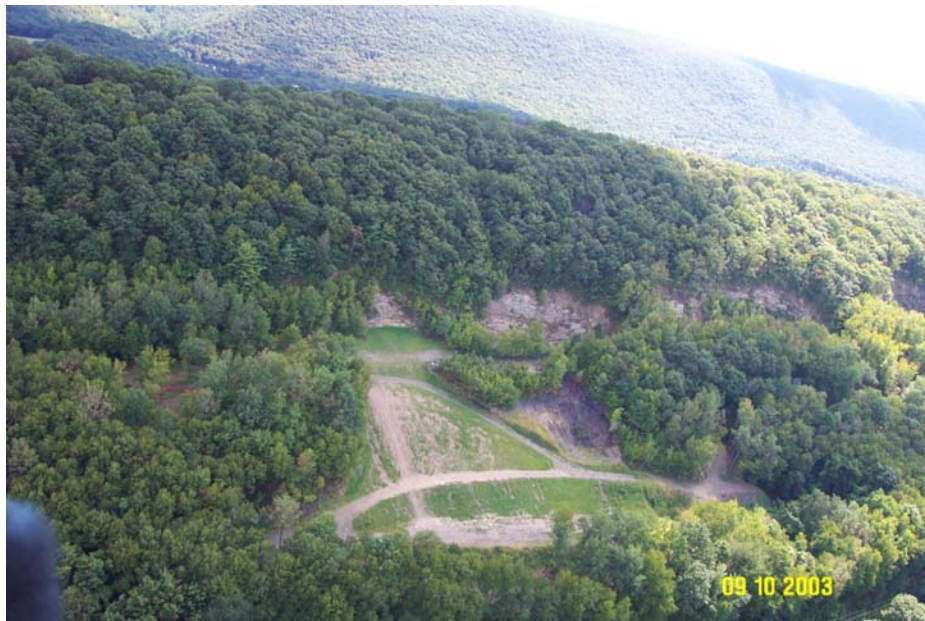
Figure 6.15. Completed Sharp Mountain demonstration project.

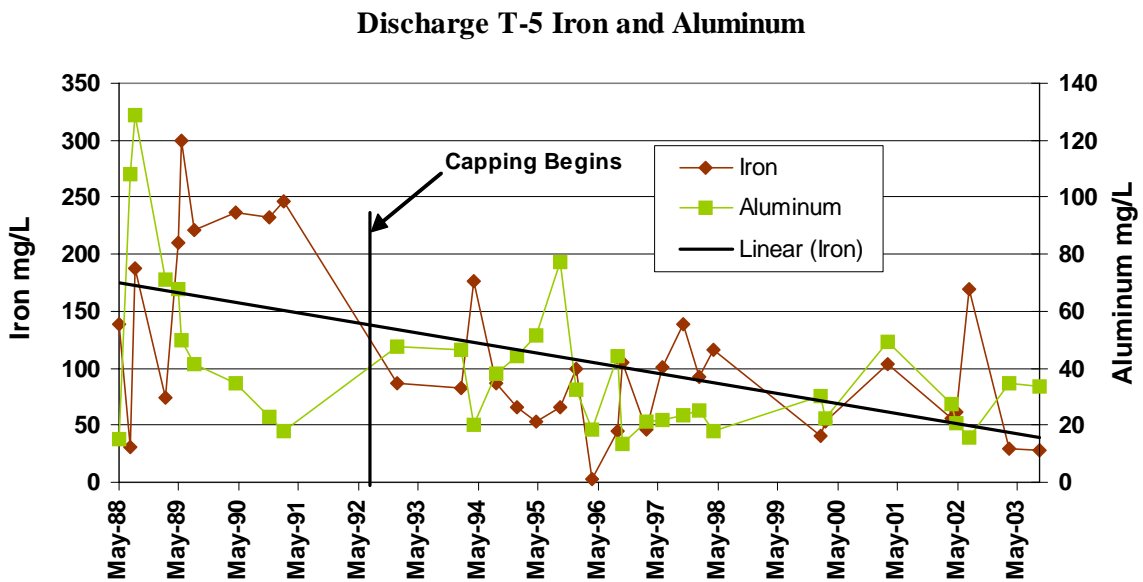
Figure 6.18. Historical quality of the T-5 discharge for aluminum and iron. Although not included, manganese follows a similar trend. The trend line for iron is included.

The chemical quality of the discharge are presented in Figures 6.17 and 6.18. Figure 6.17 presents the historical concentration for sulfate and acidity. Since the capping project began in 1992, sulfate concentrations have decreased by about 50%, from over 4000 mg/L in 1992 to a little over 2000 mg/L in 2004.

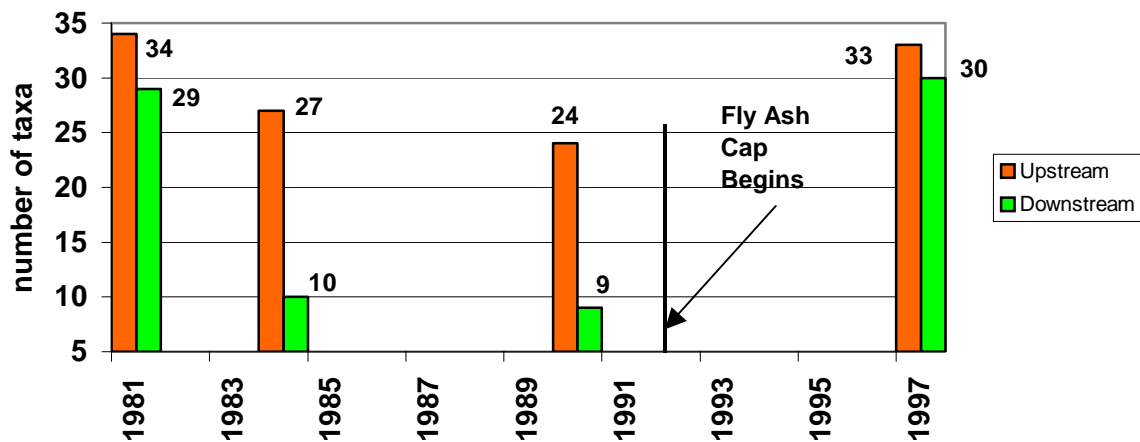
Figure 6.19. Qualitative benthic macroinvertebrate comparison upstream and downstream of discharge

The Pennsylvania Fish and Boat Commission conducted both benthic macroinvertebrate and electrofishing surveys on at least four occasions on Upper Three Runs both upstream and downstream of the fly ash capping project. The results given in Figure 6.19 are for the macroinvertebrates and the electrofishing results are given in Figure 6.20. The water quality and aquatic life in Upper Three Runs has improved significantly since the fly ash cap was placed at the site. No detectable pollution from other EPA priority pollutants has been found in Upper Three Runs.

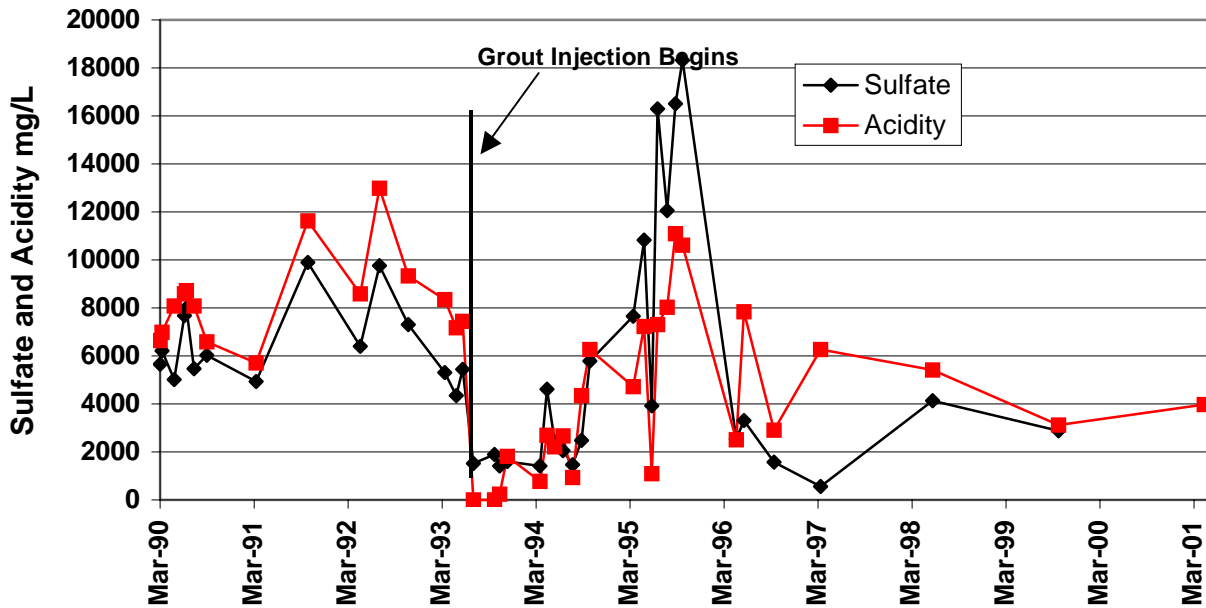
Monitoring Well L25 Sulfate and Acidity

Figure 6.23. Sulfate and acidity response to pit floor grouting effort. Note the temporary effect of the drought during 1995.

Figure 6.23 is a graph of SO_4 and acidity concentrations over time. These two variables likewise show a response to the grout supernatant. Sulfate concentrations averaged 6496 mg/L prior to grouting. After grouting, the concentrations were close to 1500 mg/L for the next four months. Since that time, the SO_4 concentrations have risen, but are presently 2900 mg/L, much lower than the pre-grouting levels. The effect of the drought conditions in 1995 are clearly evident in the graph, where concentrations of virtually all constituents increased dramatically for all wells. Acidity levels also dropped dramatically as a result of the supernatant. In fact, the alkalinity concentration 90 days after the grouting was 766 mg/L. Similar to sulfate, the acidity concentrations spiked during the 1995 drought, but returned to and remain at below pre-grouting levels. Overall, there have been reductions in concentrations of 54% and 61% for sulfate and acidity, respectively, as a result of the grouting effort.

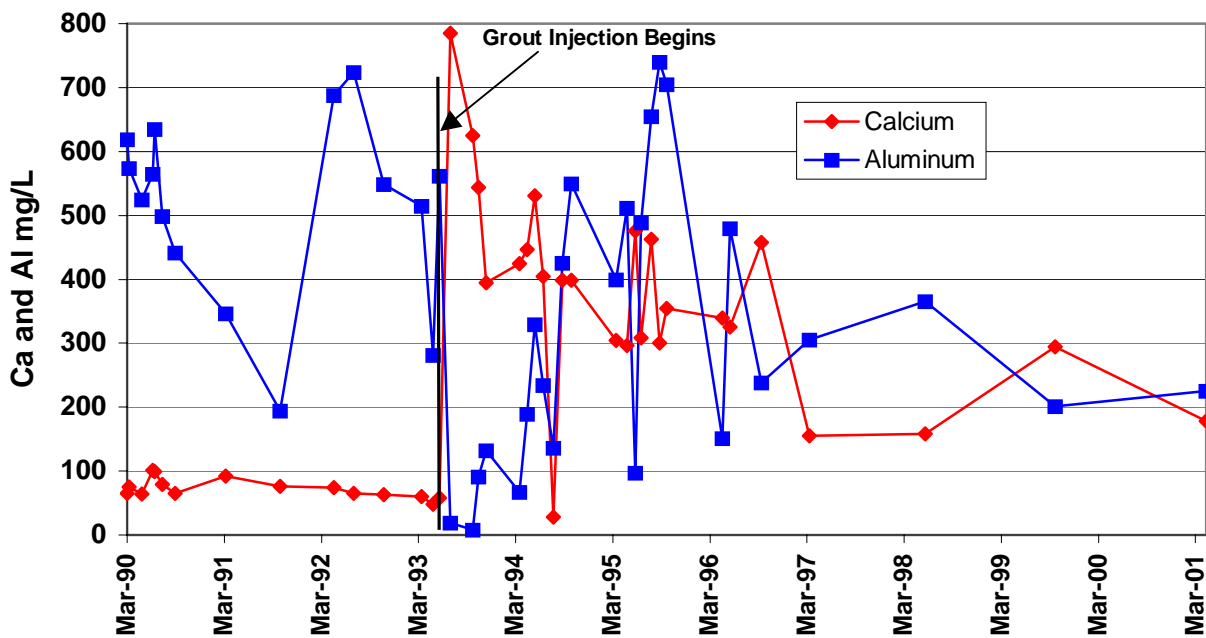
Monitoring Well L25 Calcium and Aluminum

Figure 6.24. Calcium and aluminum response to the pit floor grouting effort. Note the general inverse relationship between Al from AMD and Ca, primarily from the grout.

The long-term response by aluminum suggests that pit floor paving may be effective in reducing leaching of the clays. Calcium and aluminum concentrations are included in the graph shown in Figure 6.24.. Shortly after grouting, Al concentrations dropped to a low of 8 mg/L and have since rebounded, but are less than half of the pre-grouting concentrations. Although not shown on the graph, concentrations of iron and manganese closely paralleled that of Al. Calcium shows a rather different behavior. The mean Ca concentration prior to grouting was 72 mg/L for well L25. After injection, the concentration rose sharply to over 700 mg/L as a result of the supernatant. Since then, the mean concentration has returned to about 200 mg/L, above the pre-grouting value.

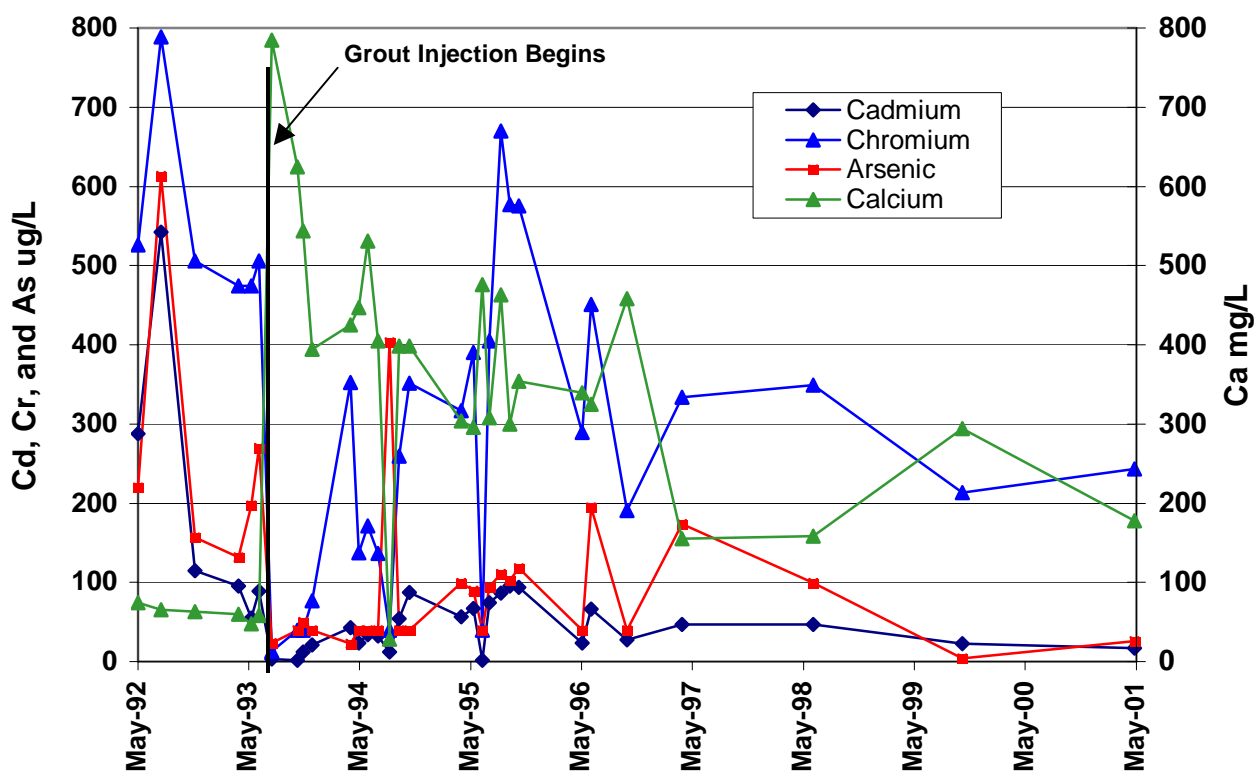
Trace Metals in Well L25

Figure 6.26. Long-term behavior of Cd, Cr, and As in well L25.
