## PART 2--FEATURES AND PHYSICAL CHARACTERISTICS OF THE WATERSHED

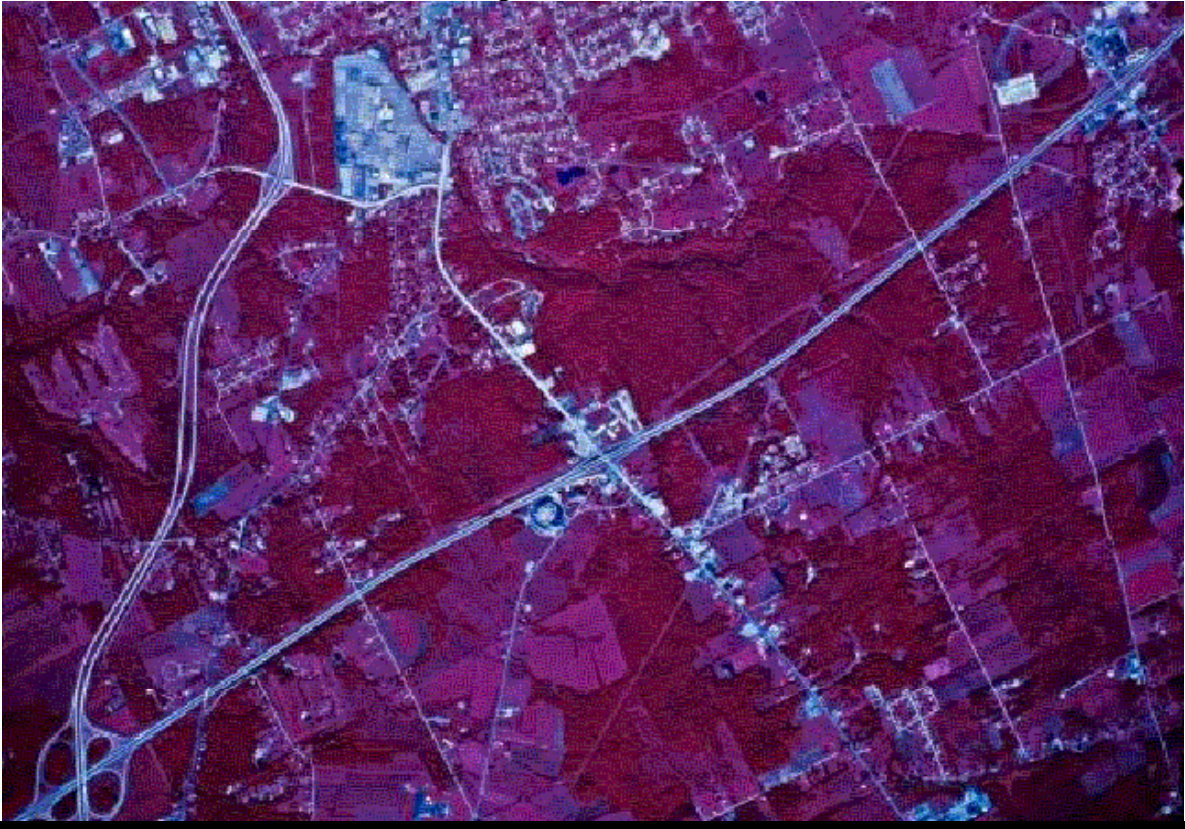
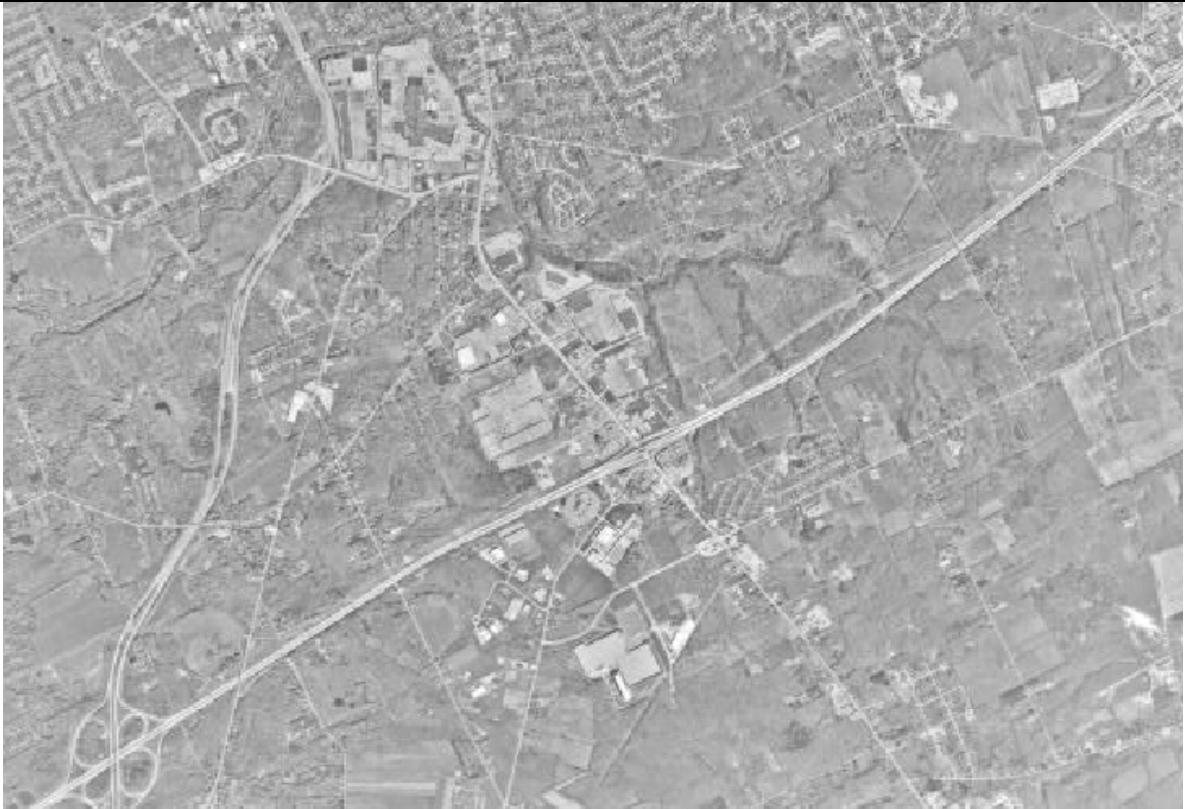
**September 4, 1987**

**May 4, 2002**

Much of the 908 acres of commercial land use, 3.73% of the watershed area, is located in the Millcreek Mall/Upper Peach Street corridor. This area has experienced intense commercial development during the past 15-20 years and projections show continued development into the foreseeable future. The following are U.S. Geological Survey aerial photographs of the area between Interstates 79 and 90, and US Highway 19 (several tributaries and the main channel of Walnut Creek can be seen running from east to west). Significant development has occurred in this area of the watershed in recent years. It is one example of the real and potential impact of concentrated development in the vicinity of major transportation corridors. It likewise demonstrates the stress this development places on limited, sensitive, source water and riparian/aquatic habitat areas within the watershed.
