SITE CHARACTERIZATION REPORT

CONESTOGA PINES PARK SITE

CITY OF LANCASTER
LANCASTER COUNTY, PENNSYLVANIA

PADEP CONTRACT NO. ME359184
WORK REQUISITION NO. 33-077

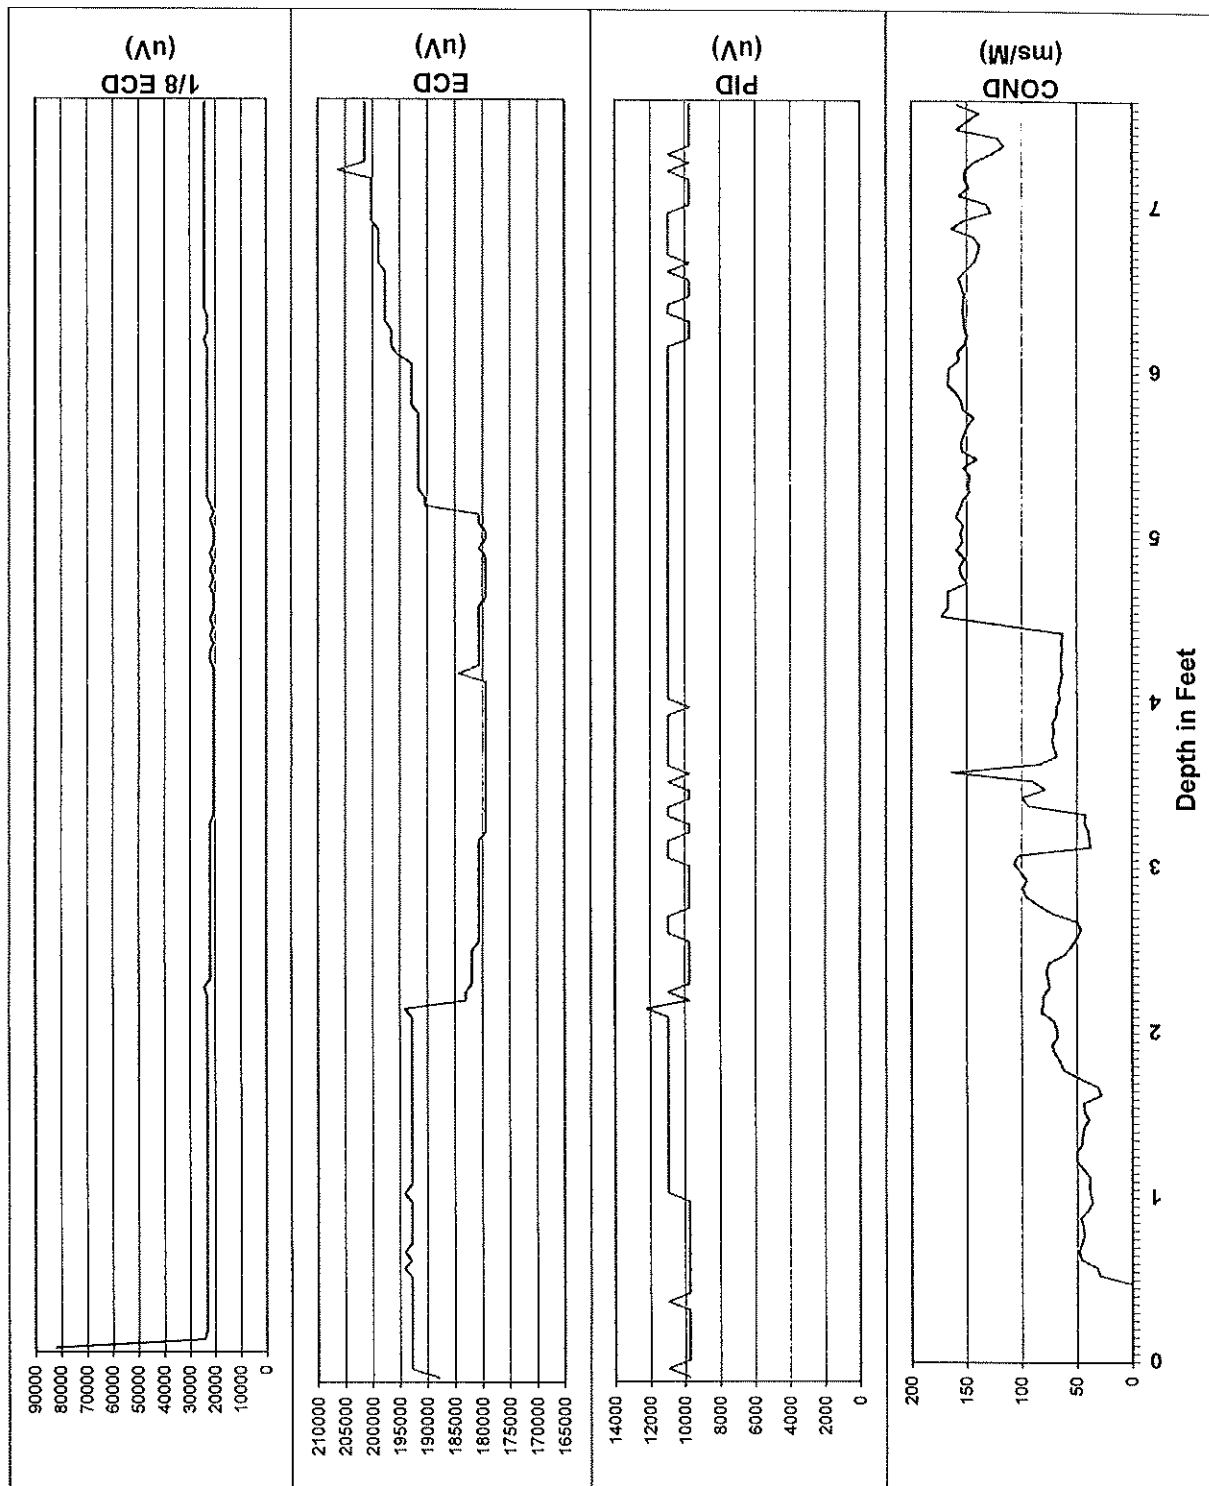
ZEBRA EC/MIP Summary Log, Point SB-64
Lancaster, PA

Date: 11/13/2001
Proj. Name: Baker/Lancaster, PA
Proj. #: ZDS04891
Operators: PMO
Point 64 of 67
