New Hope Crushed Stone

Monthly Update

November 2017

STATUS AS OF:	December 4, 2017	
PROJECT	New Hope Crushed Stone (NHCS) Quarry Reclamation and Stream Restoration	
START DATE	Reclamation: January 29, 2016 Stream Restoration: January 29, 2016	
ANTICIPATED COMPLETION DATE	Reclamation: March 2019 Stream Restoration: March 2019	
CURRENT STATUS	Quarry Reclamation	On Schedule
	Stream Restoration	On Schedule

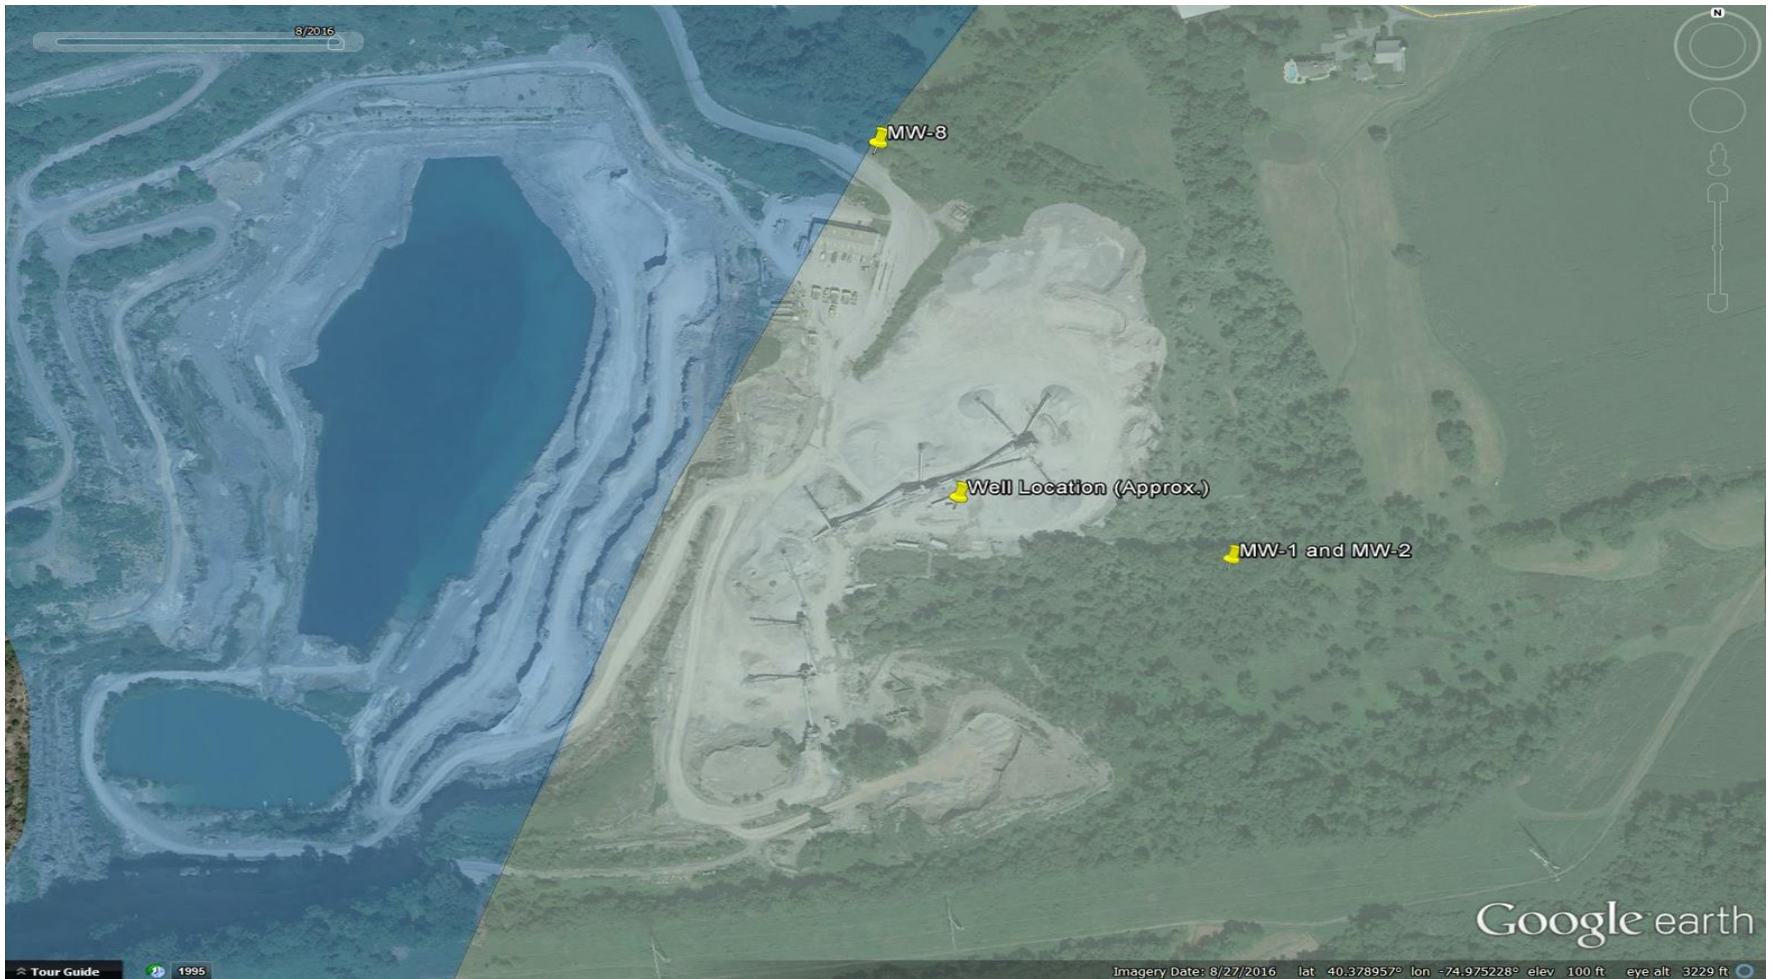
NHCS Monitoring Well Locations

Monitoring well locations are noted by MW1 and MW2 to the right and MW8 at the top center. The fourth in the center is for the plants water use.

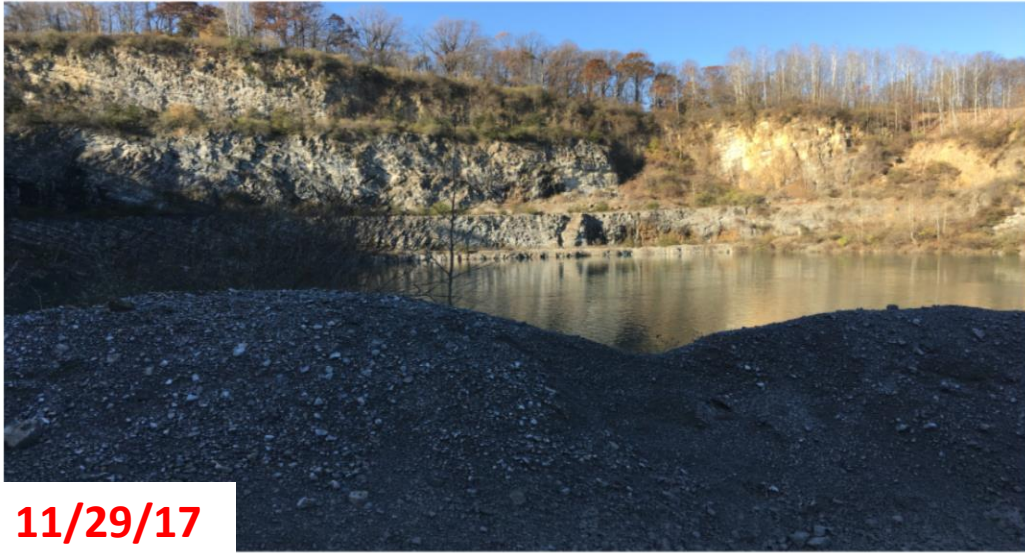
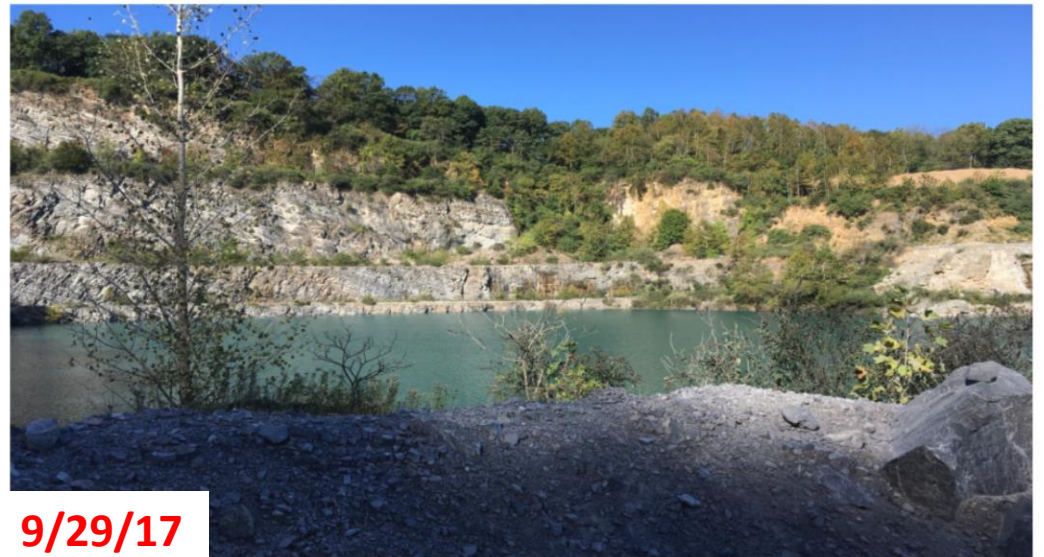
Sump Area Looking West

Note: Sump view is taken from opposite side due to the water level in the pit. It will be adjusted as the water continues to rise.

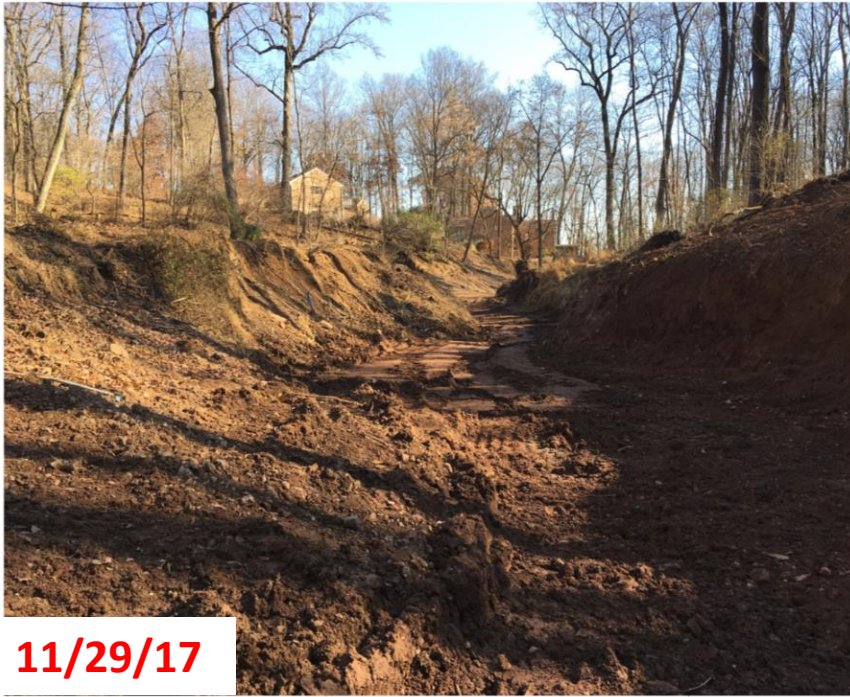
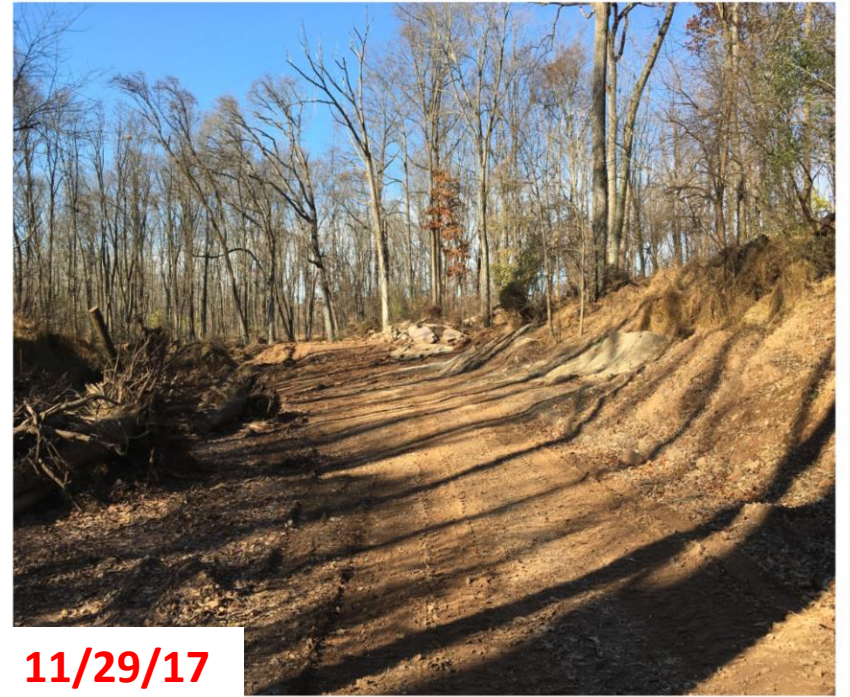
Stream Views: East and West

- Preparation work was done to move the transformer due to the rising water level.
 - Stream work was done on 6 days.
 - Stream channel work continued along the length of the stream.
