New Hope Crushed Stone

Reclamation & Restoration Vantage Photos

May 2016

May 2016 Project Status

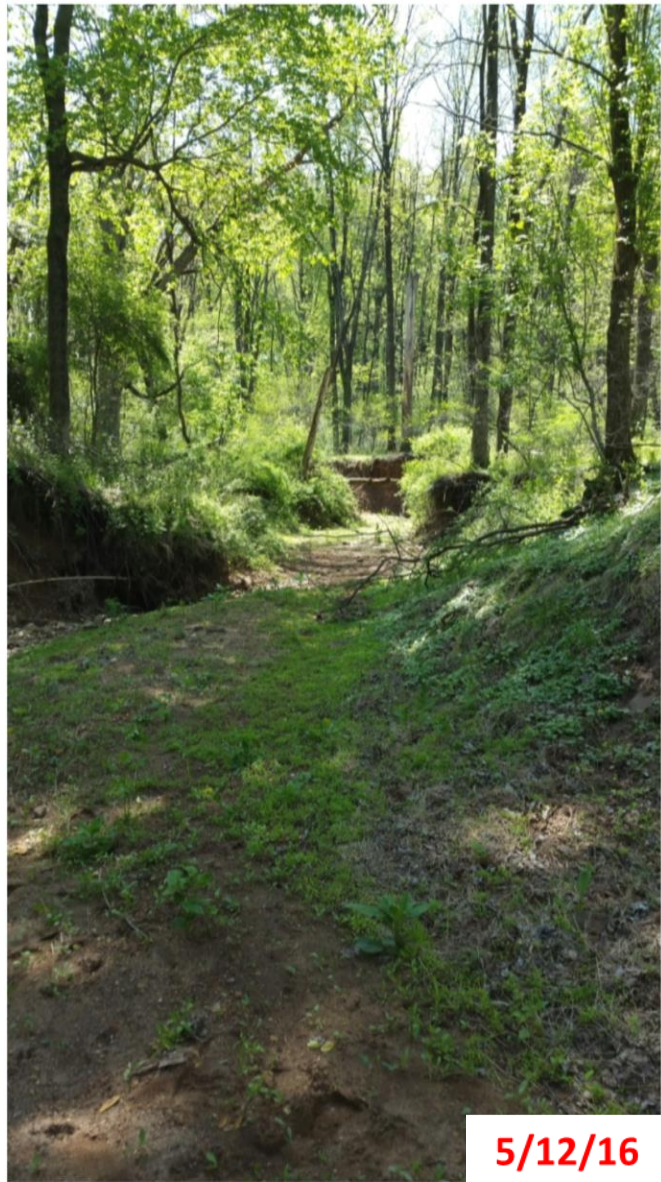
West, Looking East - Restoration

- Current condition of the stream bed
- During normal flows, water accumulates to the left (steep slope)

- Banks will be restored and revegetated
- Stream channel will slope gradually toward the quarry
- Steep slopes will be softened
- Brush cleared
- Water will evenly flow through this channel

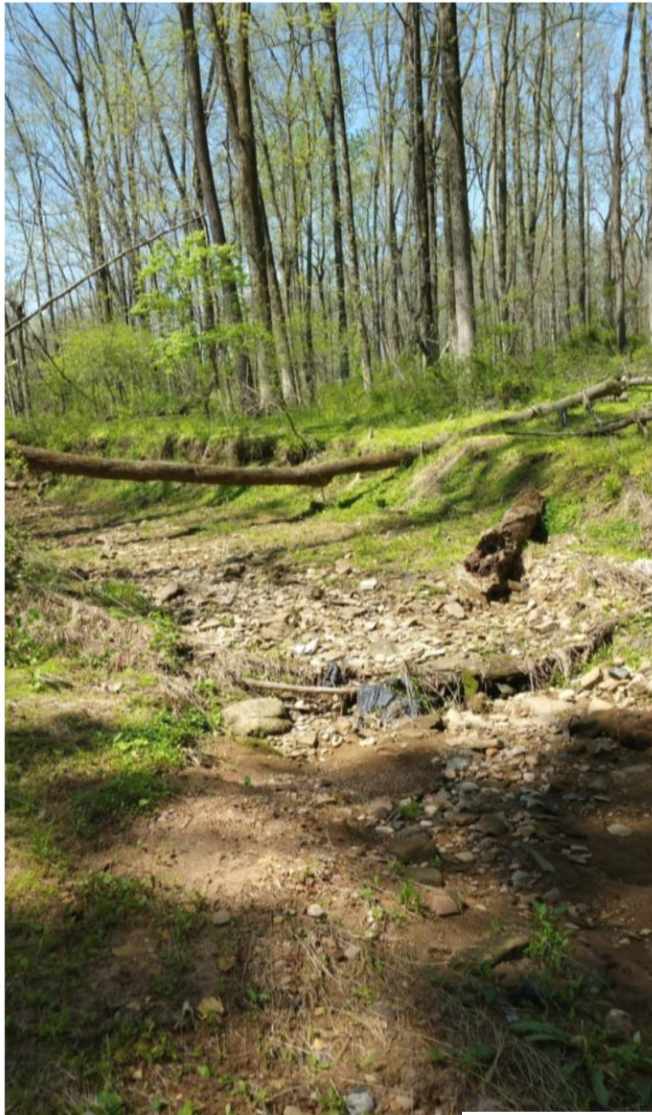
West, Looking West - Restoration

- Current condition of the stream bed
- Looking towards Solebury School
- Water samples collected near downed tree

- Water flowing this channel
- Banks will be restored and revegetated

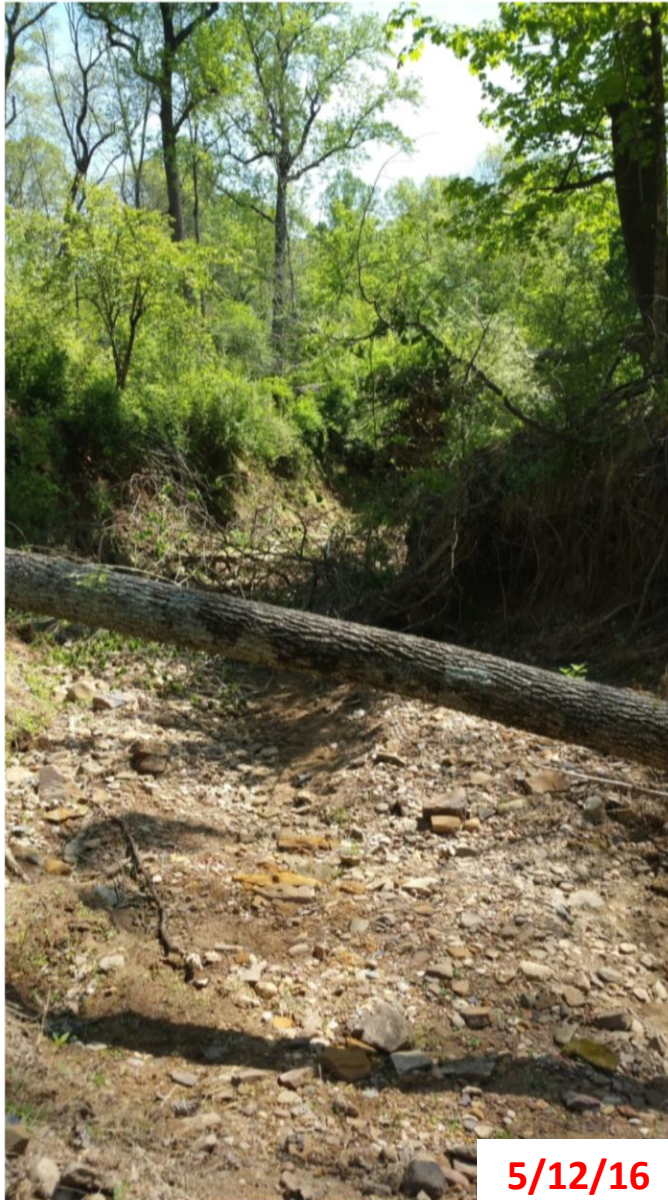
East, Looking East - Restoration

- Current condition of the stream bed
- Upstream of the swallow hole
- Stream turns to the left

- Banks will be restored and revegetated
- Sediment, brush and trees removed and cleared
- Steep slopes softened
- Water flowing this channel

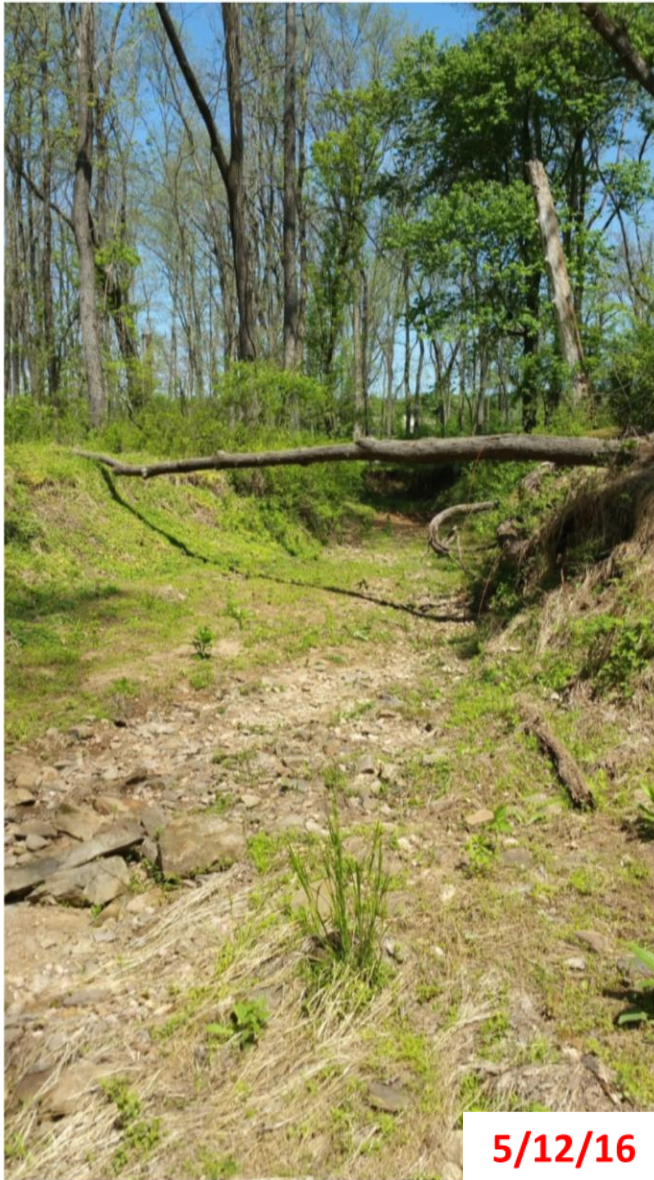
East, Looking West - Restoration

- Current condition of the stream bed
- Looking upstream towards “west” location points.

- Banks will be restored and revegetated
- Trees and sediment cleared
- Water flowing down the center

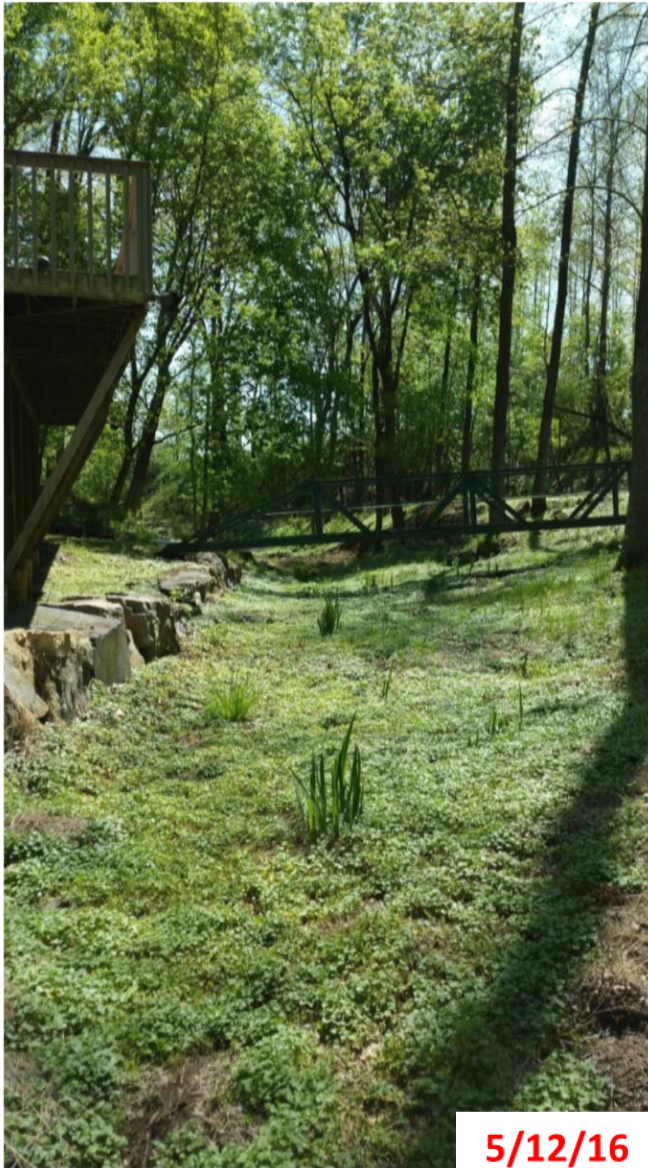
Mehok, Looking East - Restoration

- Owner's property
- Looking directly at the quarry
- This is part of the stream channel
- Only in heavy flows does water use this channel

- This channel will be deepened to get the correct pitch towards the quarry
- Water will flow through this channel

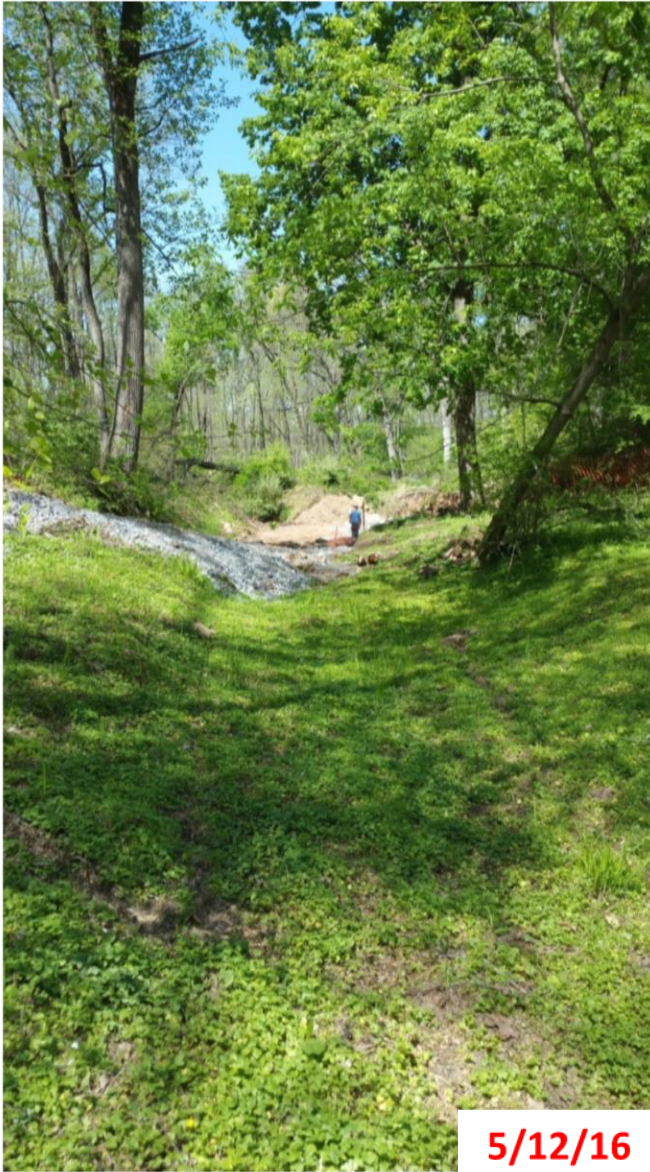
Mehok, Looking West - Restoration

- Current status of the stream bed
- Looking towards swallow area where sinkholes were fixed through emergency permit approved by DEP
- Access road, shown in gravel
- One of the main areas work will be completed

- Water will eventually be flowing here
- This area will be cut and filled
- The access road will be removed
- Downed trees and brush will be removed

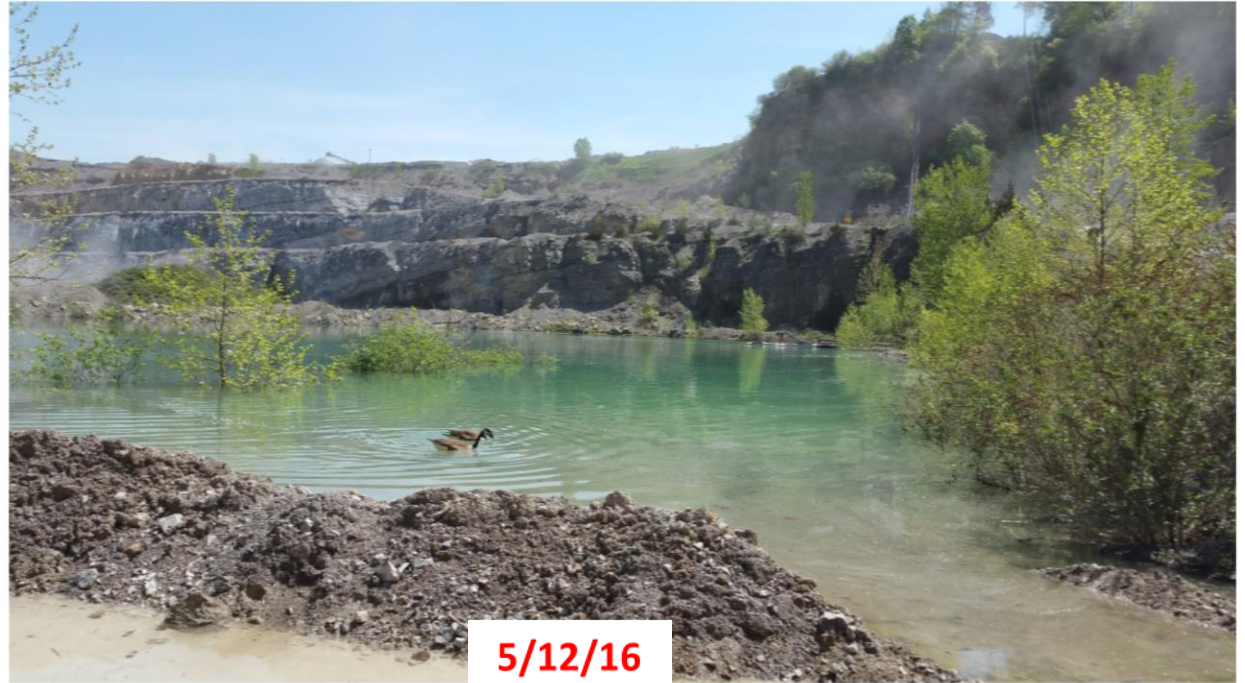
Sump - Reclamation

- Sump pump floating in back right corner
- Pond is filled by water coming from the wall
- Water level dependent on rain

- Will not be able to access this point in the future as this will be under water.

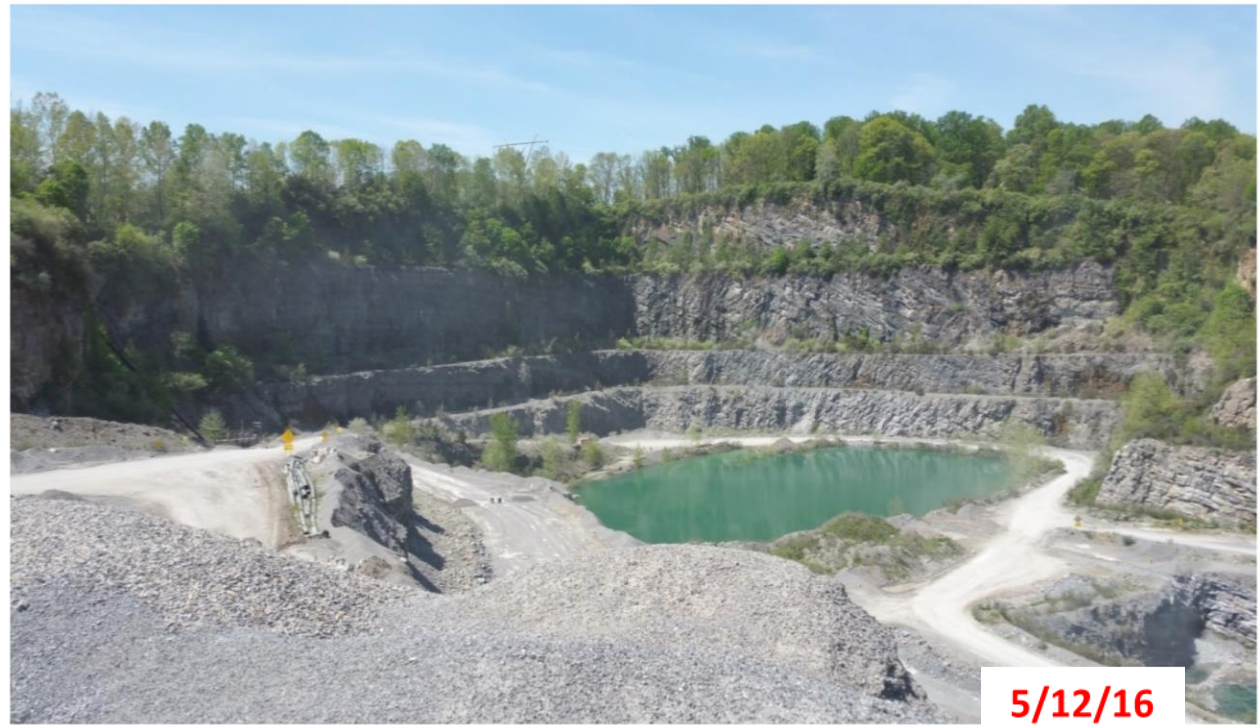
Ramp, Looking South - Reclamation

- Same pond from different angle
- “West” and “South” walls
- West high wall is grandfathered and will not be reclaimed

- More water
- No pit floor haul roads

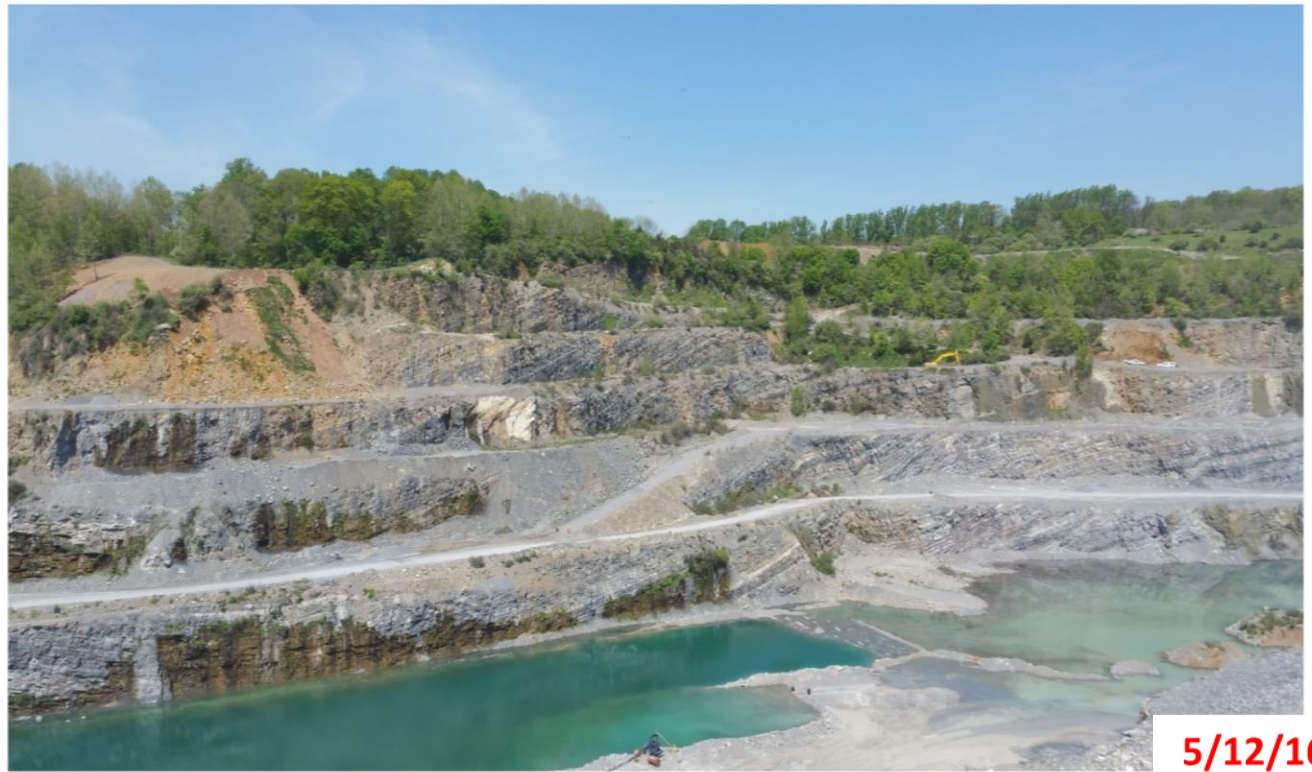
Ramp, Looking West - Reclamation

- This is inside the quarry, looking at the 'Western Wall'
- The brown area to the left has already been sloped.

- Permanent inlet installed for Primrose Creek
- Water level will continue to rise
- Continued sloping of walls

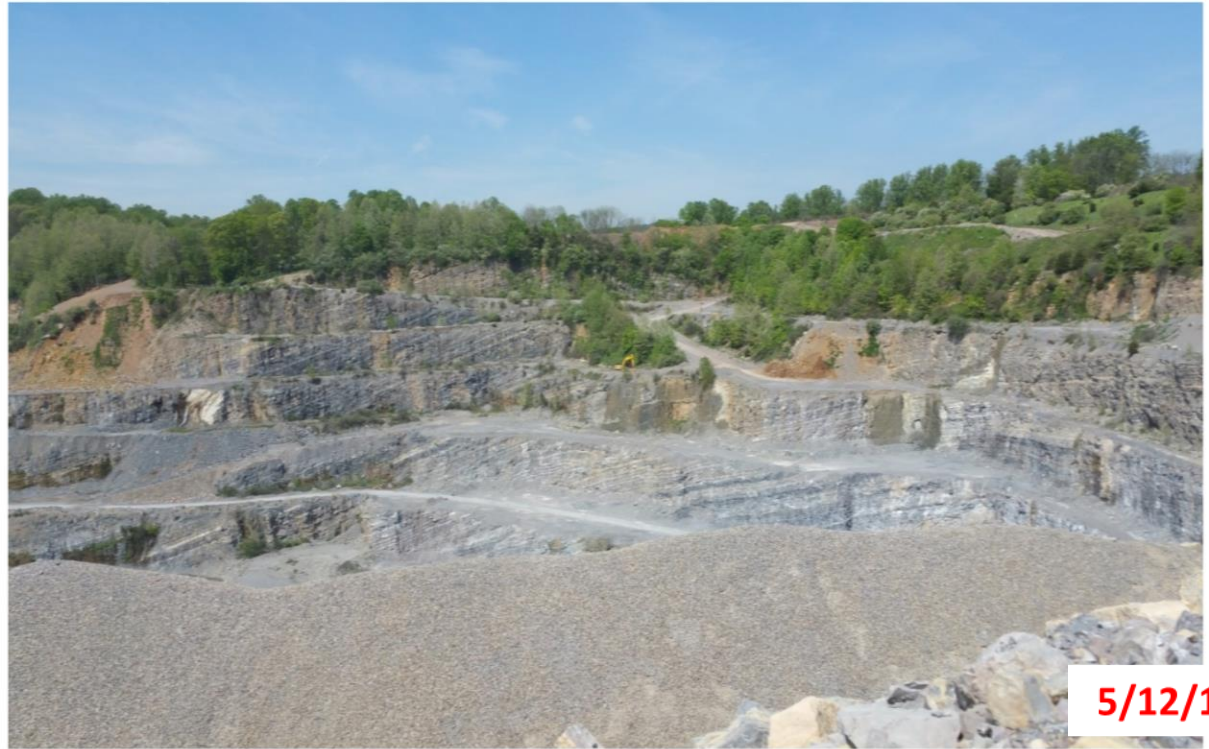
➤ Garage, Looking North - Reclamation

- Inside the Quarry, looking at the NW corner.
- This area has been used as a staging area for fill to be used for reclamation and restoration.

- Continued sloping
- More trees
- Water will be visible from this vantage point
- Foreground-sloped into water at 45 degree angle

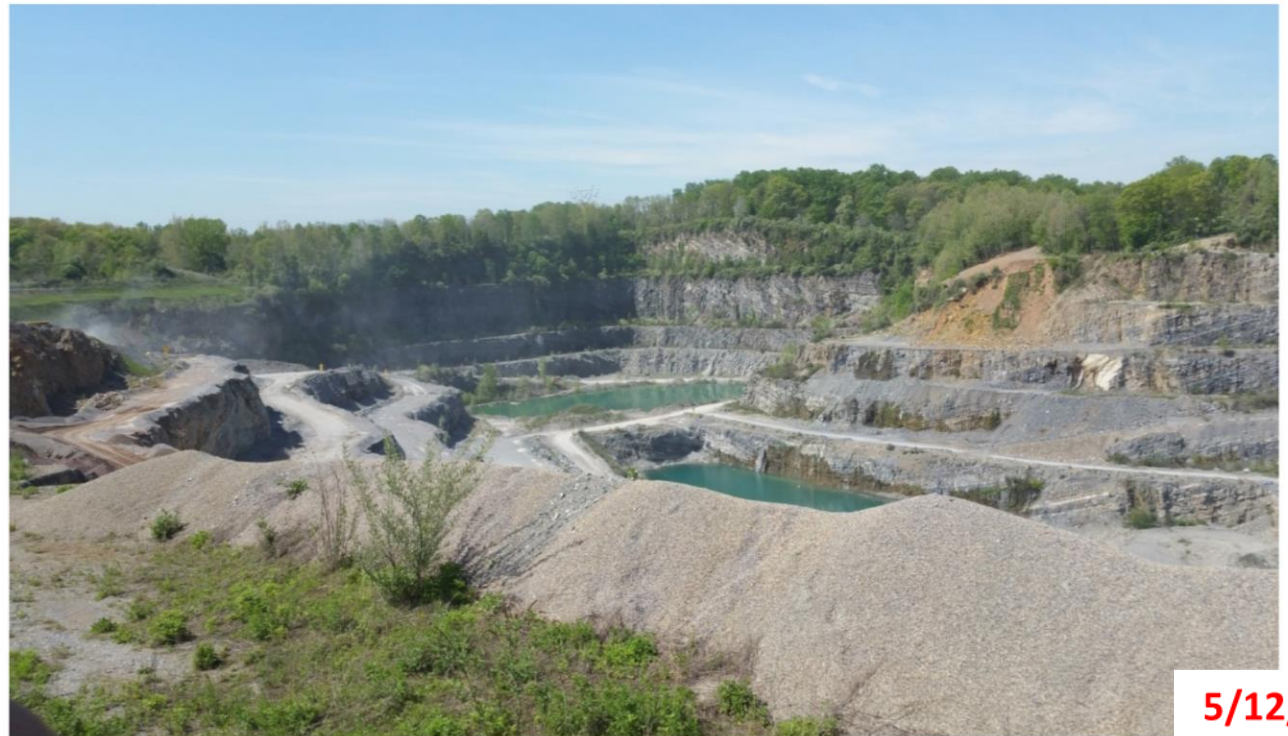
Garage, Looking South - Reclamation

- Overview of quarry, looking SW.
- Water on pit floor, sump is almost full

- Continued sloping
- More greenery
- Significant water increase over time
- Several benches will be pushed back
