New Hope Crushed Stone

Monthly Update

October 2017

October 2017 Project Status

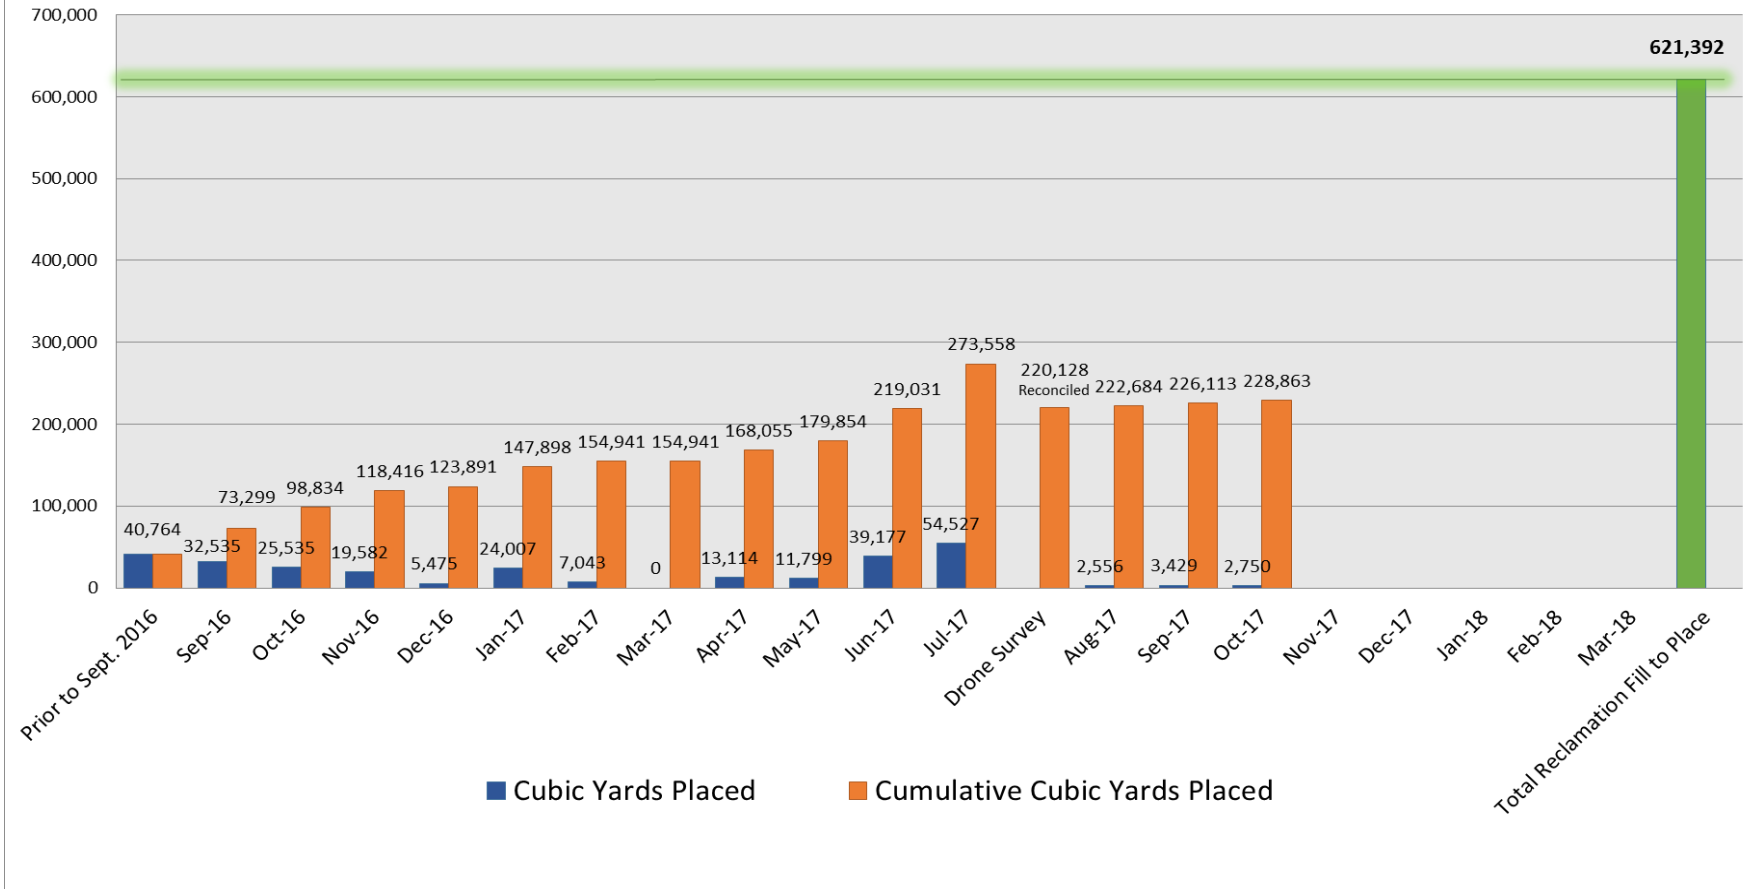
Reclamation Fill Tracking

- Reclamation and Stream Restoration Progress - Continued
 - 50 truck trips were made in October with 2,750 cubic yards of overburden trucked; the total to date is 228,863 cubic yards.
 - As of the end of September 36.8% of the total reclamation material has been moved.
 - Truck trip efficiency was fairly consistent; 55 cubic yards per load for October as compared to 56.2 cubic yards per load in September.
 - Reclamation work included removing and relocating the Hazemag foundation and coffin blocks.
 - Stream work was done on 17 days.
 - With DEP concurrence, stream restoration was emphasized starting in August to help insure the stream is stabilized moving forward. This continued to be the case in October.
 - Stream channel work continued and involved removing trees, pick up and assembly of gabion baskets, filling baskets, and moving clay.

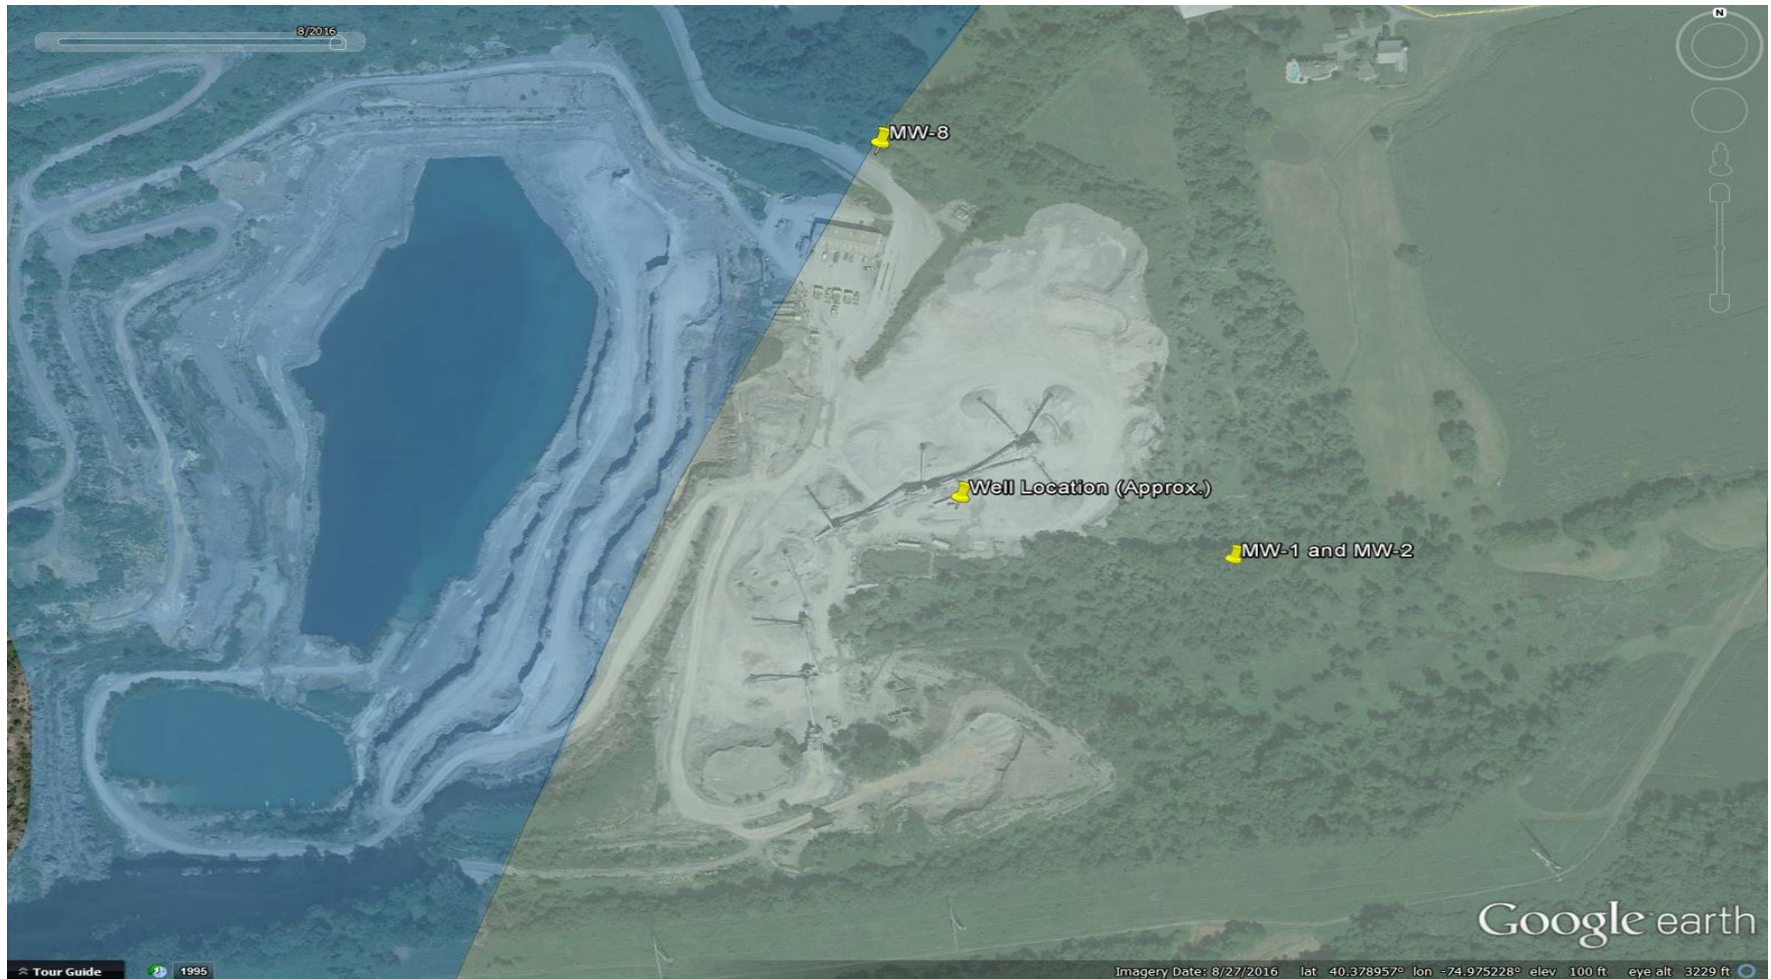
NHCS Monitoring Well Locations

Monitoring well locations are noted by MW1 and MW2 to the right and MW8 at the top center. The fourth in the center is for the plants water use.

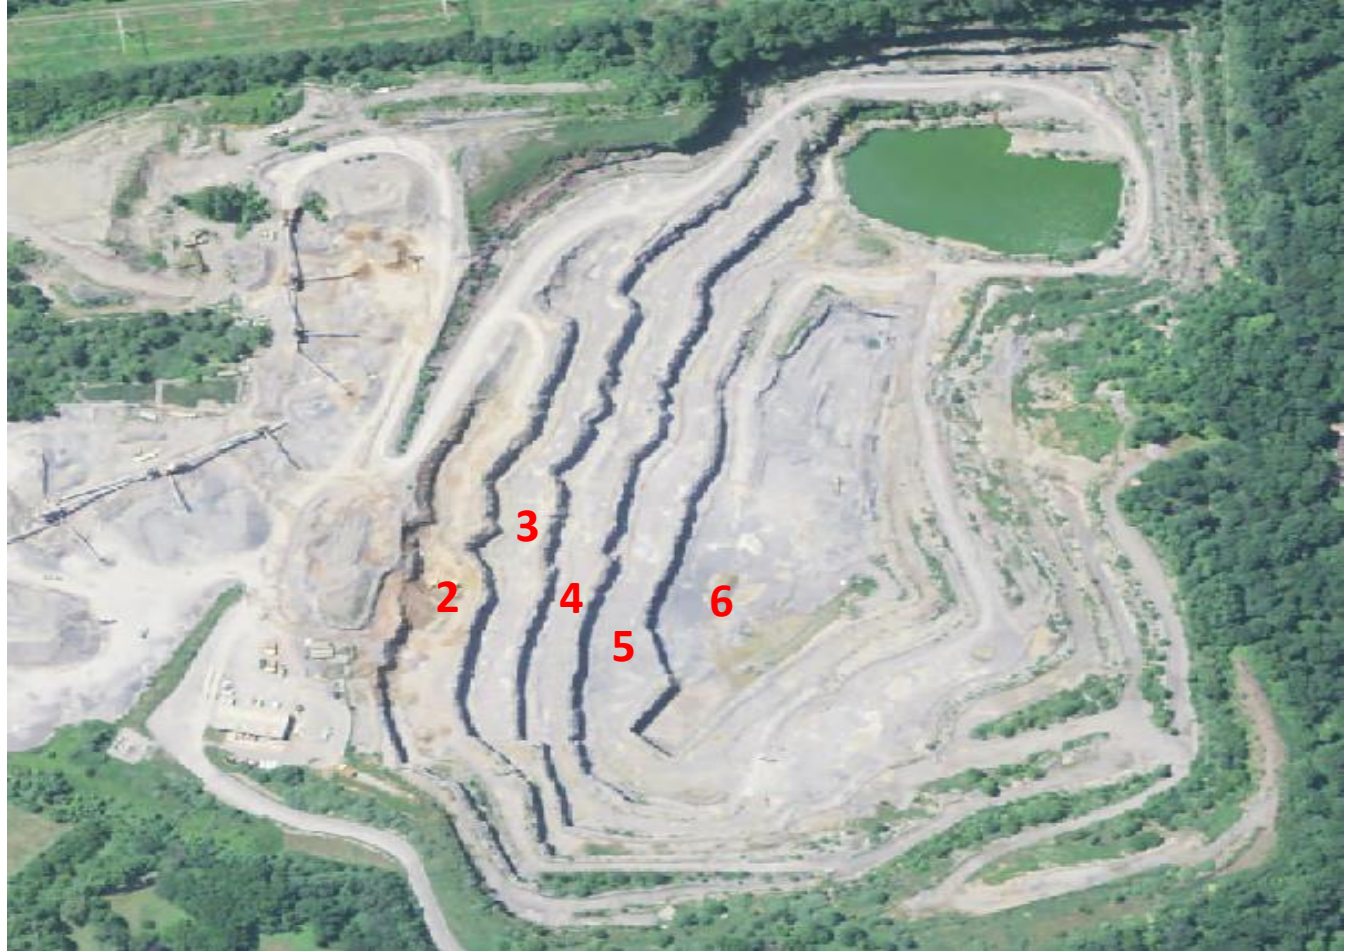
NHCS Bench Levels

- Bench 2 60' MSL
- Bench 3 10' MSL
- Bench 4 -35 MSL
- Bench 5 -85 MSL
- Bench 6 -120 MSL

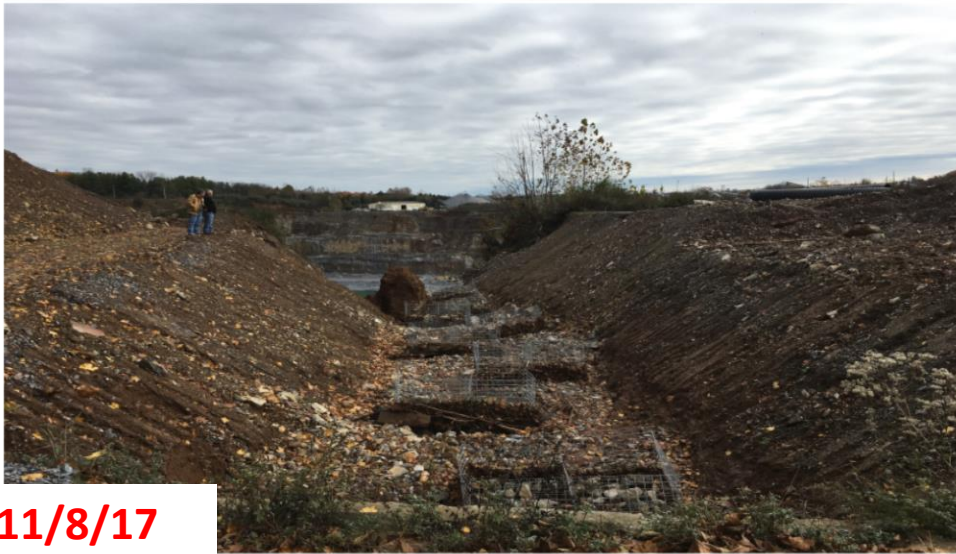
11/8/17

- Inlet work looking east.
- Comparative pictures will resume as inspections are completed.
- Informational pictures taken during site visits will be included to show other aspects of reclamation and stream restoration progress.
