**RECYCLING TECHNICAL ASSISTANCE
PROJECT #507
BOROUGH of WEST CHESTER
CHESTER COUNTY, PENNSYLVANIA**

JUNE 2013

Environmental Resources Associates

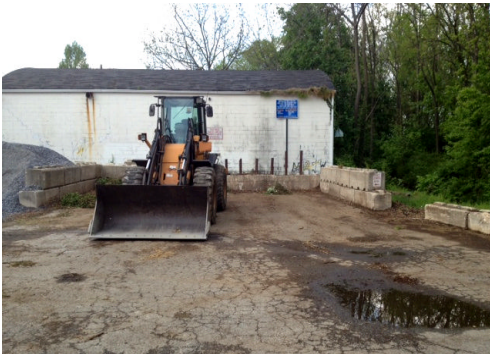
The leaf and yard waste drop-off site is located at the rear of the PWD building's parking lot and consists of a 900 square foot concrete block collection bin. The site is not staffed or secured, the existing surveillance camera system is inoperable, and it is available 24 hours a day, 7 days a week.

Drop-off Site, Collection Bin This large volume of leaf and yard waste and various prohibited wastes has resulted in additional costs for disposal of unacceptable materials and to load, transport and process acceptable materials at its compost facility. The illegal dumping has predominantly occurred over weekends and at times has nearly filled the PWD's 12,200 square foot parking lot.

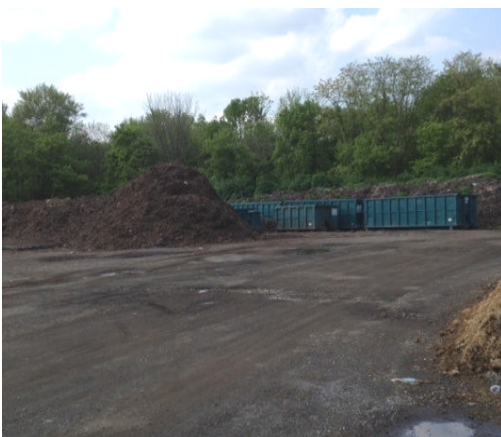
The Borough's compost facility is located approximately 1 mile south of the drop-off site adjacent to the Borough's Goose Creek Wastewater Treatment Plant. The compost facility was developed in 1990 and is approximately 3 acres in size. Leaf and yard waste is delivered by PWD directly to the facility following curbside collections and on an as needed basis from the drop-off site by PWD employees.

Open-air aerated windrow processing technology is employed for the composting of leaf wastes. Leaves are formed into parabolic shaped windrows of approximately 8' high X 16' wide X various lengths. To minimize handling, incoming loads of

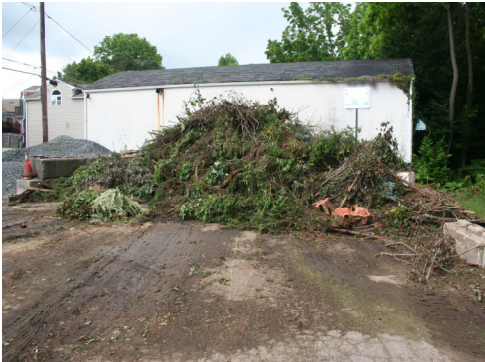
- 📍 As evidenced by the photograph taken on the Monday morning site inspection (see next page), the collection bin was filled past capacity. The materials were indiscriminately dumped on the parking lot and loaded into the collection bin by the Borough DPW personnel, to allow access to the lot by fellow employees.

Over Capacity Collection Bin

- ✦ Secure the perimeter of the parking lot with chain link fencing and lockable gates. Consider installation of a surveillance camera system as an additional deterrent to illegal dumping. Make the site available to residents on a regularly scheduled basis at convenient times and preferably open on weekends. Staff the site during operating hours to insure quality control and to identify residents. Consider dividing the collection bin into 2 compartments to allow for separation of leaf wastes and brush and tree trimmings by residents. Post additional instructional signage.

- ✦ Secure the collection bin with lockable gates and install a surveillance camera system as an additional deterrent to illegal dumping. Make the site available to residents on a regularly scheduled basis at convenient times and preferably open on weekends. Staff the site during operating hours to insure quality control and to identify residents. Consider dividing the collection bin into 2 compartments to allow for separation of leaf wastes and brush and tree trimmings by residents. Post additional instructional signage.

- ✦ The drop-off program operation has been modified and is now limited to the fourth Saturday of each month between the hours of 8am to 4pm. During the hours of operation, a DPW employee staffs the drop off site. The employee is responsible for monitoring the site to ensure individuals wishing to use the site are Borough residents and that all incoming materials being delivered are acceptable and free of contaminants. Materials delivered to the drop site are loaded into a dump truck and transported to the compost site the following Monday morning.
- ✦ When not in operation, the drop-off site is gated and locked.
- ✦ A new, digital surveillance camera system was installed at the drop-off site. To assist in identifying any violators, the system is monitored daily.

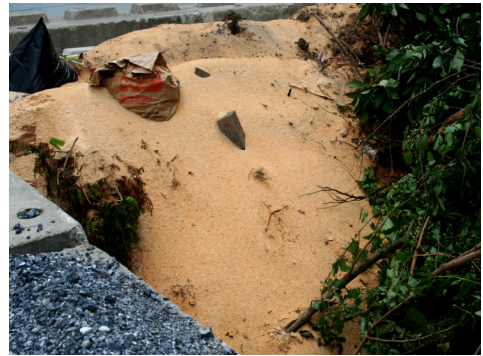
- 📍 Based on the amount and variety of materials observed (landscaping and tree removal wastes and associated debris, and sawdust), ERA concurs with the Borough's conclusion that the materials are being illegally dumped by commercial sources.

Variety of Materials and Debris
