**2009 ABANDONED MINE LAND
RECLAMATION AWARDS**

**WEST SUSCON
ABANDONED MINE RECLAMATION**

**OSM 40(3734)101.1
Jenkins Township
Luzerne County, Pennsylvania**

**Commonwealth of Pennsylvania
Department of Environmental Protection
Bureau of Abandoned Mine Reclamation
Wilkes-Barre District Office**

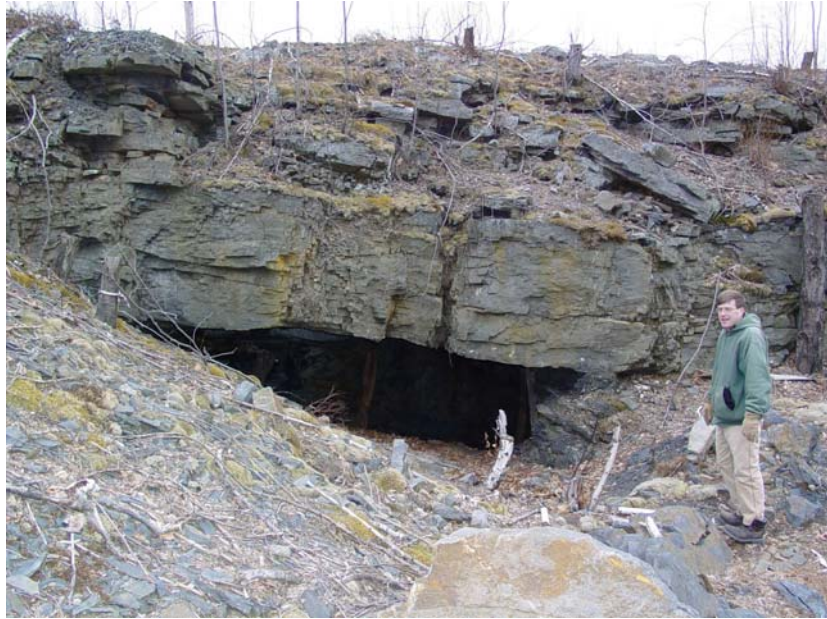
FIGURE 3
(AMLF NO. 19)

The remaining openings at the site were sealed in a more traditional manner. AMLF 19 (Figure 3) and AMLF 24 (Figure 4) are representative of the openings that had to be addressed. These openings were to be sealed using a combination of Class C concrete (2000 psi compressive strength at 28 days), rock backfill material (4 to 12 inch rock with a uniform gradation) and common backfill material (soil). AMLF 22 was a slope-type opening with abandoned mine water flowing from it. Plans called for a 24-inch diameter corrugated polyethylene pipe to be placed in the opening with common backfill around it to allow the water to continue to exit the opening while at the same time excluding unauthorized entry. AMLF 17 (Figure 5) presented its own challenges. This opening was located approximately half way up the side of a 40-foot deep strip pit. Abandoned mine drainage flowed from the opening, down the side slope of the pit and disappeared into the bottom of the pit. The floor of the pit coincided with the depth of the second mined underground coal seam, so apparently the water was entering the underground mine workings and thence the mine pool. It was not possible to fill or otherwise excavate this pit in such a way as to keep this flow above ground and out of the mine pool. A scheme was devised to fill the bottom of the pit with seven feet of R-5 rock (largest size being 18 inches), and then continue the R-5 rock up the side of the pit with a depth of about 5 feet and a width of 20 feet to the floor of the opening. The pit could then be backfilled with common material, removing the hazard of the pit while providing a flow path for the abandoned mine drainage to the mine pool.

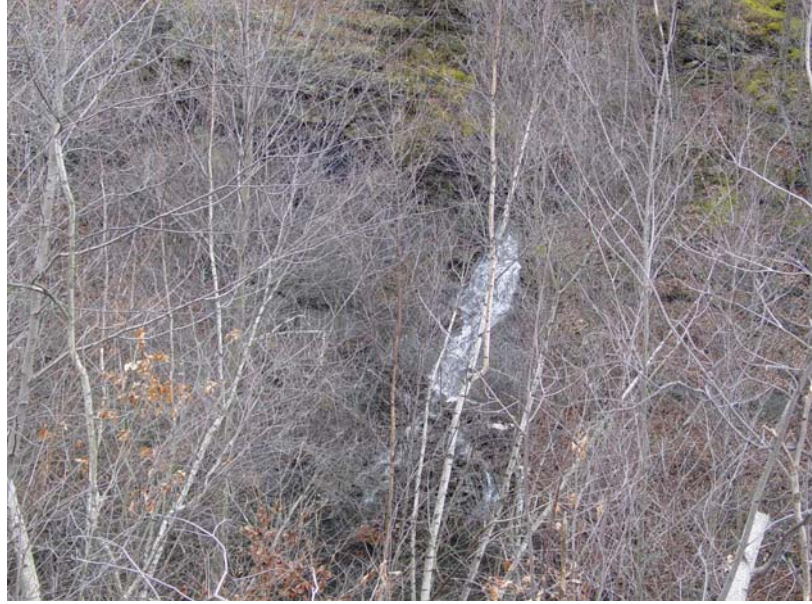
FIGURE 5

The project site is located within the Mill Creek watershed which is part of the Susquehanna River Basin. There were eleven water bodies at the site. Six of them had poor water quality because of low pH. One had high iron content. Three had good water quality but no wetland vegetation, so there was no requirement to mitigate. Lastly, one area was dry at the time of the investigation. AMD was flowing from AMLF 17 and 22.

Water coming from mine opening, AMLF No.17
and flowing down the side slope of the strip pit.

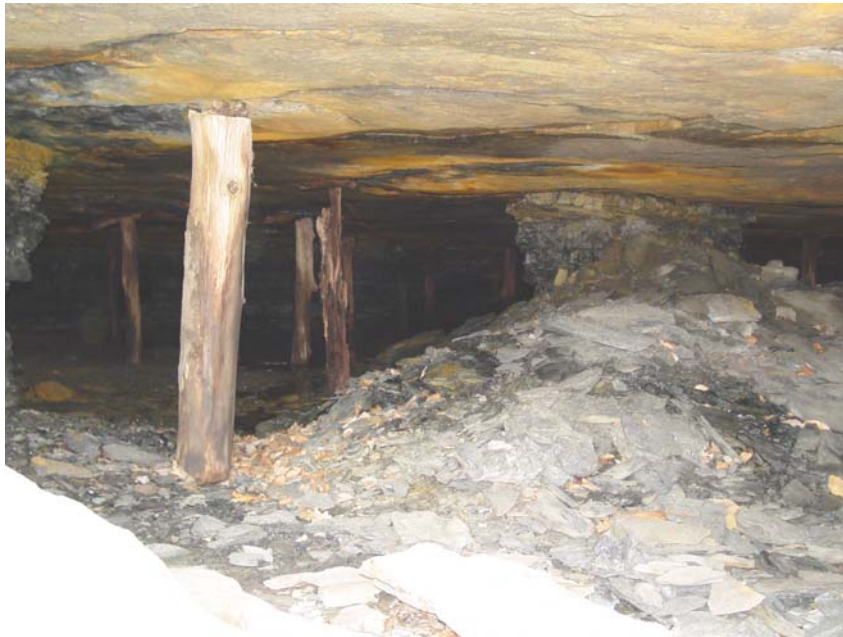
Close up view of mine opening AMLF No.17,
the source of the water shown in the top photo.

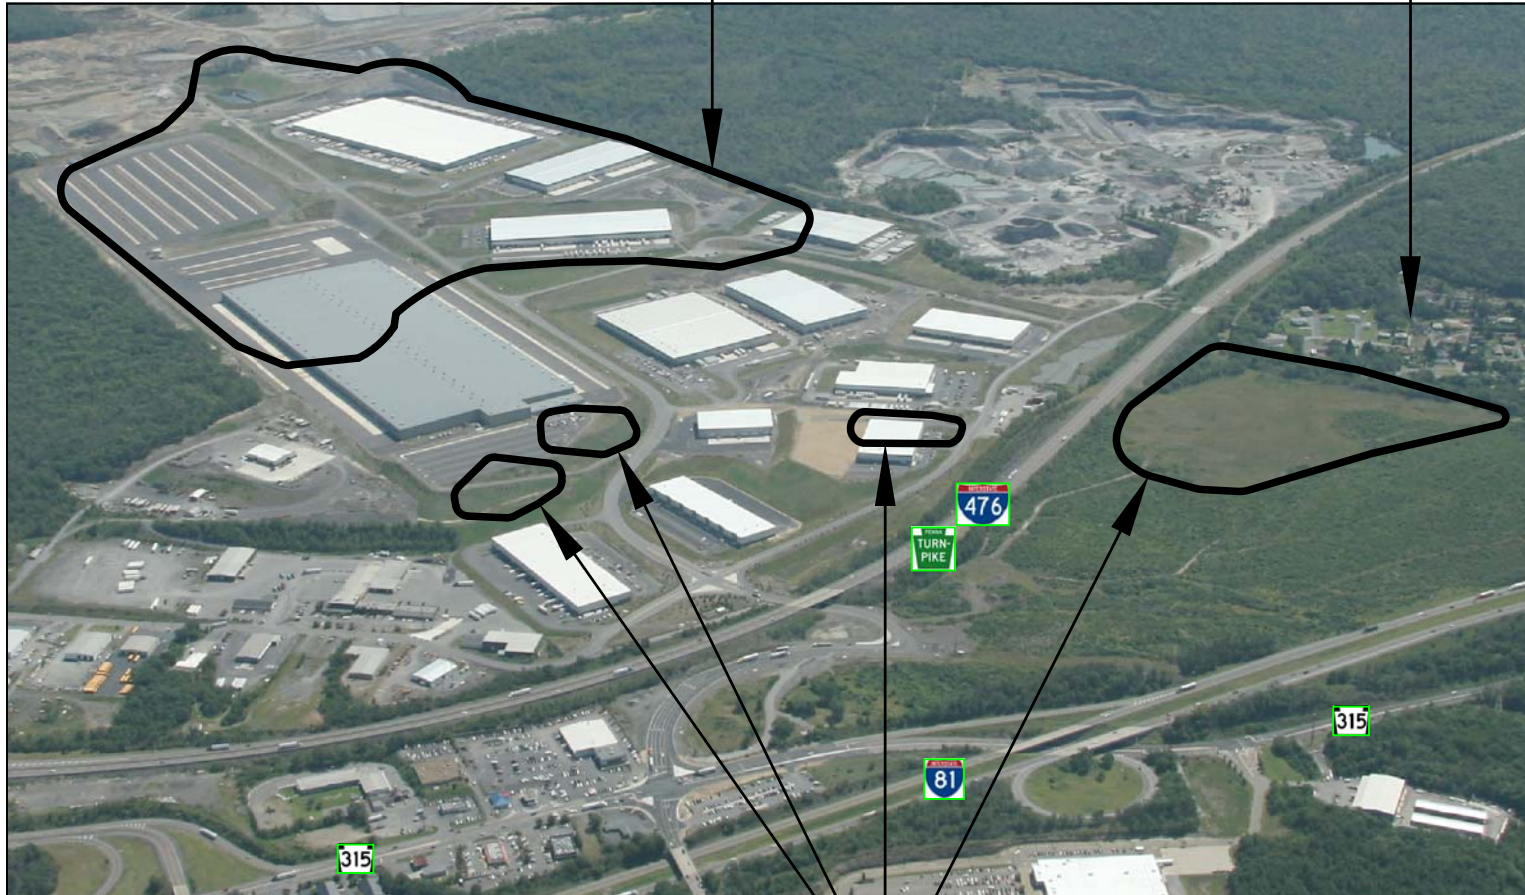
FIGURE 7
(AERIAL PHOTO OF SITE AFTER RECLAMATION WITH COMMERCIAL DEVELOPMENT)

Today, it is unlikely a person unfamiliar with this area would think that the site had formerly been a mined-scarred landscape (See Figure 7). Figure 7 is a present-day aerial photograph on which the grading limits of the New Boston Road 2 North, Old Boston and West Suscon projects are shown.
