WHEATLEY ENGINE SHAFT SUBSIDENCE Abandoned Mine Reclamation Project Contract No. NC-15-001-101.1EMER

WHEATLEY ENGINE SHAFT SUBSIDENCE ABANDONED MINE RECLAMATION PROJECT CONTRACT NO. NC-15-001-101.1EMER

FACT SHEET

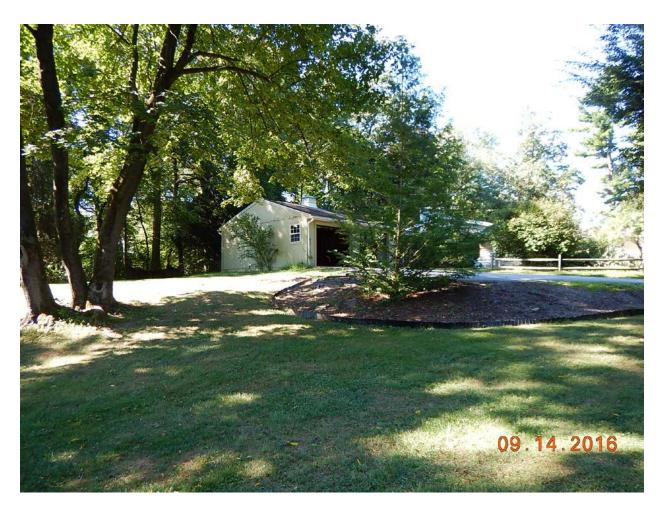
Pre-Construction

SUBSIDENCE OPENING SIDE OF ATTACHED GARAGE

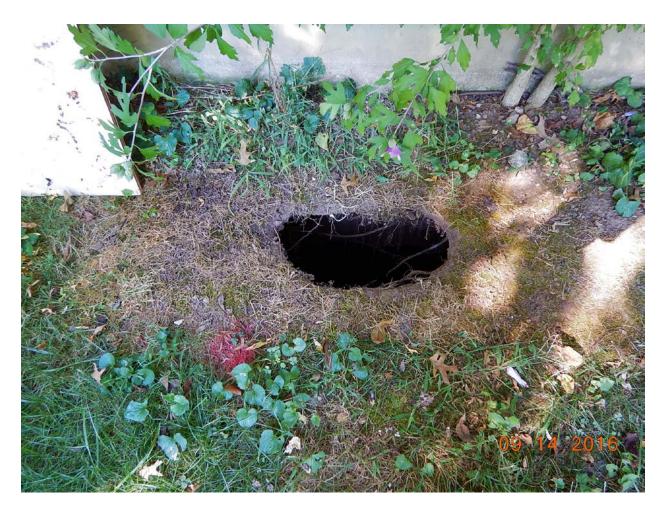
PRE-CONSTRUCTION

| <u>Location:</u> | The project site is located at Pine Tree Lane, Schuylkill Township, Chester County. From I-476, the site can be accessed by taking I- 276W/I-76W for 14 miles to the PA 29N exit and turn right onto PA 29N. Take PA 29N for 0.6 mile and turn right onto Whitehorse Road. Travel 2.8 miles and turn left onto Creek Road. Travel 0.2 mile and turn left onto Pine Tree Lane. |
|---|--|
| <u>Description:</u> | A void was encountered adjacent to a homeowner's attached garage. The void measured two feet (2') long by one foot (1') wide at the surface. Below the surface, the void undercut the garage footer and extended underneath the garage approximately 15'x15'x47' deep vertically. The exact dimensions of the void could not be determined due to safety concerns and limited visibility. Water was encountered at a depth of twenty-seven feet (27'). Further research revealed that the current GPS latitude and longitude values recorded at the void location coincided with those listed for the Wheatley Engine Shaft in Mineral Resources Report M 72, "Zinc and Lead Occurrence in Pennsylvania", published by the Pennsylvania Geological Survey in 1977. |

SUBSIDENCE OPENING

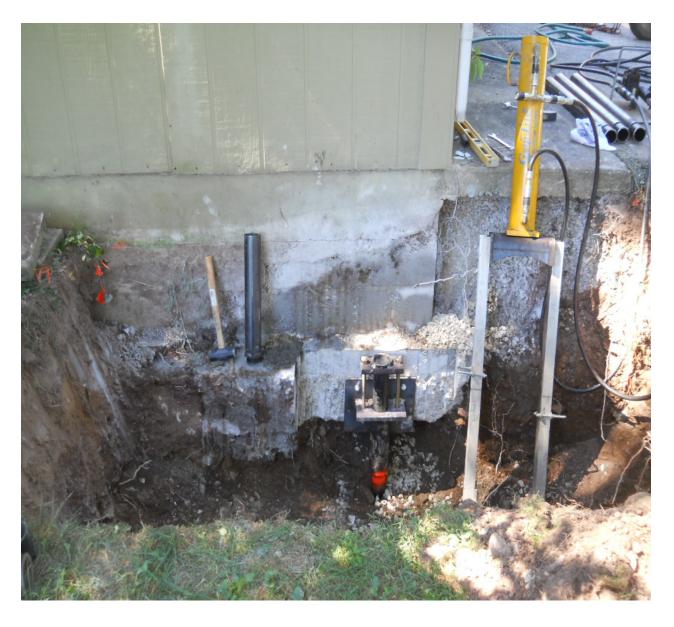
DURING CONSTRUCTION

INSTALLATION OF STEEL PUSH PIERS TO SUPPORT GARAGE

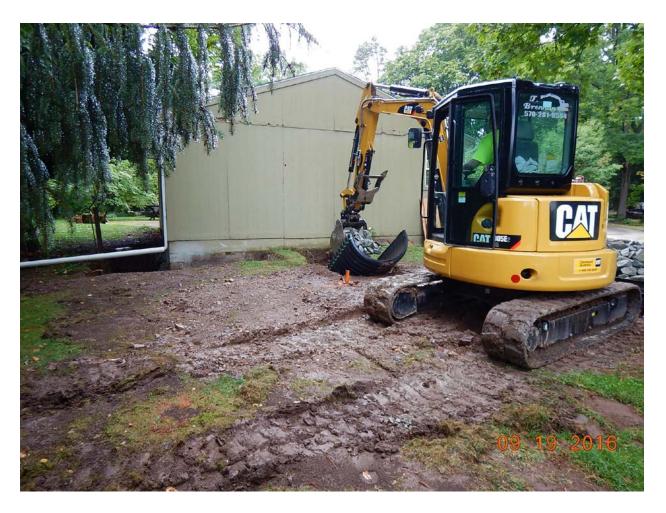
DURING CONSTRUCTION

BACKFILLING MINE SHAFT WITH ROCK

| | This Construction Emergency eliminated a public health and safety hazard by backfilling the shaft with approximately 517.6 tons of rock and 117 cubic yards of flowable fill. Four (4) six-inch (6") diameter coreholes were drilled in the garage floor to inject flowable fill into the mine void up to the bottom of the garage floor. For safety reasons, six (6) steel push piers were installed to support the garage foundation while backfilling. The driveway affected by the contractor's work was repaired with 227 square yards of superpave asphalt wearing course, $1^{1}/_{2}$ " depth, and 0.6 cubic yard Class A concrete was placed in the driveway apron. The disturbed non-paved areas were seeded with a grass seed mixture. |

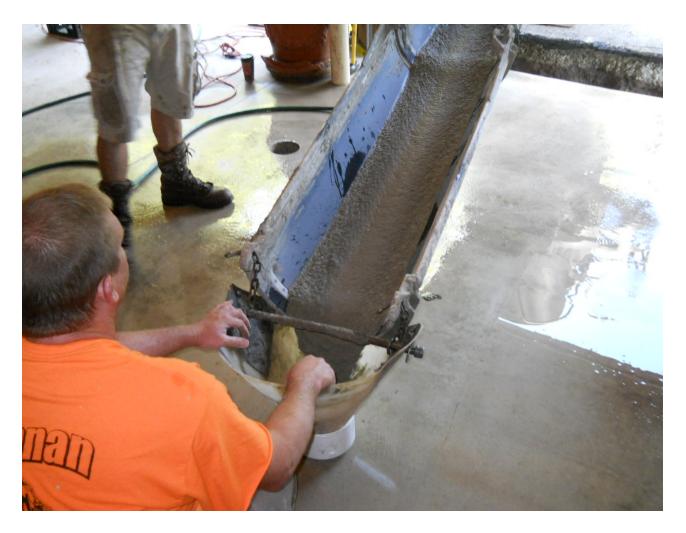
DURING CONSTRUCTION

BACKFILLING MINE SHAFT THROUGH COREHOLES WITH FLOWABLE FILL

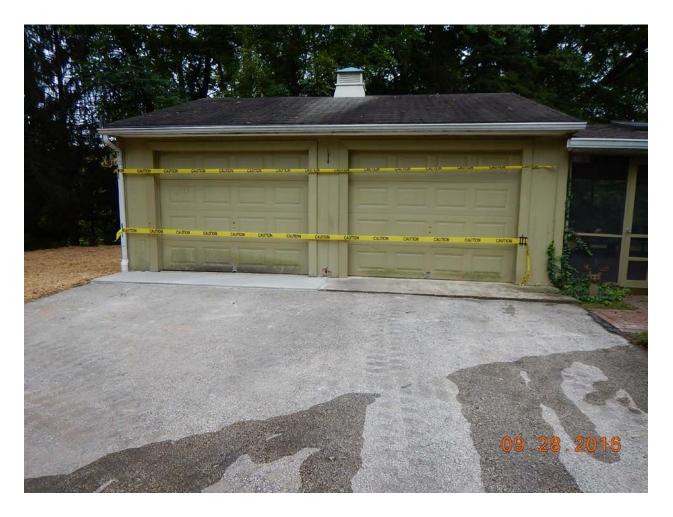
POST CONSTRUCTION

APRON REPLACED ON LEFT BAY OF ATTACHED GARAGE

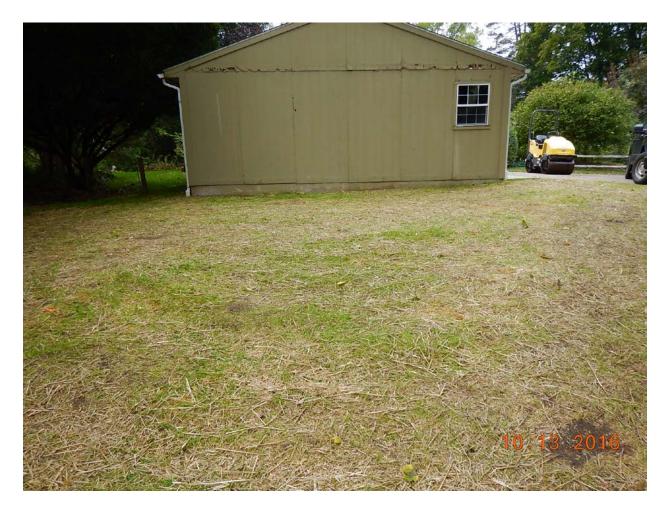
POST CONSTRUCTION

BACKFILLED SUBSIDENCE AREA

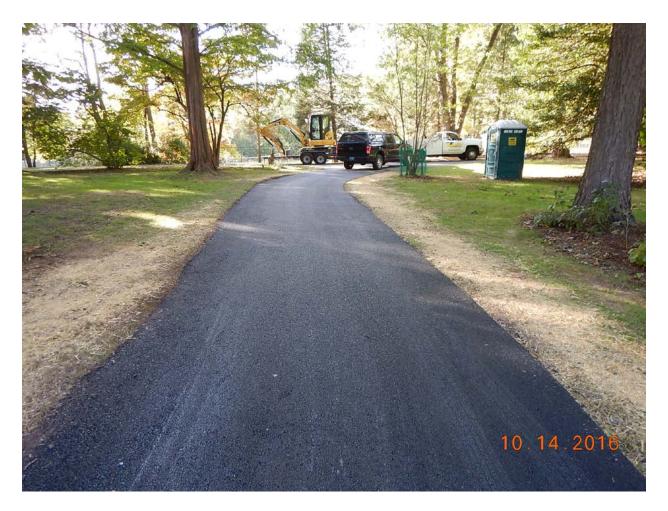
POST CONSTRUCTION

REPAIRED DRIVEWAY
