## NO. 6 SHAFT SUBSIDENCE 3

### ABANDONED MINE RECLAMATION PROJECT

Office of Active and Abandoned Mine Operations

To backfill the collapsed No. 6 mine shaft.

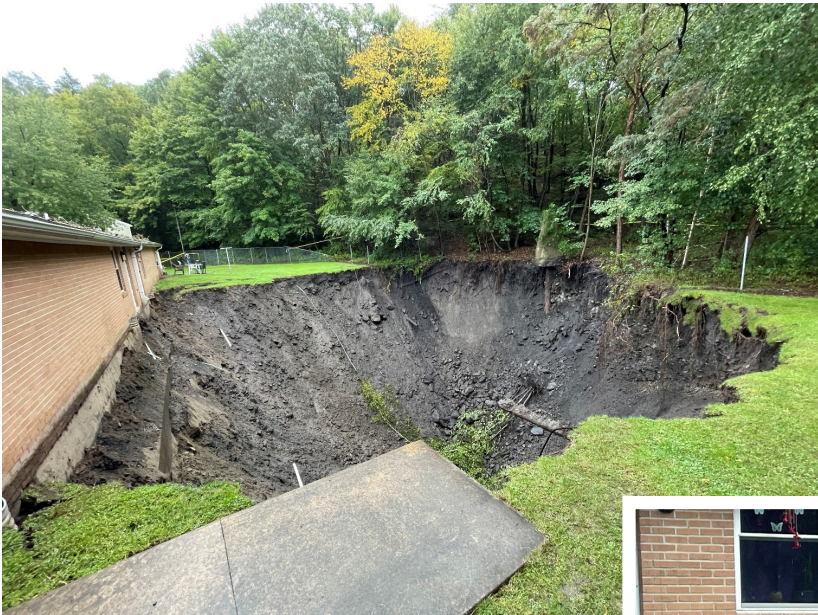
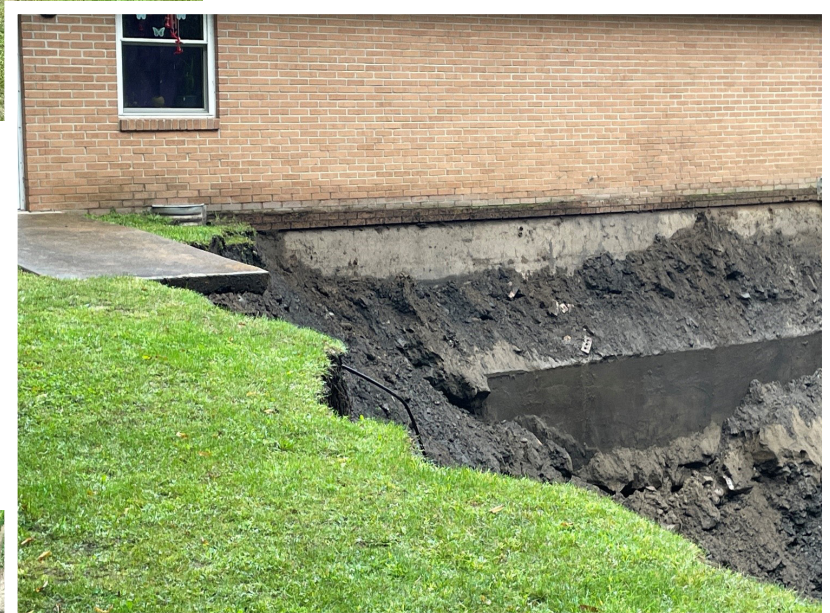
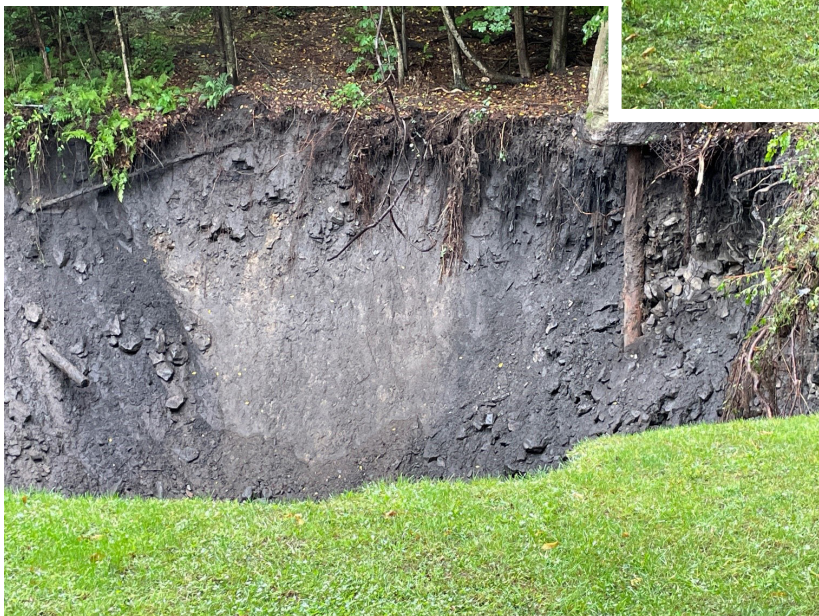
**Pre-Construction**

A large subsidence was located behind the building comprising Units 71-75, approximately 95 feet southwest from the centerline of Rock Street and 340 feet east of the intersection-bend of Newport Street and South Market Street. The subsidence measured approximately 70 feet by 80 feet and was conical to a total depth of approximately 50 feet. The subsidence was directly adjacent to the building housing Units 71-75 and the concrete cantilever footer foundation was visible; the building was not undercut and did not appear to have shifted. The sides and base of the subsidence were dirt and loose material. Material near the edges of the subsidence was actively subsiding; however, the base of the hole appeared choked off and was not deepening. There were multiple utilities visible in the subsidence including a six-inch water main and multiple small conduits with telecommunications and low-voltage power wire; no rock was visible. The water main was shut off, and the electrical meters were pulled on all the condemned units. It was noted that the weekend was very rainy, and it was raining steadily during the investigation.
