GLASSPORT

Abandoned Mine Reclamation Project

Contract No. OSM 02(0072)101.1 ARBP

FACT SHEET

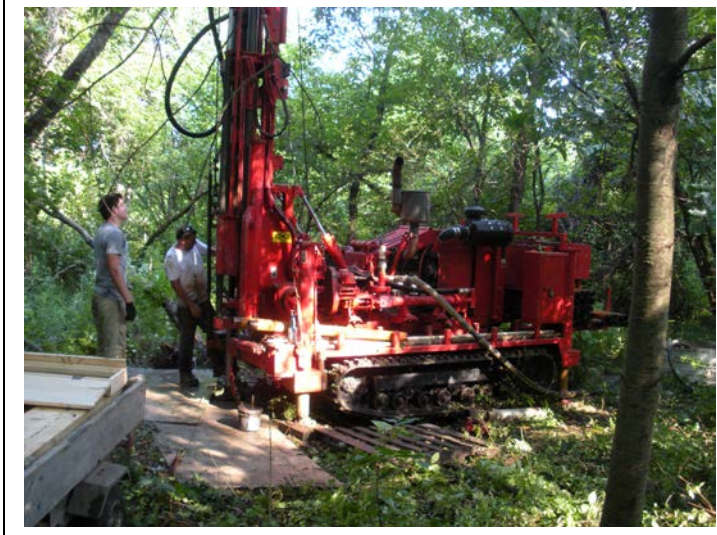
CME drilling rig on rubber track.

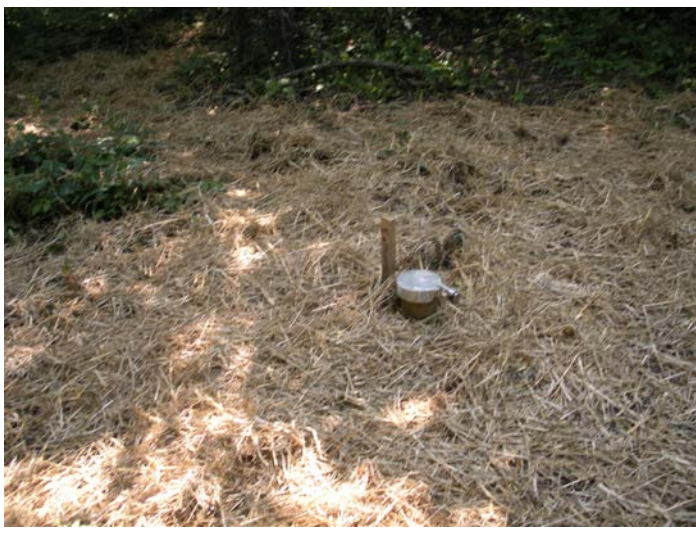
Boring Hole No. 3 with well cap.

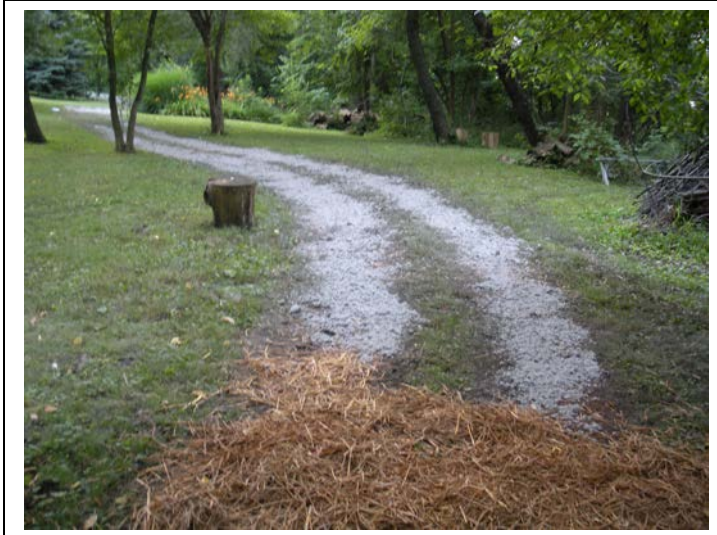
Seeding areas of property owner's yard.

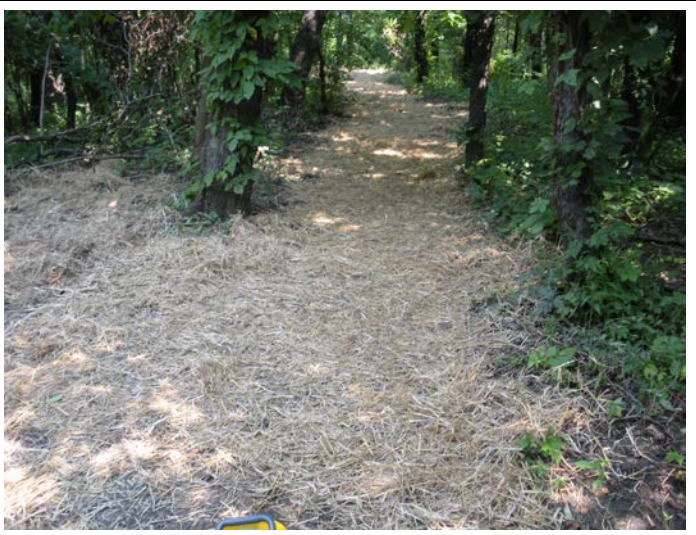
Seeding and mulching disturbed areas.

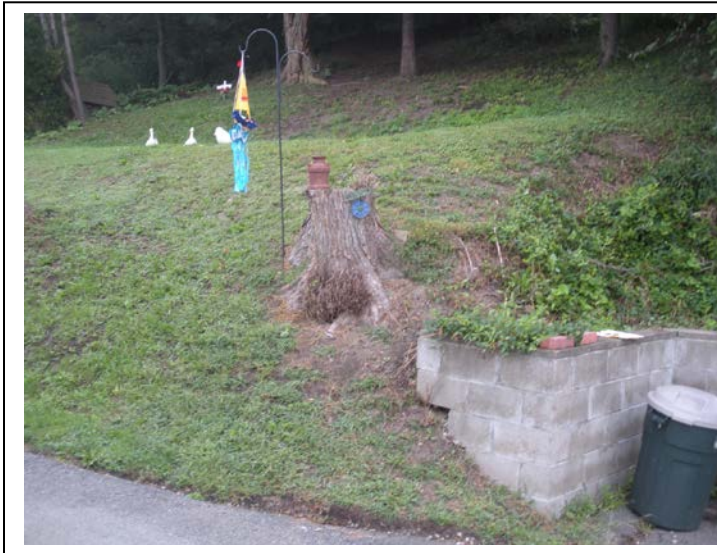
Area where wall will be constructed.

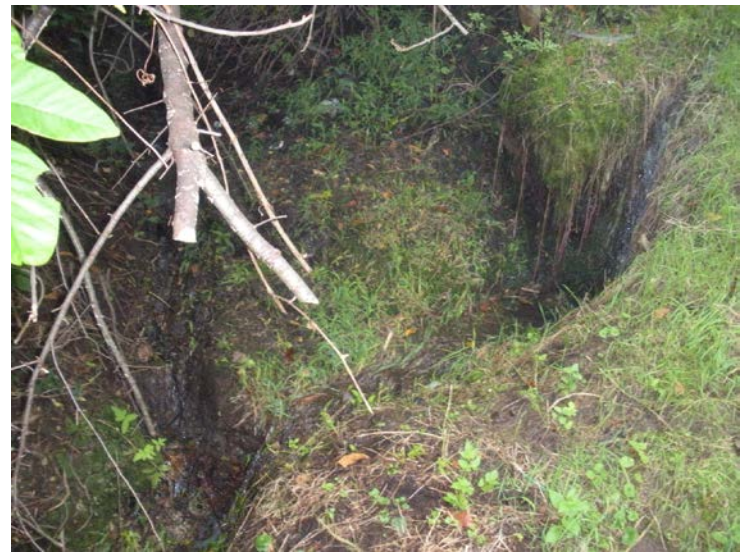
Water ditches coming off the steep wooded hillside behind Ms. Semian's house.

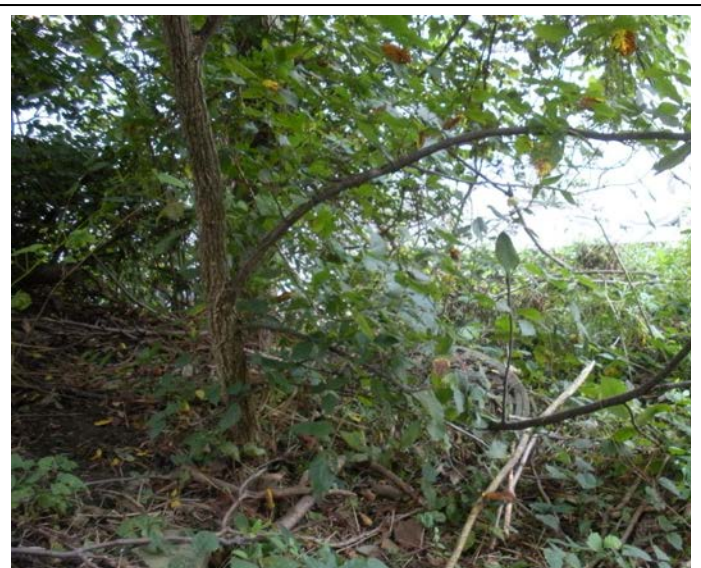
Typical view of brush areas where the drain lines will run.

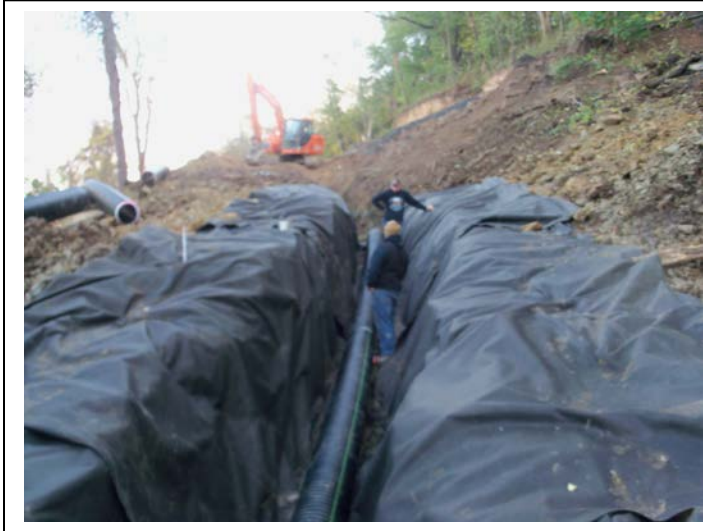
Typical look at laying pipe.

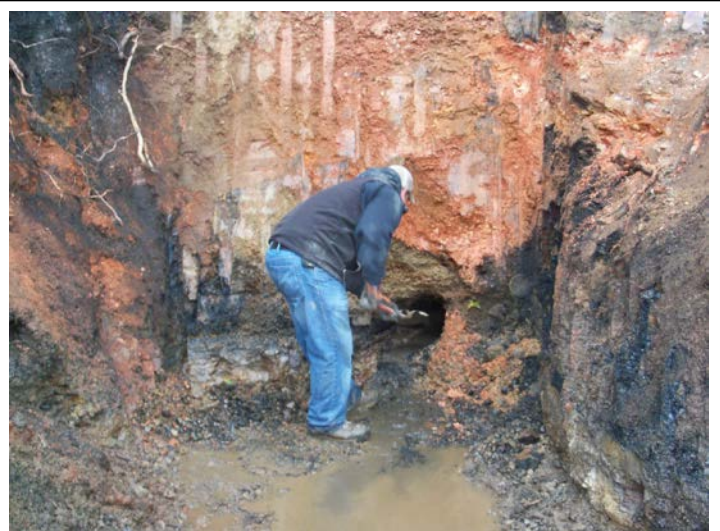
Bottom of one of the mine entries.
Note old railroad lines in opening

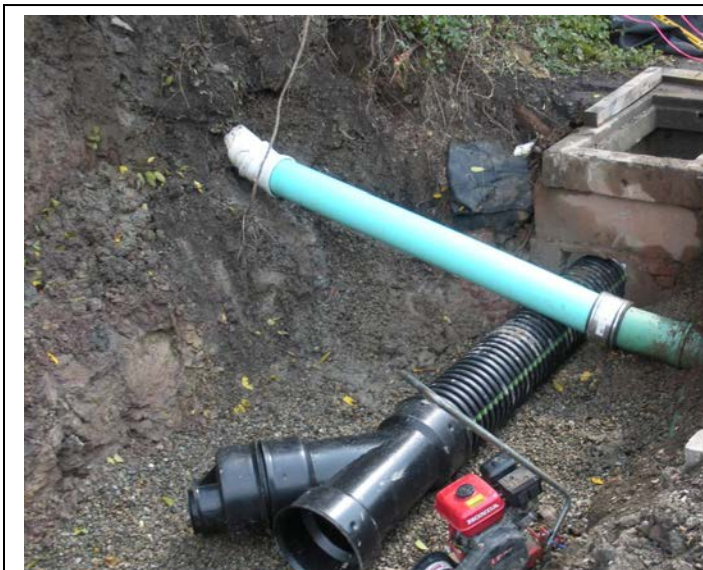
Connection into culvert at 2nd Street.

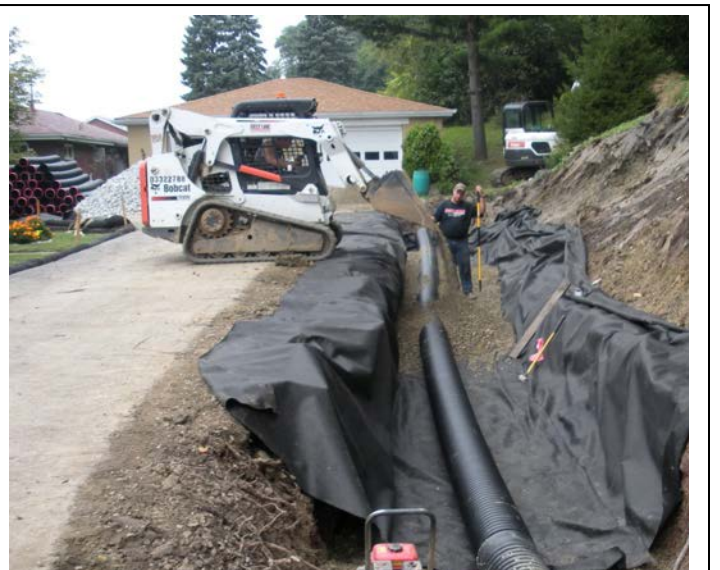
Main line along driveway at Ms. Semian's house.

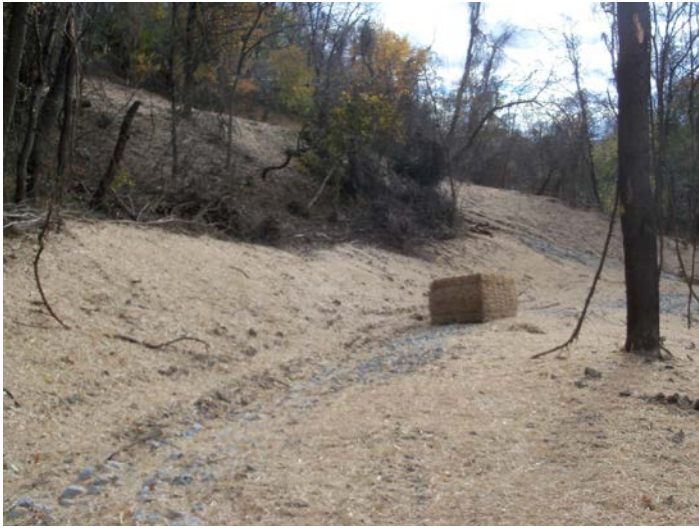
Seeding and mulching main drain line.

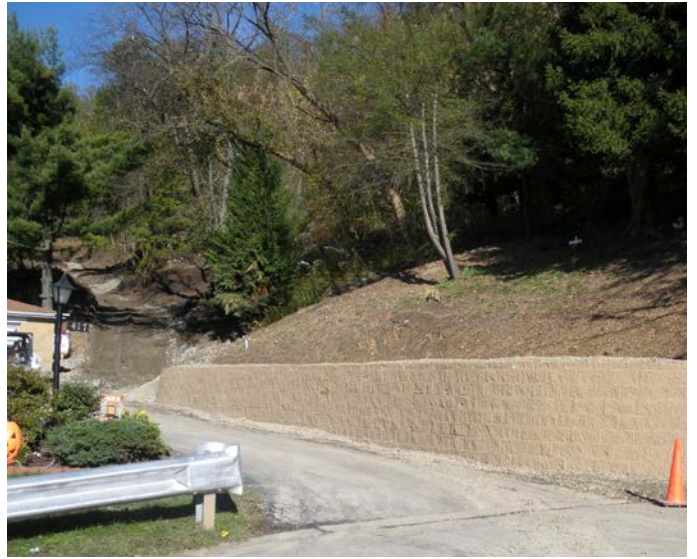
Wall constructed at Ms. Semian's home.

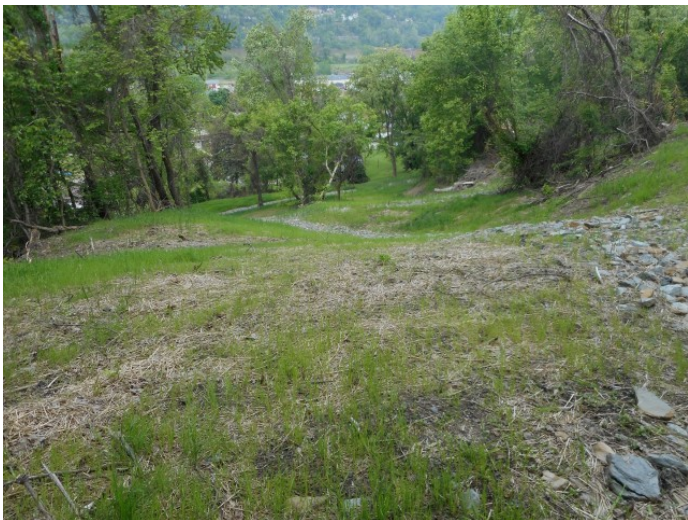
Grass on the main trunk line up the hill.

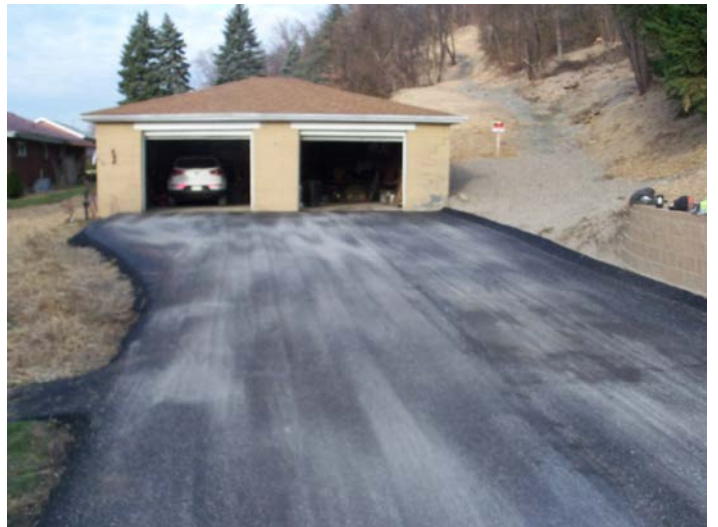
New driveway constructed by the property owner as a result of the project.
