STACKHOUSE PARK
Abandoned Mine Reclamation
Contract No. OSM 11(1052)101.1

FACT SHEET

Project Area: One (1) vertical opening 12 feet in diameter and 350 feet deep.

Purpose: To eliminate public health and safety concerns caused by the presence of a vertical opening. A public park complete with hiking trails promotes intense public visitation within the project site. Access to a 350 feet deep abandoned vertical mine opening was eliminated.

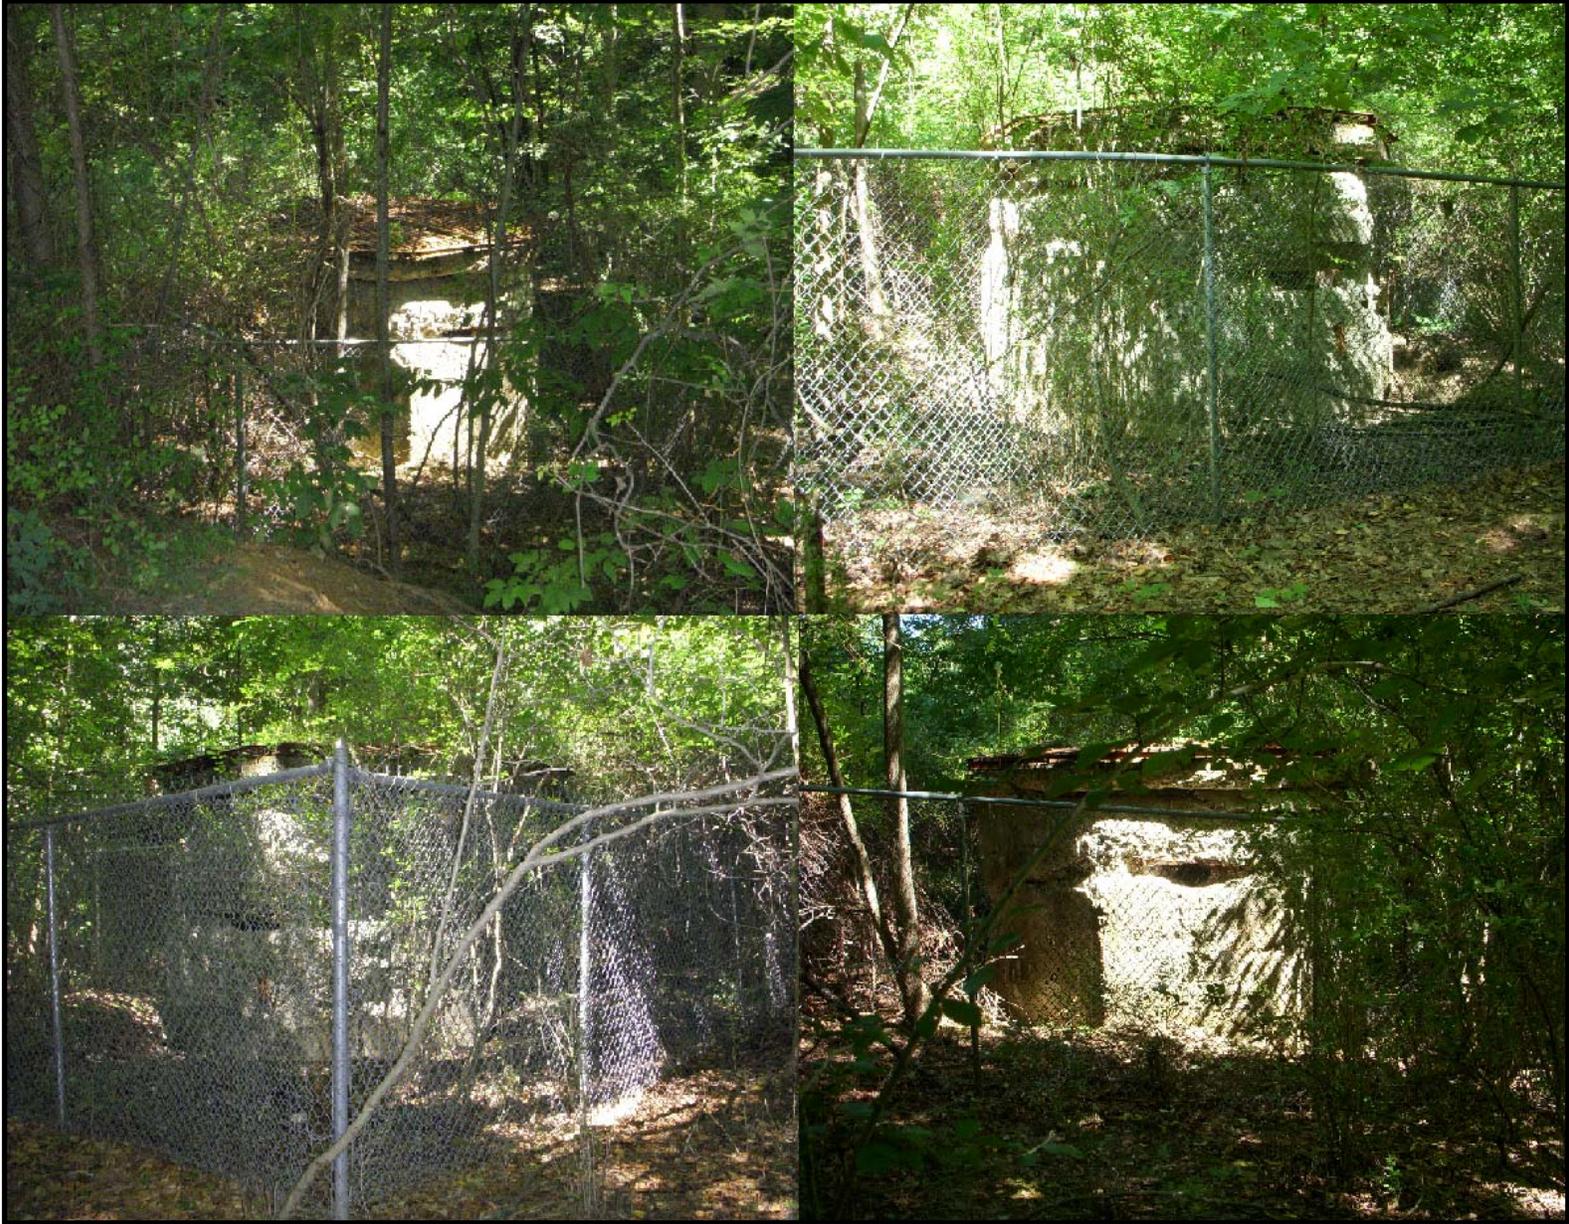
Pre-Construction

Shaft prior to reclamation

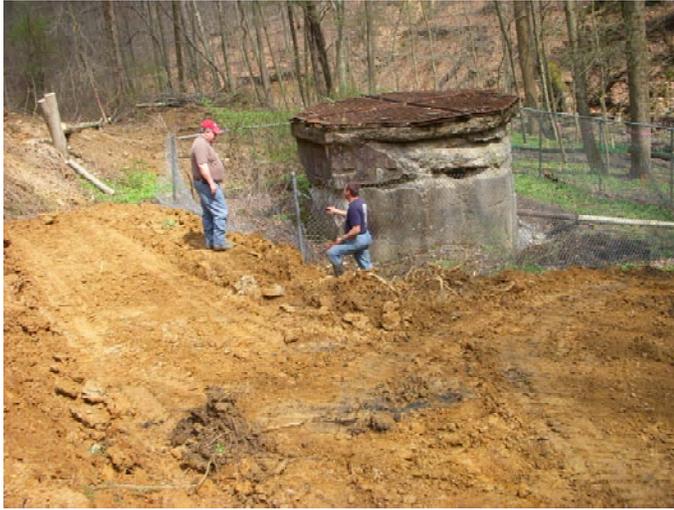
Filling shaft (Note: Grout line on right)
Removing fence

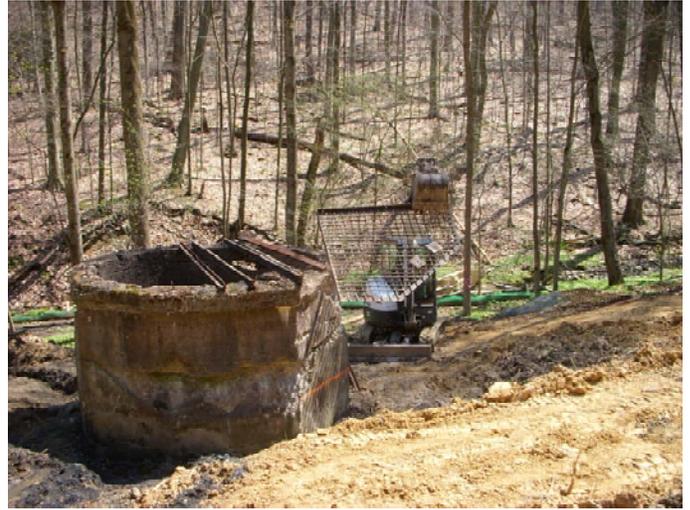
Removing grate and rails from top of collar

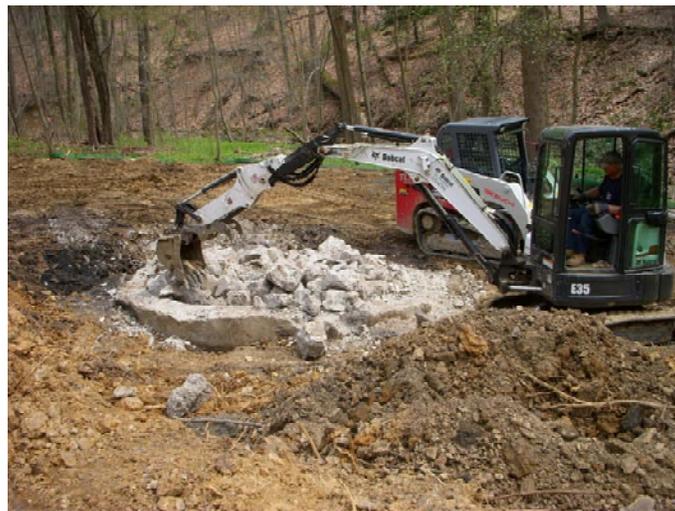
Demolishing collar and placing it into shaft

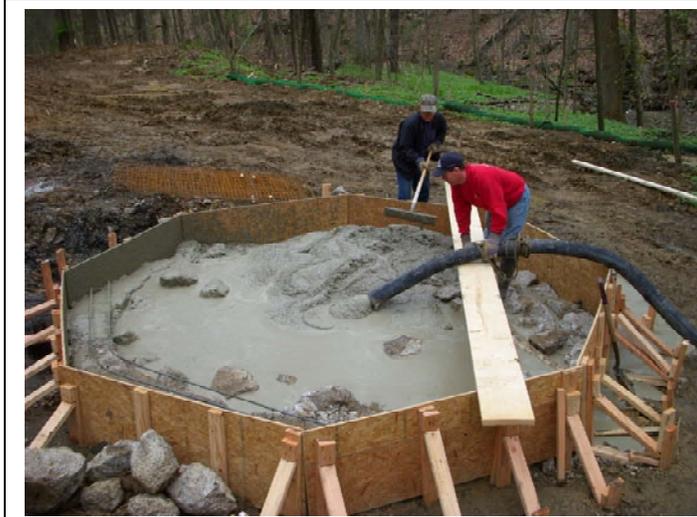
Steel reinforced concrete grout cap work being performed

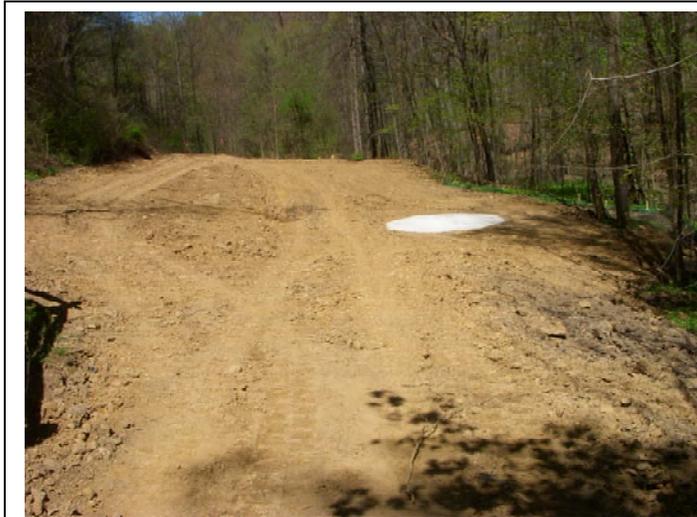
Site grading

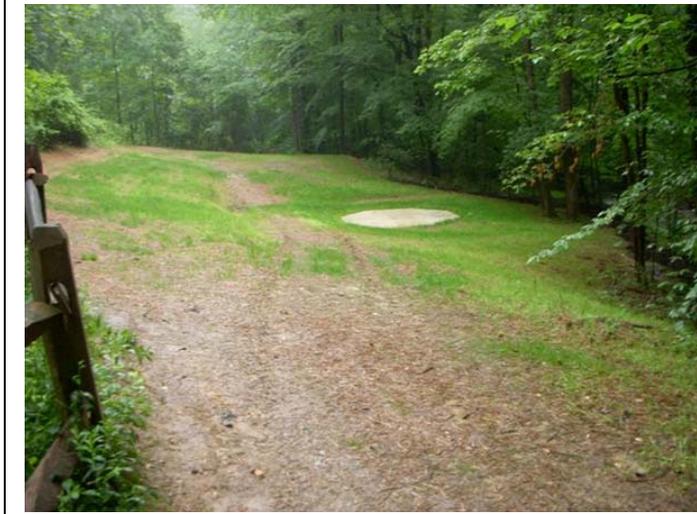
Site restoration – seeding and mulching

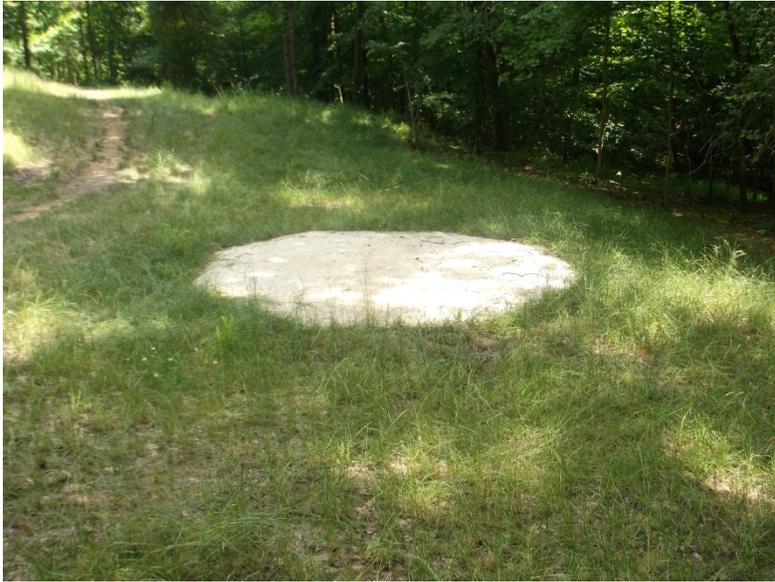
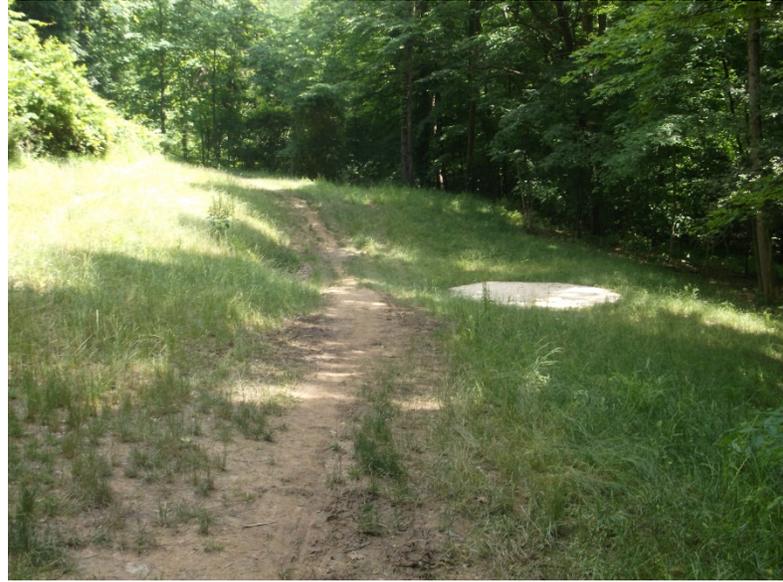
STACKHOUSE PARK
OSM 11(1052)101.1
Post-Construction
(One Year After)

Shaft area reclaimed – illustration of vegetation

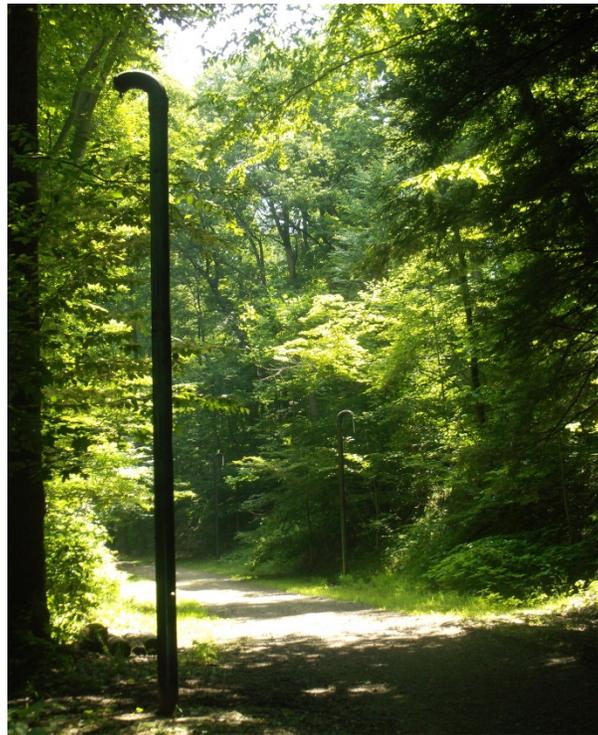
Monitoring wells
