435 FOOTE AVENUE SUBSIDENCE Abandoned Mine Reclamation Project Contract No. OSM 40(2237)102.1 EMER

435 FOOTE AVENUE SUBSIDENCE ABANDONED MINE RECLAMATION PROJECT CONTRACT NO. OSM 40(2237)102.1 EMER

FACT SHEET

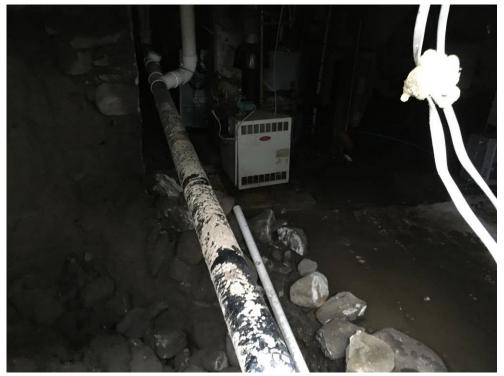
AMLF 2237-10 (VO): In the southwest corner of the basement, the subsidence appears to be choked off by foundation material and soil with no venting observed.

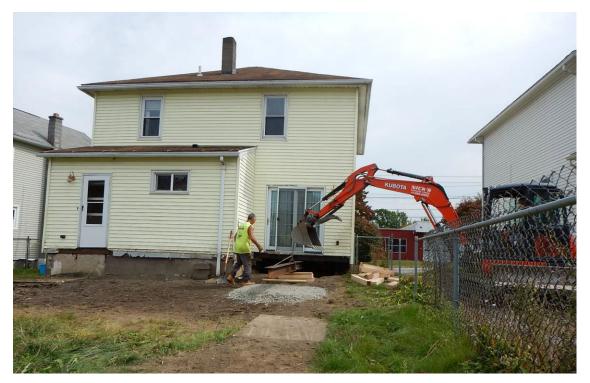
Installation of a 40-foot-long steel I-beam under the home.

The project also included the installation a 40-foot-long W8 x 24 steel I-beam under the house to stabilize the structure before proceeding with subsidence backfill work. A W8 × 24 I-beam has a depth of 8 inches and weighs 24 pounds per A wooden deck at the rear of the property was permanently removed and a portion of the chain link fence was temporarily removed to gain access for the beam installation and drilling of boreholes. Nine vertical boreholes and one angular borehole were drilled to determine if voids existed near and surrounding the subsidence area, Abandoned Mine Lands (AML) feature 2237-10 (VO), which is a vertical opening located in the former Seneca Colliery. Mine openings were discovered in three of the vertical boreholes, and six (6) inch casing was installed. A total of 29.5 cubic yards of concrete material and 102.5 cubic yards of flowable fill material was injected into the boreholes and placed atop the subsidence area in the basement. Upon completion, all boreholes were sealed, the chain link fence was replaced, topsoil and a grass seed mixture were used to restore the affected lawn area of the backyard, and modified stone was placed and compacted to restore the driveway. The steel beam remains in place.

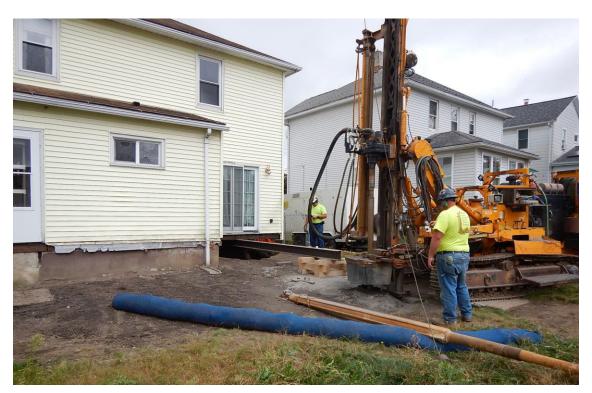
Drilling exploratory borehole in backyard

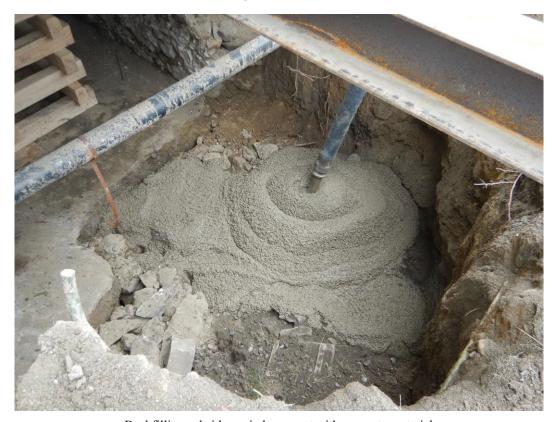
Backfilling subsidence in basement with concrete material

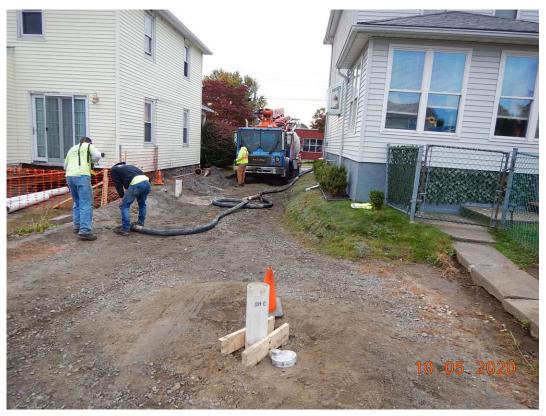
Fill material injection of borehole

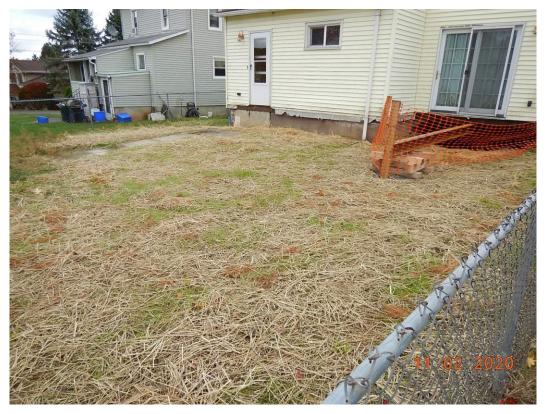
Backyard restored; steel beam remains in place

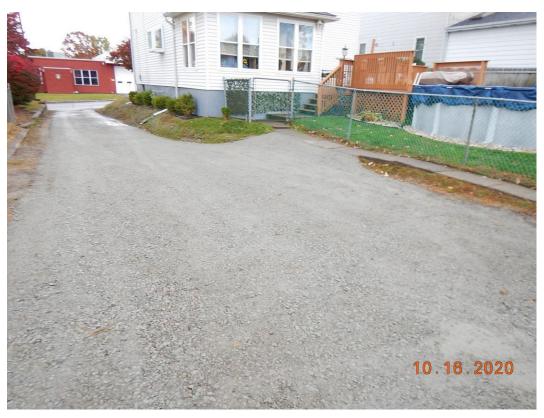
Driveway restored with 2A modified stone
